# ***ANNEX***

*G-1 Project Investigation Sheet*

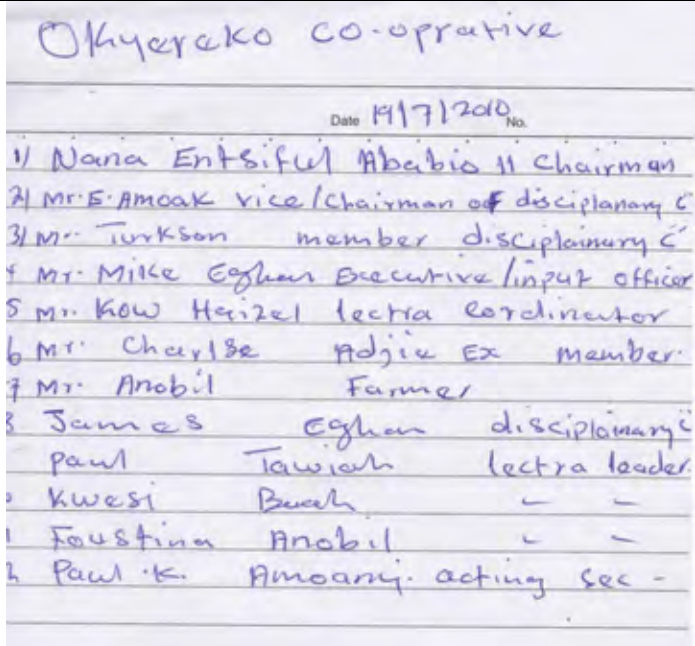
<p>Okyerako CO-operative</p> <p>Date 11/7/2010 No.</p> <ol style="list-style-type: none"> <li>1/ Nana Entsiful Ababio II Chairman</li> <li>2/ Mr. E. Amoak Vice/Chairman of disciplinary C</li> <li>3/ Mr. Turkson member disciplinary C</li> <li>4/ Mr. Mike Eghan Executive/Input officer</li> <li>5/ Mr. Kow Hazel Lectra coordinator</li> <li>6/ Mr. Charlse Adjie Ex member</li> <li>7/ Mr. Anobil Farmer</li> <li>8/ James Eghan disciplinary</li> <li>9/ Paul Tawiah Lectra leader</li> <li>10/ Kwesi Buah - -</li> <li>11/ Faustina Anobil - -</li> <li>12/ Paul K. Amoany acting sec -</li> </ol>

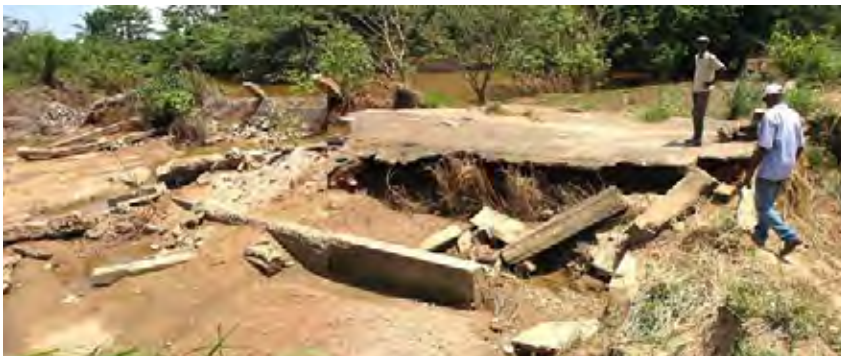
Damaged part by Flood at the  
intake site  
Protection Dyke and Spill way  
were washed out

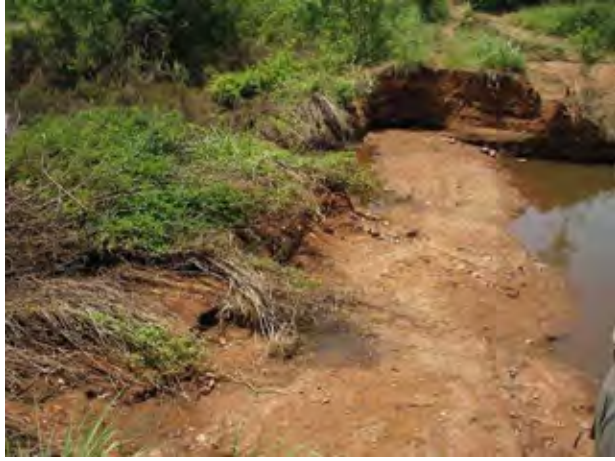
Broken dyke near the pump station

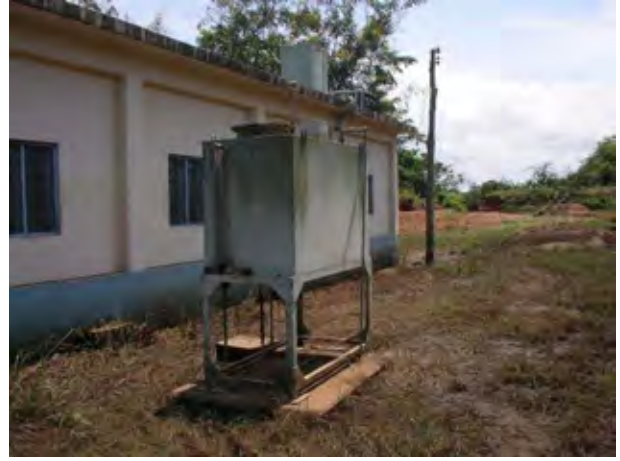
The pump house shows traces of the flood to the middle height of windows.  
Test operation was not conducted after the flood.  
By the way, power transmission lines were stolen. Test operation is difficult to conduct.  
(As shown in the Photo, wooden pole beside the house has no power line.)

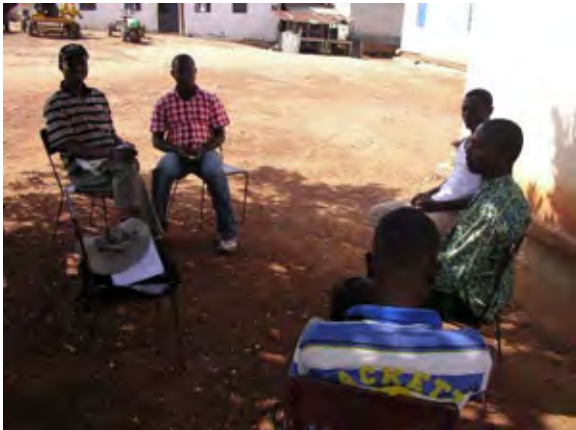
Interview with farmers' representatives:  
Pump units and a small tractor for pump have been left in  
a open space. (See the upper left)

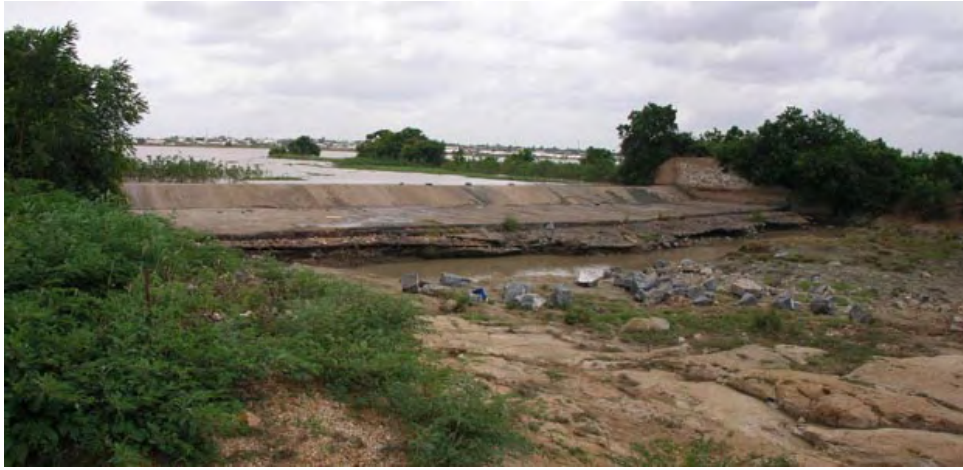
Deteriorated Spillway of the Reservoir (Right bank of the reservoir)

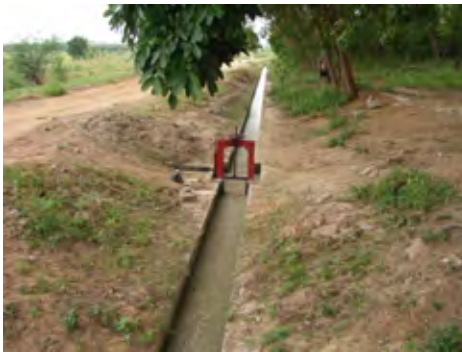
Right Main Canal in Operation

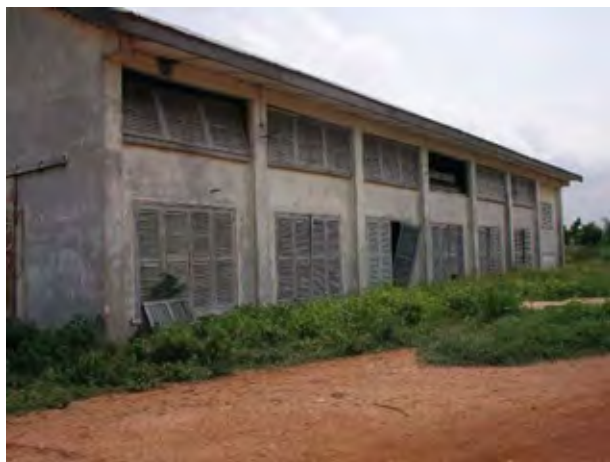
Pump station is not in use because of deterioration.

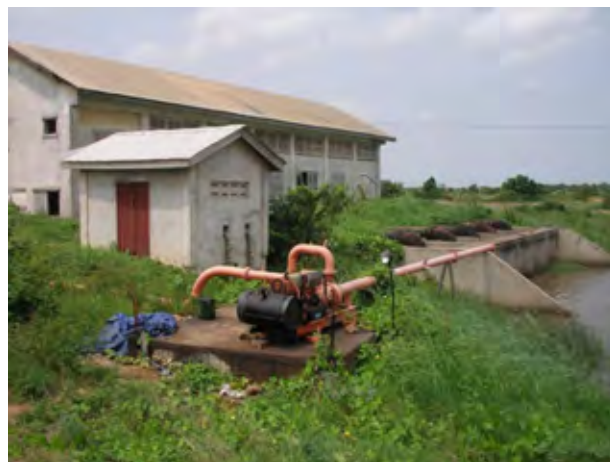
Farmers' own pump installed at suction sump of existing station

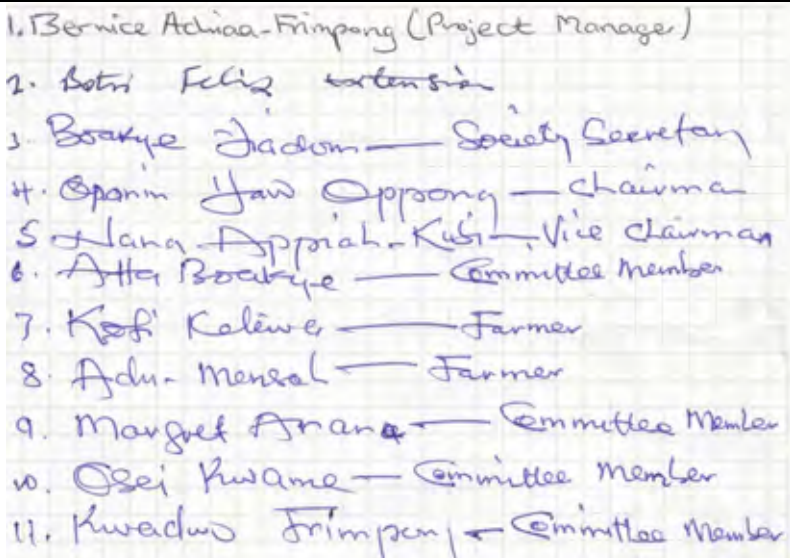
<p>1. Bernice Adhiaa-Frimpong (Project Manager)  2. Botri Felix Katsinda  3. Boakye Jaden — Society Secretary  4. Opanin Jaw Oppong — Chairman  5. Nana Appiah-Kubi — Vice Chairman  6. Atta Boakye — Committee Member  7. Kofi Kelwe — Farmer  8. Adu Mensah — Farmer  9. Margaret Anana — Committee Member  10. Osei Kwame — Committee Member  11. Kwadwo Frimpong — Committee Member</p>

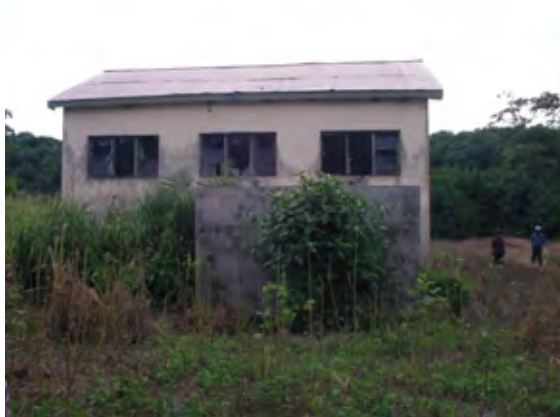
Block -A: Deteriorated Pump House

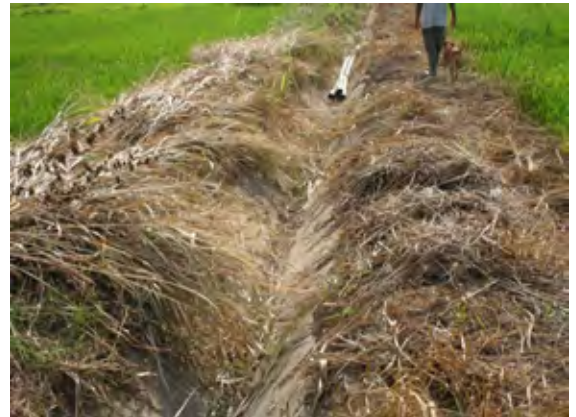
Block-A : a Secondary canal with concrete lining

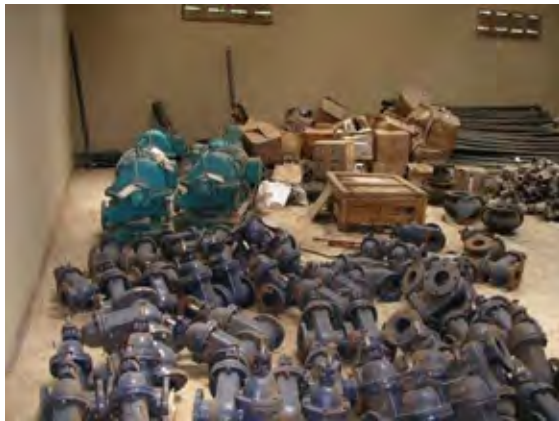
Unused Pump Units caused by wrong delivery

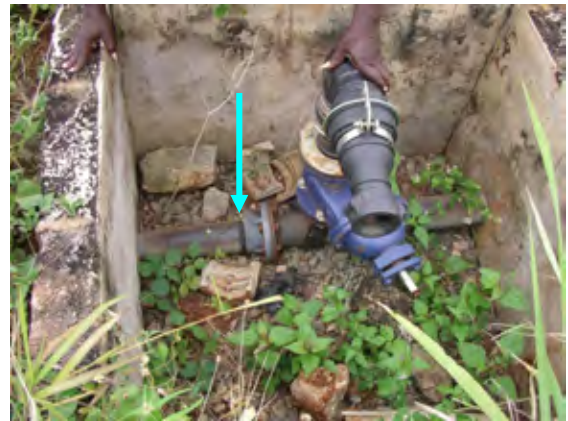
Leakage joint portion (pointed by an blue arrow)

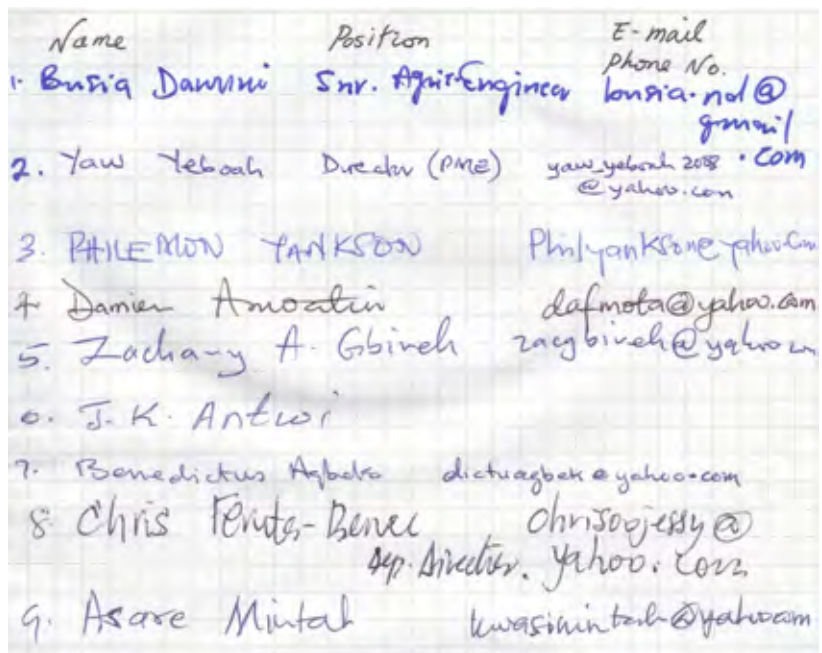
<table><tr> <th>Name</th> <th>Position</th> <th>E-mail</th> </tr></table>

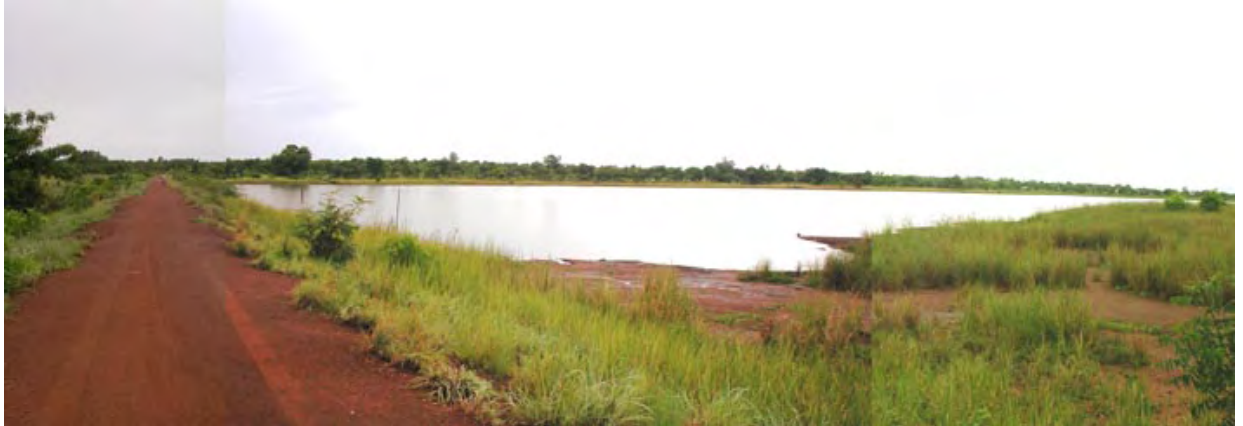
Irrigation Pond rehabilitated in 1999

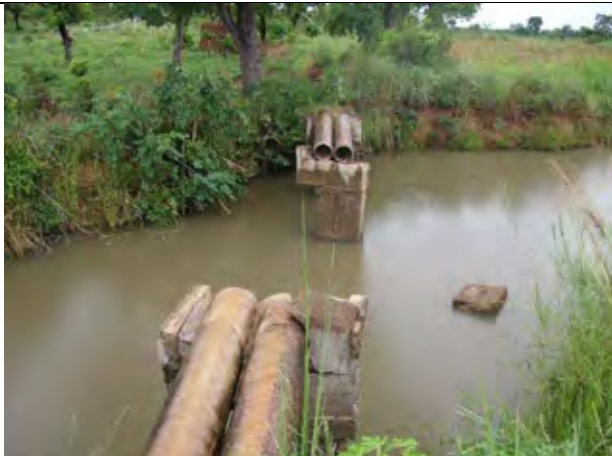
Repair works of concrete patching were carried out by WUA on the right bank.

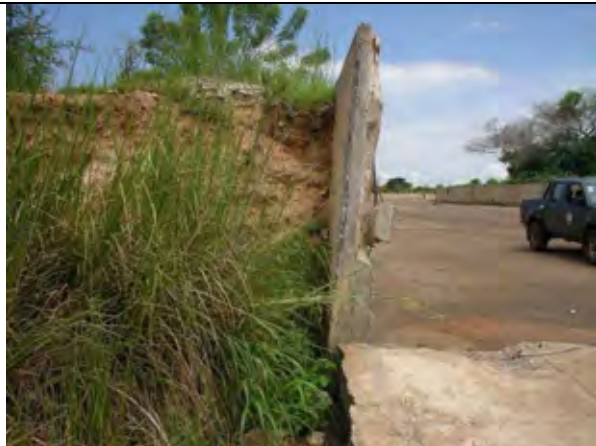
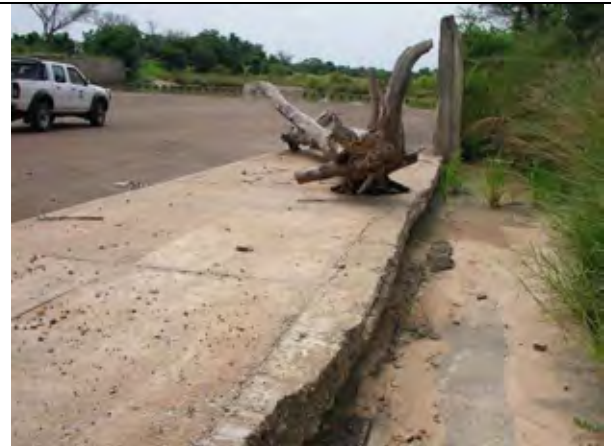
Spillway canal wall collapse was observed along the length of 20m. Without restoration, other wall sections might be affected. Main reason of this collapse might be pressure of high groundwater level in the rainy season, and weak structure of the wall. At least, weep holes should be installed.

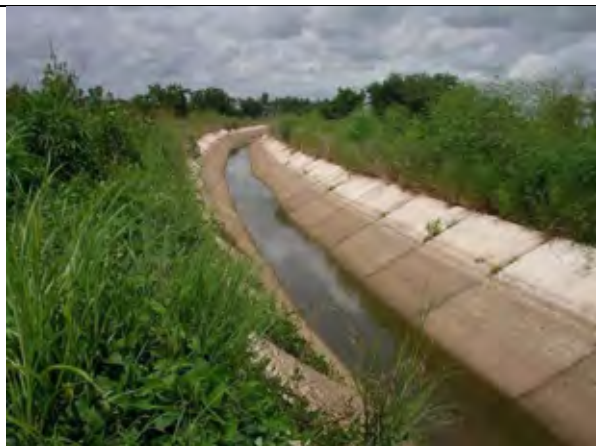
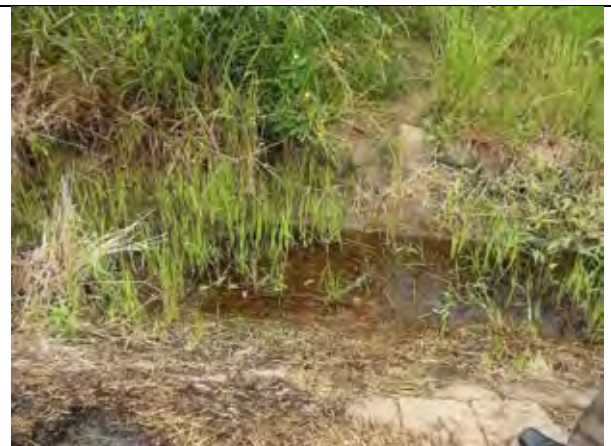
Main canal rehabilitated in 2007 by national budget and CIDA support

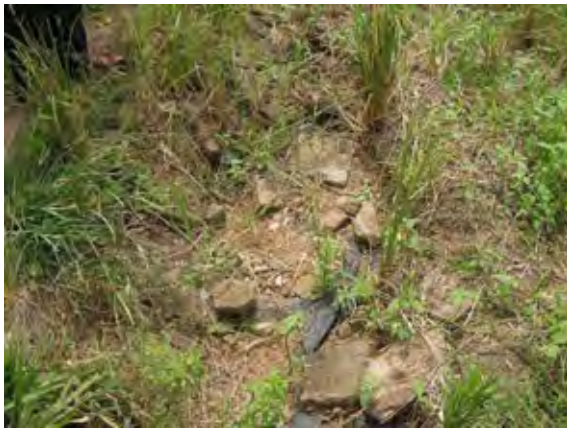
Deteriorated secondary canal. Trace of block lining was seen.

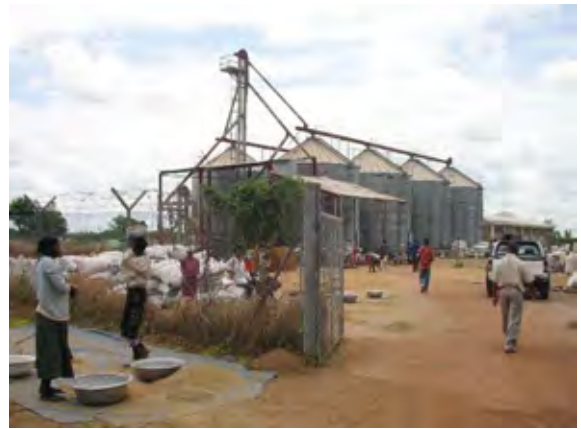
Post harvesting facilities. Silos lost their function due to aging.

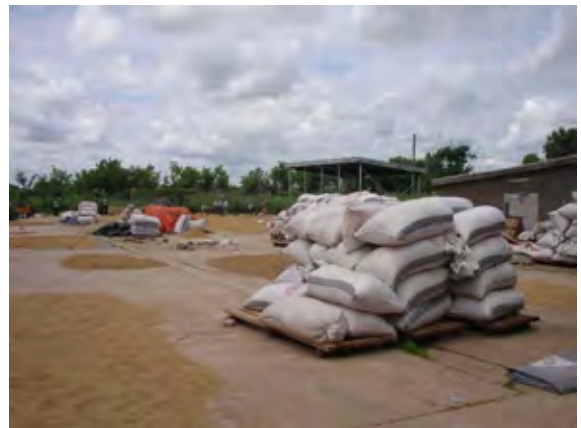
To prevent rice from degradation of quality by rainfall, farmers requested a shed.

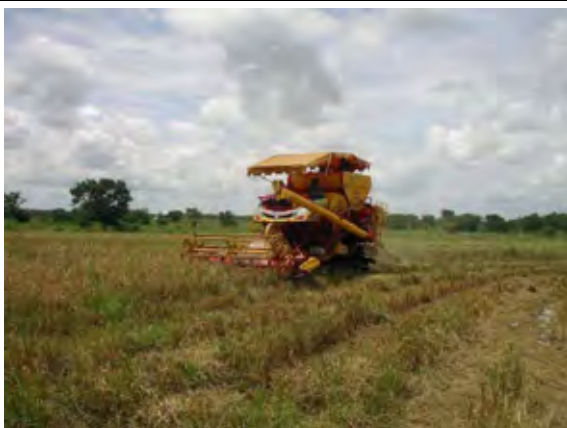
Harvesting was conducted mainly by three combine harvesters. Additional combine harvesters are requested by farmers for timely harvesting.

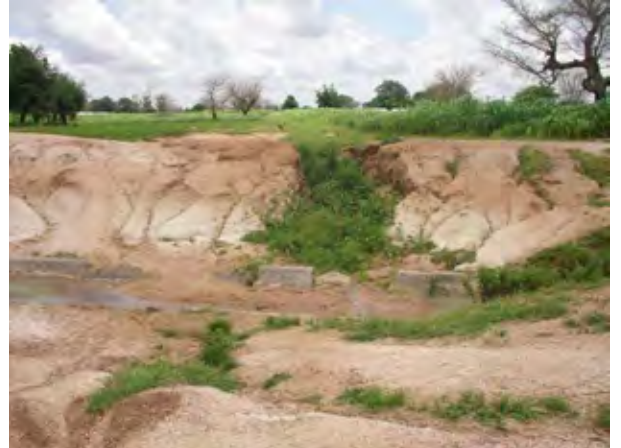
Right Main Canal : Excavated Section  
Deteriorated section by drainage water from outside

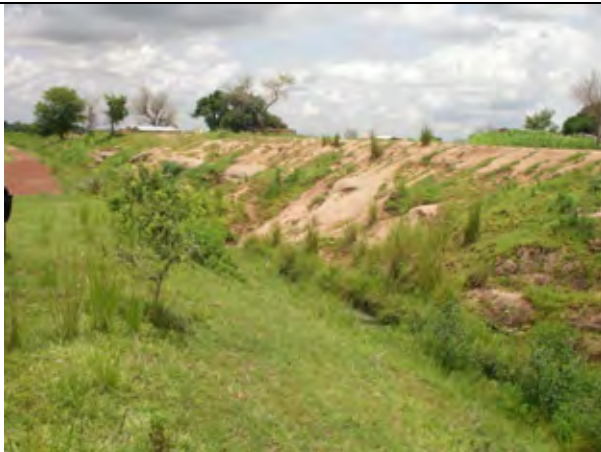
Right Main Canal: Excavated Section  
Maintenance of open canal system is difficult.

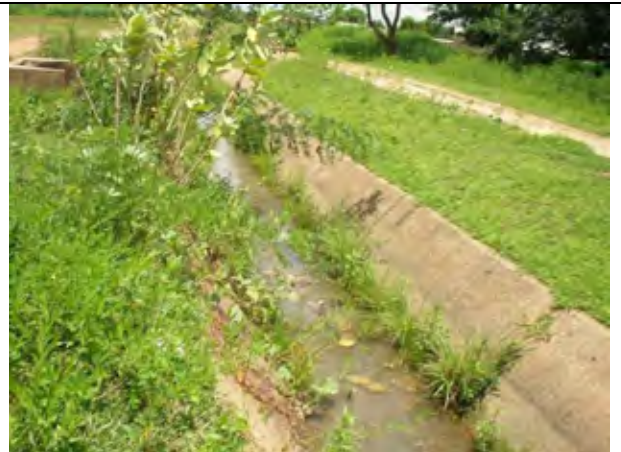
Right Main Canal in the middle part  
Condition of the canal is fair.
