**Ministry of Agriculture and Irrigation
The Republic of the Union of Myanmar**

**THE PROJECT
FOR
PRESERVATION OF FARMING AREA FOR URGENT
REHABILITATION OF AGRICULTURAL
PRODUCTION AND RURAL LIFE IN AREAS
AFFECTED BY CYCLONE NARGIS
IN
THE REPUBLIC OF THE UNION OF MYANMAR**

**FINAL REPORT
MAIN REPORT**

**JAPAN INTERNATIONAL COOPERATION AGENCY (JICA)
SANYU CONSULTANTS INC. NIPPON KOEI CO., LTD.**

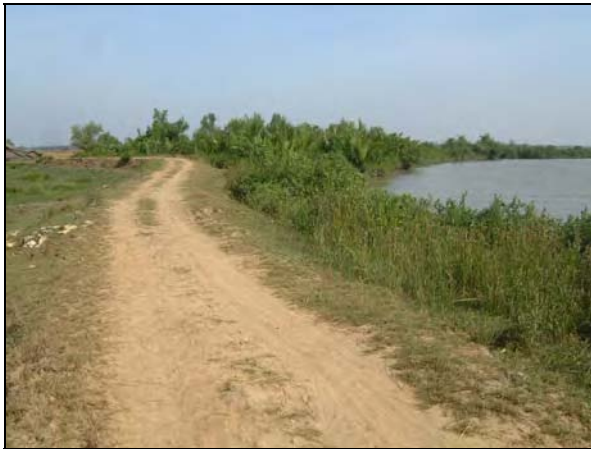
Before Rehabilitation – Polder Dike
Common view of polder dike with farmland, mangrove and river (January 2010).

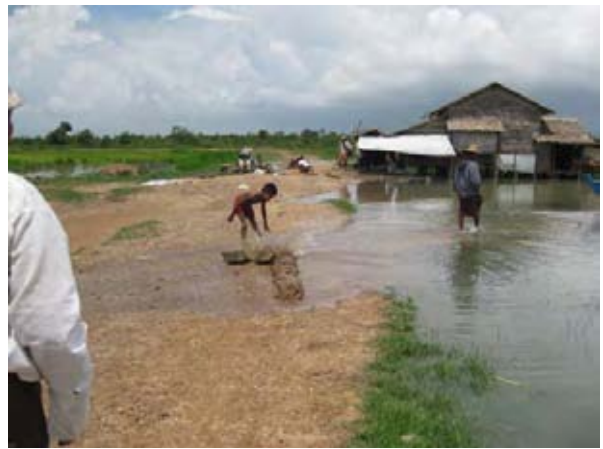
Before Rehabilitation – Polder Dike
Overtopping river water into polder during high tide near Hpobe Sluice (August 2010).

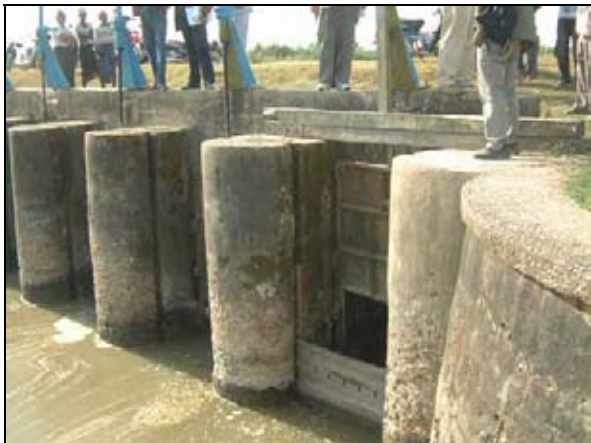
Before Rehabilitation – Sluice Gate
Broken slide gate at Danedan Sluice (January 2010).

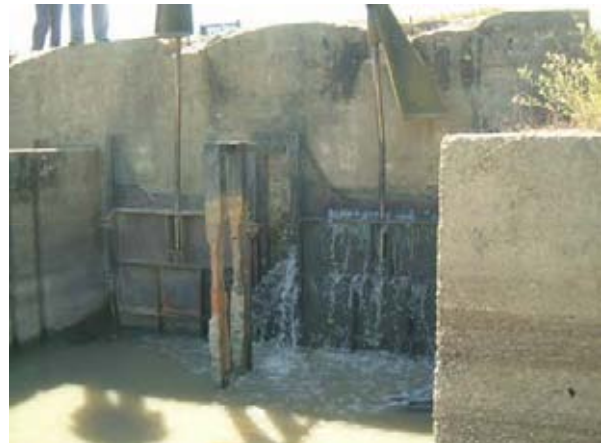
Before Rehabilitation – Sluice Gate
Water leakage due to flap gate non-functioned (January 2010).

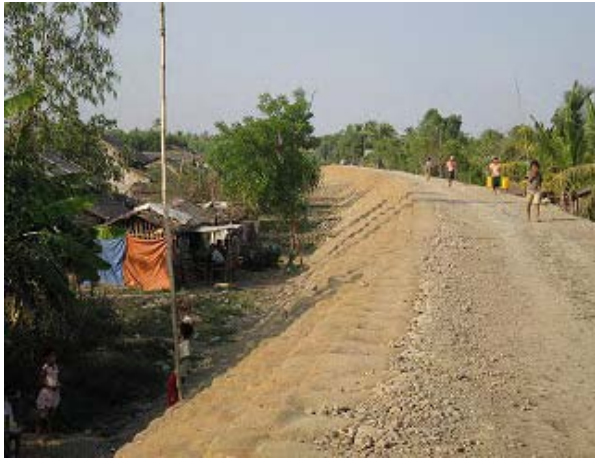
Polder Dike Rehabilitation Work
Completed with manpower embankment.

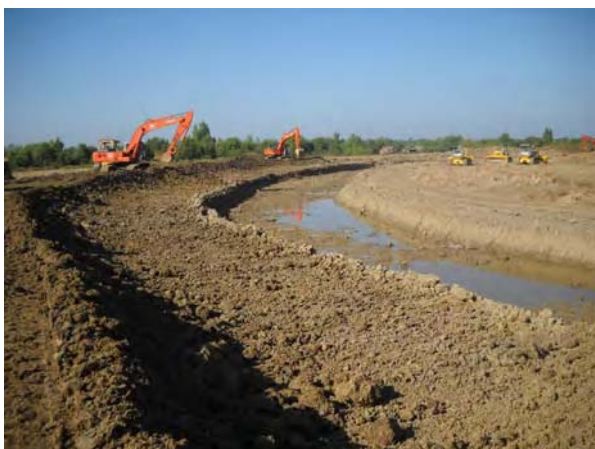
Polder Dike Rehabilitation Work
Under machine embankment work.

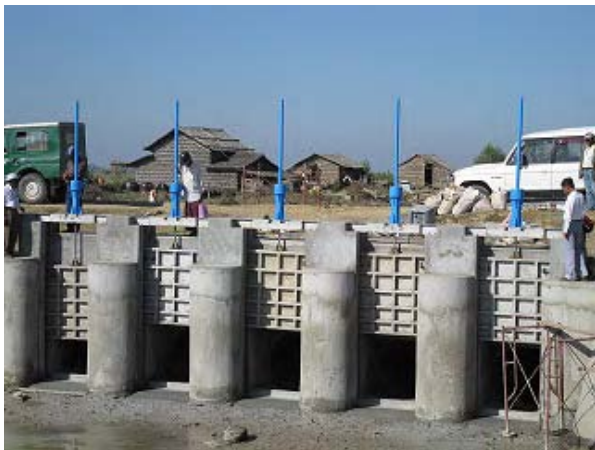
Sluice Rehabilitation Work
Under final setting of slide gates at Mayan
South Sluice.

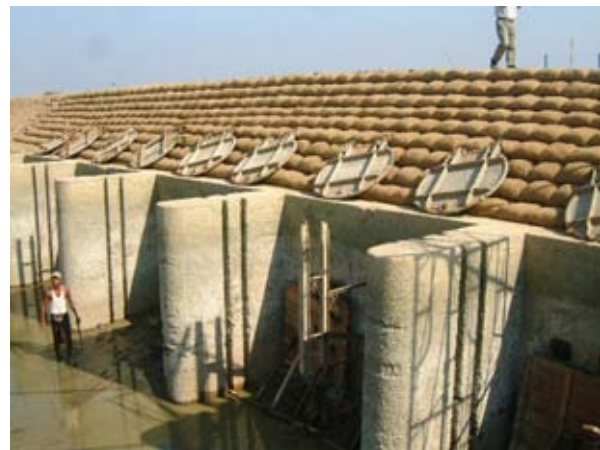
Sluice Rehabilitation Work
Just after removal of existing flap gates at
Hpobe Sluice.

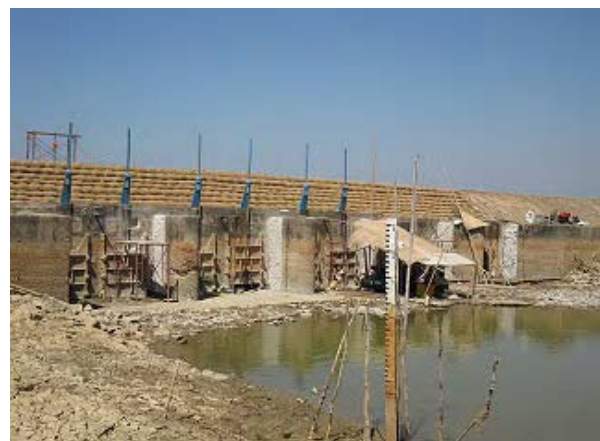
Sluice Rehabilitation Work
Under chipping of existing concrete for
repair of slide gates at Hpobe Sluice.

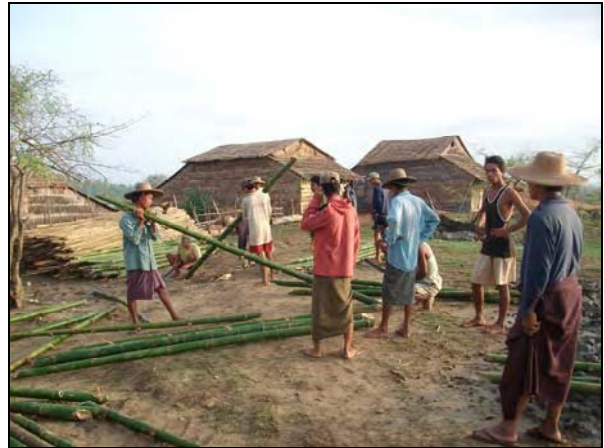
Mangrove Windbreak Project
Preparation of tide protection fence using bamboo by villagers (May 2010).

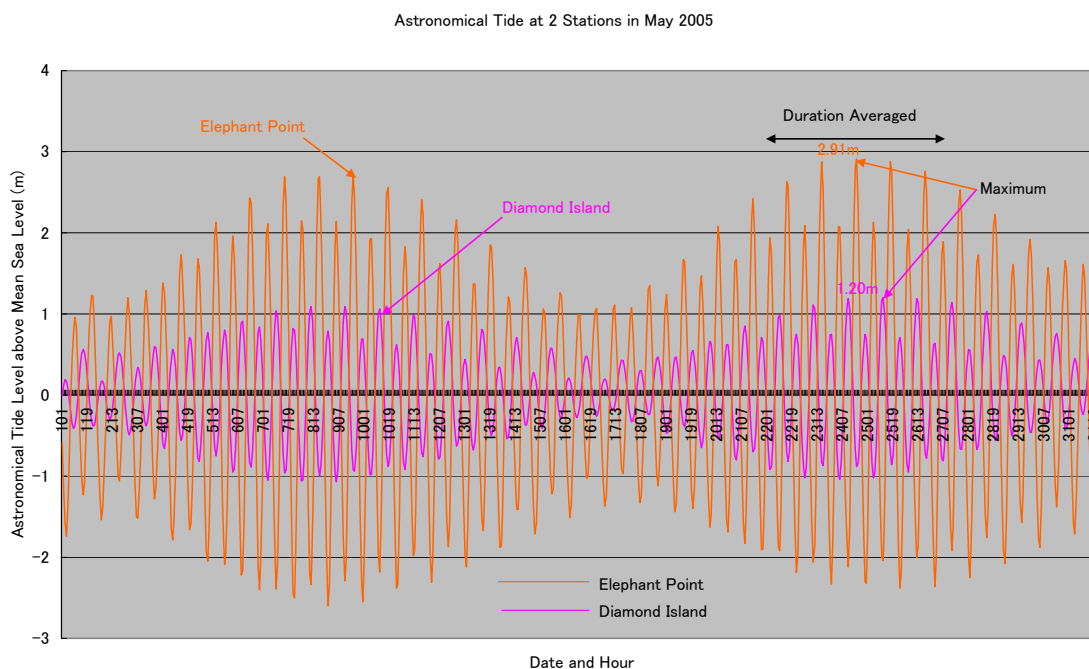
Figure 2.1-3 Astronomical Tide at Diamond Island and Elephant Point

The tidal regime along the coast of the delta is mainly semi-diurnal in character, but with significant diurnal variations. In total, 12 ocean outfalls of the delta are spread along about 250 km of coastline. The spring tide range varies from a minimum of 1.5m at the Phyapon River entrance to a maximum of 5m at the entrance to the Yangon River (Elephant Point). The phase of the main M2 tidal constituent at the mouth of the Yangon River is about 6 hours later than that at the Bassein River entrance. Astronomical tides calculated at both Diamond Island, some 10 km off the Bassein River entrance, and Elephant Point is given in **Figure 2.1-3**.

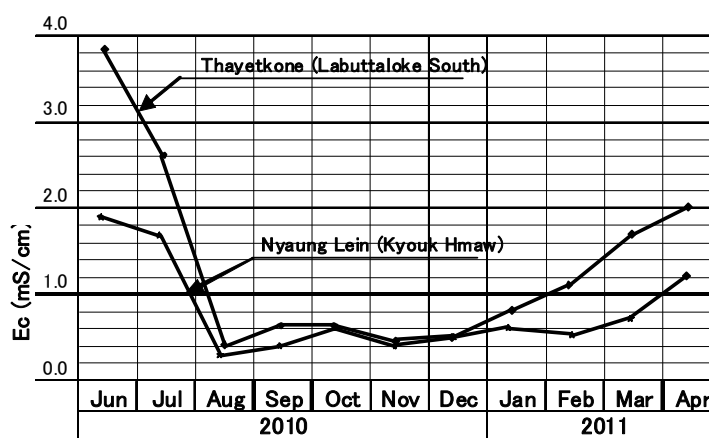
Figure 2.4-2 Ec of Canal Water for Irrigation of Vegetable

The pilot project of high quality paddy seed production and the pilot project of vegetable cultivation for income generation have been implemented. The paddy seed production was implemented during the wet season and no direct irrigation water supply was expected from drainage canals, however, vegetable cultivation was expected to produce vegetable during the dry season, and naturally the water from the drainage canal was the vital source for irrigation to the vegetable cultivation. EC values were obtained from the drainage canals where the pilot project of vegetable cultivation was implemented. These drainage canals are located several hundreds meters away from the sluices and the obtained EC values are less than 3 mS/cm excepting one measurement in June before starting the vegetable cultivation. The EC values obtained in the periodic measurements are less than 2 mS/cm and it was judged adequate to be used for irrigation water for vegetable cultivation.

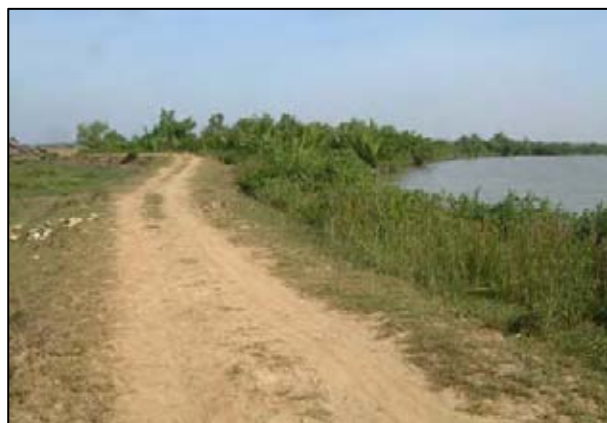
Present Condition of Existing Dike: Small & Low
(January 2010, at the time of high tide)

It is judged from the field inspection that the crest elevation of polder dikes had already lowered considerably by about 0.9 - 0.6m (4.0 - 3.0 ft) on the average before the cyclone Nargis, from their original heights when constructed by Lower Burma Paddy Land Development Project, Phase I & II in 1980's, due to settlement of embankment, erosion by rainfall, wind-drift and others. Under those conditions, high tides and high waves of the river induced by the Nargis had overflowed the polder dikes and caused a great deal of damage to the inside of the polder. After cyclone Nargis, emergency restoration works for all damaged polder dikes have been implemented to recover the original height of the embankment by ID.

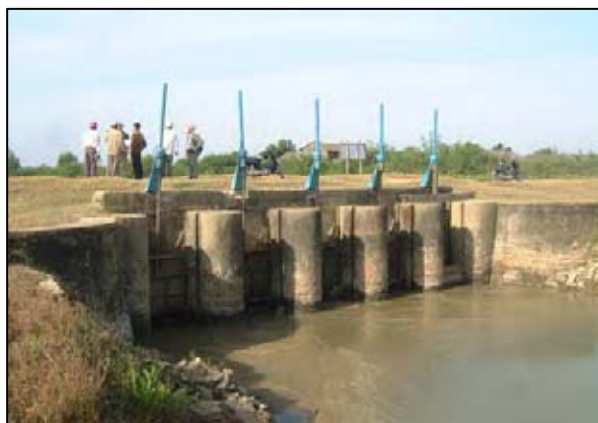
Present Condition of Existing Sluice: Slide Gate Side
(January 2010)

At the sluice facilities, leakage is observed through flap gates as well as slide gates. At some sluices, entire gates have disappeared or gates are not operational due to broken gate hoist including damages of concrete base.

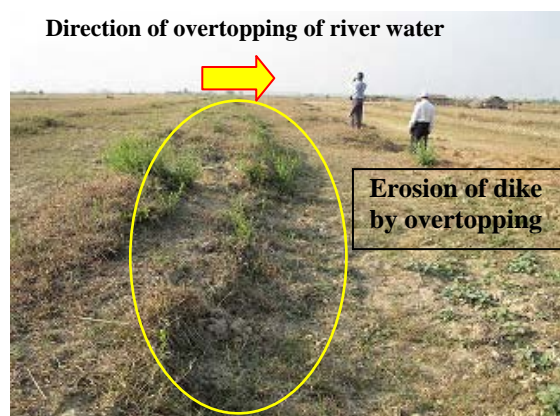
East Side in Labutta (North) Polder
