**THE PROJECT FOR DEVELOPING  
COUNTERMEASURES AGAINST LANDSLIDERS IN  
THE ABAY RIVER GORGE**

**FINAL REPORT  
SUMMARY**

**January 2012**

**KOKUSAI KOGYO CO., LTD.  
JAPAN CONSERVATION ENGINEERS CO., LTD.**

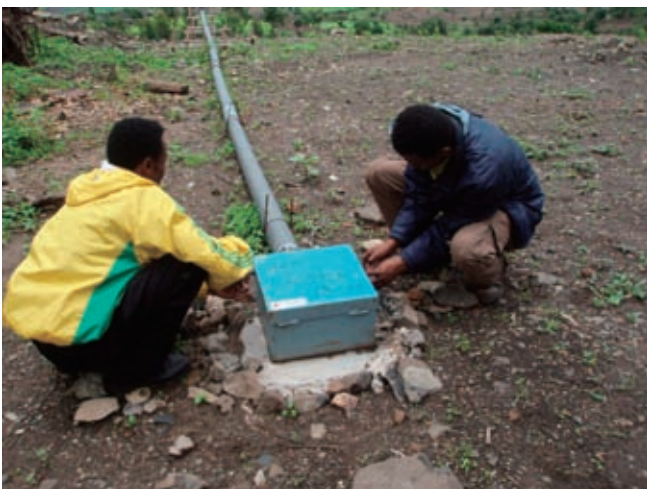
Installed extensometer at the landslide

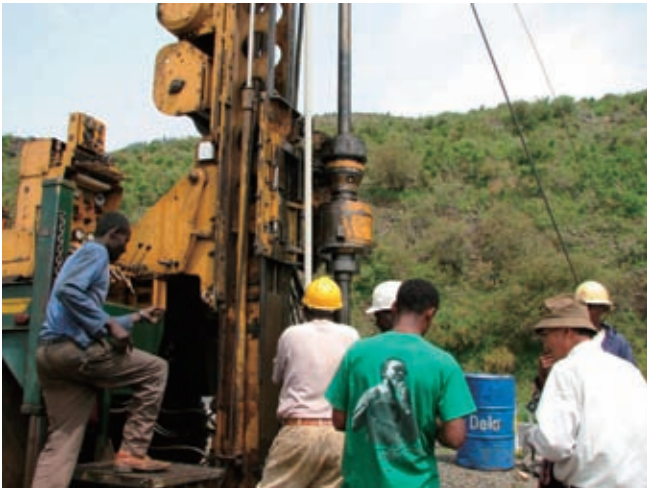
Technical transfer on drilling. Installation of casing  
pipes for inclinometer, 12<sup>th</sup> Jul. 2011

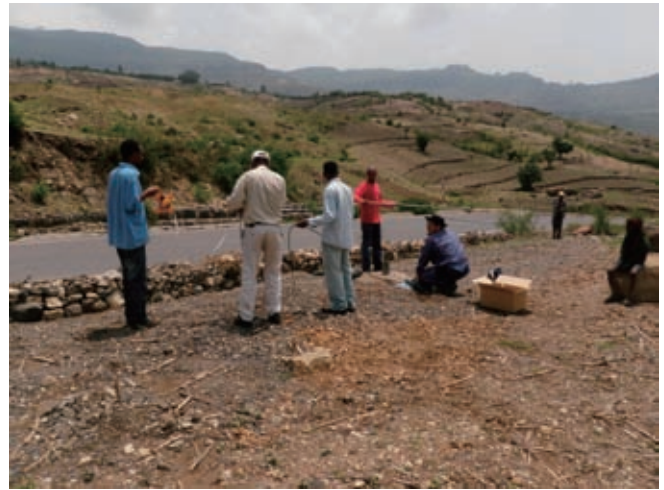
Installation of groundwater level meter, 22<sup>nd</sup> Jun. 2011

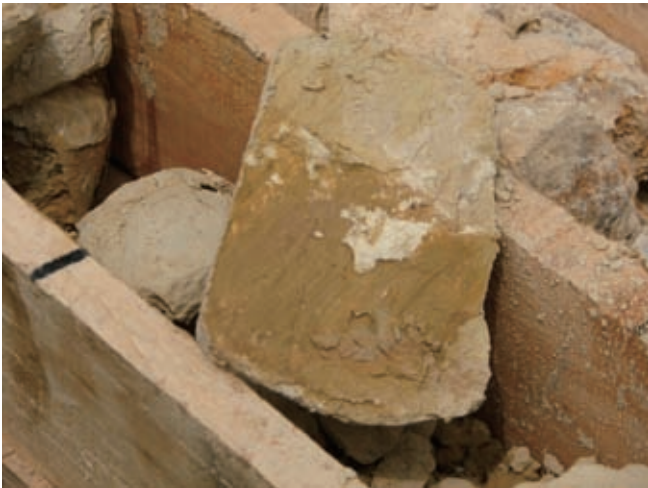
Slip surface on the core at B05-13

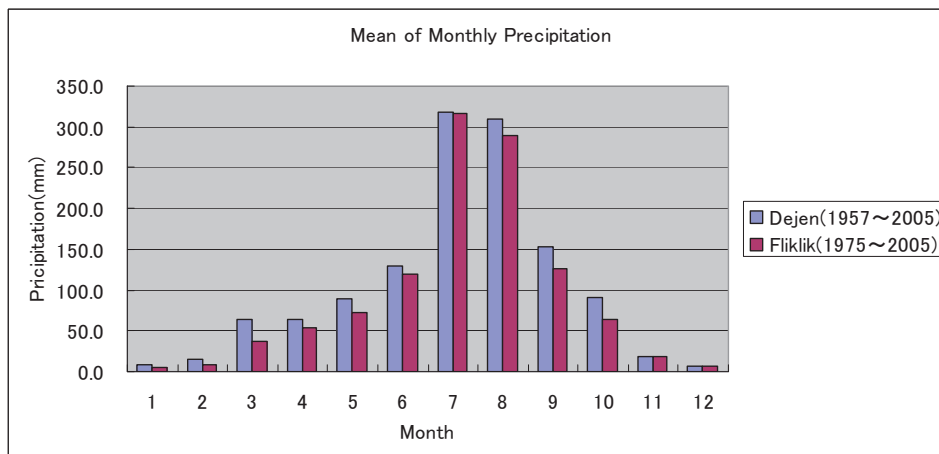
Figure 2.2.2 Mean of Monthly Precipitation

Existing rainfall observation records in the Abay Gorge area are 49 years and 34 years for Dejen town and Filiklik village respectively. In addition, the annual average rainfall is 1,394 mm/year and 1,195 mm/year for Dejen and Filiklik respectively (Figure 2.2.2).

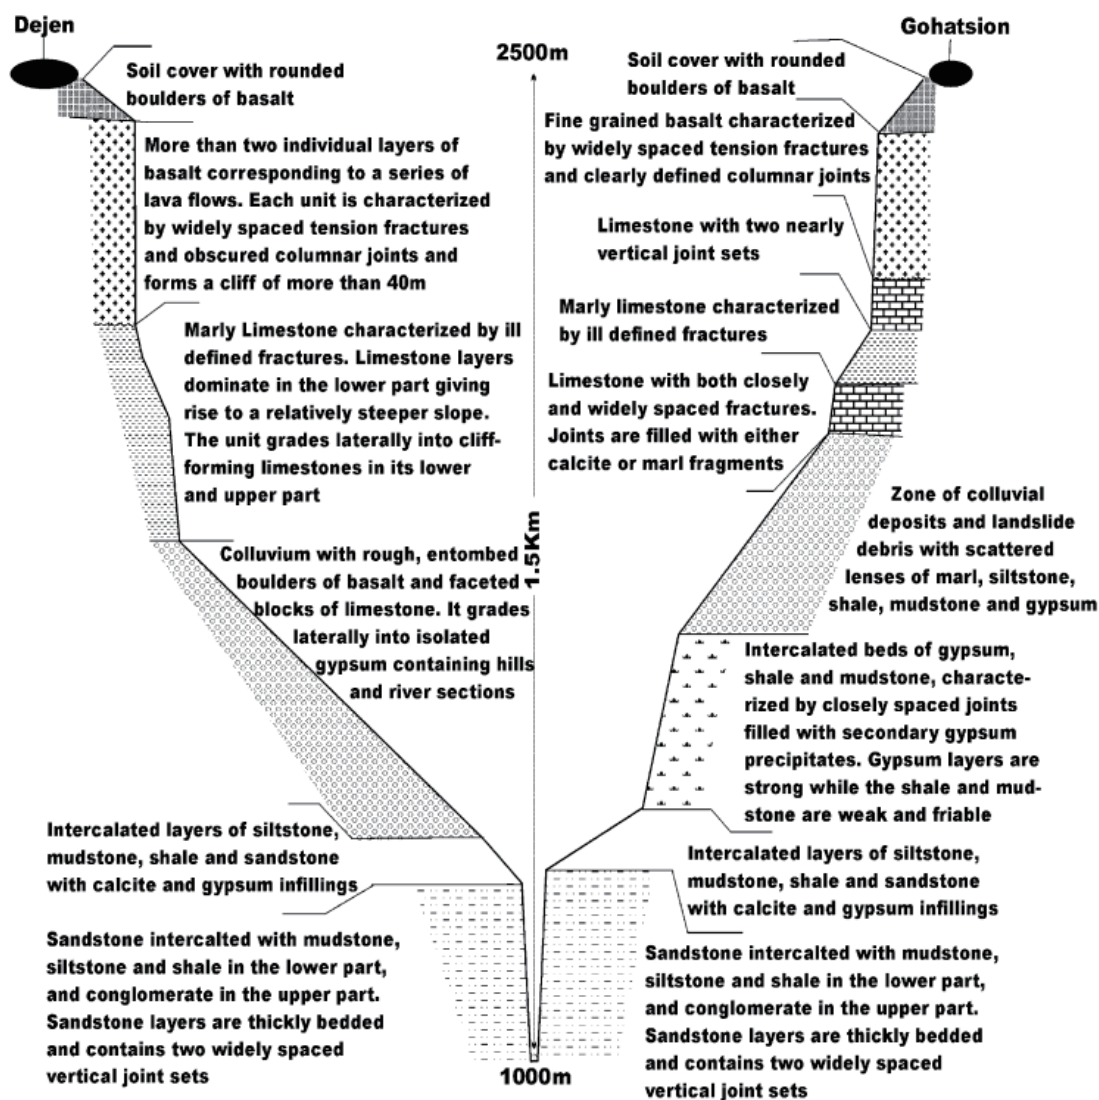
Figure 2.3.2 Schematic geological section in the Abay Gorge (Ayalew and Yamagishi, 2003)

Although the sedimentary and volcanic rocks in the area are exposed largely as symmetrical stratigraphy on both sides of the Abay River, the detailed sequences are unevenly distributed. The sequence in the area is not disturbed due to major faults and is generally horizontally stratified. However, there are a lot of minor normal faults with a down throw of 1-2 meters. Figure 2.3.2 shows a schematic geological cross section of the Abay area (Ayalew and Yamagishi, 2003). The characteristics of the stratigraphy on the major sequences are also described by Almaz and Tadesse (1994).

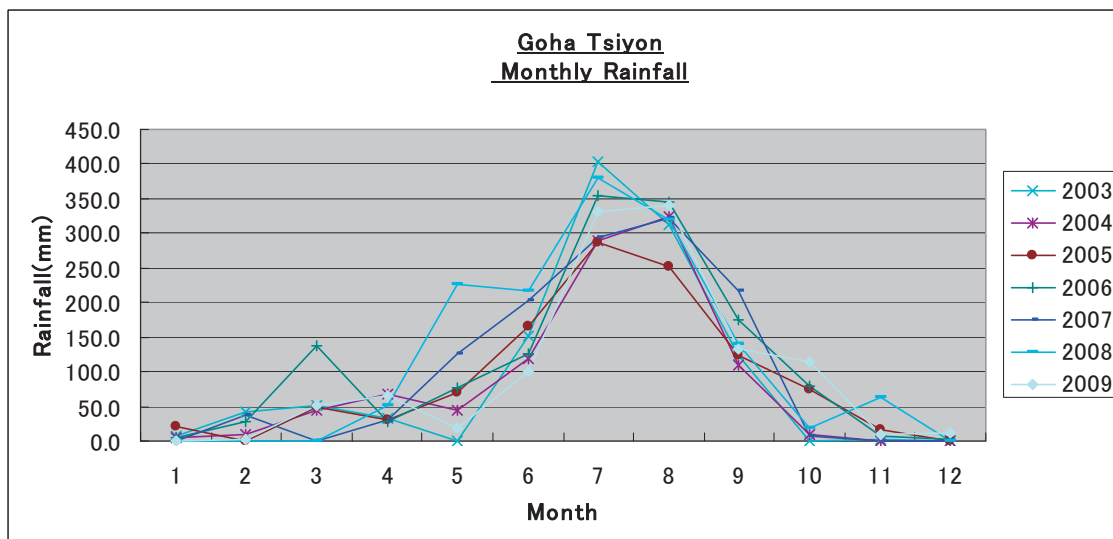
Figure 3.1.1 Monthly Rainfall (Goha Tsiyon)

Monthly rainfall data and return period in Goha Tsiyon station are shown in Figure 3.1.1.

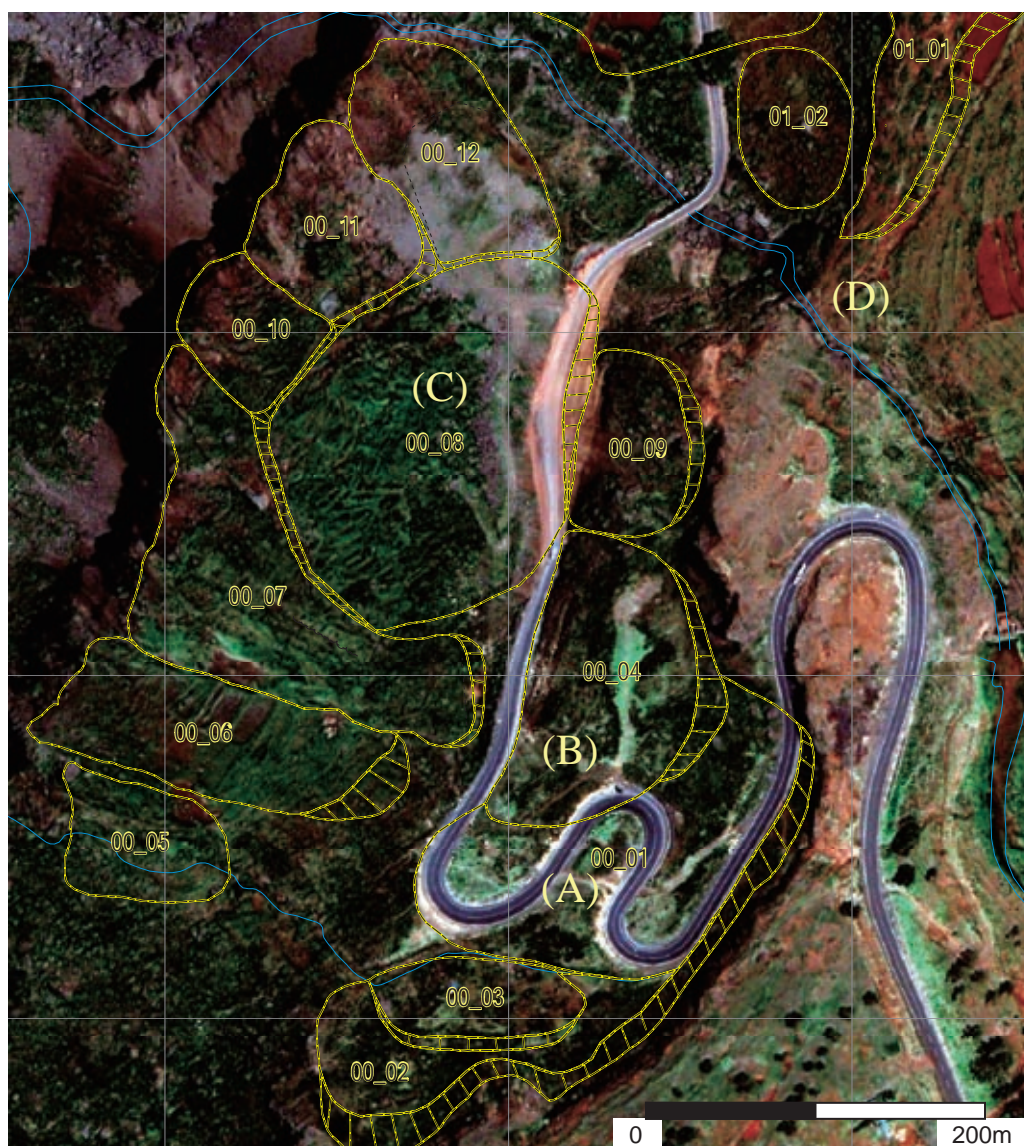
A horse-shoe shaped depression surrounds the S-curve in the road near ST.0+000, which is the scarp of an old landslide (A). Within that, several smaller landslides, thought to have occurred more recently, can be identified. Within this large landslide there is a smaller landslide formation (B).

Landslide (C) is interpreted as moving in-line with or obliquely - west-southwest - to the road, judging from the mound near the foot of the moving mass. There is only one river system here (D), which flows from Goha Tsiyon Town.

Figure 3.3.1 Satellite image interpretation ST.0+000 to ST.1+200
