3.4 Geological Survey

3.4.1 Geology of the landslide area

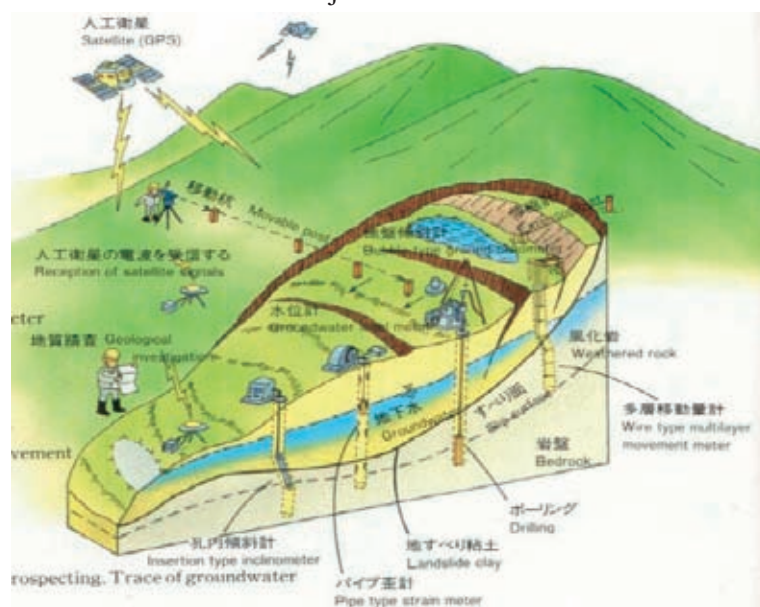
Figure 3.5.1 Various kinds of devices for landslide monitoring

Location	Purpose	Method of monitoring
Borehole	Slip surface survey	Borehole inclinometer measuring
		Pipe strain gauge measuring
		Borehole extensometer measuring
	Groundwater survey	Borehole water level measuring
		Borehole pore pressure measuring
		Groundwater survey Groundwater quality investigation
Ground surface	Ground surface deformation survey	Ground surface extensometer survey
		Ground surface inclinometer survey
		Ground survey
		GPS survey
	Inducing factors survey	Precipitation observation
		Surface water observation
		Seismic observation
		Traffic census (landslide near roads)

Devices in **bold** were installed in the Project.

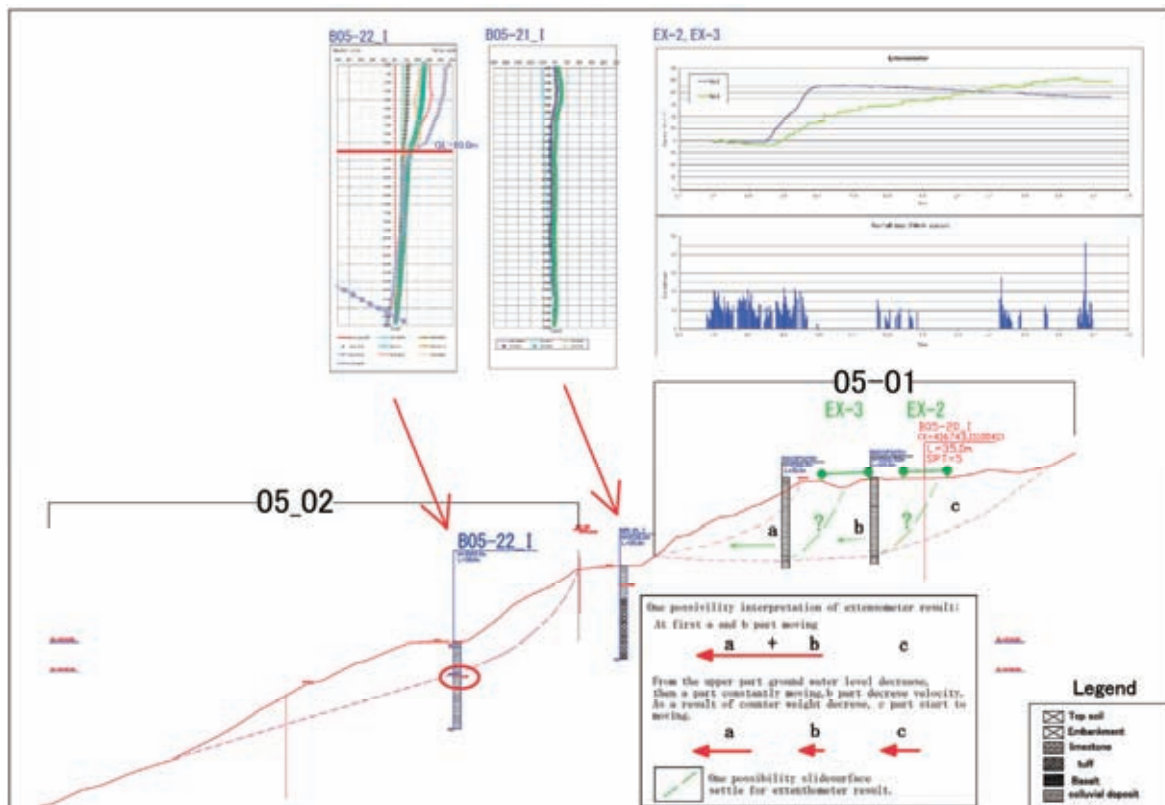
Figure 3.10.2 Summarized cross section on L/S05

Figure 3.10.2 summarized the survey results at the site.

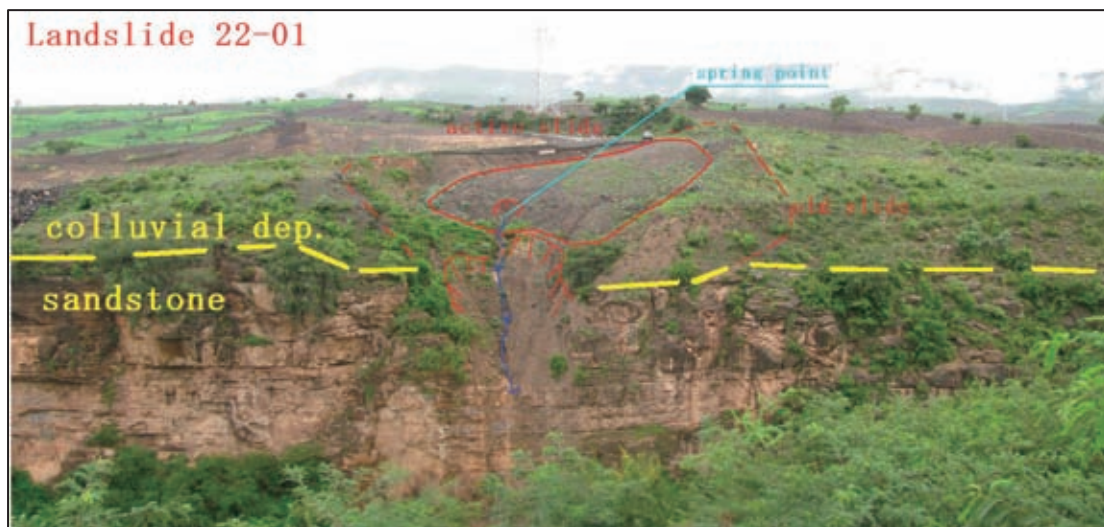
Photo 3.10.1 Landslide 22-01 from opposite side terrace cliff.

On the field observation, the area is included an old large landslide block. The boundary of sandstone and colluvial deposit is considered as a slip surface. The ground water springs out from the upper part of the slip surface. (Photo 3.10.1)

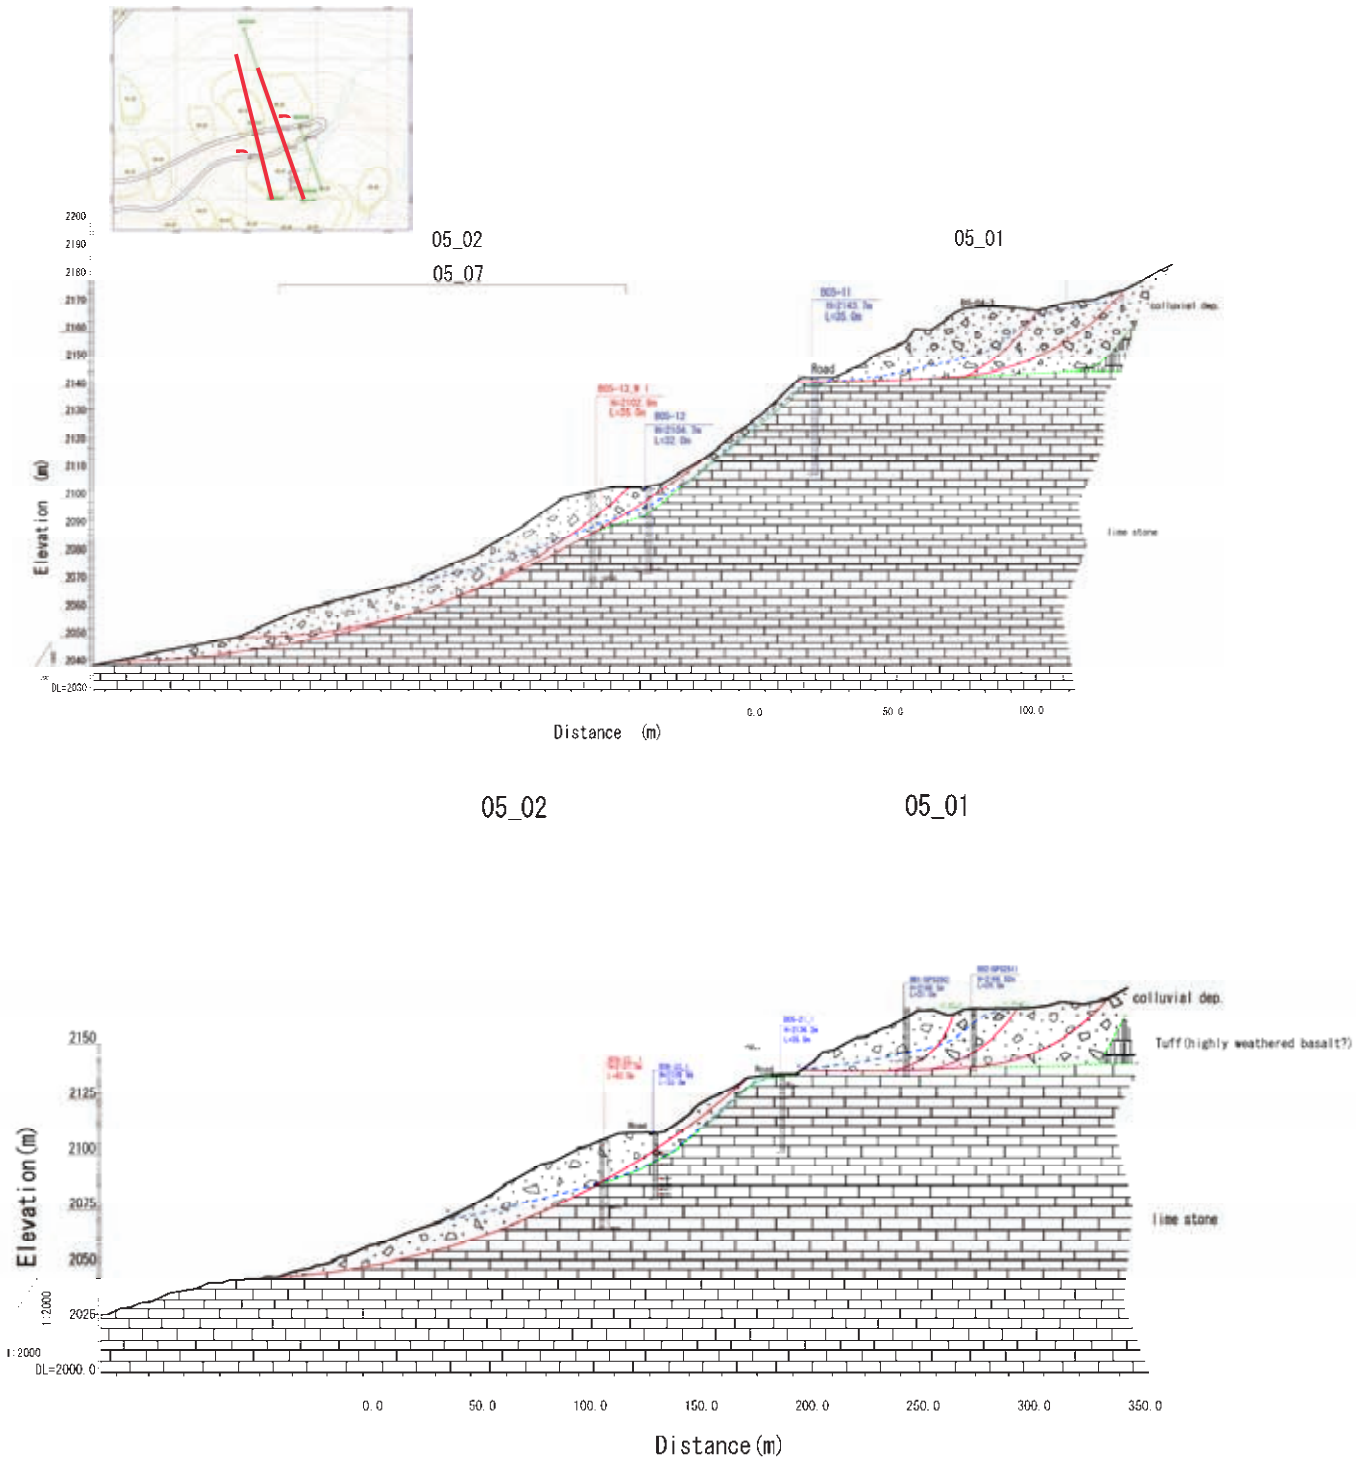
Figure 4.4.6 Geological cross section in L/S05 (above: B0-04, bottom: B0-05)

In this area, two kinds of landslide were identified. Landslide 05-01, located on the upper slope, is classified as a debris movement of past landslide materials. It was initially a rockslide during basaltic material and limestone. And the other (05-02, 05-07) located on the lower slope were classified as debris material landslide derived from upper slopes colluvial deposits.

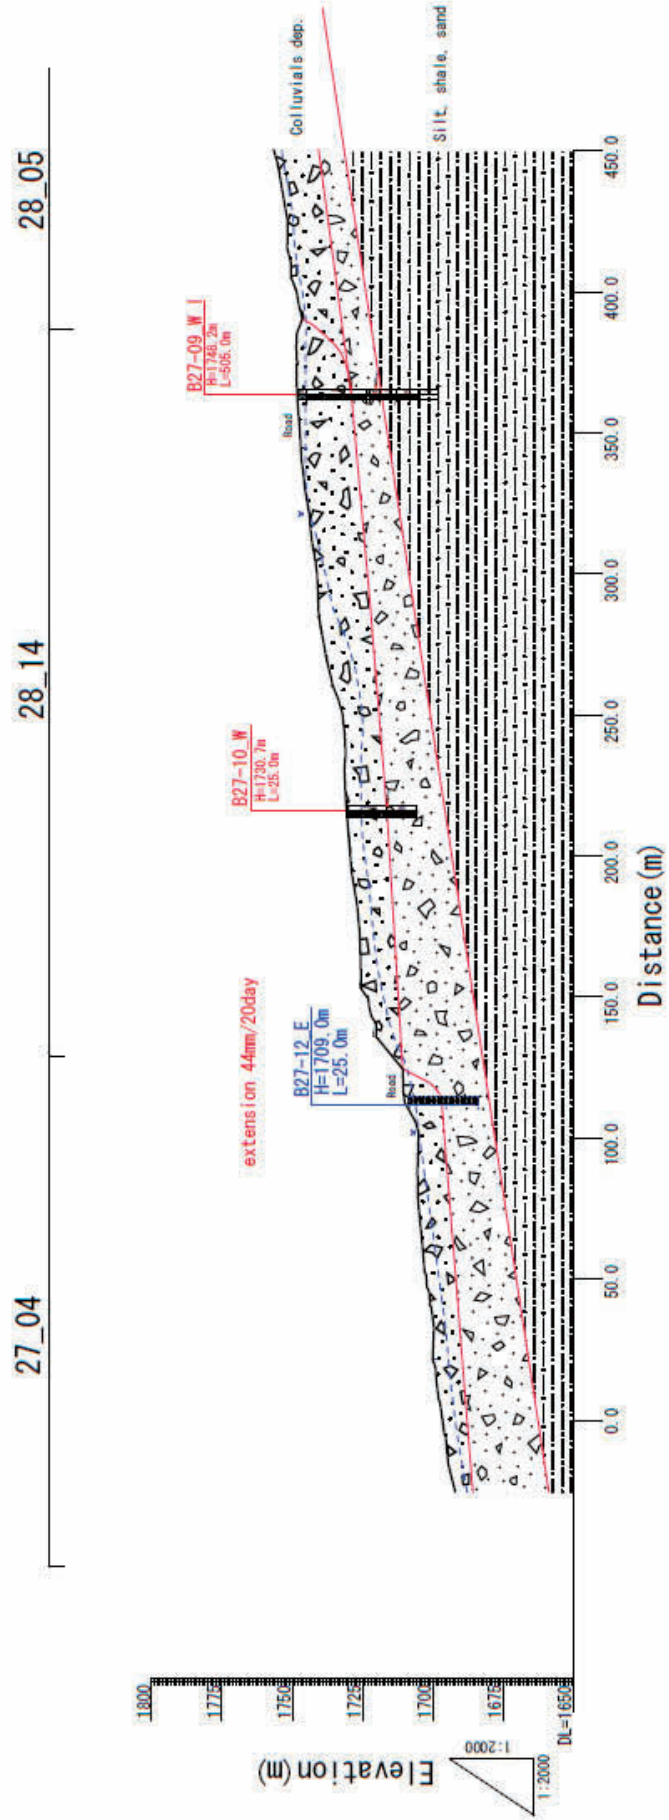
Figure 4.4.9 Geological cross section in L/S27/28 (B0-08)

In this area, two kinds of landslide were classified. Initial landslide is classified as weathered rock landslide that is considered as initially rockslide and debris movement which covered the entire landslide area of L/S27-28. In this area, the basement rocks are not exposed due to weathering or erosion, and are covered by colluvial. Therefore the area is mostly flat planes and/or gentle slopes.

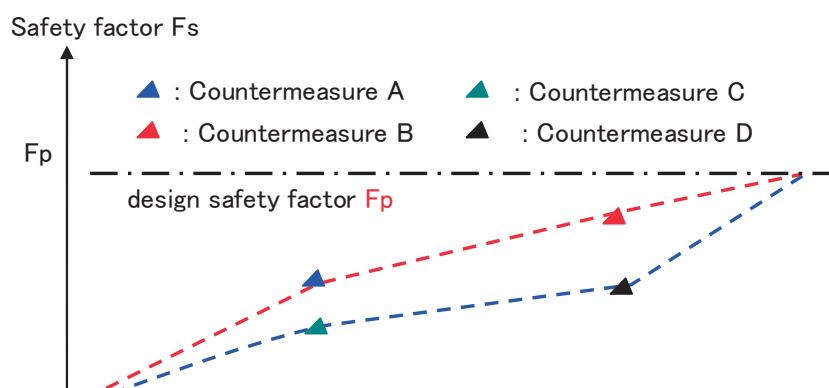
Figure 4.6.1 Using slope stability analysis to evaluate the effect of countermeasure works

In a landslide countermeasure project, combinations of different countermeasure methods should be tested before determining the grand design of the countermeasure plan. Generally, multiple combinations of countermeasure works should be examined according to their cost effectiveness and feasibility. Figure 4.6.1 shows the changes in factor of safety when multiple countermeasure works are applied. Assuming there are two possible combinations to achieve a planned factor of safety (F_p), i.e., a combination of A and B, and a combination of C and D, the necessary number of each countermeasure and the resulting increments of the factor of safety can be estimated through the stability analysis. Based on the stability analysis, an appropriate combination can be decided according to the cost effectiveness and feasibility.

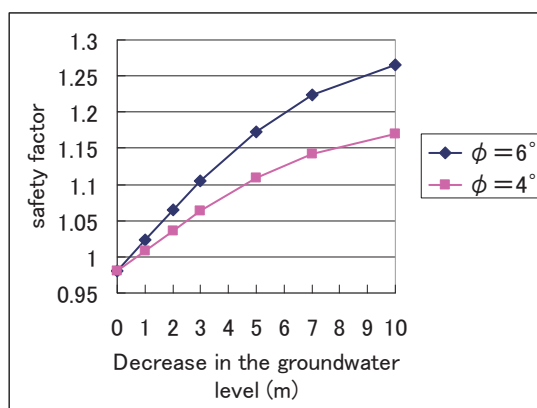
Figure 4.6.2 Changes in the factor of safety in response to decrease in groundwater level

Figure 4.6.2 shows the trial calculation result representing the effect of the groundwater drainage works. It indicates increase in the factor of safety in response to the decline of groundwater level. Two cases are plotted in the figure. Using two sets of specified shear strength parameter ϕ , where one is $\phi = 6^\circ$ and the other is $\phi = 4^\circ$, cohesion (c) was calculated through back-analysis. The results were plotted as blue and pink lines. According to the result indicated in blue when $\phi = 6^\circ$, by lowering the groundwater level (highest groundwater level) by 6 m, the planned factor of safety ($F_p = 1.2$) can be achieved. However, in the case when $\phi = 4^\circ$, the planned factor of safety cannot be achieved even by decreasing the groundwater level for 10 m. It is therefore clear that the effect of groundwater drainage may be overestimated when using a larger friction angle.

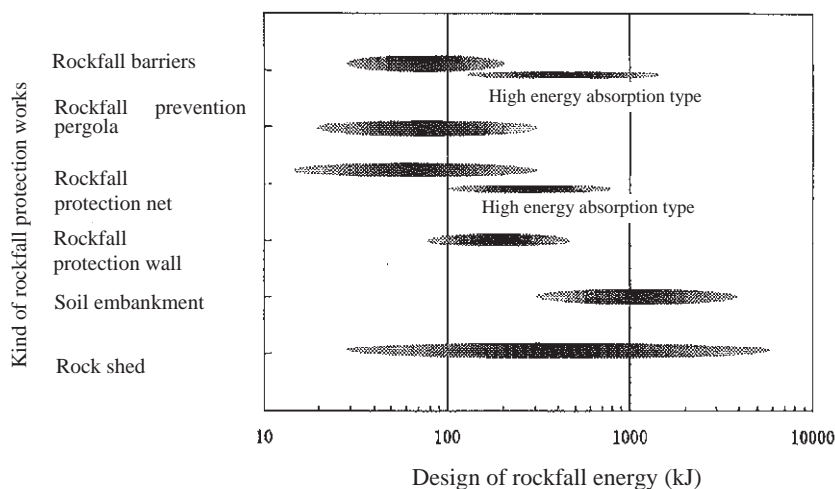
Figure 5.4.2 Guideline for Applicable Range of Rockfall Countermeasures

Selection of the most suitable rockfall countermeasure or combination of countermeasures for the state of the road and the state of the slope at the site should involve consideration of functions, durability, workability, economic efficiency, and potential maintenance and management problems for countermeasures. Selection of the most suitable rockfall protection work should involve consideration of rockfall energy.
