PARTICLE SIZE DISTRIBUTION & LIQUEFACTION POTENTIAL

Client: njs - JICA

Project number: NGTS01011

PROJECT : Port Moresby Sewerage System Upgrading

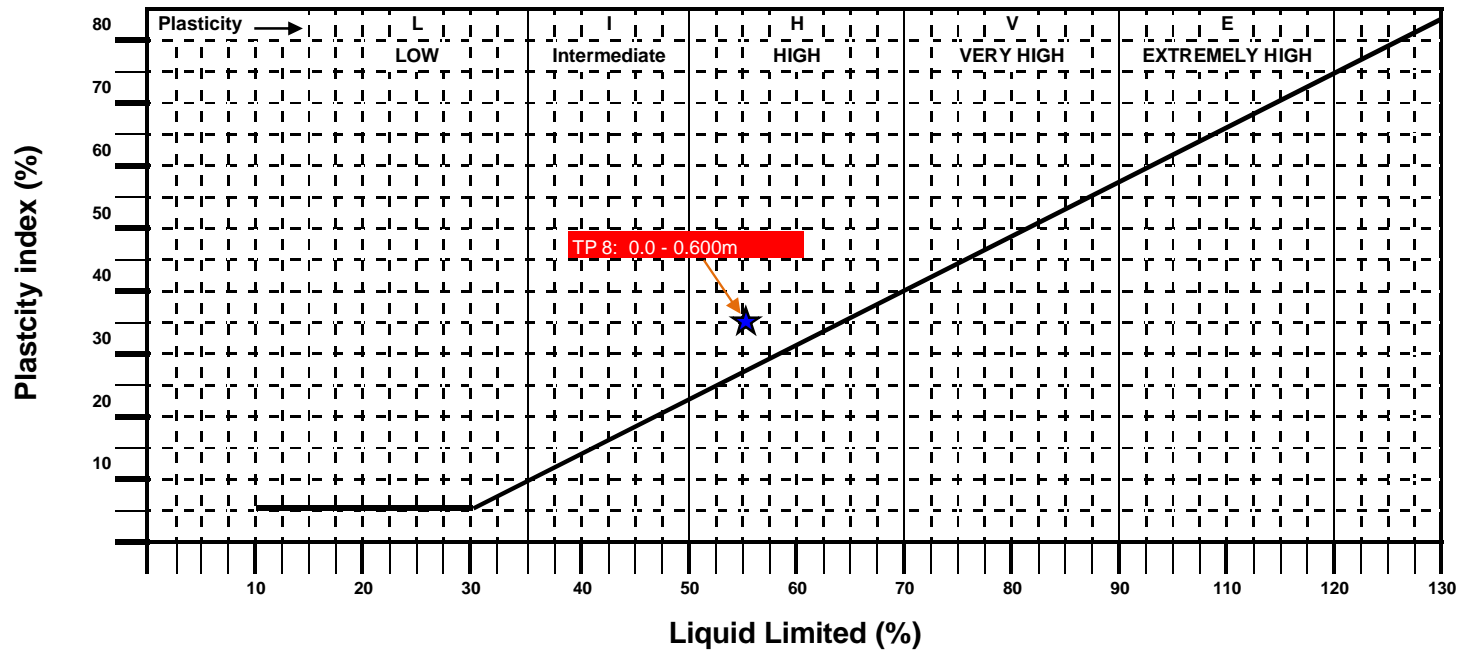
Figure 17. CASAGRANDE PLOT FOR SUBSOIL MATERIAL FROM TEST PIT # 8

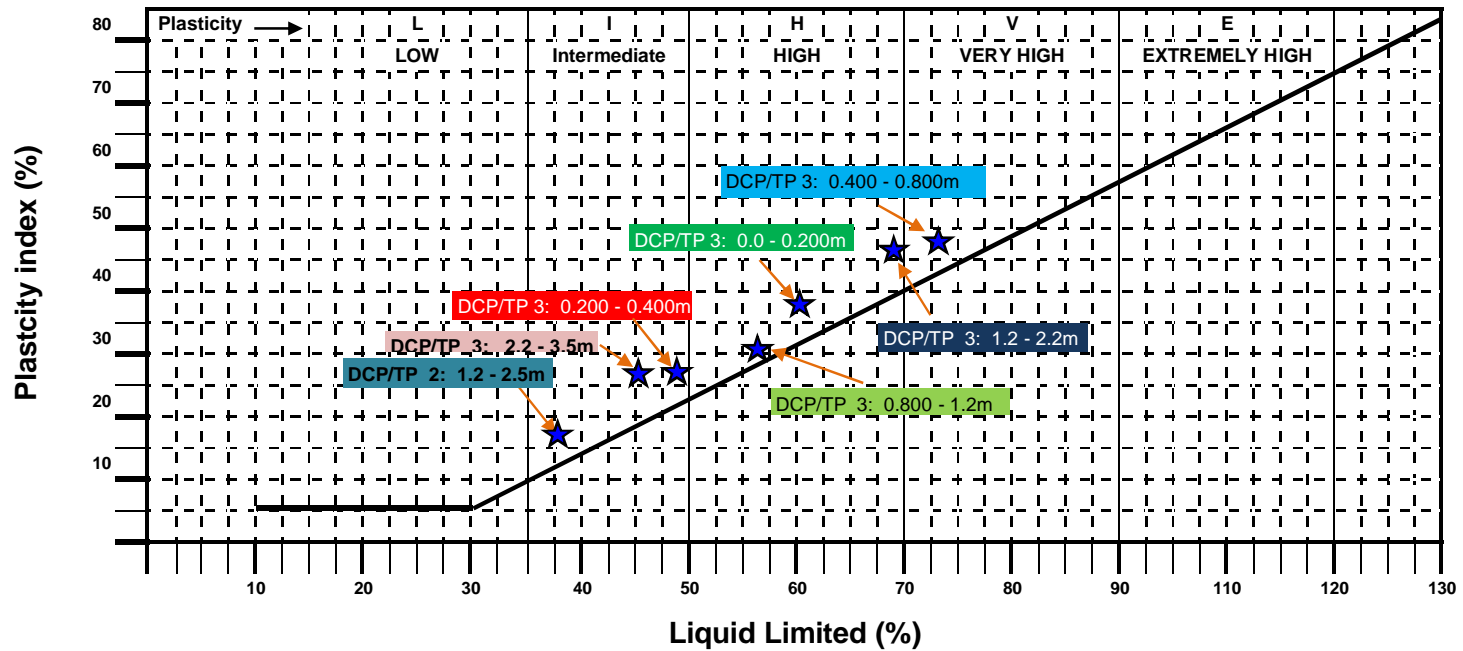
Figure 25. CASAGRANDE PLOT FOR SUBSOIL MATERIAL FROM TEST PIT AT MORATA

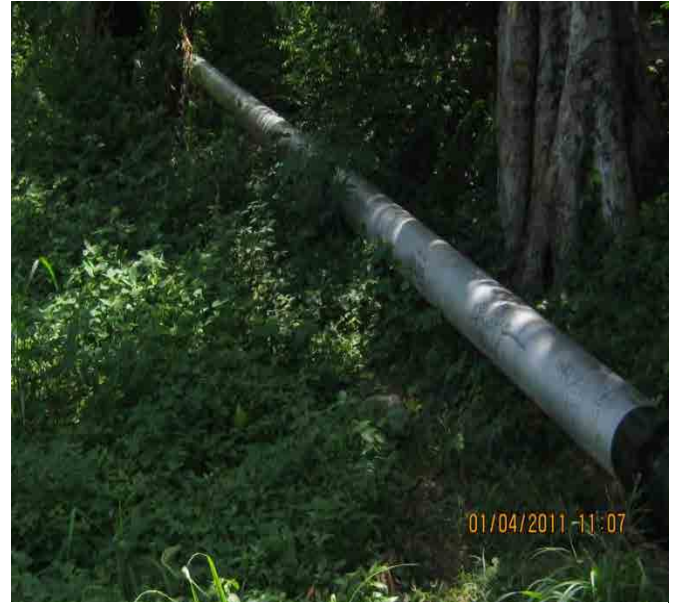
Inter Oil pipeline lying 3metres away from the proposed location

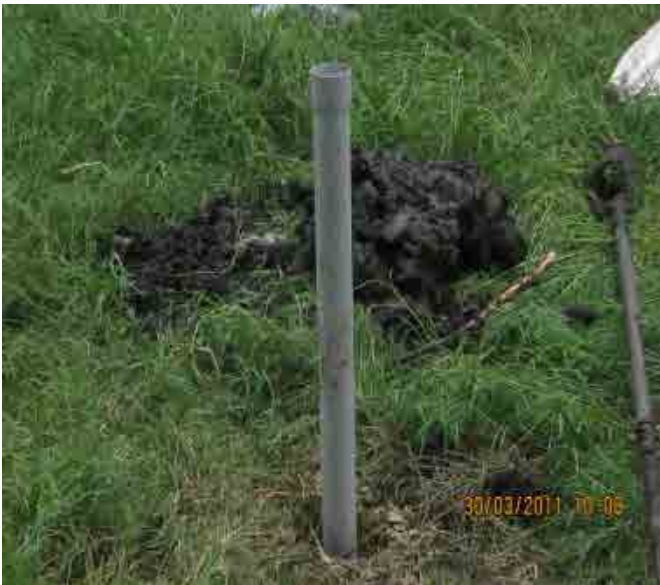
Stand Pipe for Piezometer Measurement

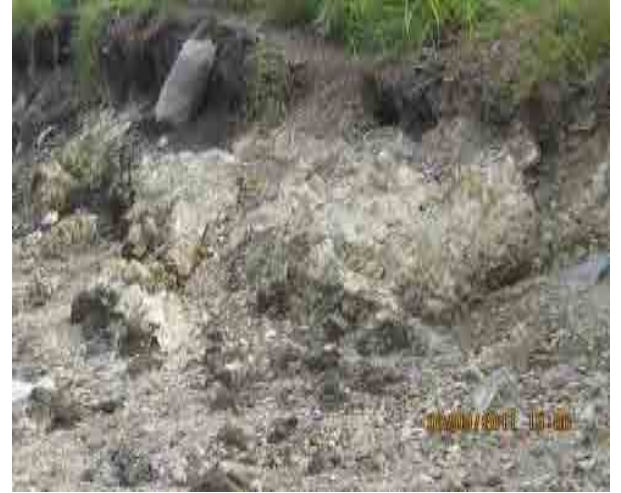
Calcurious mudstone at shoreline during low tide

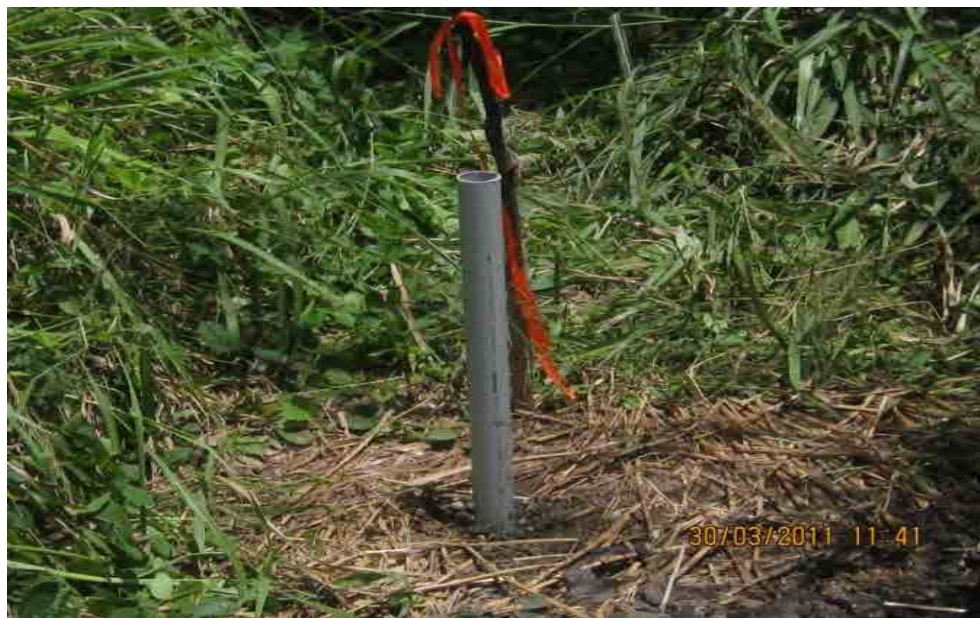
Stand Pipe for Piezometer Measurement
