**MALAWI POLYTECHNIC
CIVIL ENGINEERING DEPARTMENT**

**REPORT ON GEOTECHNICAL INVESTIGATIONS ON THE PROJECT
FOR RE-CONSTRUCTION AND EXPANSION
OF SELECTED COMMUNITY DAY SECONDARY SCHOOLS (CDSSs)
PHASE II**

6-3 Borehole Investigation Reports (Abstract)

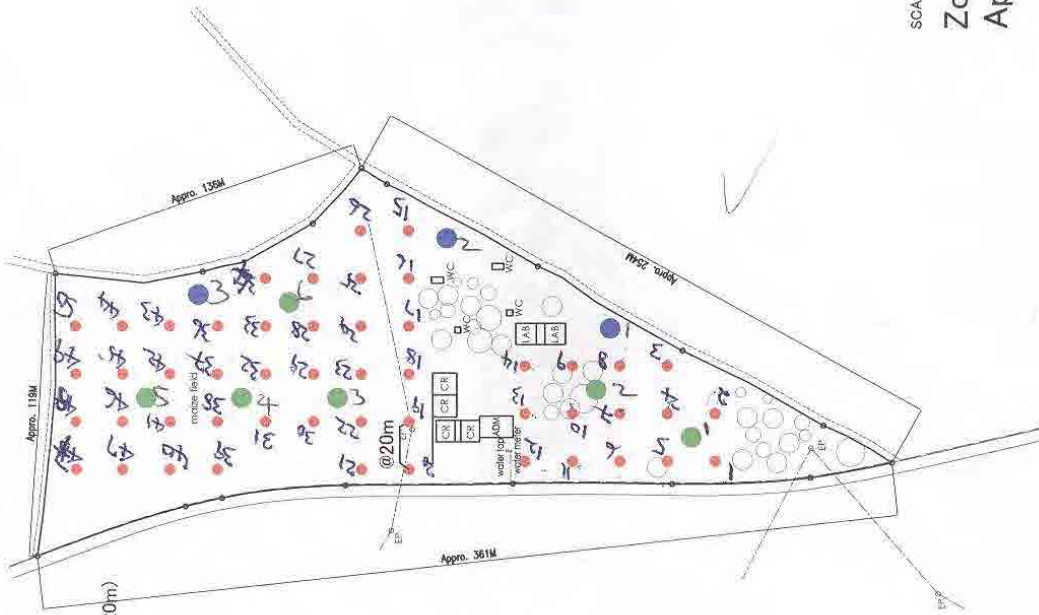
SCALE 1/2500
 Zolozolo CDSS
 Appra. 2.9ha

- Dynamic Cone Penetrometer Test Points (50 No. @20m)
- Water Penetration Test Points (3 No.)
- Lab. Sample (6 No.)

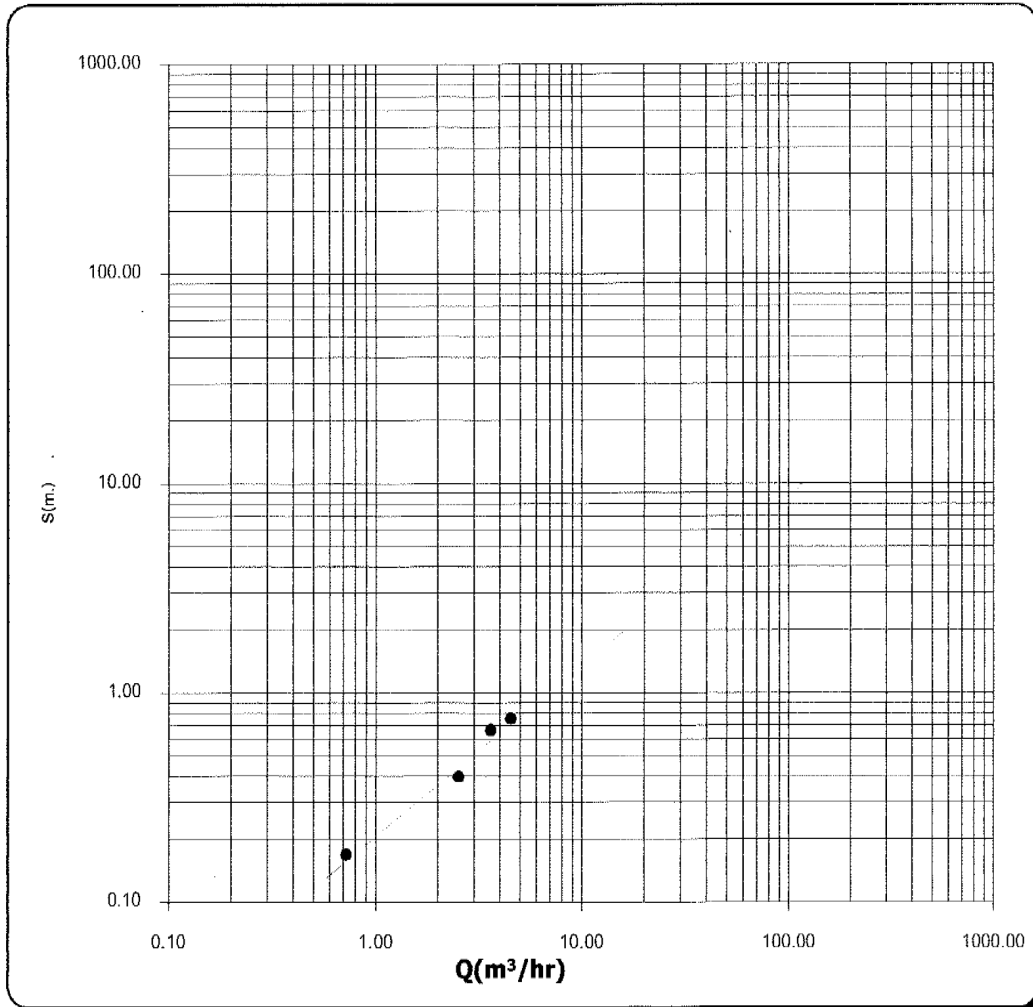
STEP DRAWDOWN TEST

| BOREHOLE No. | Matenje No.1 | STATIC WATER LEVEL | 8.64 m. |

| STEP | DISCHARGE Q (m³/hr.) | DYNAMIC LEVEL N.D. (m.) | DRAWDOWN S (m.) | SPECIFIC CAPACITY Q/S (m³/hr/m.) |
| FIRST(1st) | 0.72 | 8.81 | 0.17 | 4.2353 |

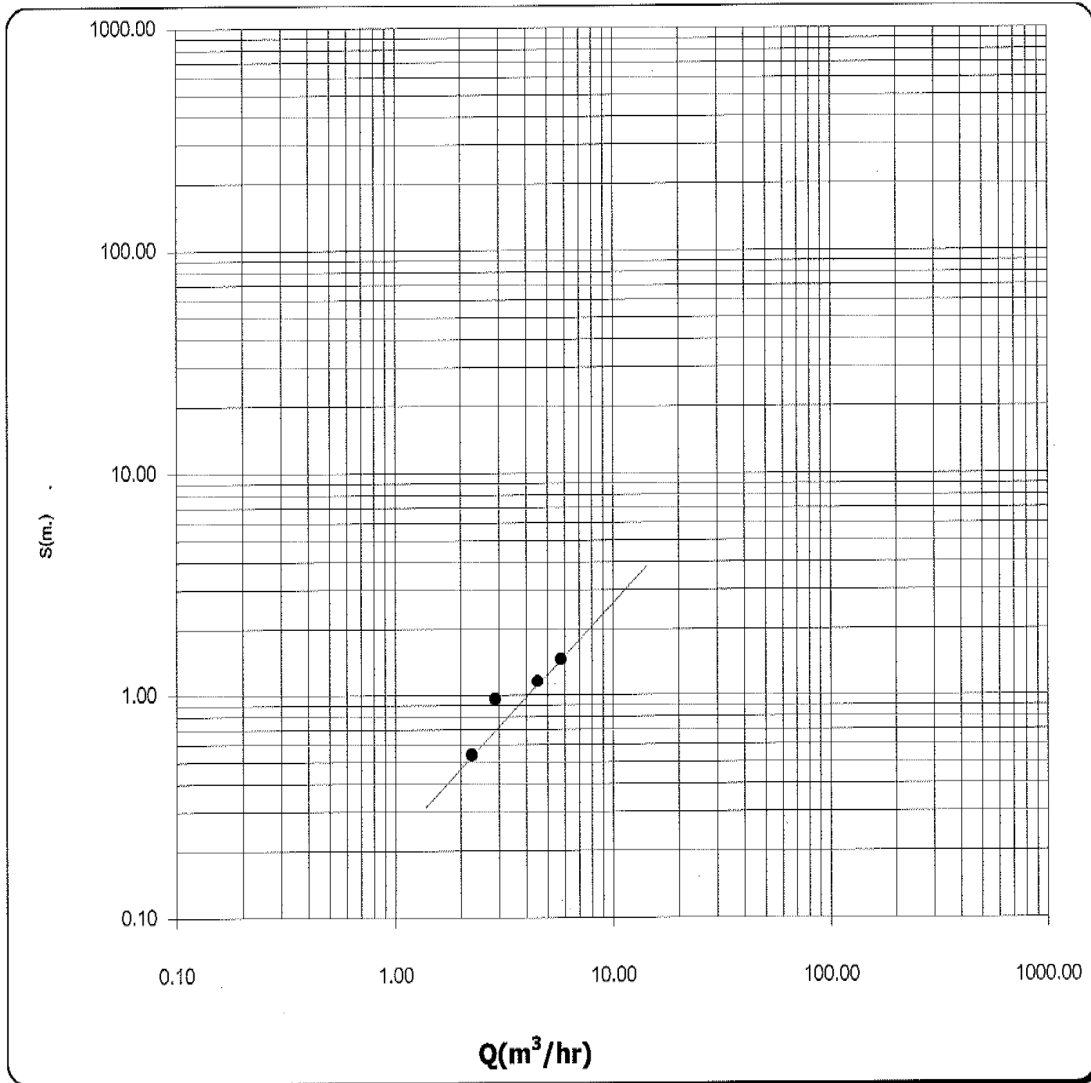
STEP DRAWDOWN TEST

| BOREHOLE No. | Liwaladzi No.1 | STATIC WATER LEVEL | 6.35 m. |

| STEP | DISCHARGE Q (m³/hr.) | DYNAMIC LEVEL N.D. (m.) | DRAWDOWN S (m.) | SPECIFIC CAPACITY Q/S (m³/hr/m.) |
| FIRST(1st) | 2.25 | 6.89 | 0.54 | 4.1667 |

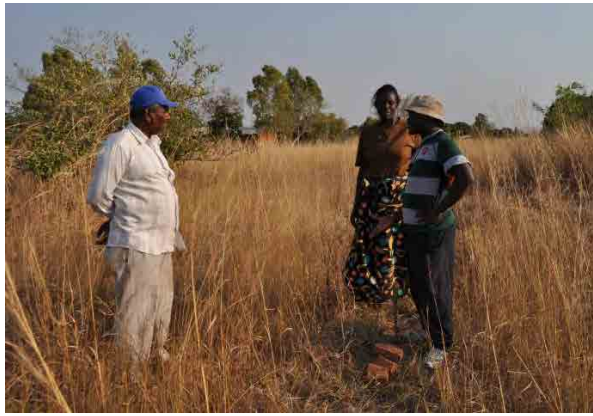
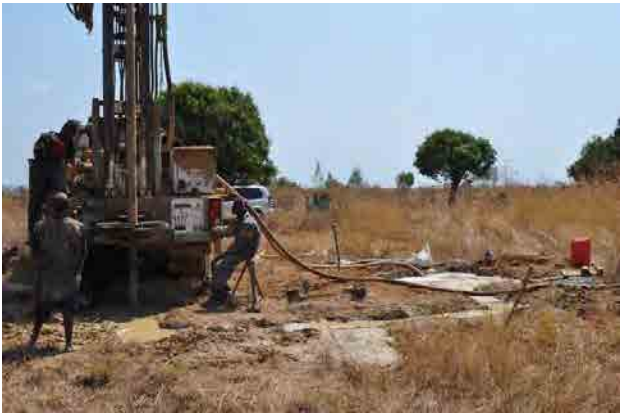
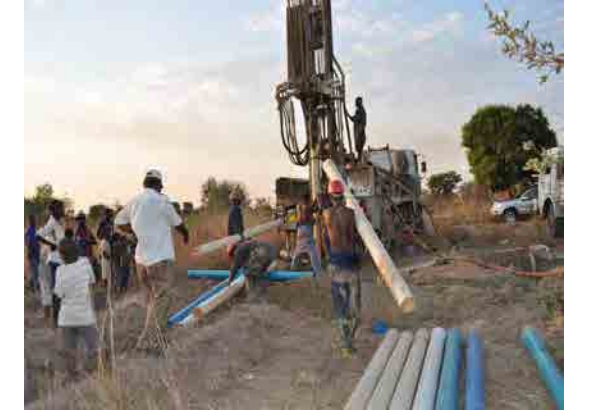
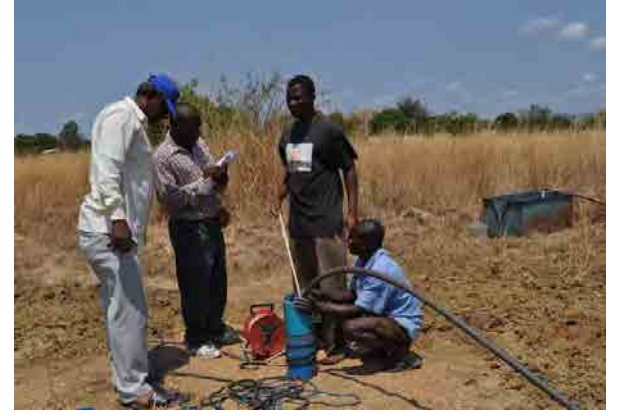
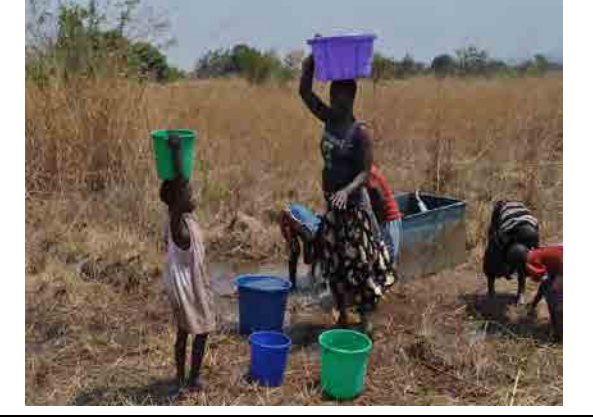
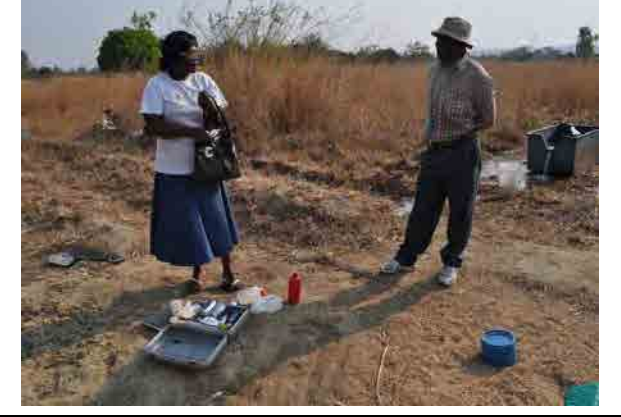
Figure-10 Liwaladzi CDSS (No.1) Photo

| <p>1. Liwaladzi CDSS Drilling Point (Matenje No.1 together with Head Teacher)</p> | <p>2. Liwaladzi CDSS Drilled by Mud Surculation Method (Lilawadzi No.1)</p> |
| <p>3. Liwaladzi No.1 installed Screen & Casing (September 2011)</p> | <p>4. Liwaladzi No.1 Pumping Test (September 2011)</p> |
| <p>5. Liwaladzi CDSS , Liwaladzi No.1 (Village Family taking Water from Pumping Test)</p> | <p>6. Liwaladzi CDSS, Liwaladzi No.1 (Water Quality Sampling from Lilongwe Laboratory, Ministry of Agriculture, Irrigation and Water Development)</p> |

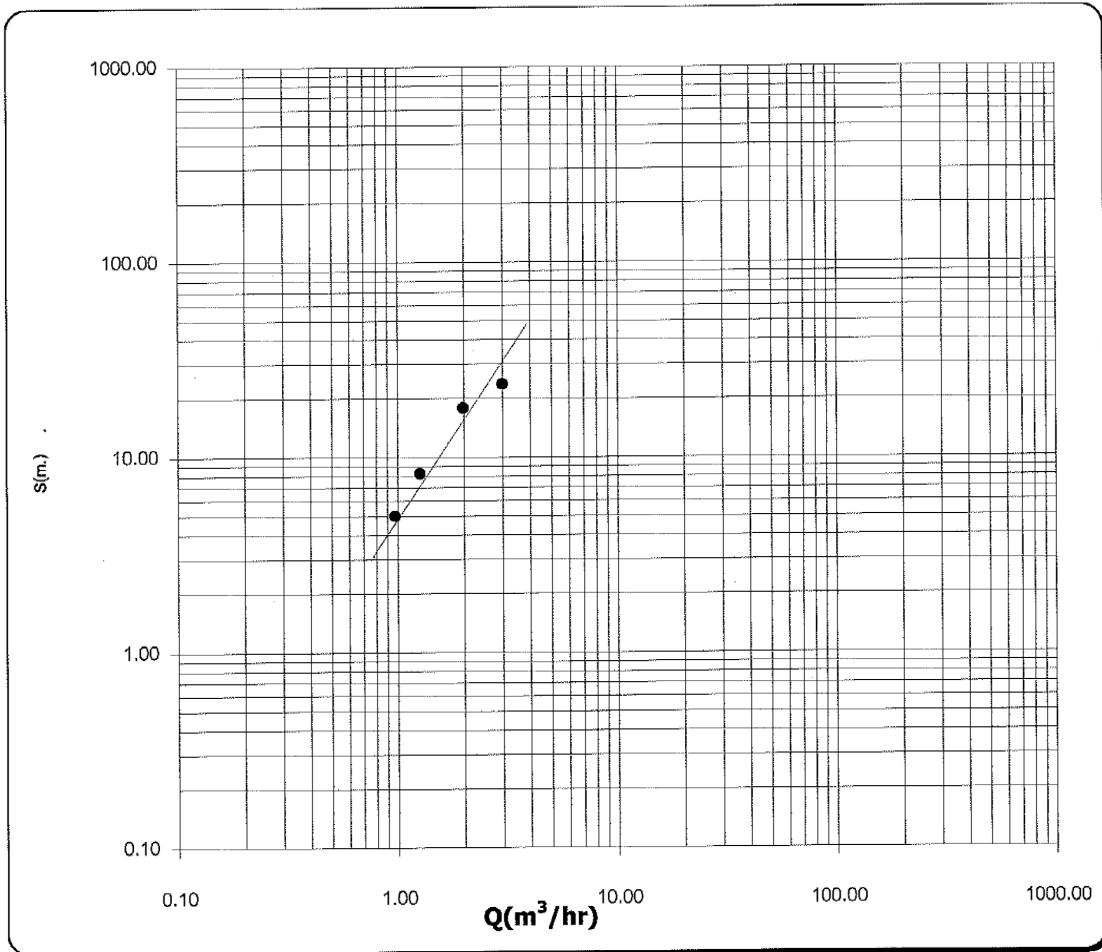
STEP DRAWDOWN TEST

| BOREHOLE No. | Ezondweni No.2 | STATIC WATER LEVEL | 26.35 m. |

| STEP | DISCHARGE Q (m³/hr.) | DYNAMIC LEVEL N.D. (m.) | DRAWDOWN S (m.) | SPECIFIC CAPACITY Q/S (m³/hr/m.) |
| FIRST(1st) | 0.97 | 31.37 | 5.02 | 0.1936 |

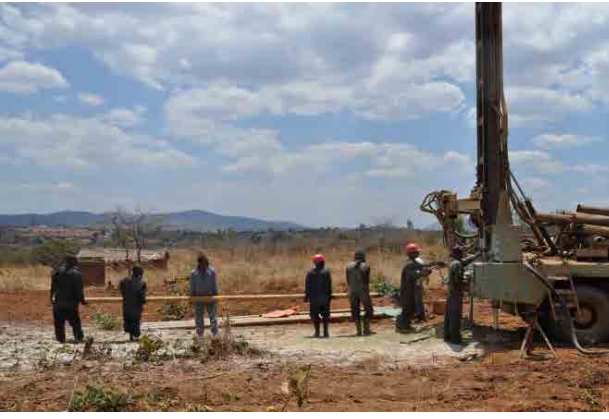
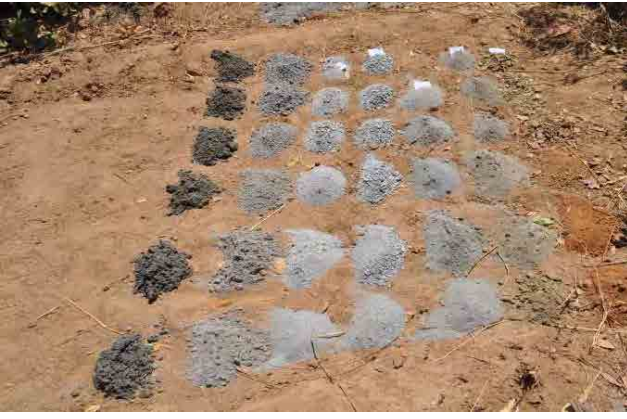
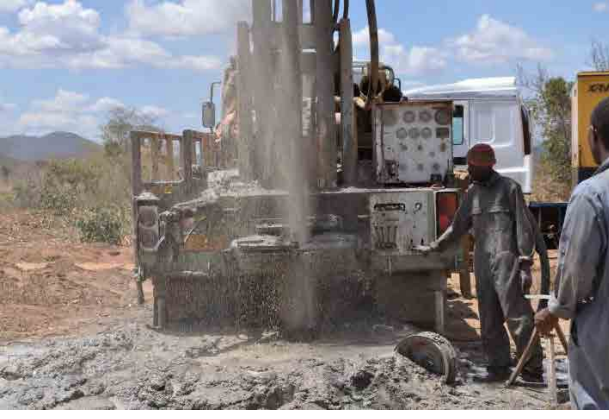
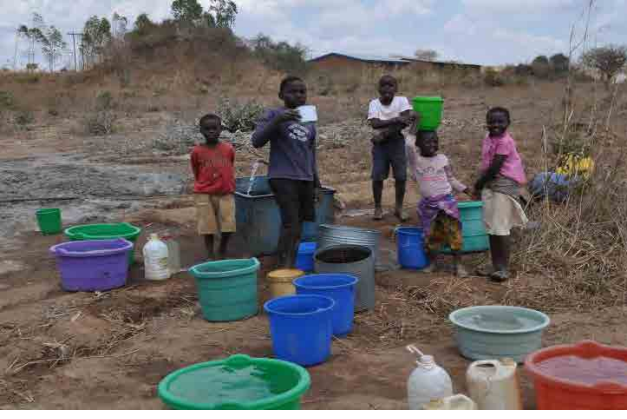
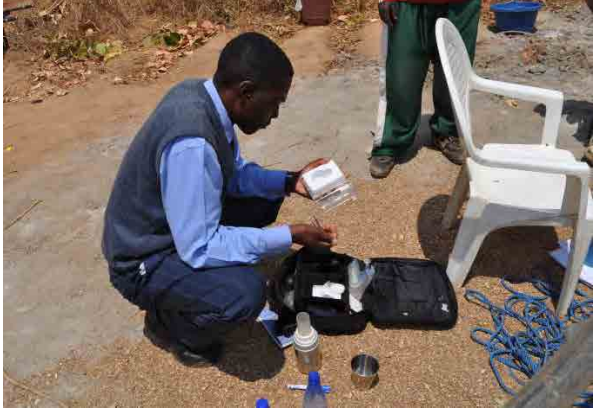
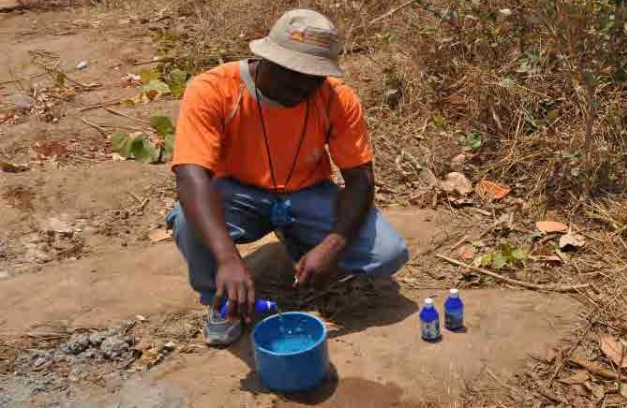
Figure-16 Ezondweni CDSS (No.1&No.2) Photo(2011. Sep)

| <p>1. Ezondweni CDSS Test Drilling (Ezondweni No.1 Unsuccessful Dryhole)</p> | <p>2. Ezondweni CDSS Drilled Ezondweni No.2 (Groundwater hit at 36m in depth)</p> |
| <p>3. Ezondweni No.2 Down The Hammer (DTH) Drilling Method (Success No.2, September 2011)</p> | <p>4. Ezondweni No.2 Pumping Test (Village Family taking Water from Pumping Test)</p> |
| <p>5. Ezondweni CDSS , Ezondweni No.2 Water Quality Sampling from Mzuzu Laboratory, Ministry of Agriculture, Irrigation & Water Development)</p> | <p>6. Ezondweni No.2 Water Guard for New Borehole and Closed (September 2011)</p> |
