**PREPARATORY SURVEY REPORT
ON
THE PROJECT
FOR COUNTERMEASURE CONSTRUCTION
FOR THE LANDSLIDES
ON SINDHULI ROAD(SECTION II)
IN
FEDERAL DEMOCRATIC REPUBLIC OF NEPAL**

JAPAN INTERNATIONAL COOPERATION AGENCY

NIPPON KOEI CO., LTD.

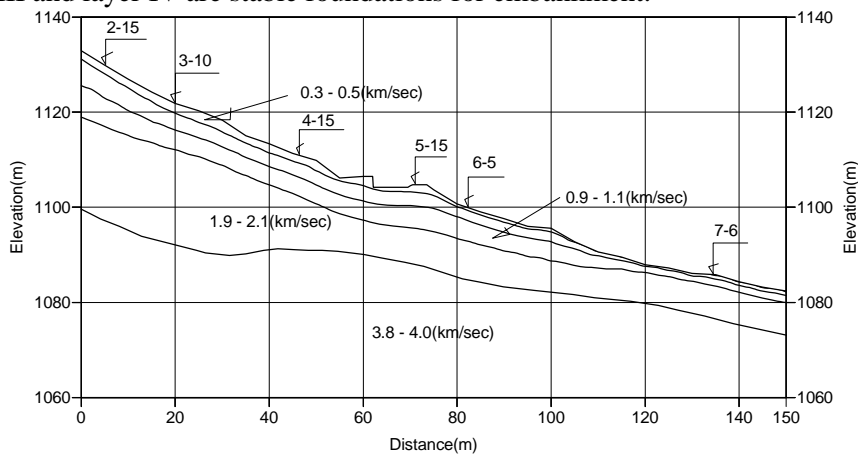
Figure 1.3.2 Seismic Exploration Result (B Line)

The conclusion below is taken from the exploration result.

- ✓ The loose surface layer with thickness of about 1-2 m needs to be treated carefully as the foundation of embankment.
- ✓ Layer III and layer IV are stable foundations for embankment.

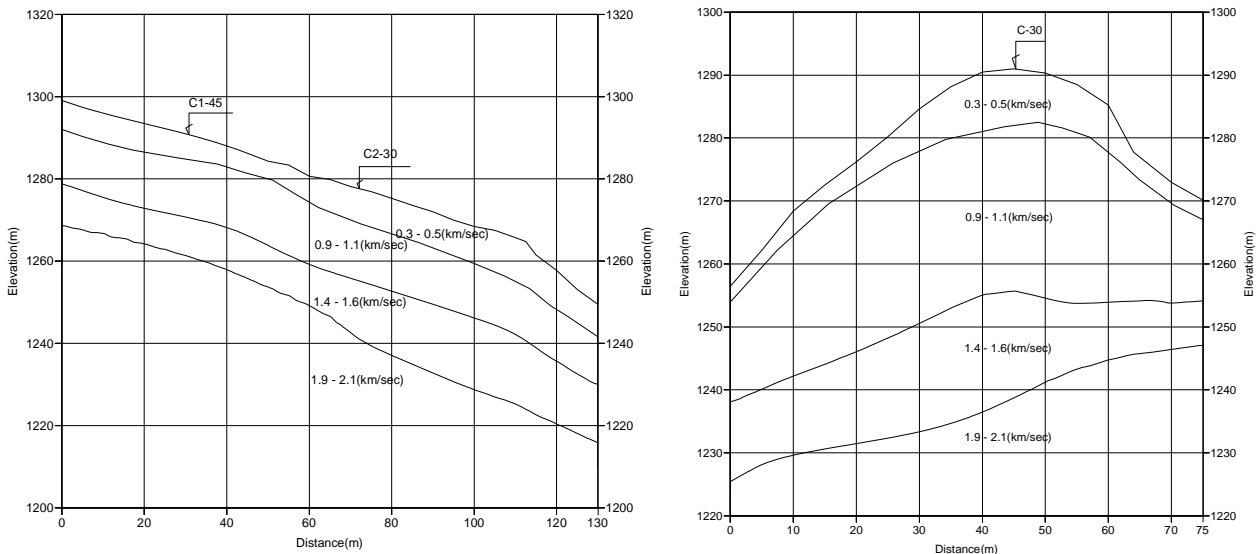
Figure 1.3.5 Seismic Exploration Result (C Line) at Sta. 18+200

The 1st layer (gravels) could be excavated by power shovel and bulldozer without ripper. But to excavate soft rocks from 2nd to 4th layer, it is necessary to use power shovel and bulldozer with ripper. It is estimated that hard rocks that include soft rocks and part of soft rocks in the 4th layer require the use of dynamite and static fracture dynamite for excavation.

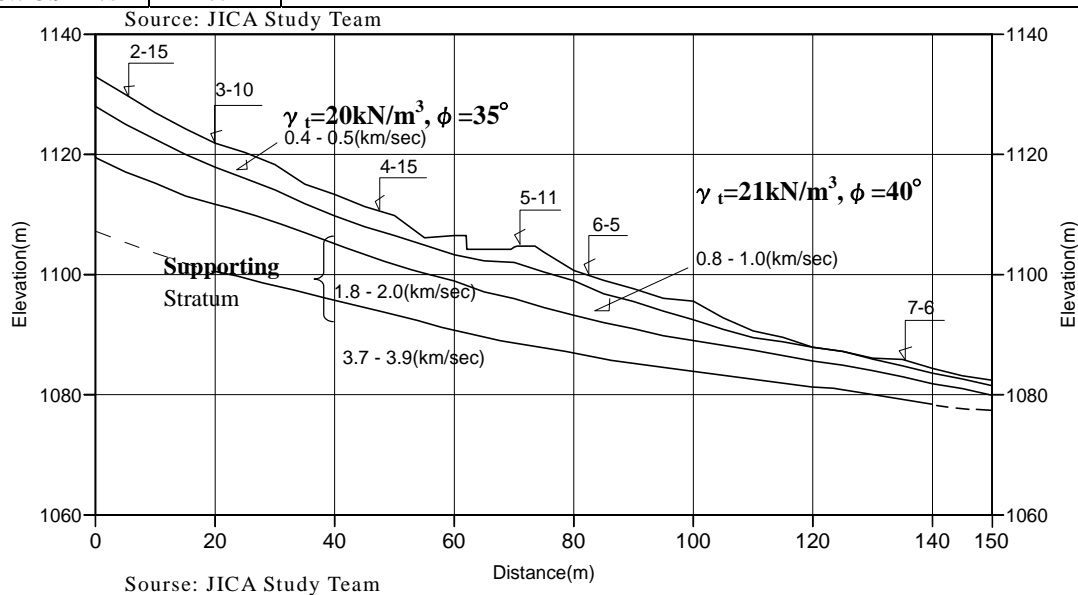
Figure 1.3.8 Soil Constants of Each Foundation Ground

Classification of Layers		Density Test Result			Soil Constants		
					Weight	Shear	Strength
Velocity Layer	Layer	Wet Density γ (kN/m ³)	Void Ratio e_b	Relative Density D_r (%)	Wet Density γ (kN/m ³)	Cohesion C (kN/m ²)	Internal Friction Angle ϕ (°)
1st Layer 0.4-0.5 km/s	Gravelly Soil	19-21	0.3-0.4	33-71	20	0	35
2nd Layer 0.8-1.0 km/s	Talus or Soft Rock	-	-	-	21	0	40
3rd Layer 1.8-2.0 km/s	Soft Rock	Supporting Stratum					
4th Layer 3.7-3.9 km/s	Hard Rock

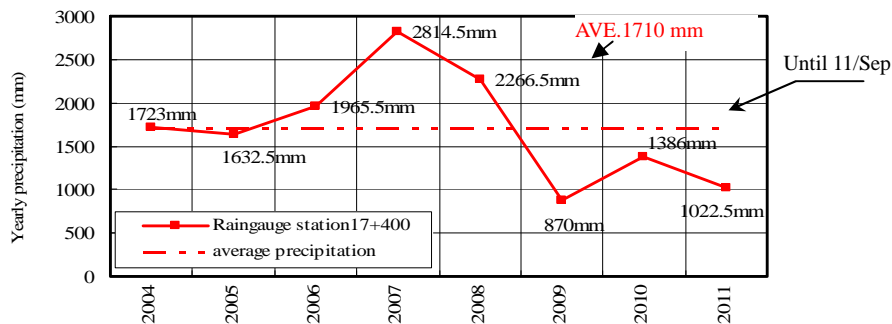
Figure 2.1.3 Annual Rainfall

0 mm in November and December. The recorded annual rainfall in 2007 was 2,814.5 mm. (Refer to Figure 2.1.3) The period between late May and early October falls under the monsoon season. Pavement works such as double bituminous surface treatment (DBST) and asphalt concrete pavement should not be performed during the monsoon season in consideration of quality control and construction safety, respectively. The normal rate of operations was adopted for other works as there would be no large influence of rainfall.

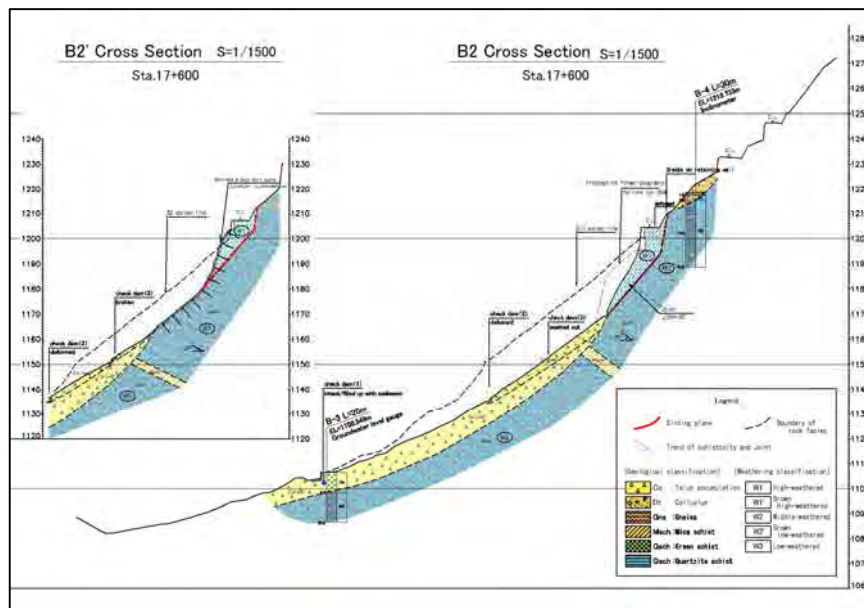
Figure 2.2.2 Geological Section of Landslide A

In case that the slope, including the road in the vicinity of Sta. 17+600, would collapse, realignment of the road to the mountainside will not be possible since its other section runs through a slope above Sta. 17+600. In effect, excavation of the slope for such realignment will reach the other section of the road above. Therefore, stabilization of the landslide itself is necessary without realigning the road at this section.

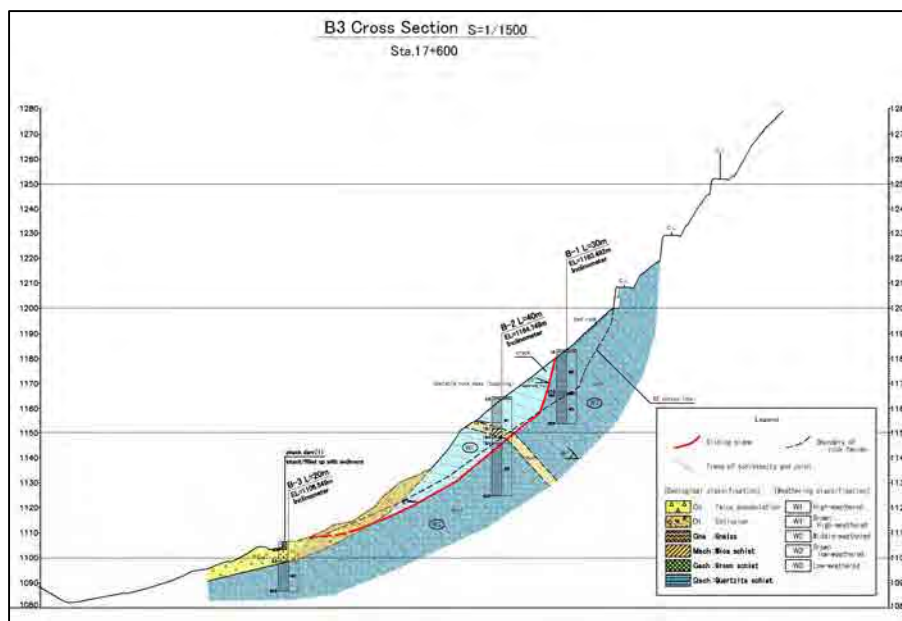
Figure 2.2.3 Geological Section of Landslide B

If the entire area of Landslide B becomes unstable and it falls down, it is possible that the upper slope where the road is located will become secondarily unstable. In that case, the road on the entire area of the upper slope of Landslide B will be destroyed and it will be difficult to recover the traffic on the steep slope. Therefore, stabilization of the loosened zone itself will be necessary in the future.

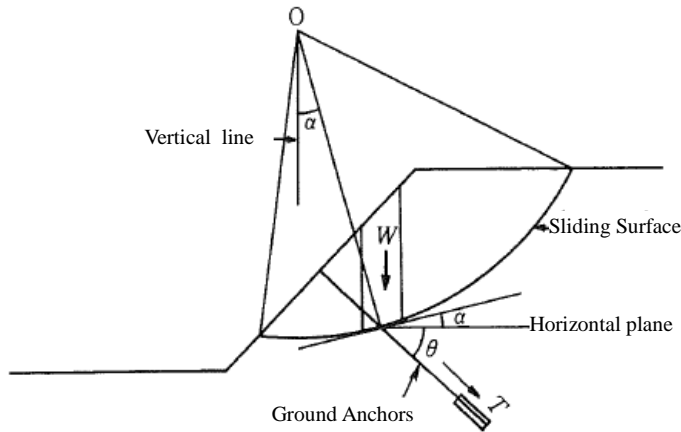
Figure 2.2.20 Calculus Method of Ground Anchors

Figure 2.2.20 shows the diagram for the calculus equation.

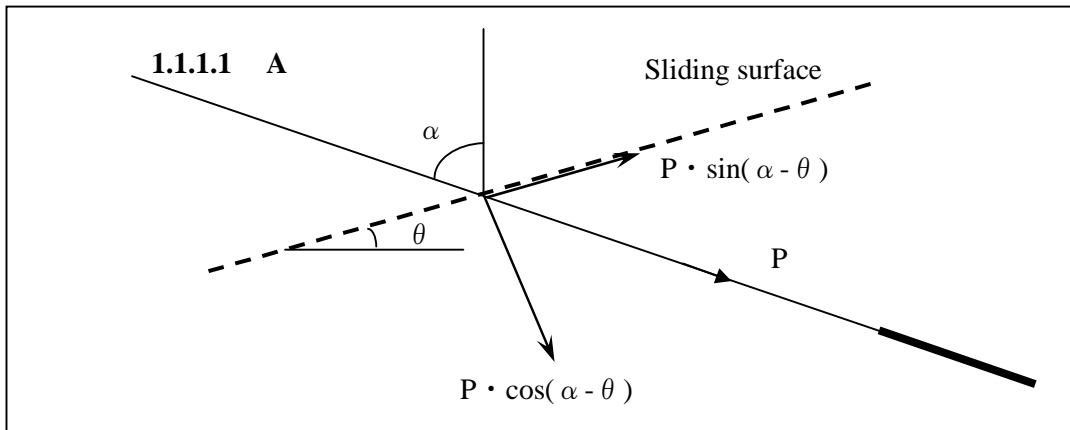
Figure 2.2.21 Functional Description of an Anchor

Figure 2.2.21 shows a diagram of the forces applied by the anchors.

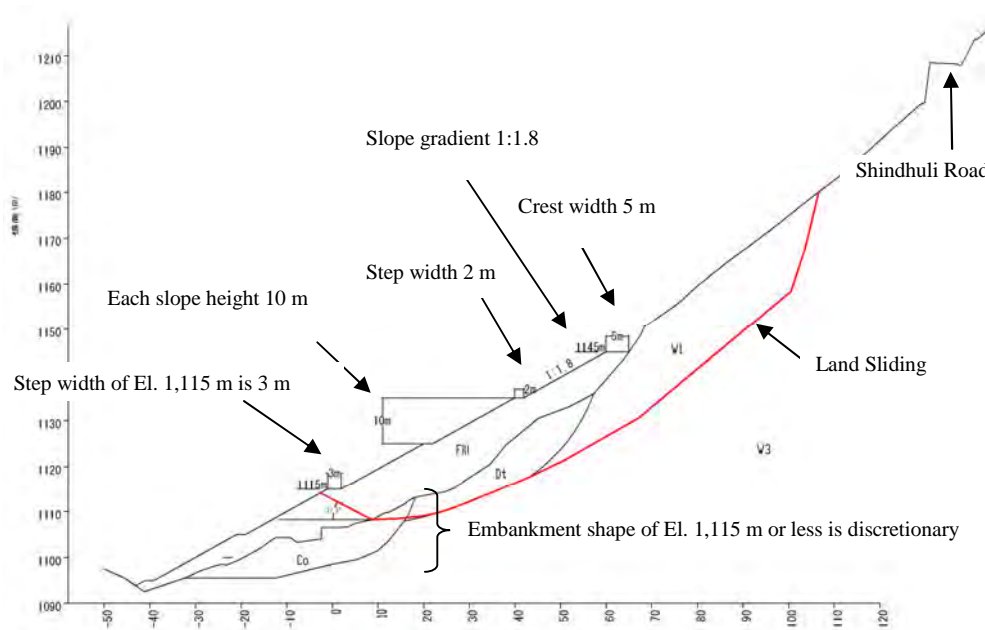
Figure 2.2.22 Minimum Condition of Embankment needed for Landslide Stability

Ref. : The embankment mass below at 1,115 m will not contribute to landslide stability, hence, the configuration of the embankment should be decided by its stability.

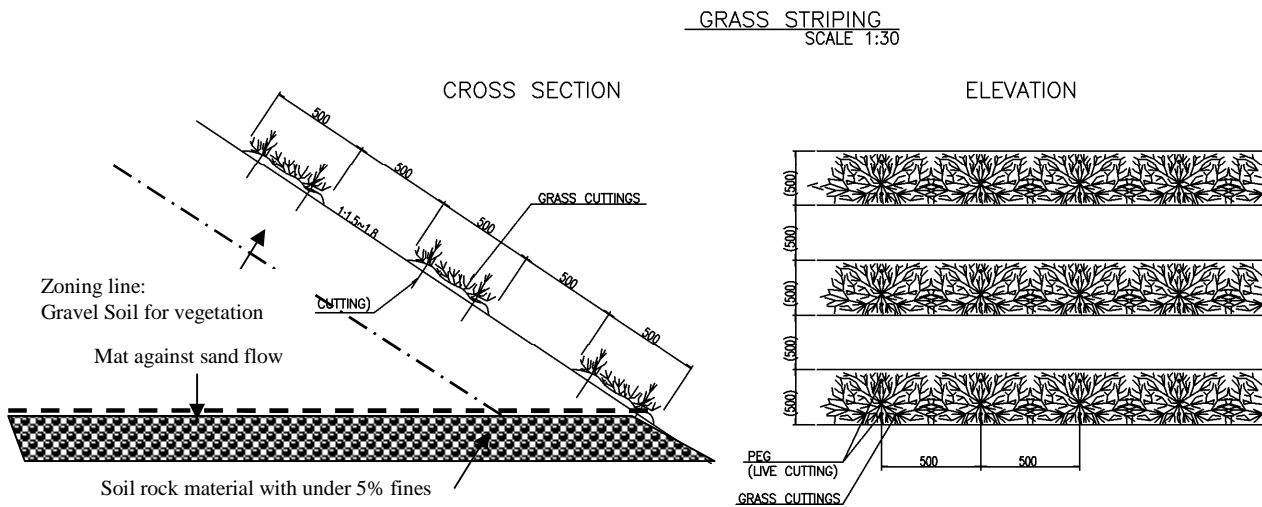
Figure 2.2.26 Vegetation Works on Embankment

typical set-up for vegetation works on embankment. Table 2.2.22 shows the land use for vegetation works while Table 2.2.23 lists the slope grades and geological conditions for cut slopes.

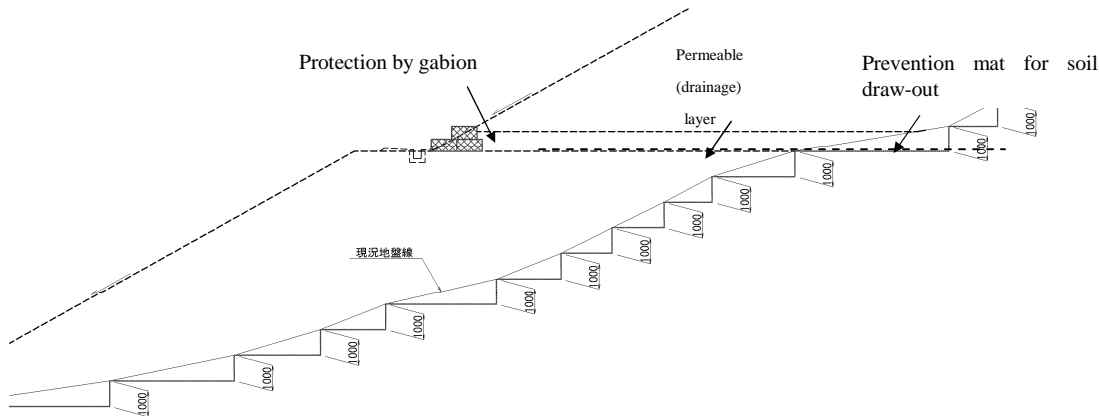
Figure 2.2.27 Drainage Layer in the Embankment

-Treatment of Osmosis Water in the Embankment: Although embankment material having less than 10% of fine content is highly permeable, if groundwater enters the embankment, the factor of safety then shifts under the design factor of safety. For this reason, the drainage layer with less than 5% of fine content is designed to drain osmosis water into open ditches along cat walks. In the drainage layer, particle size analysis should be conducted for quality control before filling works and permeability test after construction.

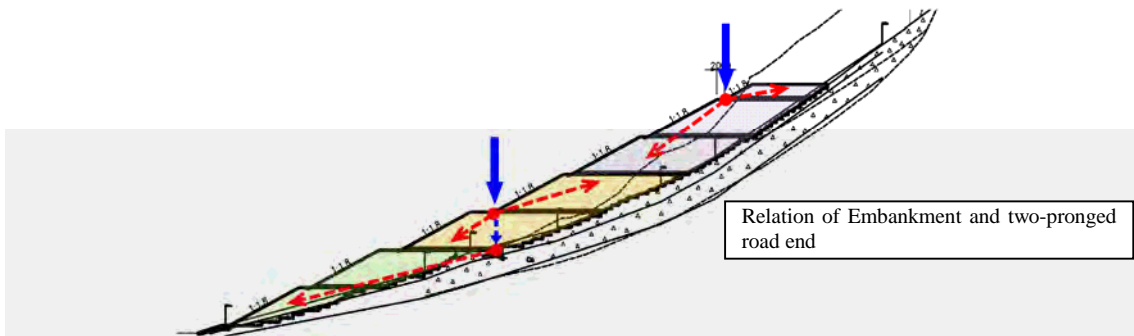
Figure 2.2.30 Plan of the Temporary Road

Figure 2.2.30 shows the plan of the temporary road.

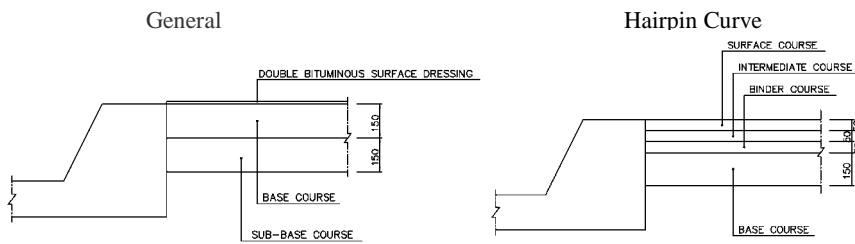
Figure 2.2.33 Structure of Pavement

Figure 2.2.33 shows the structure adopted for the pavement.

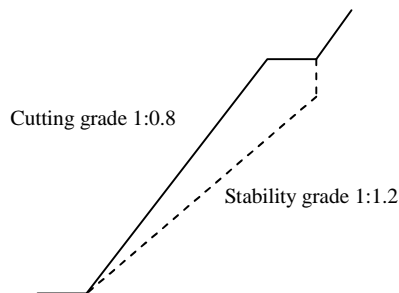
Figure 2.2.36 Model of Slope Failure

The stability grade of the slope at Sta.18+200 is 1:1.2. However, the design grade needed at Sta. 18+200 is 1:0.8 in order to mitigate environmental impacts. Therefore, reinforced earth method for this slope is needed. The slope failure forms a delta from the stability grade of 1:1.2 and cutting grade of 1:0.8, as shown in Figure 2.2.36. The depth of slope failure is about 2 m. The dimensions of the reinforced earth method follows the experimental design method described in the Manual for Slope Protection by the Japan Road Association as shown in Table 2.2.35. Rock bolts with lengths of 3 m are adopted because the depth of slope failure is about 2 m.

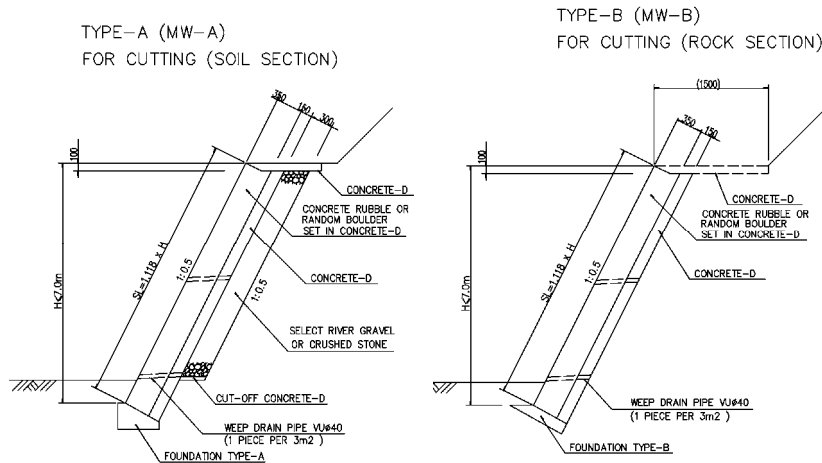
Figure 2.2.37 Wet Stone Masonry Wall (Type-A and Type-B)

Retaining walls are arranged to support the cut slope necessary for road realignment. Considering the height of walls and the geological conditions of the slope, the structure of the wet masonry wall to be applied would be either Type-A or Type-B, as shown in Figure 2.2.37.
