**JAPAN INTERNATIONAL COOPERATION AGENCY  
GEOLOGICAL SURVEY OF ETHIOPIA**

**THE PROJECT FOR DEVELOPING  
COUNTERMEASURES AGAINST LANDSLIDES IN  
THE ABAY RIVER GORGE**

**SUPPLEMENTARY REPORT**

**March 2012**

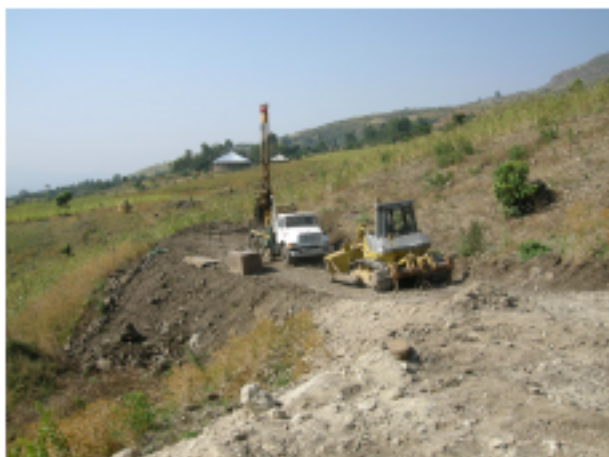
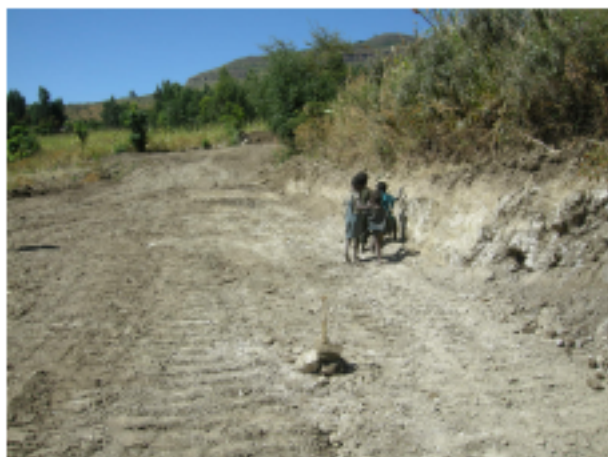
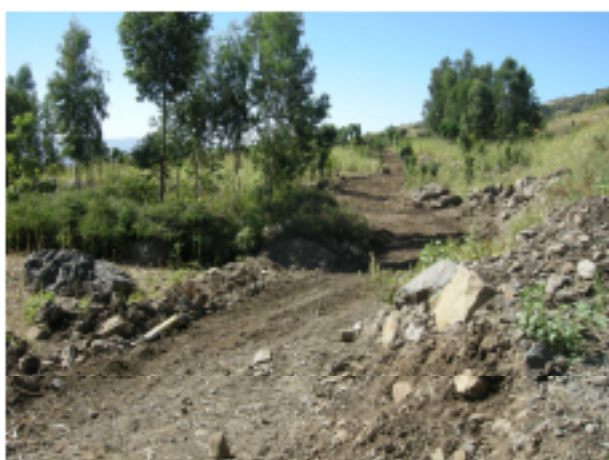
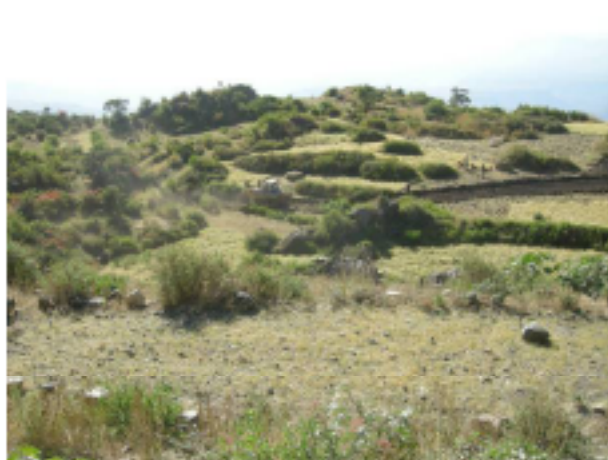
Figure 2.2.3 Photos of access road construction

Construction of access road for drilling point B28-33  
(sorghum field)

Construction of access road for drilling point B28-12  
(sorghum field)

Construction of access road for drilling points B27-13  
and B27-24 (maize field)

Construction of access road for drilling points B00-15  
and B00-16 (teff field)

Access road routes were planned and arrangements made, taking due consideration to minimize land damage, before the drilling survey started (shown in Figure 2.2.3).

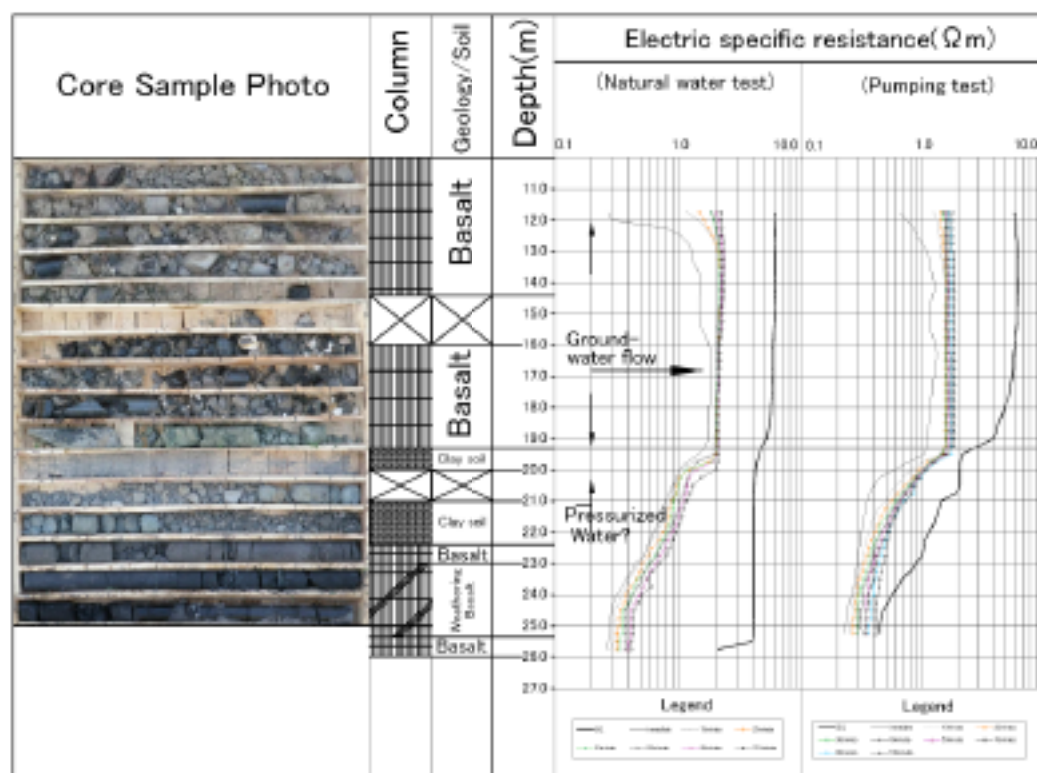
Figure 2.4.4 Groundwater logging (B00-16)

Location	Borehole Number	Natural water test		Pumping test	
		Zone(m)	Flowing division	Zone(m)	Flowing division
L/S 00	B00-16	11.75-20.00	Groundwater flowing-in	11.75-20.25	Groundwater flowing-in
		20.00	Leakage of groundwater	20.25-20.50	Pressured groundwater
L/S 05	B05-31	23.50-25.00	Groundwater flowing-in	23.50-25.00	Groundwater flowing-in
		28.25	Leakage of groundwater	25.00-34.00	No flowing
L/S 27	B27-24	21.75-22.50	Groundwater flowing-in	22.00-23.75	No flowing
		23.75	Leakage of groundwater	23.75	Leakage of groundwater
L/S 28	B28-10	31.50-38.75	No flowing	31.50-34.00	Groundwater flowing-in
				34.75	Leakage of groundwater
				34.75-38.75	No flowing
	B28-33	—	—	23.00-28.00	No flowing

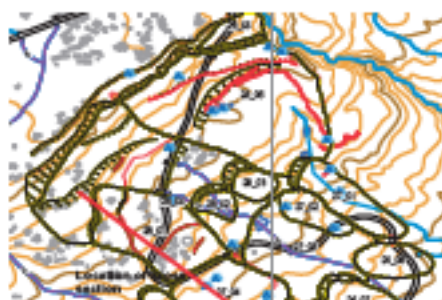
Figure 3.1.3 Geological cross section in L/S27

Silt and shale	Siltstone and shale with limestone mixed with sliding soil mass. Gentle slope. Landslide forms.	BH27-11,12,21,22,23, BH28-11,21,31,32,41

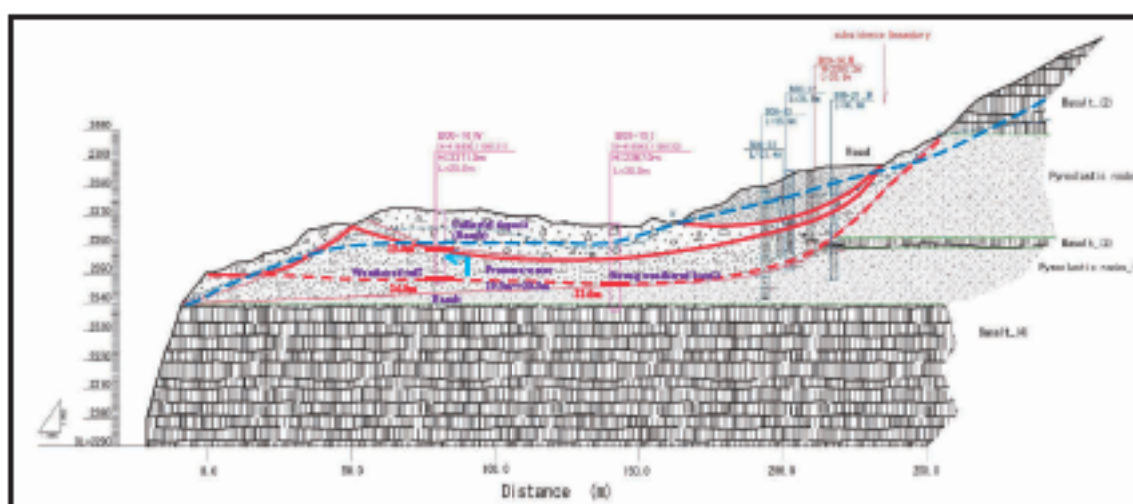
Figure 3.4.1 Landslide section (BO-12 in L/S00 area)

From the additional borehole investigation result, it is found that strongly weathered basalt at the depth from 19.0m to 22.6m in borehole B00-15 and weathered tuff layer the depth from 21.0m to 24.0m in borehole B00-16 existed. From the groundwater logging result in B00-16, a pressured groundwater flowing layer was recognized at the depth from 19.5m to 20.5m. Based on these kind of results, it is reasonable to consider that, after passing the basalt and pyroclastic rock, the groundwater formed a flow in the clay layer and weathered tuff layer which is located along the boundary between colluvial deposit and basalt layer, and then became pressured groundwater and infiltrated into the colluvial deposit, finally, formed a inter-stratum water and flow in the colluvial deposits.

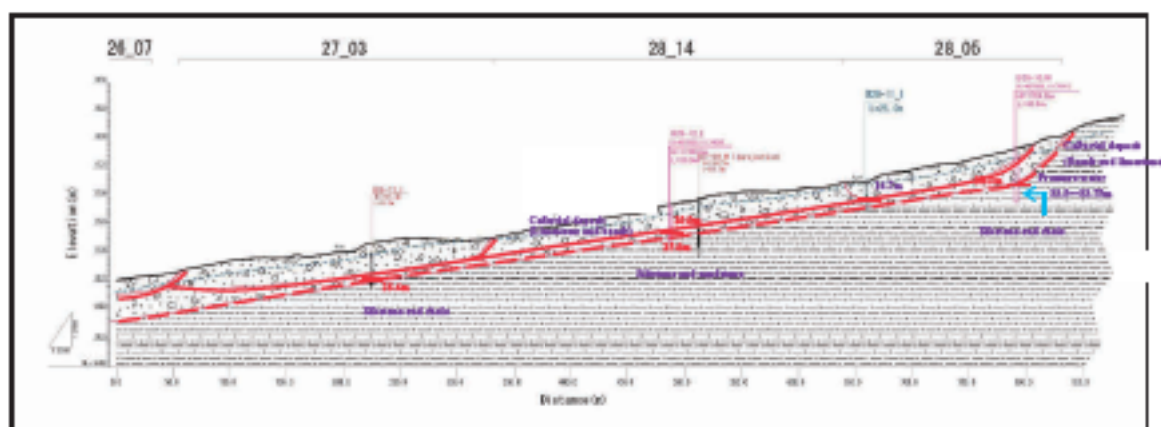
Figure 3.4.3 Landslide section (BO-13 in L/S28 area)

In borehole B28-10, it is found that the depth of the boundary between colluvial deposits containing basalt and limestone gravel and the bedrock of siltstone or shale layer was 28.2m. While in borehole B28-12, the depth of the boundary between the colluvial deposit containing basalt gravel and bedrock of siltstone or mudstone was 25.6m, and weathered mudstone layer were located at the depth between 18.0m and 20.0m, and at the depth between 23.3m and 25.6m. From the landslide block situation, it is also considered that two types of landslide may exist in this area: one is a shallow slide in the shallow colluvial layer, and the other is a deep slide along the bottom of the deep colluvial deposit. The groundwater level in borehole B28-10 in dry season was 31.5m. This makes the deep slip surface can always be kept under the groundwater. Additionally, the groundwater logging result of borehole B28-10 shows a weakly pressured groundwater flowing existed in the siltstone and shale layer at the depth between 33.5m and 33.75m. It may be possible that after passing the weathered siltstone, the groundwater infiltrated into the colluvial deposits mixed with basalt gravels.

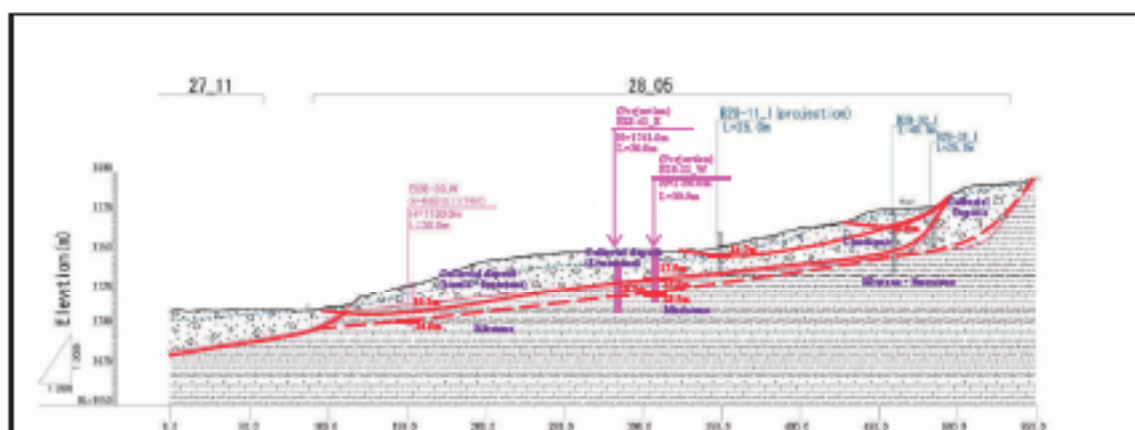
Figure 3.4.4 Landslide section (BO-14 in L/S28 area)

In borehole B28-22, it is found that the depth of the boundary between colluvial deposits and the bedrock of mudstone or siltstone layer was 28.5m, especially the depth of between 17.3m and 17.5m, and the layer between 24.4m and 25.6m are strongly weathered. In borehole B28-33, the depth of the boundary between the colluvial deposit and bedrock of siltstone layer was 24.6m, especially the layer between 18.0m and 19.2m is strongly weathered. In borehole B28-42 the depth of the boundary between colluvial deposits and the bedrock of mudstone or siltstone layer was 18.5m. While the borehole bending occurred at depth 14.5m of borehole B28-11 and depth 10.0m of B28-32. From the landslide block situation, it is considered that two types of landslide may exist in this area, one is a shallow slide in the shallow colluvial layer, and the other is a deep slide along the bottom of the deep colluvial deposit. In dry season, the groundwater level in borehole B28-33 was 23.2m, there always is a water head existing over the slip surface. Additionally, the groundwater logging result shows that there is weak surface water flowing existing at the depth between 23.25 and 23.5m. In this block, the groundwater is an unconfined groundwater, and it infiltrates to the weathered siltstone or mudstone layer.

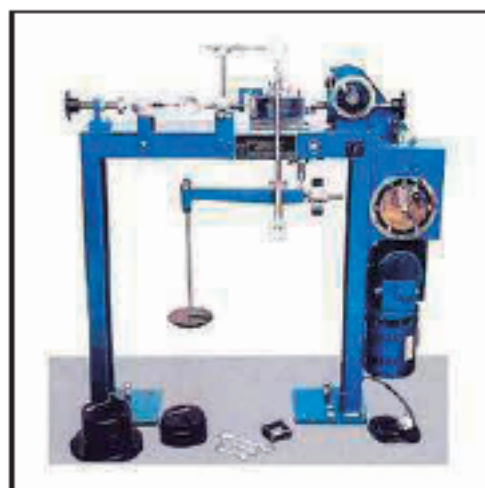
Figure 4.2.2 Direct shear strength test

Direct shear strength test clarifies the physical values which are vertical pressure,  $\sigma$ , shear strength,  $\tau$ , cohesion,  $c$ , angle of internal friction,  $\phi$ . Procedure of this test is; 1) setting a soil sample in a box which can be separated up and down, 2) sliding the upper part of box by applying vertical pressure on it, 3) shearing a soil sample and measuring vertical pressure,  $\sigma$ , and shear strength,  $\tau$ , when shear failure occurs, 4) repeating same tests for several samples with various vertical pressures. Cohesion,  $c$ , and angle of internal friction,  $\phi$ , can be calculated from the coordinate of vertical pressure,  $\sigma$ , and shear strength,  $\tau$ , which

values were measured directly by the tests. The values that were plotted in the coordinate, x-axis :  $c$ , y-axis :  $\phi$ , draw a straight line of a linear equation which was composed by cohesion,  $c$ , and angle of internal friction,  $\phi$ . The equation is as below,

Cohesion,  $c$ , and angle of internal friction,  $\phi$ , can be found from this equation. This equation is called "Coulomb failure criteria".

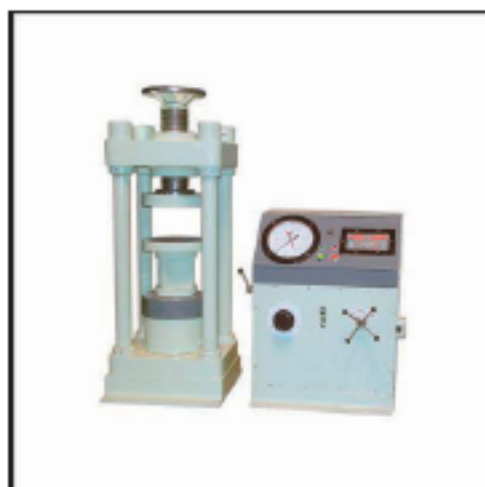
Figure 4.2.3 Compressive strength test machine for soil

Compressive strength test is carried out to estimate the resisting force against shearing force of cohesive soil under undrained condition which is called undrained shear strength,  $s_u$ , by using compressive strength of the soil,  $q_u$ . The equation to calculate  $s_u$  is as below,

In this test, a soil sample is compressed up and down until the sample is destroyed. Also, compressive strength,  $q_u$ , can be calculated from amount of compression,  $\Delta H$ , and compressing force,  $P$ , which are measured by the test. The compressive strength is interpreted as resisting force against shearing force by soil mass movement. This test is carried out on undisturbed materials like clay or accumulated alluvial soil near roads at a site.

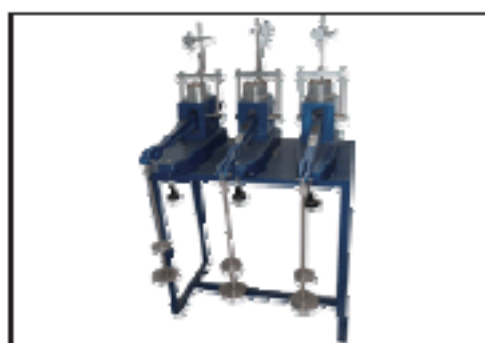
Figure 4.2.4 One-dimensional consolidation test machine

Soil is composed of soil grain and pore water or gas. Consolidation is the phenomenon of that low permeable soil loses its volume with discharging pore water for a longer time by a load. Consolidation test measures the decrement of the volume. Because saturated cohesive soil has low permeability and much pores in soil, it takes time to discharge pore water and the decrement of volume is high. Therefore, the amount of consolidation becomes large in saturated cohesive soil. In addition, discharged water might cause high pore water pressure in a closed system like a main slip surface in ground. Also, the water increases weathering of bedrock. These facts influence the condition of main surface slip caused by landslide and they are related to the landslide mechanisms. High pore water pressure lifts up the soil mass of landslide body and decreases resisting force against shearing

force of landslide. To avoid such phenomena that increase the extent of a landslide, appropriate countermeasures are determined using the results of consolidation tests. The decrement of consolidation and the velocity which were measured from consolidation test are related to soil plasticity. Therefore, soil consistency test is needed.

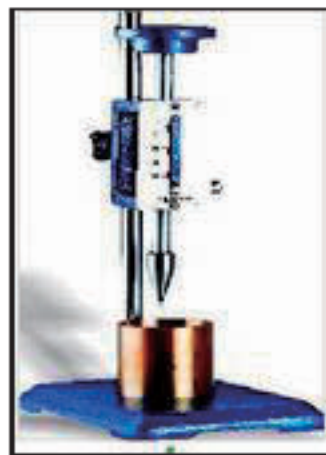
Figure 4.2.5 Cone penetrometer

Behavior of soil mass is changed by the water content; “solid” - “semisolid” - “plastic body” - “liquid”. This change is called soil consistency. Liquid limit is the water content ratio when a soil changes into liquid from plastic body. Soil consistency test is based on the relationship between moisture content and the penetration of a cone into the soil sample under controlled conditions. Simple liquid limit test without a cone penetrator is less-accurate. Therefore, this test using a cone penetrator is important to be measured accurately. Cone penetrometer enables the determination of liquid limit to be performed. When the water contents ratio of soil is closing to plastic limit, the soil is stable. But soil closing to liquid limit is unstable and it becomes easy to flow like liquid by a small shock. Thus, liquid limit test shows when soil becomes and behaves like liquid.
