5. 參考資料

ASSUNTO: SOIL INVESTIGATION ON THE PROJECT FOR THE IMPROVEMENT
OF A PRIMARY TEACHER TRAINING INSTITUTE IN NAMPULA PROVINCE AND
THE PROJECT FOR THE IMPROVEMENT OF SECONDARY SCHOOLS IN THE
NORTHERN REGION IN THE REPUBLIC OF MOZAMBIQUE

REPORT ON
GEOTECHNICAL SITE INVESTIGATION
 FOR PROPOSED CONSTRUCTION OF A SECONDARY SCHOOL
 IN NAMPULA

Second Round of Geophysical Surveys at Seven Districts, in Nampula Province.

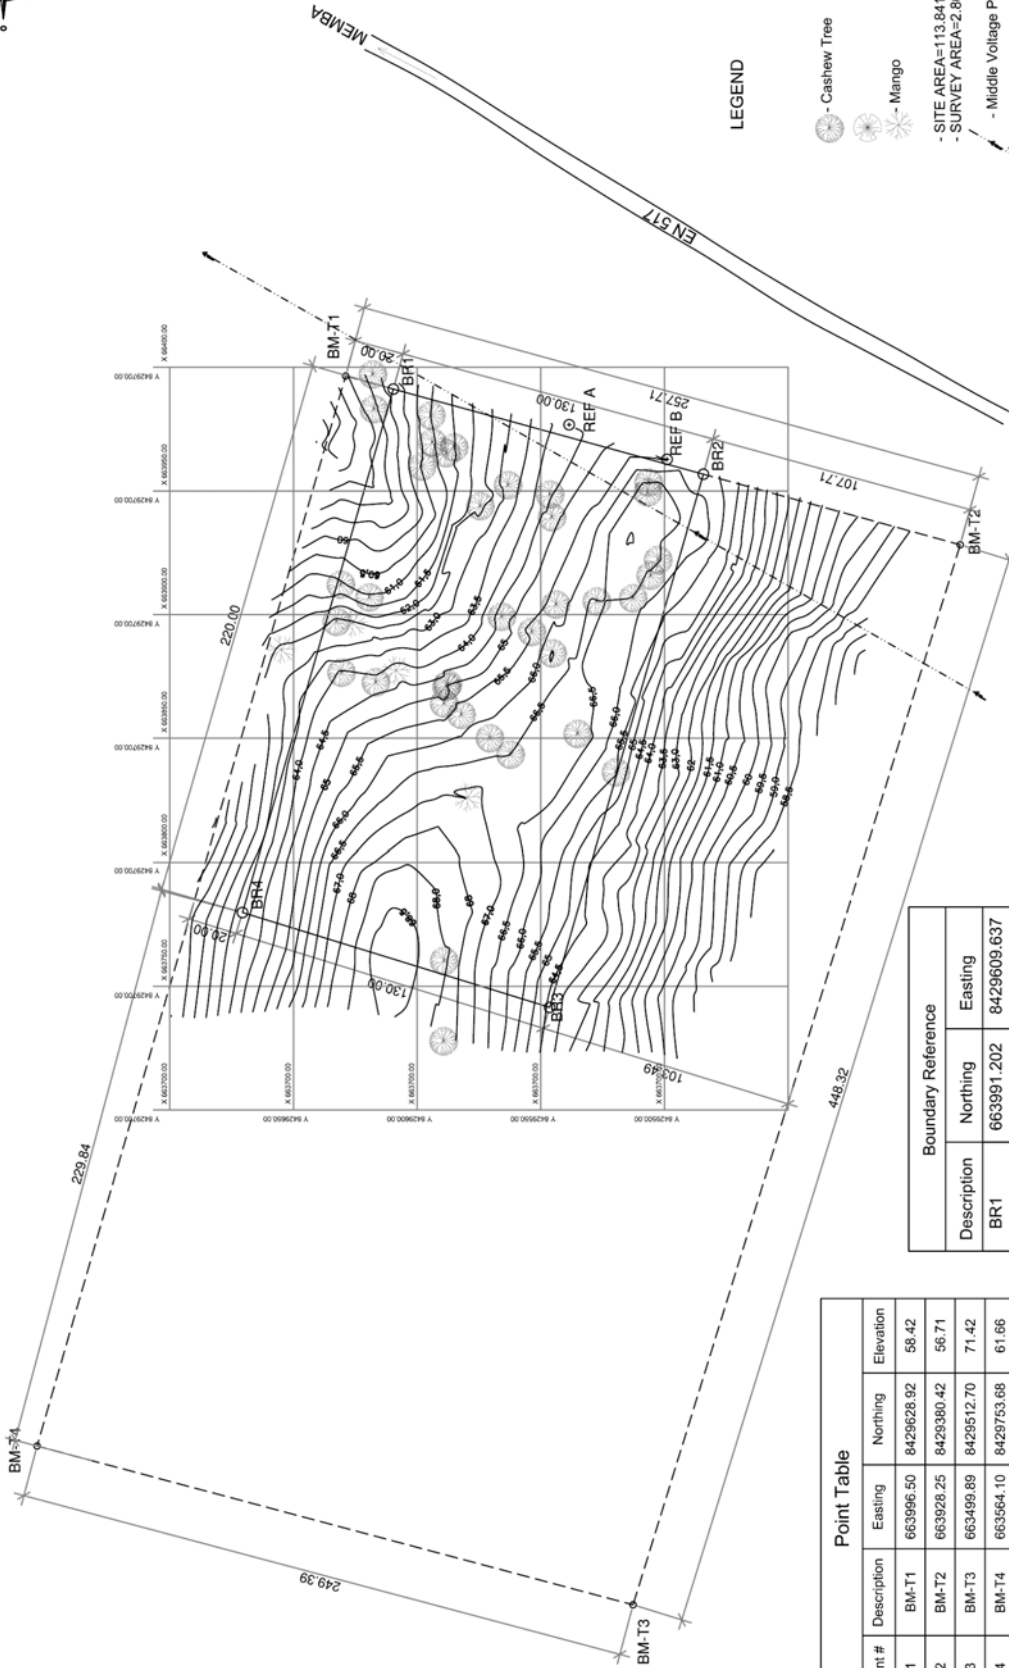
DESENHO N° PTO-CP-TP-007
PROJECTO N° 469
ASSUNTO GENERAL LAYOUT - MEMBA
ESCALA 1:2000

- Cashew Tree
- Mango
- SITE AREA=113.84ha
- SURVEY AREA=2.86ha
- Middle Voltage Power Line
- Boundary Reference and lines
- BR1
- BR2
- BM Benchmark
- Control points

Point #	Description	Easting	Northing	Elevation
1	BM-T1	663996.50	8429628.92	58.42
2	BM-T2	663928.25	8429380.42	56.71
3	BM-T3	663499.89	8429512.70	71.42
4	BM-T4	663564.10	8429753.68	61.66
5	REF A	663976.81	8429538.56	64.48
6	REF B	663962.80	8429498.95	65.66

Description	Northing	Easting
BR1	663991.202	8429609.637
BR2	663956.774	8429484.279
BR3	663741.485	8429546.405
BR4	663779.824	8429670.623

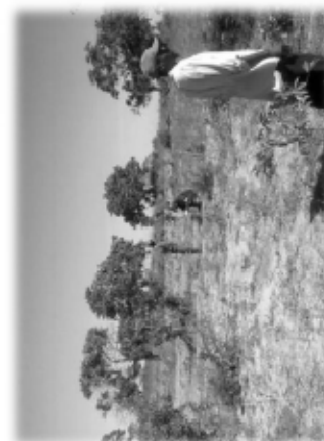
Figure 4. A VES ongoing in Nacala-a-Velha

This site, located in relatively low land deserved dedicated attention of the Consultant. Five profiles, totaling 1235 meters were carried out along the site, complemented by 4 VESes. The actual direction of the profiles was not far different from the planned one, as not very expressive anomalies were identified along the survey. Apart from the original sketch, few smaller profiles were carried out to confirm some anomalies detected in the main profiles.

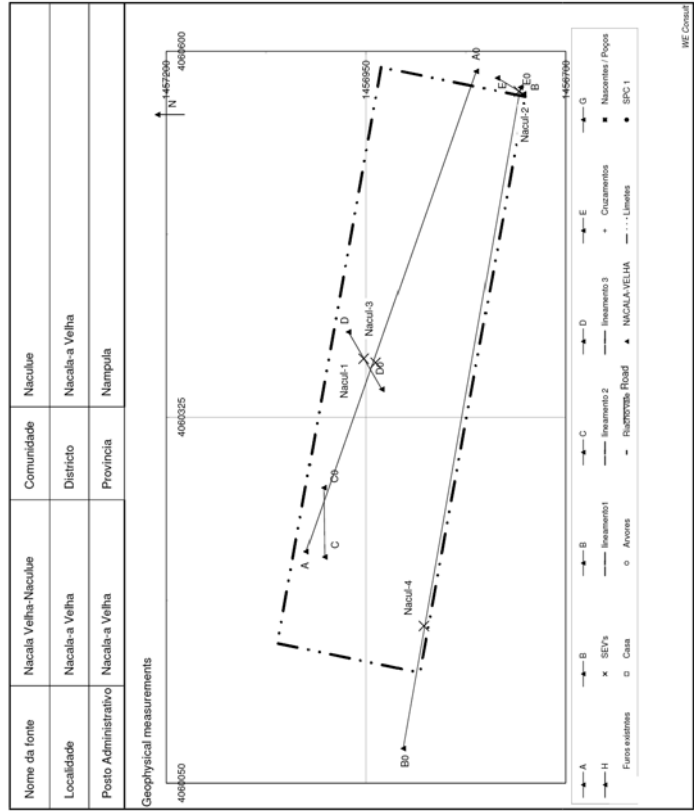
Localização:		Nacala Velha-Naculue			
Meio SEV	Nacu-2	Longitude(E)	4060570	Latitude(S)	1456759
Recomendada para perfuração:	Nao	Altitude (amsl)	36		
Profundidade esperada rocha duras (m)		SEV alternativa	Nacu-N tem		
Profundidade recomendada (m):	27	Acessibilidade da comunidade:	Bom		
Formação esperada:	Argila	Acessibilidade do Sítio:	Difícil		
Potencial:	Muito Baixo	Pessoa contactável:	Pessoa contactável:		
Observações:	O local recomendado esta perto do marco 4 do terreno.
