5. 參考資料

6. その他

ASSUNTO: SOIL INVESTIGATION ON THE PROJECT FOR THE IMPROVEMENT
OF A PRIMARY TEACHER TRAINING INSTITUTE IN NAMPULA PROVINCE AND
THE PROJECT FOR THE IMPROVEMENT OF SECONDARY SCHOOLS IN THE
NORTHERN REGION IN THE REPUBLIC OF MOZAMBIQUE

REPORT ON
GEOTECHNICAL SITE INVESTIGATION
FOR PROPOSED CONSTRUCTION OF A SECONDARY SCHOOL
IN NAMPULA

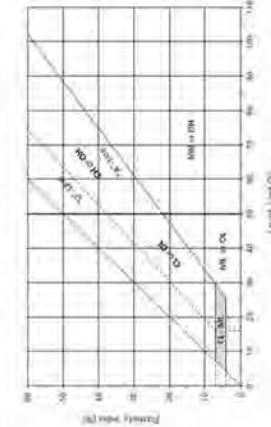
For classification of fine-grained soils and fine-grained fractions of coarse-grained soils

Equation of "A" Line: Horizontal at $PI = 4$ to $LL = 25$; then $PI = 0.73(LL - 25)$

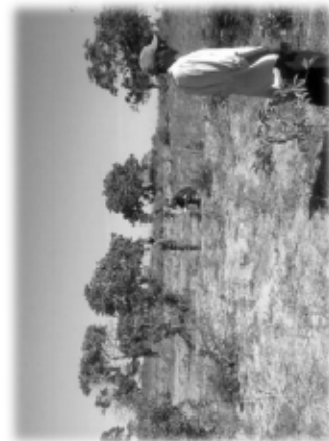
Figure 4. A VES ongoing in Nacala-a-Velha

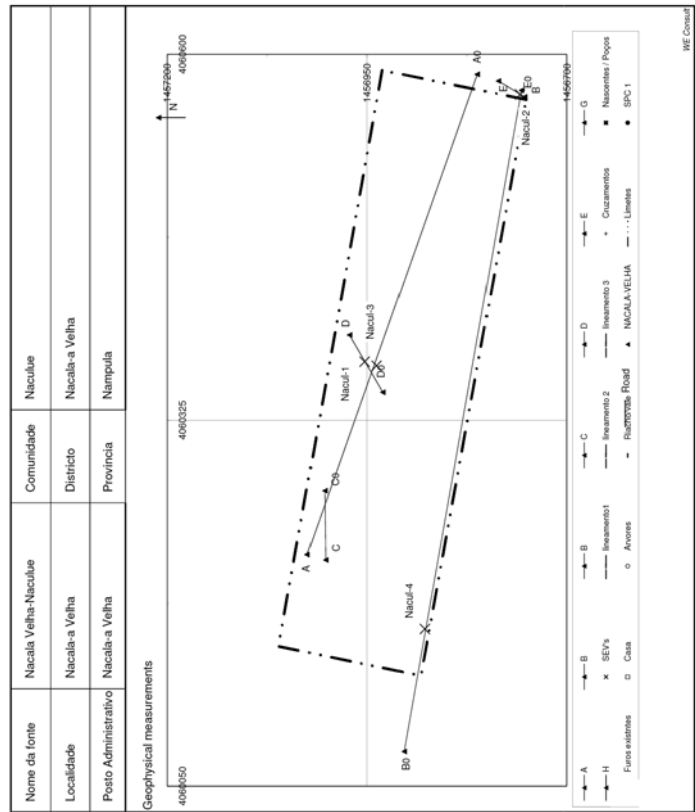
Localização:		Nacala Velha-Naculue			
Meio SEV	Nacu-2	Longitude(E)	4060570	Latitude(S)	1456759
Recomendada para perfuração:	Nao	Altitude (amsl)	36		
Profundidade esperada rocha duras (m)		SEV alternativa	Nacu-N tem		
Profundidade recomendada (m):	27	Acessibilidade da comunidade:	Bom		
Formação esperada:	Argila	Acessibilidade do Sítio:	Difícil		
Potencial:	Muito Baixo	Pessoa contactável:	Pessoa contactável:		
Observações:	O local recomendado esta perto do marco 4 do terreno.
