6. Outros Documentos e Informações

ASSUNTO: SOIL INVESTIGATION ON THE PROJECT FOR THE IMPROVEMENT OF A PRIMARY TEACHER TRAINING INSTITUTE IN NAMPULA PROVINCE AND THE PROJECT FOR THE IMPROVEMENT OF SECONDARY SCHOOLS IN THE NORTHERN REGION IN THE REPUBLIC OF MOZAMBIQUE

REPORT ON
GEOTECHNICAL SITE INVESTIGATION
 FOR PROPOSED CONSTRUCTION OF A SECONDARY SCHOOL
 IN NAMPULA

Second Round of Geophysical Surveys at Seven Districts, in Nampula Province.

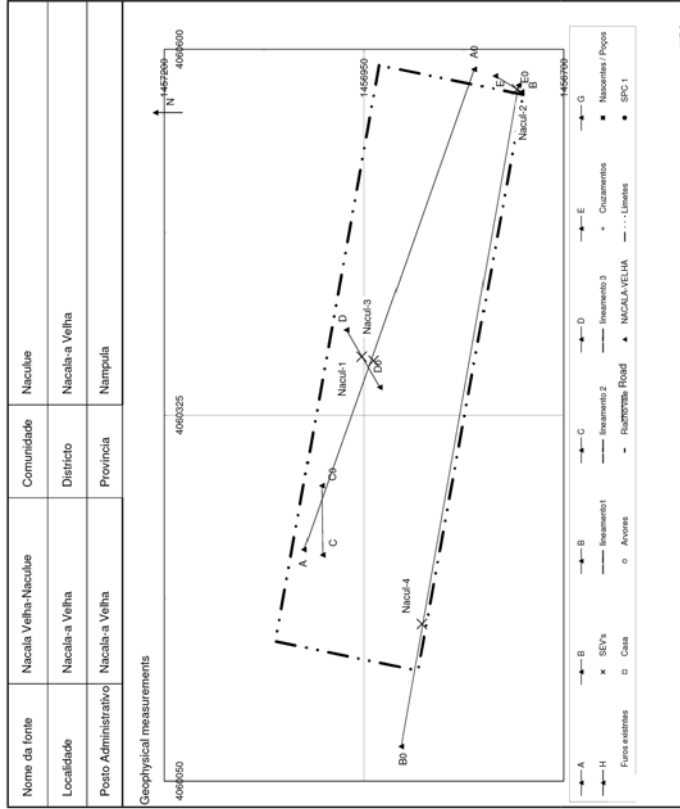
Localização: Nacala Velha-Naculue					
Melhor SEV	Nacu-2	Longitude(E)	4066570	Latitude(S)	1456759
Recomendada para perfuração:	Nao	Altitude (amsl)	36		
Profundidade esperada rocha duras (m)		SEV alternativa	Nacu-N Item		
Profundidade recomendada (m):	27	Acessibilidade da comunidade:	Bom		
Formação esperada:	Argila	Acessibilidade do Sítio:	Difícil		
Potencial:	Muito Baixo	Pessoa contactável:			
Observações:	O local recomendado esta perto do marco 4 do terreno.
