List of Field Survey Results (3/3)

List of the results of the evaluation of the surveyed bridges (1/4)

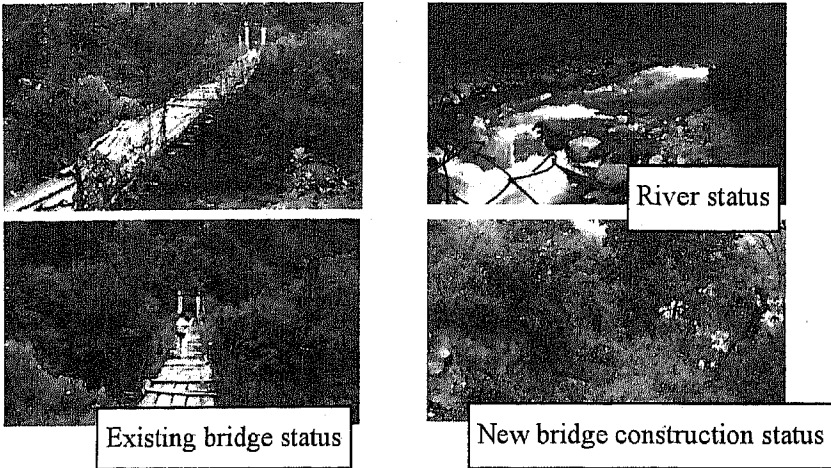
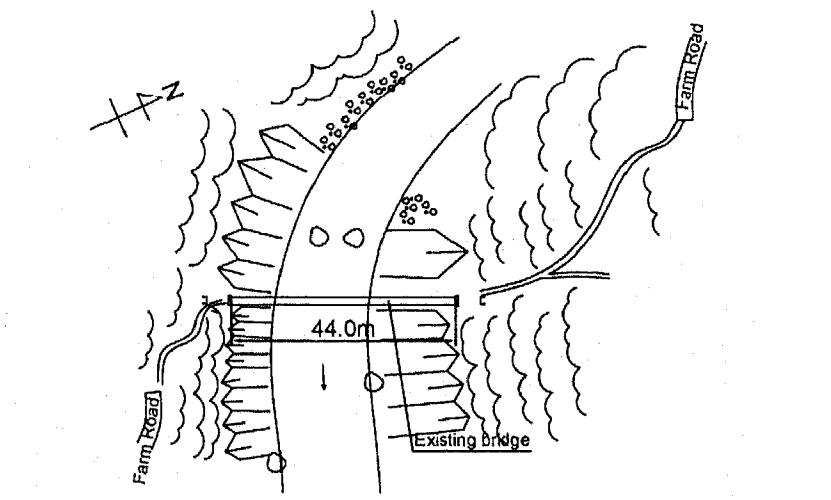
No.19 Kela Bridge	No.20 Jangbi Bridge	No.21 Chenchey Bridge
Field photograph

Bridge status quo	There is significant damage such as deterioration of the main bridge structure and falling of the wooden slabs.	No damage is observed.	This bridge has already been washed out, and the superstructure has been removed. Landslide of the banking around the abutments and destruction of the joints of the abutment walls have been confirmed. Low construction quality influenced the damage. There is a plan in progress to reconstruct a new bridge at a location 800 m upstream.
Access road status	There are farm roads at both ends. If a bridge is constructed, vehicles will be able to cross the river.	There are farm roads at both ends. If a bridge is constructed, vehicles will be able to cross the river.	Feeder roads have been constructed. There is a plan in progress to construct an alternative road to the new bridge upstream.
Importance of route	This is one of the important farm roads covered in the 10th Five-Year Plan.	For poverty reduction of residents on the opposite shore, this route is considered relatively important. There is a plan to promote construction of a farm road on the opposite shore from December 2010 to June 2011.	There is a plan to construct a new bridge upstream including an alternative road. The route has low importance.

Possibility of damage from similar floods	Since sufficient vertical clearance is ensured, there is a low possibility of damage from similar floods.	Since sufficient vertical clearance is ensured, there is a low possibility of damage from similar floods.	Since there is a plan to construct a new bridge upstream, there is a low possibility of damage.

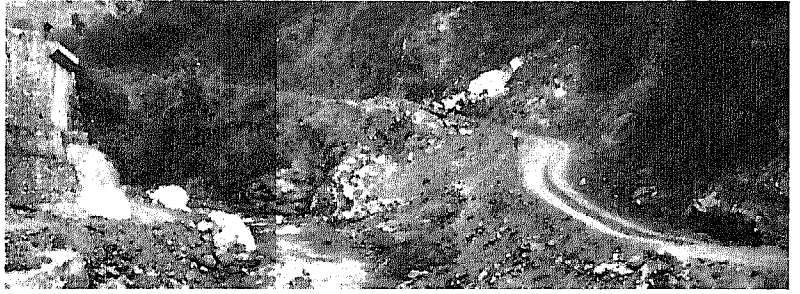
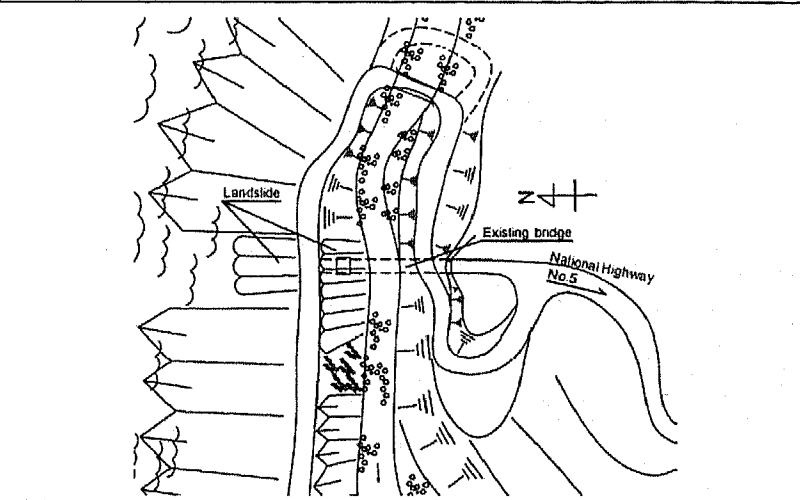
Preparations are underway to build a new bridge (Bailey bridge) at a point 800m upstream of the existing bridge.

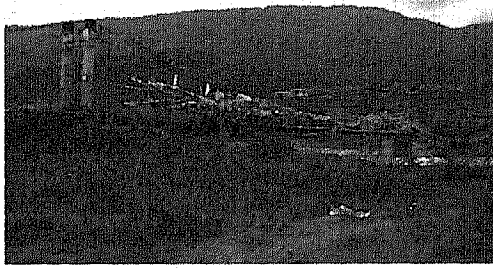
No.5 Tshendona Bridge	
Road classification	Farm Road
Jurisdiction	DoA
Existing Size	L=30m
Existing Bridge Type	Suspension Bridge
Beneficiaries	-

※ The piers are tilted because of scouring resulting from the insufficient width of the abutment footings and insufficient depth of embedding

<p>【Urgency】 As a road bridge was constructed 3.5 km downstream of the site in a Japanese ODA project, replacement of this bridge with a road bridge is not urgently required.</p>	△
<p>【Scale of beneficiaries】 As there are few scattered houses around the bridge, the number of users is limited.</p>	△
<p>【Importance of the route】 As a pedestrian bridge is sufficient to meet local demand, the need to construct a road bridge is low and the importance of the route is also low.</p>	△
<p>【Possibility of suffering damage caused by a similar disaster】 The bridge is unusable because it has collapsed.</p>	△
<p>【Difficulty of construction】 The Bhutanese side will be able to construct a pedestrian suspension or Bailey bridge at the site.</p>	△

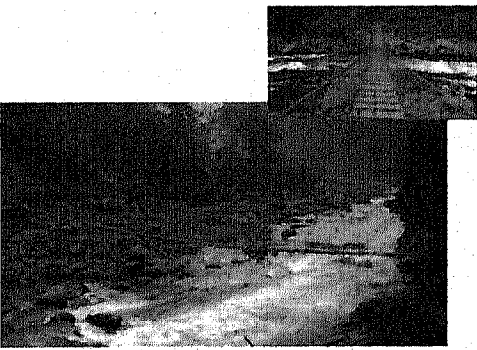
No.9 Mangdechhu (Reotala) Bridge	
Road classification	Farm Road
Jurisdiction	DoA
Existing Size	L = 70m
Existing Bridge Type	Bailey Bridge
Beneficiaries	210HH (3,000 people)

※ The pier collapsed because of poor work on the joints.

<p>【Urgency】 Since a temporary pedestrian/road bridge was constructed on the abutments after the bridge was washed out, the bridge is likely to be washed out in the rainy season. There is no detour if the bridge is washed out. For these reasons, reconstruction of this bridge is urgently required.</p>	◎
<p>【Scale of beneficiaries】 Since the bridge is a major access route to a village of 3,000 people, the number of beneficiaries is large.</p>	◎
<p>【Importance of the route】 As the route is included in the 10th Five-Year Plan, it is a very important farm road. It is also an important route because of the scale of beneficiaries.</p>	◎
<p>【Possibility of suffering damage caused by a similar disaster】 Since the girders of the temporarily erected bridge are below the high water level recorded when Cyclone Aila hit the area, the temporary bridge is likely to suffer damage from a similar disaster.</p>	◎

<p>【Difficulty of construction】 The pier of the existing Bailey bridge collapsed because of improper work on the joints. Because of the height of the substructure, construction of the new bridge will be technically difficult. The new bridge is expected to be a Bailey suspension bridge, which the Bhutanese side will be able to construct.</p>	◎

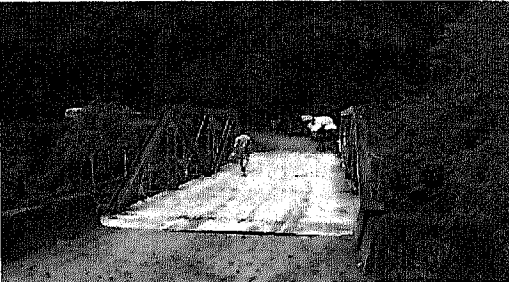
No.16 Dzongkhachulum Bridge	
Road classification	National Highway No.4
Jurisdiction	DoR
Existing Size	L=23m
Existing Bridge Type	Truss Bridge
Beneficiaries	3 dzongkhags

※ Damage to the main structure by fallen rocks

<p>[Urgency] Despite the damage caused by fallen rocks, vehicles can cross the bridge. The traffic is relatively light.</p>	△
<p>[Scale of beneficiaries] Although the bridge is used by the general public because it is on National Highway No. 4, the traffic is relatively light.</p>	○
<p>[Importance of the route] The importance of the bridge is high because of its location on National Highway No. 4.</p>	◎
<p>[Possibility of suffering damage caused by a similar disaster] Because it has sufficient vertical clearance, the bridge is not likely to suffer damage.</p>	△
<p>[Difficulty of construction] Construction of a new bridge is difficult because a bridge with a span length of 70 m will have to be constructed in order to avoid falling rocks. If a temporary baily bridge (a span length of 30 to 35 m) is constructed next to the existing bridge, the Bhutanese side will be able to construct it.</p>	○

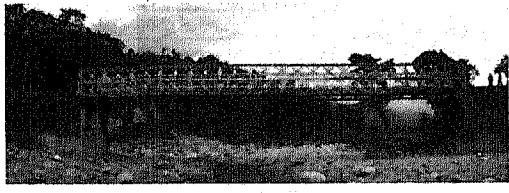
No.17 Dolkhola Bridge	
Road classification	National Highway No.5
Jurisdiction	DoR
Existing Size	L=40m
Existing Bridge Type	Bailey Bridge
Beneficiaries	5 dzongkhags

Downstream side

※ Reduction in the width of the river channel by the bridge

<p>[Urgency] The bridge reduces the width of the river channel and the revetment is partially eroded. In addition, since there is no detour nearby, reconstruction of this bridge has relatively high urgency.</p>	○
<p>[Scale of beneficiaries] The bridge is located on National Highway No. 5 and is used by the general public.</p>	◎
<p>[Importance of the route] The bridge is located on National Highway No. 5, which is an important route from Gelephu to Sarpang and Wangdi.</p>	◎
<p>[Possibility of suffering damage caused by a similar disaster] The bridge reduces the width of the river channel and there are traces (an area with gravel deposit) suggesting that the river was once wider upstream of the bridge. There are also the remains of a collapsed bridge of a similar scale. For these reasons, the bridge at this site is likely to suffer damage from a similar flood.</p>	◎
<p>[Difficulty of construction] The existing bridge is a Bailey bridge. Since replacement with a permanent bridge with a span length of 35 m which can be used by 40 t trucks is assumed, the construction work will technically be very difficult.</p>	◎

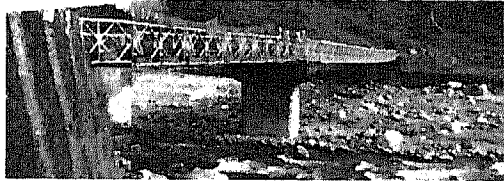
No.18 Jigmiling Bridge	
Road classification	National Highway No.5
Jurisdiction	DoR
Existing Size	L=64m
Existing Bridge Type	Bailey Bridge
Beneficiaries	5 dzongkhags

※ Erosion of the revetment ※ Short distance between the abutments and the piers

<p>[Urgency]</p> <p>The short distance between the piers and the abutments is likely to increase the flow velocity near the bridge in the event of flooding. In fact, the revetment is partially eroded. In addition, since there is no detour nearby, reconstruction of this bridge has relatively high urgency.</p>	○
<p>[Scale of beneficiaries]</p> <p>The bridge is located on National Highway No. 5 and is used by the general public.</p>	◎
<p>[Importance of the route]</p> <p>The bridge is located on National Highway No. 5, which is an important route from Gelephu to Sarpang and Wangdi.</p>	◎
<p>[Possibility of suffering damage caused by a similar disaster]</p> <p>The short distance between the piers and the abutments is likely to increase the flow velocity near the abutments in the event of flooding. The high flow velocity may damage or even wash out the bridge. (It is recommended to erect piers at appropriate locations.)</p>	◎

<p>[Difficulty of construction]</p> <p>The existing bridge is a Bailey bridge. Since replacement with a permanent bridge with a span length of 35 m which can be used by 40 t trucks is assumed, the construction work will technically be very difficult.</p>	◎

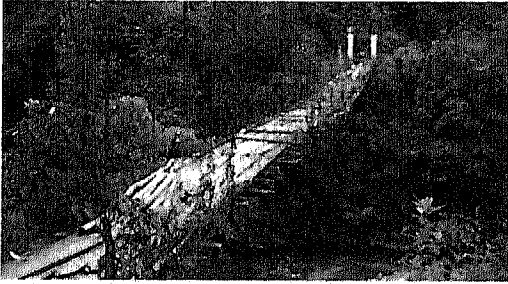
No.19 Kela Bridge	
Road classification	Farm Road
Jurisdiction	DoA
Existing Size	L=45m
Existing Bridge Type	Suspension Bridge
Beneficiaries	2 villages, 57HH

※ Farm road under construction

<p>[Urgency]</p> <p>The existing bridge which was built a long time ago is badly damaged. Since the route is included in the 10th Five-Year Plan and a farm road is being constructed on each side of the bridge, replacement with a road bridge is expected.</p>	○
<p>[Scale of beneficiaries]</p> <p>People from 57 households in two villages are expected to use the bridge.</p>	△
<p>[Importance of the route]</p> <p>As the route is included in the 10th Five-Year Plan, it is a very important farm road.</p>	◎
<p>[Possibility of suffering damage caused by a similar disaster]</p> <p>Because it has sufficient vertical clearance, the bridge is not likely to suffer damage.</p>	△
<p>[Difficulty of construction]</p> <p>Since a Bailey bridge is the assumed structure of the new bridge, it will be possible for the Bhutanese side to construct it's superstructure.</p> <p>As the bridge will be constructed on steep slopes, the substructure work will be somewhat difficult.</p>	○

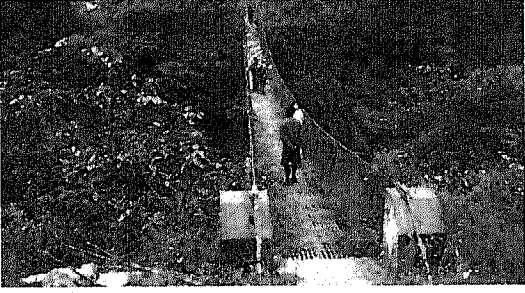
No.20 Jangbi Bridge	
Road Classification	Farm Road
Jurisdiction	DoA
Existing Size	L= 53m
Existing Bridge Type	Suspension Bridge
Beneficiaries	5 villages, 64HH

* Farm road under construction	
[Urgency] Since access by vehicles is required for poverty reduction and a farm road is being constructed on each side of the bridge, construction of a new road bridge is expected.	○
[Scale of beneficiaries] The bridge will be used by people from 64 households in five villages	△
[Importance of the route] As a farm road is being constructed on each side of the bridge, it is considered to be a relatively important route in Bhutan.	◎
[Possibility of suffering damage caused by a similar disaster] Because it has sufficient vertical clearance, the bridge is not likely to suffer damage.	△
[Difficulty of construction] Since a Bailey bridge is the assumed structure of the new bridge, it will be possible for the Bhutanese side to construct it's superstructure. As the bridge will be constructed on steep slopes, the substructure work will be somewhat difficult.	○
