Chapter 5

Observation Well Drilling

5.1 Purpose and methodology

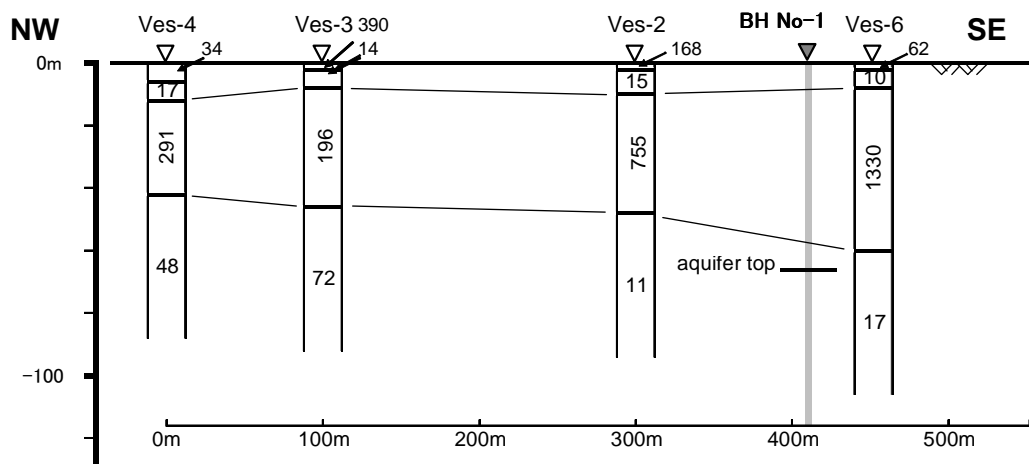
Figure 5.1: Resistivity Profile at Site No-1

The following figure illustrates the resistivity profile of a survey line that intersects RVS BH -1. The profile shows a very low resistivity layer of 10 to 17 Ω -m for the first 10 to 15m. This zone probably corresponds to the fine weathered tuff layer in the geological log (see Annex). From 10 to 60m is a high resistivity layer of more than 800 Ω -m around BH No-1. This zone corresponds to the pumice-rich tuff, sand and welded tuff where there is no pore water in the sediment. In the borehole, below this section is a productive aquifer of sand and gravel and fractured welded tuff. This water bearing layer is clearly detected in the resistivity profile as the deepest layer of the resistivity value of 11 to 17 Ω -m.

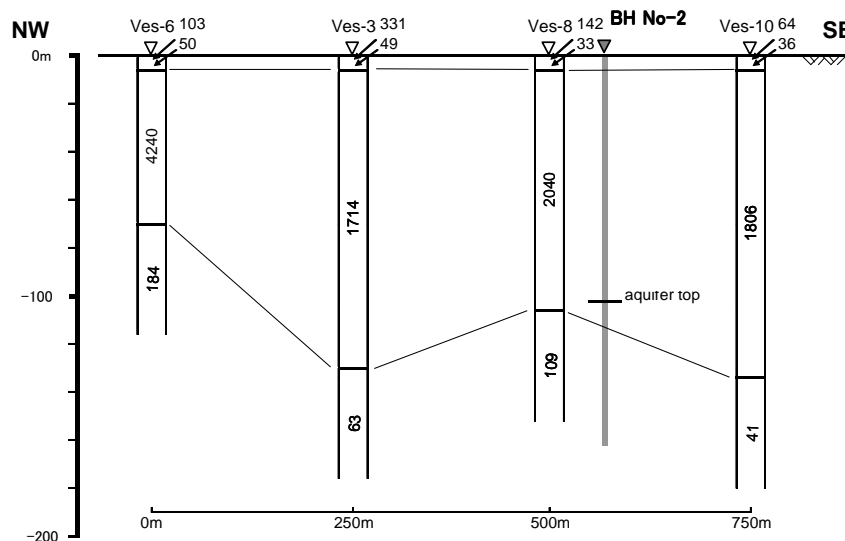
Figure 5.2: Resistivity Profile at Site No-2

Below this is a thick layer (70 to 130m thick) of very high resistivity. The resistivity value reaches over $4000\Omega\text{-m}$ at point VES-6. This remarkably high resistivity values can be explained by the fact that there is a thick porous pumice layer that is underlain by hard welded tuff. Both layers contain no water. Water bearing layer starts at around 100m where the welded tuff layer ends (aquifer top). The resistivity values of the aquifer ranges 40 to $200\Omega\text{-m}$ (about $100\Omega\text{-m}$ near BH No-2). This is a reasonable range of value for water bearing pumice and coarse with gravel in the geological log.

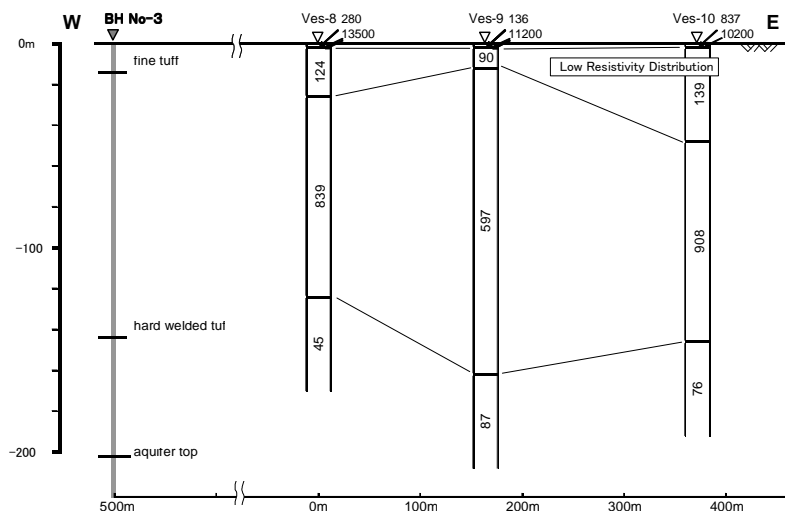
Figure 5.3: Resistivity Profile at Site No-3

In the resistivity profile, the bottom most low resistivity layer occurs at around 150m. This depth coincides with the top of thick tuff breccia formation. This formation is moderately consolidated but it has a block in matrix structure and can hold some water in its loose matrix portion. Though a small amount of water was reported to have been struck around 200m at the time of drilling, but the formation may be saturated up to the bottom of welded tuff layer (143m). If that is the case, the bottom low resistivity layer in the profile may represent the water bearing zone.

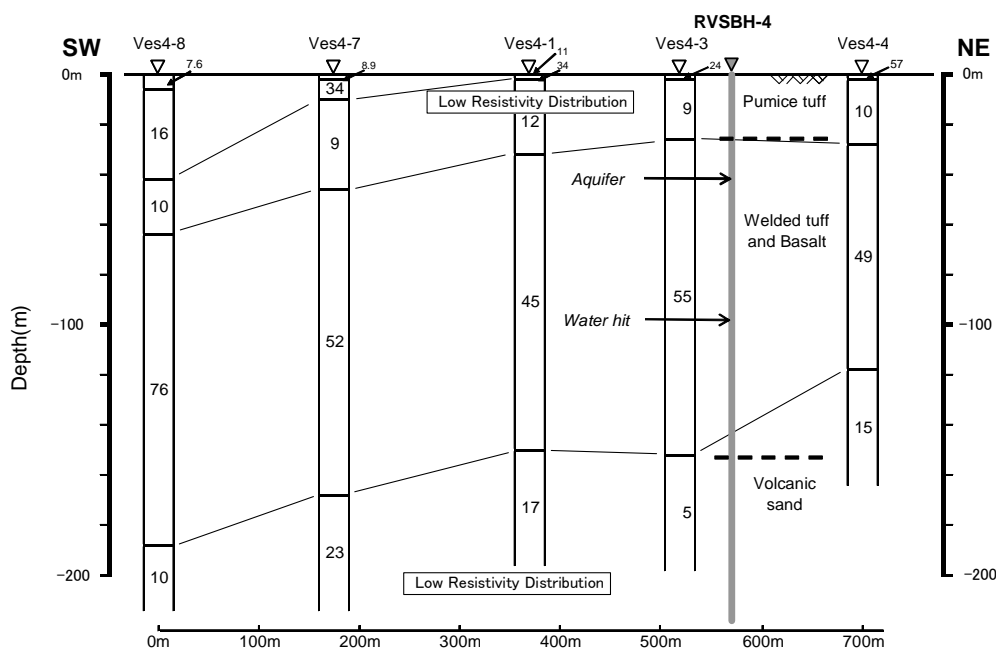
Figure 5.4: Resistivity Profile at Site No-4

The following figure illustrates the resistivity profile of a survey line that intersects survey point VES-4-3 at site No-4. The well (RVS BH -4) was drilled about 60m to the north east of VES-4-3 on the survey line. The profile shows a low resistivity layer of around 10 Ω -m for the first 20 to 30m around the well. This zone probably corresponds to the weathered pumice tuff layer that contains water in the geological log (see the Annex). The underlying thick zone of intermediate resistivity of around 50 Ω -m seems to correspond to section of welded tuff and basalt layers that exhibit high resistivity values in the borehole logging as well. The aquifer zone could not be clearly indicated in this profile probably due to high static water level (about 8m).

The bottom low resistivity layer on the other hand, seems to correspond to the volcanic sand formation in the geological log. At this site, the formations were all water bearing due to abundant shallow groundwater. Thus, resistivity profile did not reflect the water bearing zone but rather the difference in the geological materials.

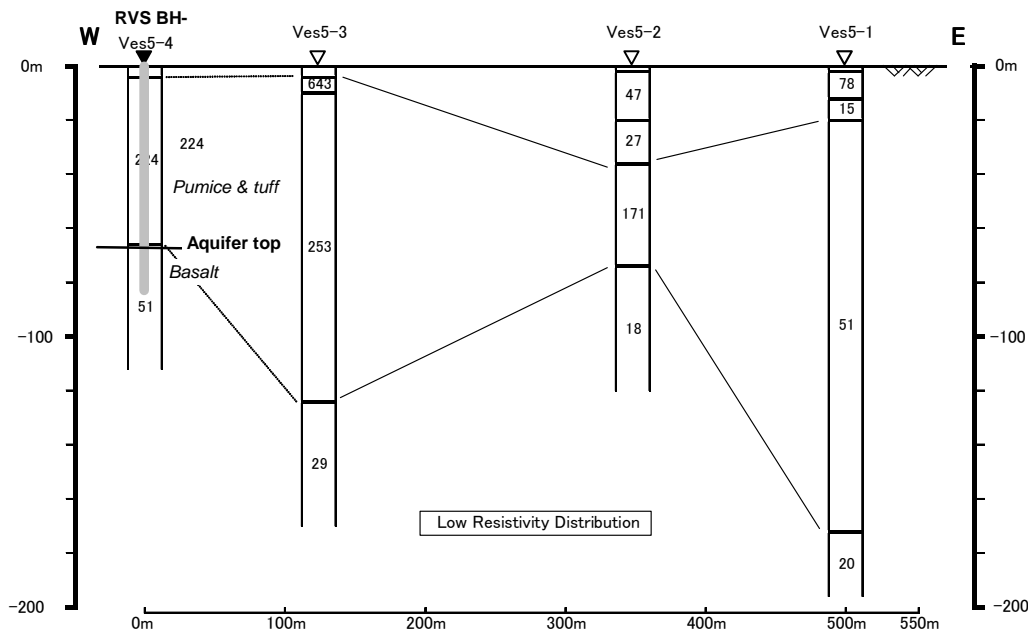
Figure 5.5: Resistivity Profile at Site No-5

The following figure illustrates the resistivity profile of a survey line that intersects RVS BH-5. The profile shows a layer of low resistivity of 20 to 50 Ω -m starts at various depths of 65 to 170 m at the bottom of the profile. This low resistivity zone probably corresponds to the water bearing layer. At the drilling point of RVS BH-5, the resistivity profiling almost accurately predicted the beginning of water bearing layer (aquifer top) that corresponds to the blocky basalt layer in the geological log (see Annex).. The occurrence of highly variable top surface of the low resistivity layer in the interpreted profile might indicate that the terrain is shredded into small hydrogeologically independent sections due to excessive faulting.

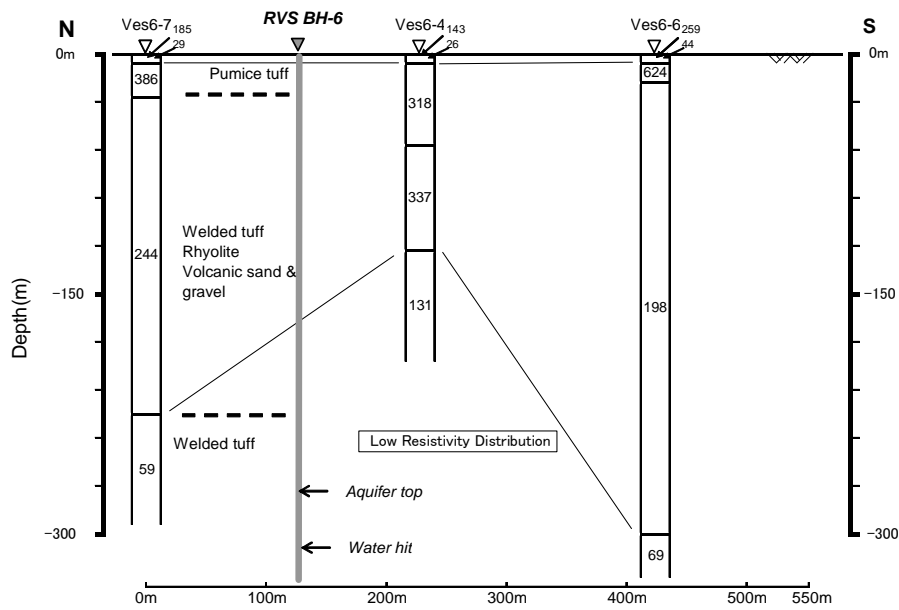
Figure 5.6: Resistivity Profile at Site No-6

The following figure illustrates the resistivity profile of a survey line that intersects survey point VES-6-7 and VES 6-4 at site No-6. The well (RVS BH No-6) was drilled between the two points a bout 30 m off the survey line. The profile shows two low layers of intermediate resistivity around 300 Ω -m down to 180 m to 220 m. This zone probably corresponds to the dry formations. The low resistivity layer is found below these depths. However, the water was struck around 274 m during the drilling as indicated as aquifer top. This profiling could not detect the water bearing zone. The assumed resistivity layers rather coincides with different lithological sections in the geological log of the borehole. The depth of the water bearing zone was probably too deep to be detected by the resistivity survey.

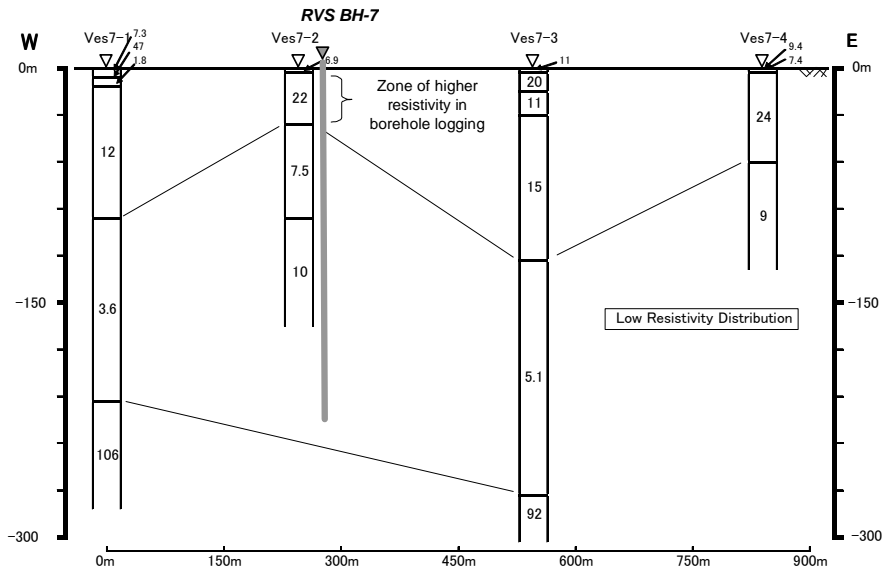
Figure 5.7: Resistivity Profile at Site No-7

The following figure illustrates the resistivity profile of a survey line that intersects survey point VES 7-2 at site No-7. The well (RVS BH-7) was drilled about 20 m to the north of VES 7-2 on the survey line. The profile shows a low resistivity layer of 5 to 10 Ω -m from around 30 m below around the well. There is a layer of relatively higher resistivity at the surface and its thickness varies. However, the resistivity values do not show significant change with depth. Also, the static water level at this site is very shallow and no distinct water flow was detected during the drilling operation. The borehole resistivity log data also shows a flat profile but the top 45 m section has slightly higher values of resistivity. This zone seems to be captured in this profiling as indicated in the figure. Geologically the borehole is a succession of volcanoclastic materials including reworked sand and gravel layers and most of the layers are considered water bearing. Thus, no clear correlation was found between the resistivity and geology either.

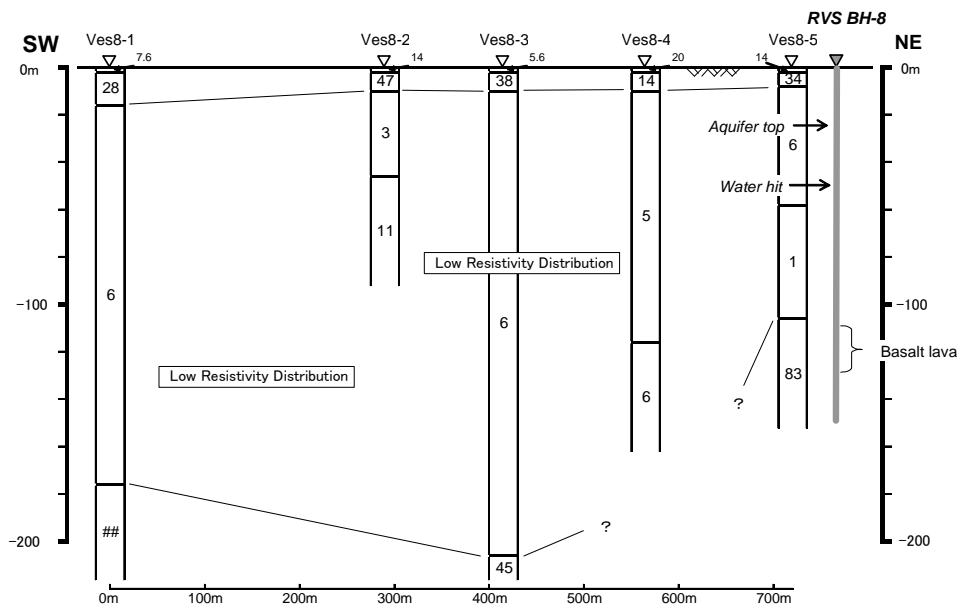
Figure 5.8: Resistivity Profile at Site No-8

The following figure illustrates the resistivity profile of a survey line that intersects survey point VES 8-5 at site No-8. The well (RVS BH-8) was drilled about 50m to the east of VES 8-5 on the extended survey line. The profile shows a 10 m thick low resistivity layer of 34 Ω -m at the surface. Below this are two layers of extremely low resistivity of 1 to 6 Ω -m up to around 110 m. These layers are underlain by a higher resistivity layer of 83 Ω -m. The zones of striking water during the drilling operation that are considered the top of aquifers do not correspond to the boundaries of the resistivity layers. The dry zone at the top of the borehole that may be detected as higher resistivity zone was interpreted much thinner in the resistivity profile. The sudden change in the resistivity value at around 110 m may, however, correspond to the top of the basalt lava in the geological log. This zone also showed relatively higher resistivity values in the borehole logging.

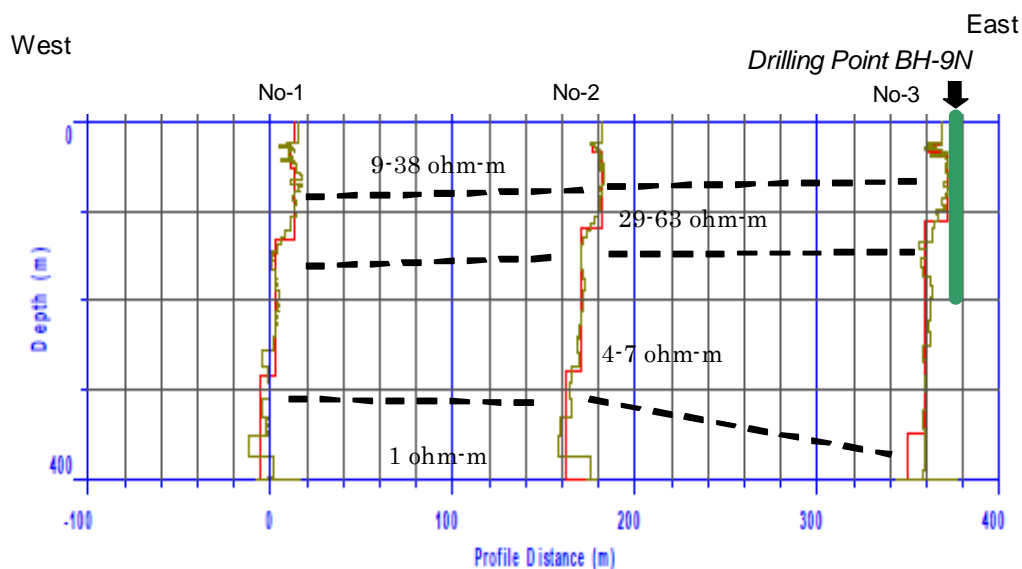
Figure 5.9: TEM Resistivity Profile at Site No-9N

The geophysical survey at this newly selected site (alternative of Site No-9) was conducted with TEM (Transient Electro Magnetic) survey method. The analyzed resistivity profile along the line that intersects the drilling point No-9N was shown below. The borehole was drilled right beside survey point No-3. As can be seen in the figure, four layers of different resistivity values were recognized as a result of analysis. At the drilling point, major water was struck around 89 m and 100 m, and these were considered the major aquifer zone. The top depth of aquifer zone (89 m) is about 10 to 15 m below the boundary of first (9 - 38 ohm-m) and second (29 - 63 ohm-m) layers in the figure. As a result of the comparison with the geological log and this resistivity layer structure, the second resistivity layer seem to correspond to the aquifer zone. Although the resistivity values of the first layer is unusually low. The corresponding geological formation is dry tuff and punice, which does not explain the low resistivity of the zone. The third and fourth layers on the figure have very low resistivity values. There is a every thick formation of damp clay below 130 m in the borehole. Thus, this zone may correspond to that clay formation. The TEM survey did not vary accurately locate the zone of aquifer but gave some indication of it at this site too

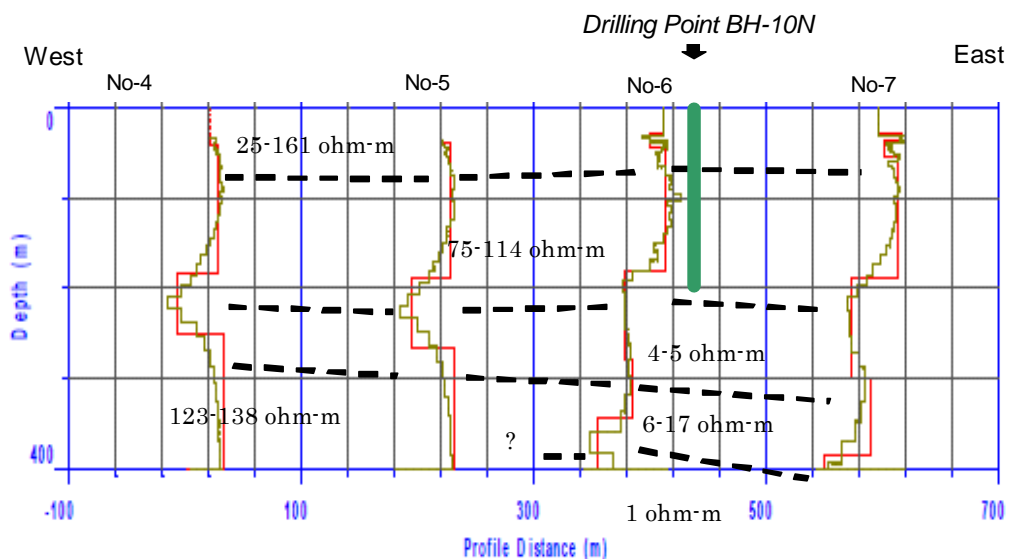
Figure 5.10: TEM Resistivity Profile at Site No-10N

The geophysical survey at this newly selected site (alternative of Site No-10) was conducted with TEM (Transient Electro Magnetic) survey method. The analyzed resistivity profile along the line that intersects the drilling point No-10N was shown below. As can be seen in the figure, five layers of different resistivity values were recognized as a result of analysis. At the drilling point, major water was struck around 65 m and this is considered to be the top of the aquifer zone. This depth corresponds to the boundary of first (25-161 ohm-m) and second (75-114 ohm-m) layers. Although the difference in the labeled resistivity values is relatively small, at point No-6, the resistivity curve shows higher contrast than at points No-4 and 5. The TEM survey successfully located the zone of aquifer at this site too

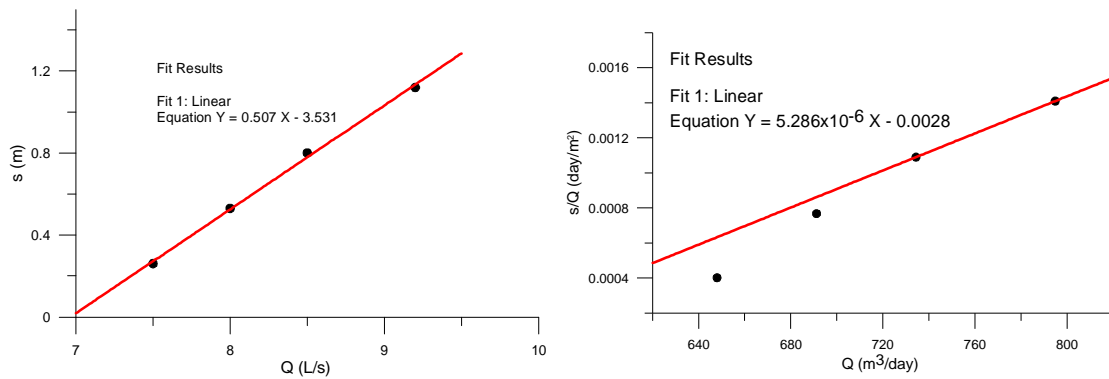
Figure 5.12: s-Q Plot (Left) and s/Q-Q Plot (Right) for Site No-2

The same analysis was performed using the data set from Site No-2. The resultant graphs are presented in the following:

At No-2 site, the aquifer potential was far over the capacity of the largest submersible pump available. Thus, only a small amount of drawdown (maximum 1.23 m) was created by the pumping test. This means that the test could not put sufficient stress to the aquifer. As a result, the s-Q plot is almost linear and the plots show no sign of deviation from the linearity. Deviation from this line may have occurred at higher discharges.

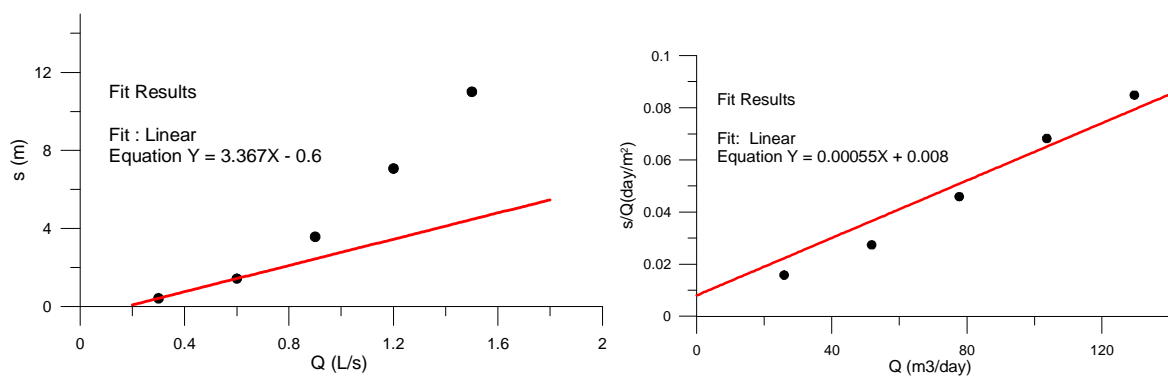
Figure 5.13: s-Q Plot (left) and s/Q-Q Plot (right) for Site No-3

At site No-3, the static water level is as low as 172 m and this made pumping at high rates practically impossible. On the other hand, the aquifer potential is also relatively low. Thus, reasonable amount of drawdown was created in spite of low pumping rates. The result shows that the s-Q plot clearly deviates from the straight line after the second step, showing possible

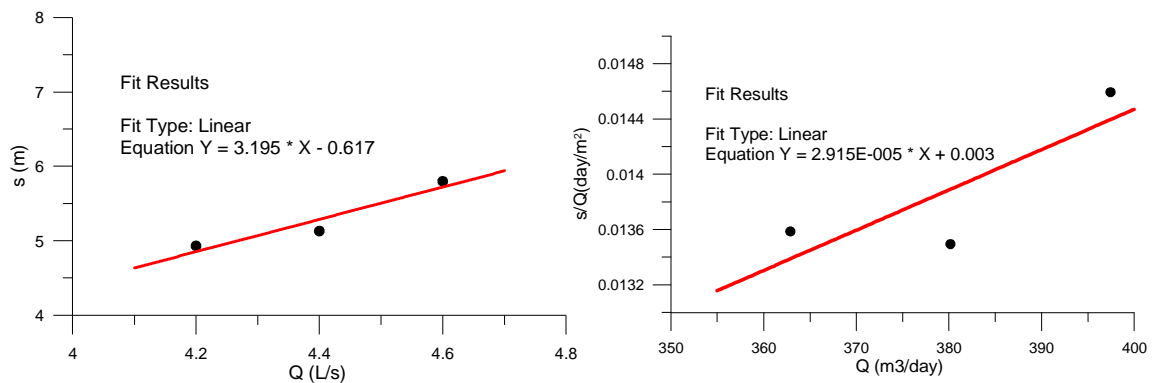
Figure 5.15: s-Q Plot (left) and s/Q-Q Plot (right) for Site No-6

Due to the limitation of the pump capacity, the test was conducted in three steps. The data was analyzed and the result shows that the s - Q plot shows moderately linear relation between s and Q , showing moderate effect of well loss. However, the data may carry some error due to small interval between the pumping rates.

On the s/Q - Q plot, the regression line was drawn using all the data points although the data points were not plotted in a straight line. The evaluation indicates that:

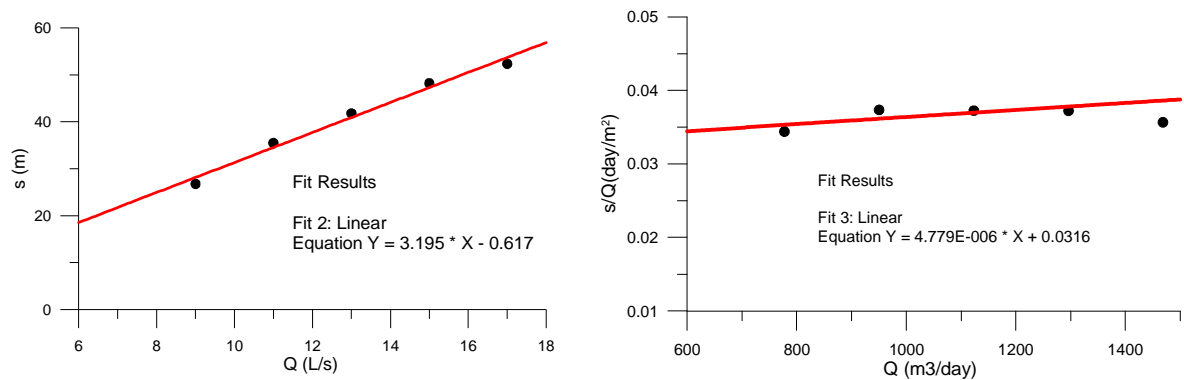
Figure 5.16: s-Q Plot (left) and s/Q-Q Plot (right) for Site No-7

The step drawdown test was conducted in five steps. The data was analyzed and the result shows that the s-Q plot shows nearly linear relation between s and Q, showing little effect of well loss.

On the s/Q-Q plot, the data points were not plotted in a straight line, with the last three points slightly lower than expected values. Thus, the regression line was drawn using all the data points. The evaluation indicates that:

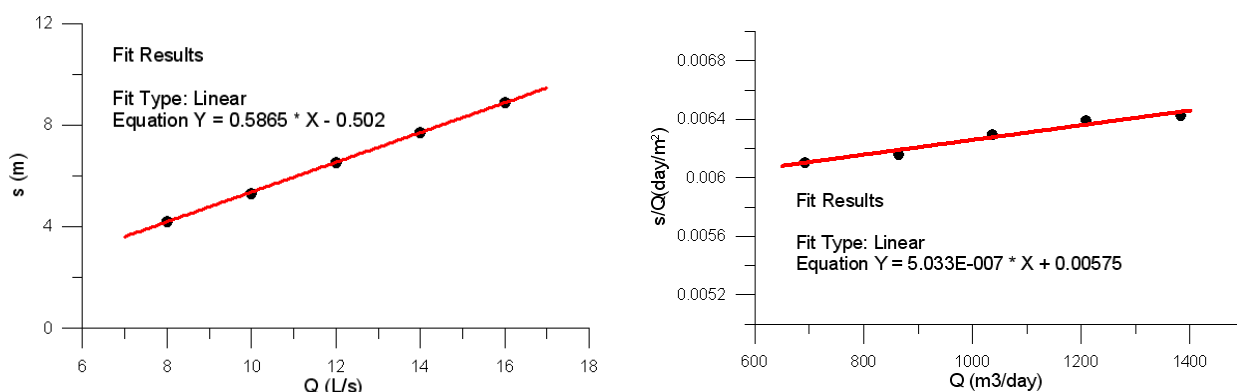
Figure 5.17: s-Q Plot (left) and s/Q-Q Plot (right) for Site No-9N

$$B = 0.0058, \quad C = 5.03 \times 10^{-7}$$

The results are compiled in the table below. For discharge $Q = 16 \text{ L/s}$ ($1382.4 \text{ m}^3/\text{day}$), the largest pumping rate in the step test, the well efficiency (E_w) is calculated to be :

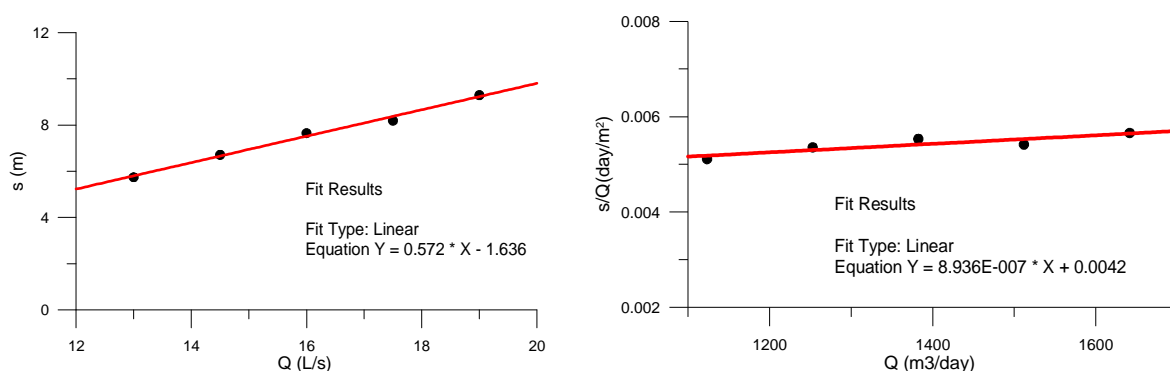
Figure 5.18: s-Q Plot (left) and s/Q-Q Plot (right) for Site No-10N

The same analysis was performed using the data set from Site No-10N. The resultant graphs are presented in the following.

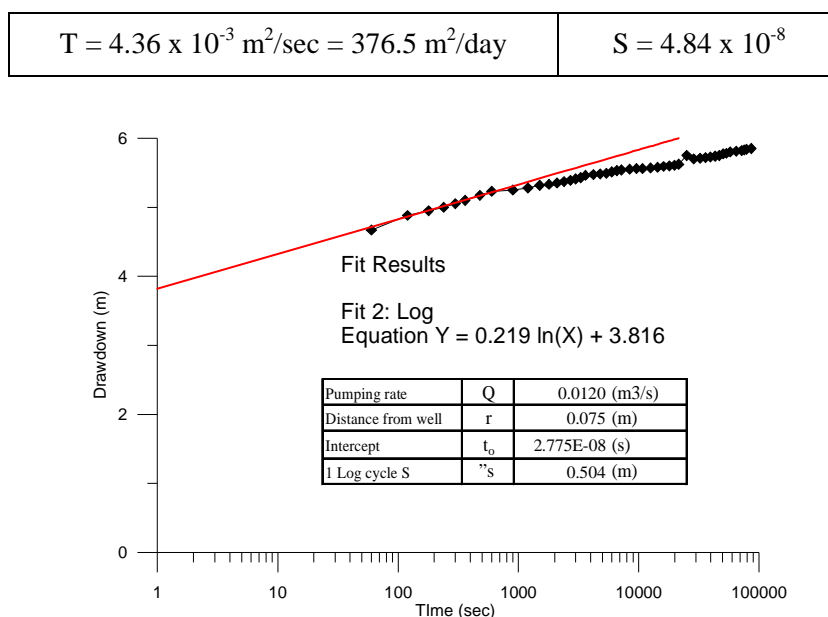
Figure 5.19: Cooper-Jacob Analysis of Data from Site No-1

The plotted data starts deviating from the straight line after 10 minutes, indicating possible recharge from surrounding layers. The regression line is drawn thus, through the 2nd to 7th plots. The resultant formula of the regression line is shown on the figure. The hydrogeological parameters were calculated as follows.

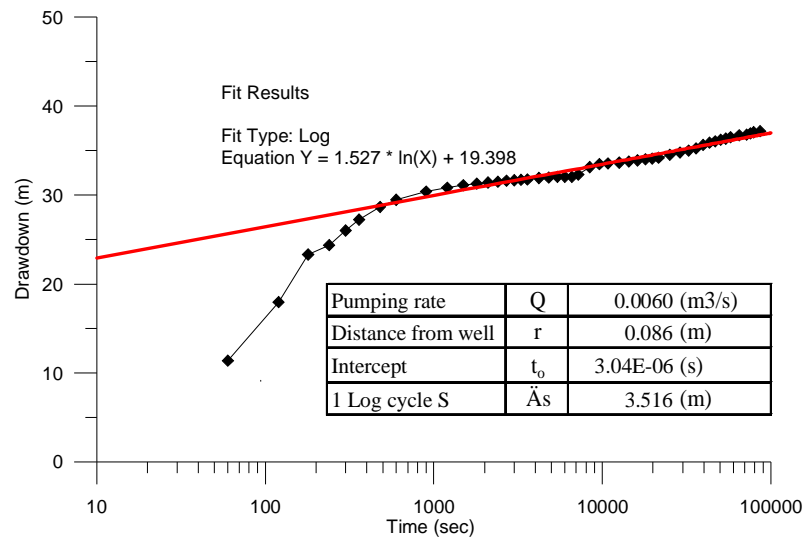
Figure 5.22: Cooper-Jacob Analysis of Data from Site No-4

The continuous pumping test was conducted for 24 hours with a discharge of 6.0 L/s. The result was analyzed on the following graph.

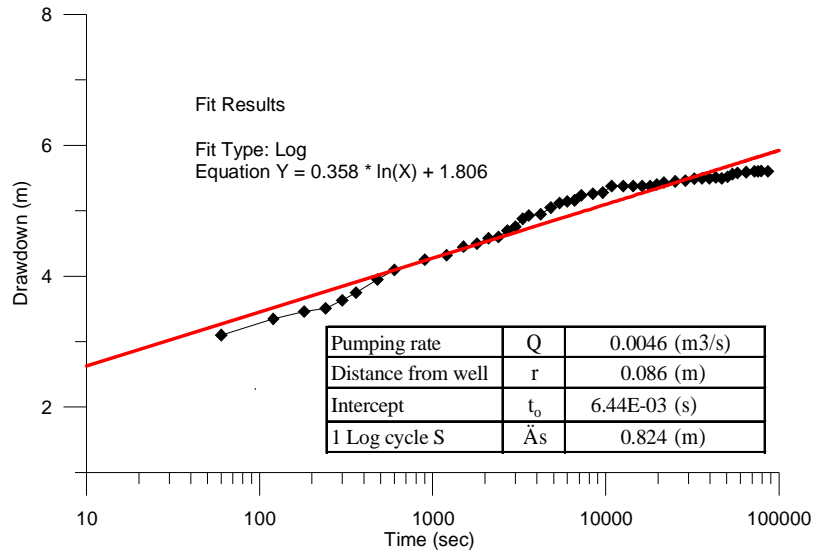
Figure 5.23: Cooper-Jacob Analysis of Data from Site No-6

The continuous pumping test was conducted for 24 hours with a discharge of 4.6 L/s. The result was analyzed on the following graph.

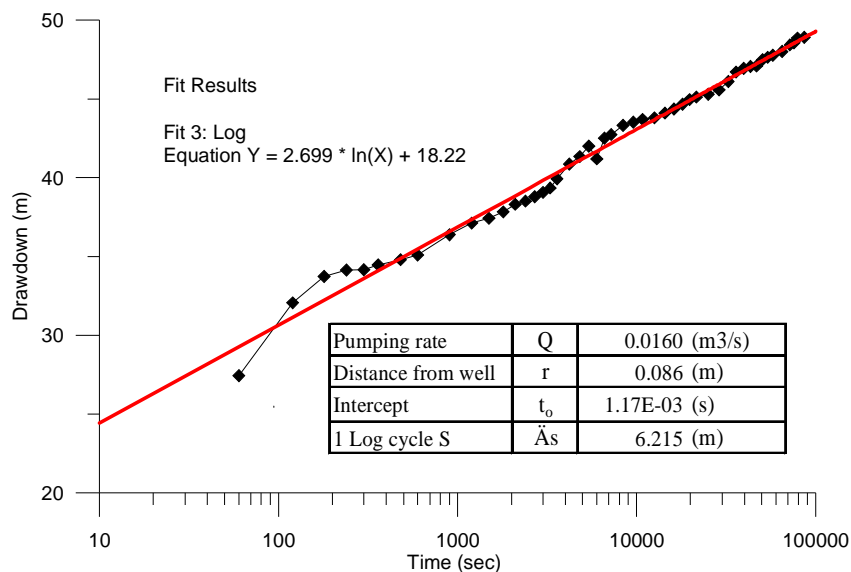
Figure 5.24: Cooper-Jacob Analysis of Data from Site No-7

The continuous pumping test was conducted for 24 hours with a discharge of 16 L/s. The result was analyzed on the following graph.

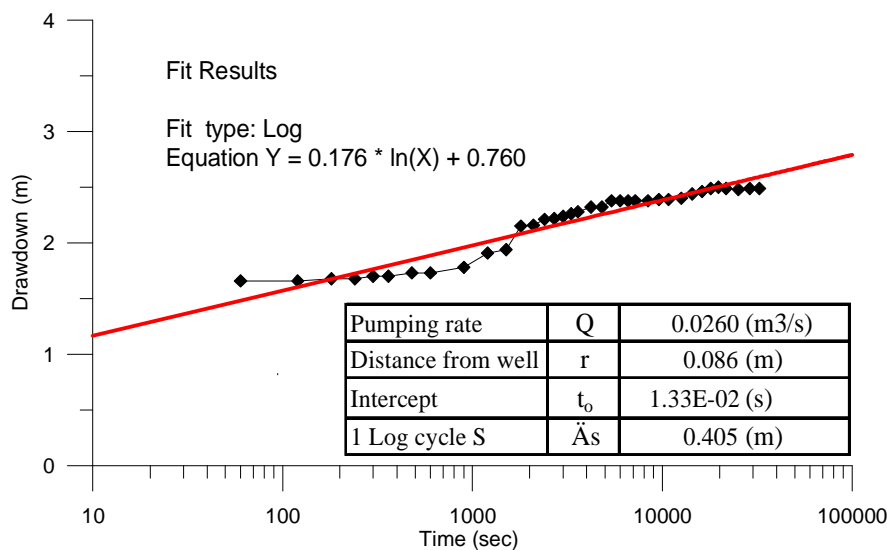
Figure 5.25: Cooper-Jacob Analysis of Data from Site No-8

The continuous pumping test was conducted for nine hours with a discharge of 26 L/s. The result was analyzed on the following graph.

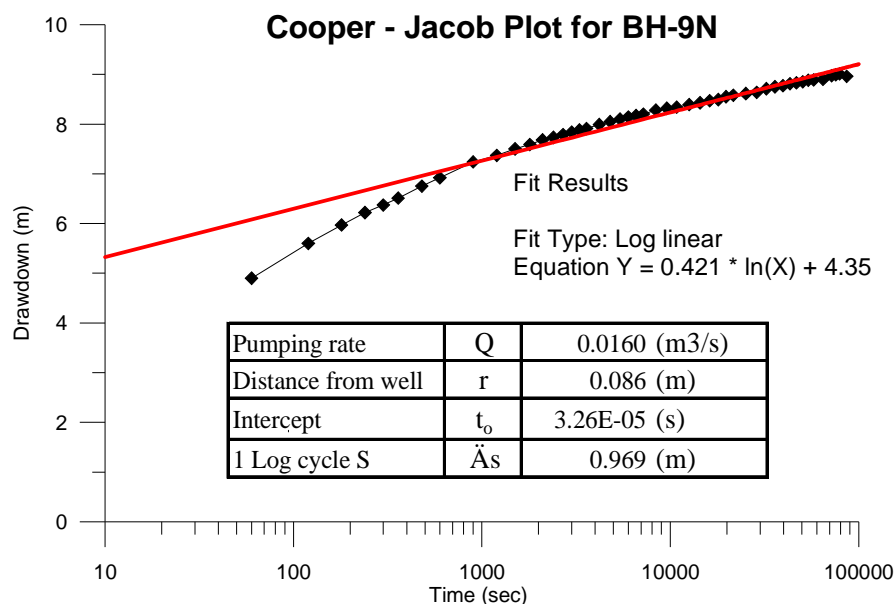
Figure 5.26: Cooper-Jacob Analysis of Data from Site No-9N

The continuous pumping test was conducted for 24 hours with a discharge of 16 L/s. The result was analyzed on the following graph.

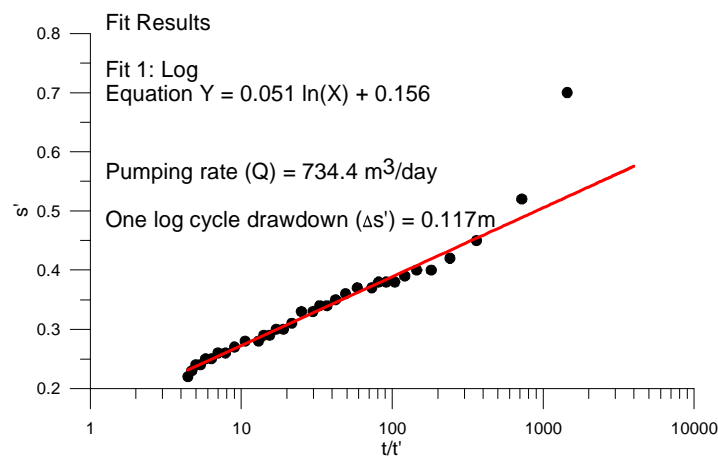
Figure 5.29: Analysis of Recovery Test Data at Site No-2

The well was pumped for 24 hours at a constant rate of 8.5 L/s and the maximum drawdown observed was 1.23m. After the pump was stopped the water level in the well recovered close to the original water level after 410 minutes. The data was plotted on $s' - t/t'$ graph and transmissivity was calculated in the same way as explained above.

As a result, transmissivity was evaluated to be as follows:

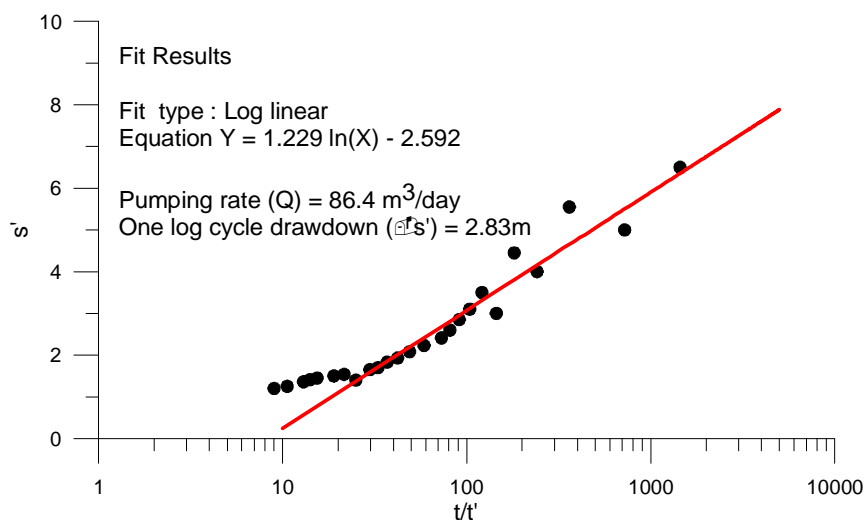
Figure 5.30: Analysis of Recovery Test Data at Site No-3

The well was pumped for 24 hours at a constant rate of 1 L/s and the maximum drawdown observed was 7.3 m. After the pump was stopped, 90 % of the drawdown in the well was recovered within three hours. The data was plotted on $s' - t/t'$ graph. The first seven data plots show some variation and the last seven data points deviate from the linear trend of the entire data set. Thus, the regression line was drawn to follow the general trend of the data plots.

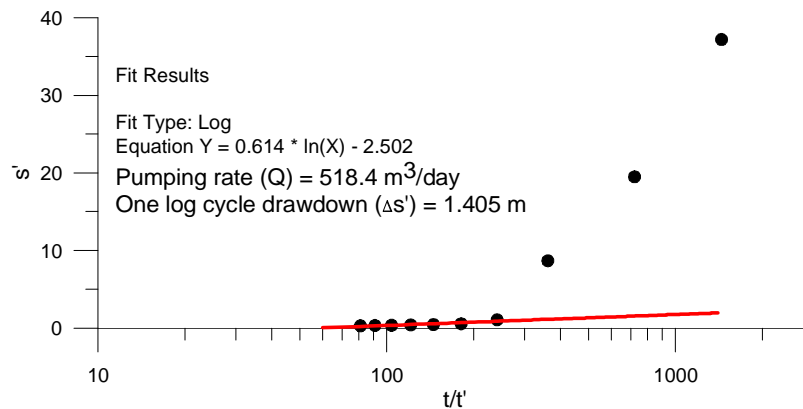
Figure 5.31: Analysis of Recovery Test Data at Site No-4

The well was pumped for 24 hours at a constant rate of 6 L/s and the maximum drawdown observed was 37.2 m. After the pump was stopped, approximately 97 % of the drawdown in the well was recovered within only six minutes. After that, the rate of recovery significantly slowed down. The data was plotted on $s' - t/t'$ graph. The plots displayed two distinctive line segments. The first three data plots (t/t' over 200) show significant deviation from the rest of the plots and have a steep slope. On the other hand the rest of the data plots have gentle slope, indicating the existence of two aquifers of different characteristics. Since the first three data plots were considered non-essential, the regression line was drawn through the remaining data plots on the left half of the graph below.

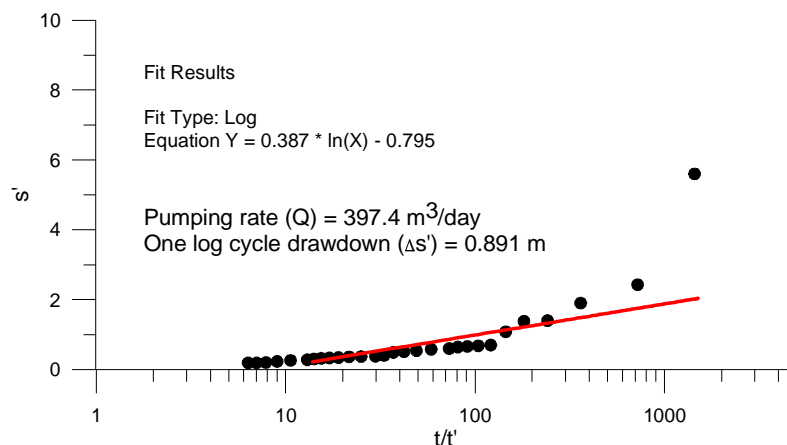
Figure 5.32: Analysis of Recovery Test Data at Site No-6

The well was pumped for 24 hours at a constant rate of 4.6 L/s and the maximum drawdown observed was 5.6 m. After the pump was stopped, 88 % of the drawdown in the well was recovered within 12 minutes. The data was plotted on $s' - t/t'$ graph. The first six data plots show some variation, especially the first one (right most plot). Thus, the regression line was drawn to follow the general trend of the remaining data plots that form a line segment.

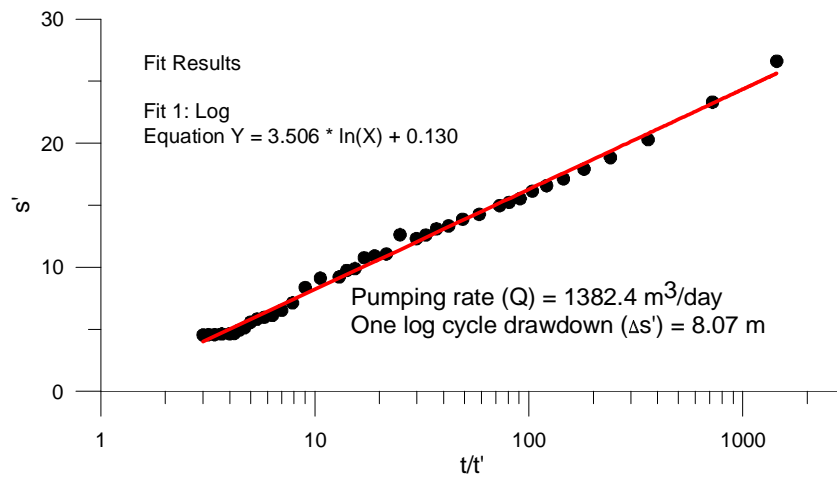
Figure 5.33: Analysis of Recovery Test Data at Site No-7

The well was pumped for 24 hours at a constant rate of 16 L/s and the maximum drawdown observed was 48.9 m. The water level recovery was observed 12 hours after the pump was stopped and approximately 91 % of the drawdown in the well was recovered. The data was plotted on s' – t/t' graph. The data plots form a straight line. Thus, the regression line was drawn to follow the general trend of the remaining data plots that form a line segment.

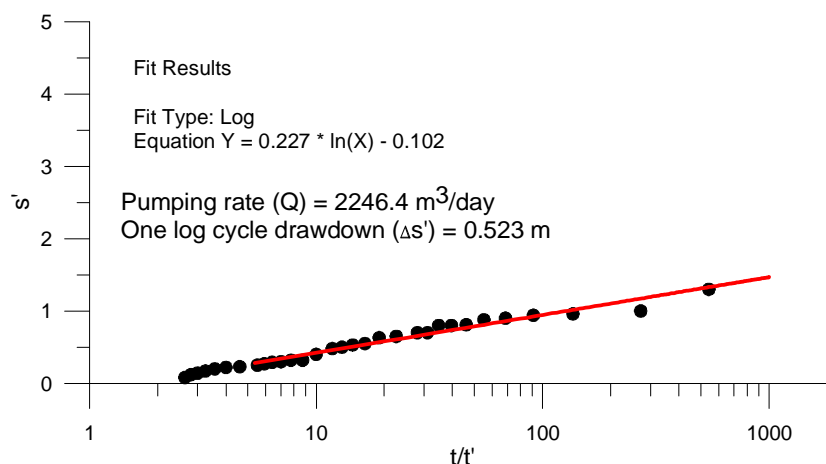
Figure 5.34: Analysis of Recovery Test Data at Site No-8

The well was pumped for nine hours at a constant rate of 26 L/s and the maximum drawdown observed was as small as 2.49 m. The water level recovery was observed 5.5 hours after the pump was stopped and within this time, approximately 97 % of the drawdown in the well was recovered. The data was plotted on s' – t/t' graph. The data plots form a straight line. Thus, the regression line was drawn to follow the general trend of the entire data plots.

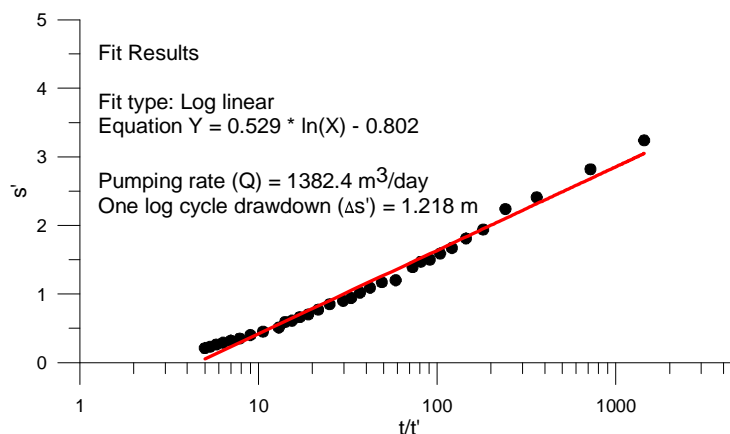
Figure 5.35: Recovery Analysis of Data from Site No-9N

The data was plotted on $s' - t/t'$ graph where s' is the residual drawdown, t is the time since the pump was started, and t' is the time after the pump was stopped. The result is shown in the Figure below. Theoretically the plots should form a straight line and most points, in this case, were plotted on a straight line.

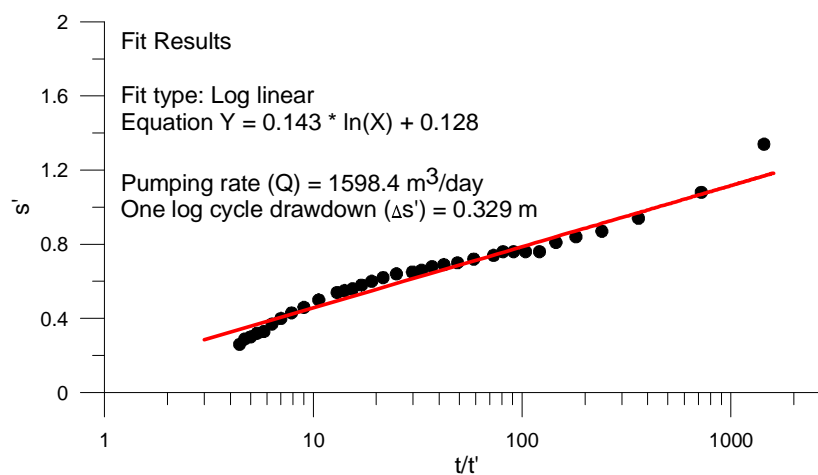
Figure 5.36: Recovery Analysis of Data from Site No-10N

The well was pumped for 24 hours at a constant rate of 18.5 L/s and the maximum drawdown observed was 8.73m. After the pump was stopped, 90 % of the drawdown in the well recovered within only six (6) minutes. The data was plotted on $s' - t/t'$ graph and transmissivity was calculated in the same way as explained above.

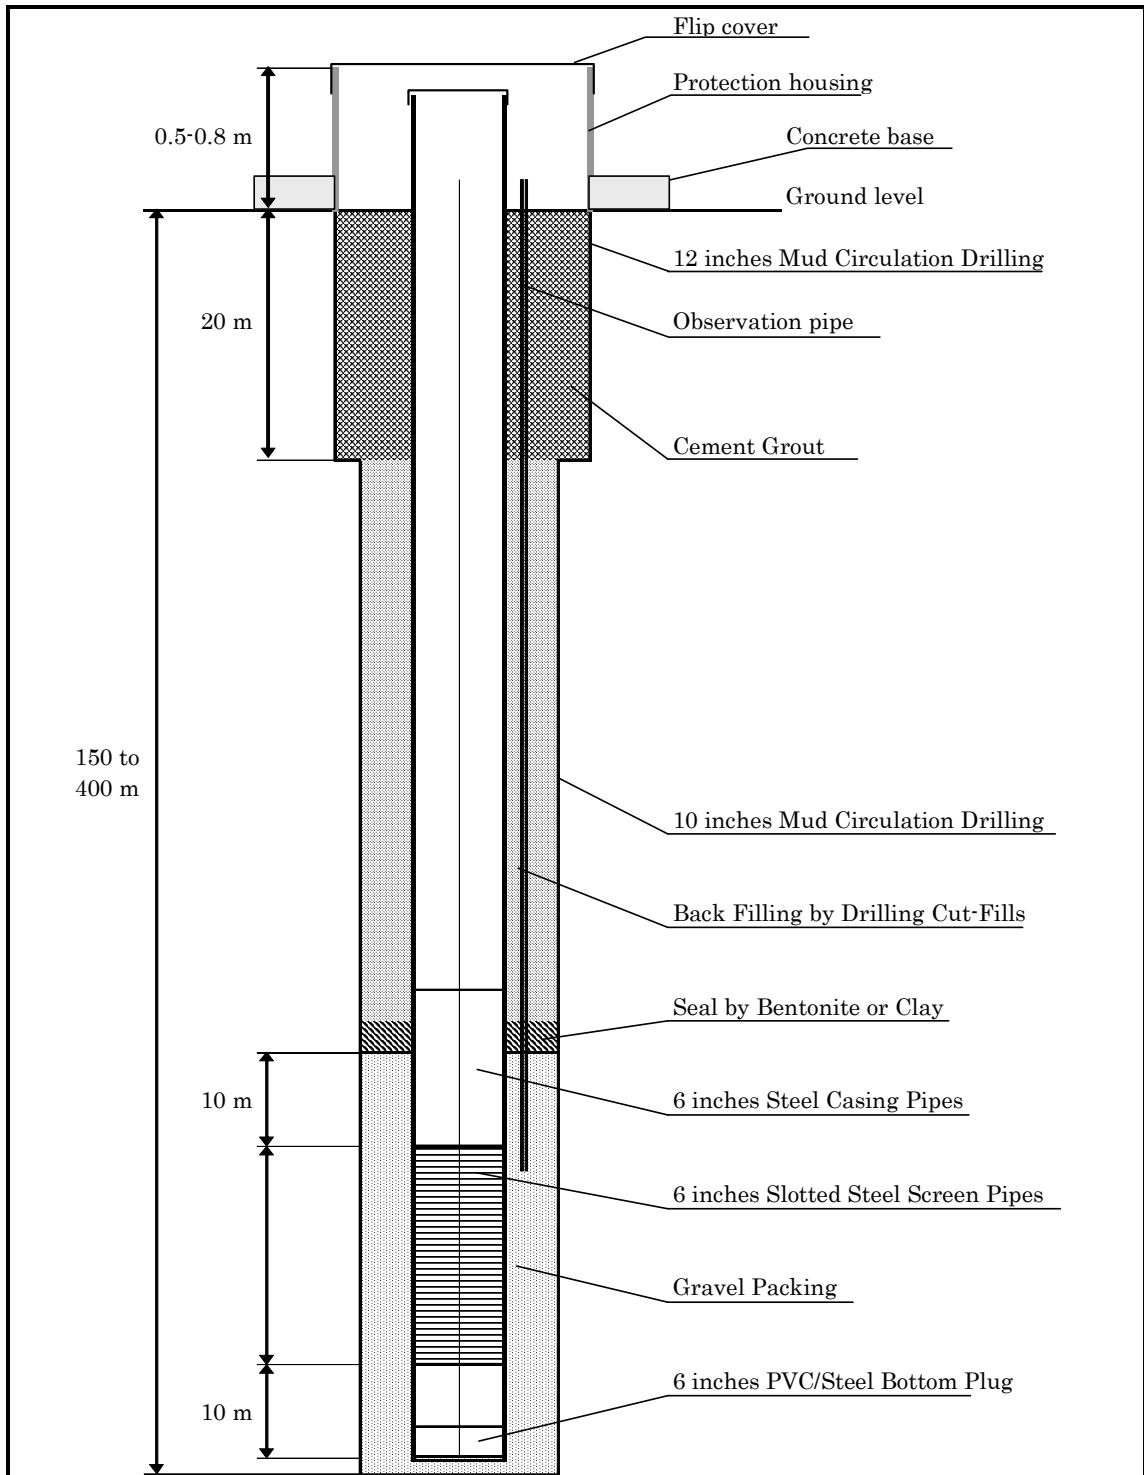
Figure 5.38	Specification of Observation Well
THE STUDY ON GROUNDWATER RESOURCES ASSESSMENT IN THE RIFT VALLEY LAKES BASIN	
JAPAN INTERNATIONAL COOPERATION AGENCY (JICA)

In the study, a total of 10 wells were planned to be drilled and completed as regular water supply wells. The wells were used for water level observation purpose during the study period and they may be used for water supply after the study. The general specification of the well is shown in Figure 5.38 and summarized in the table below.

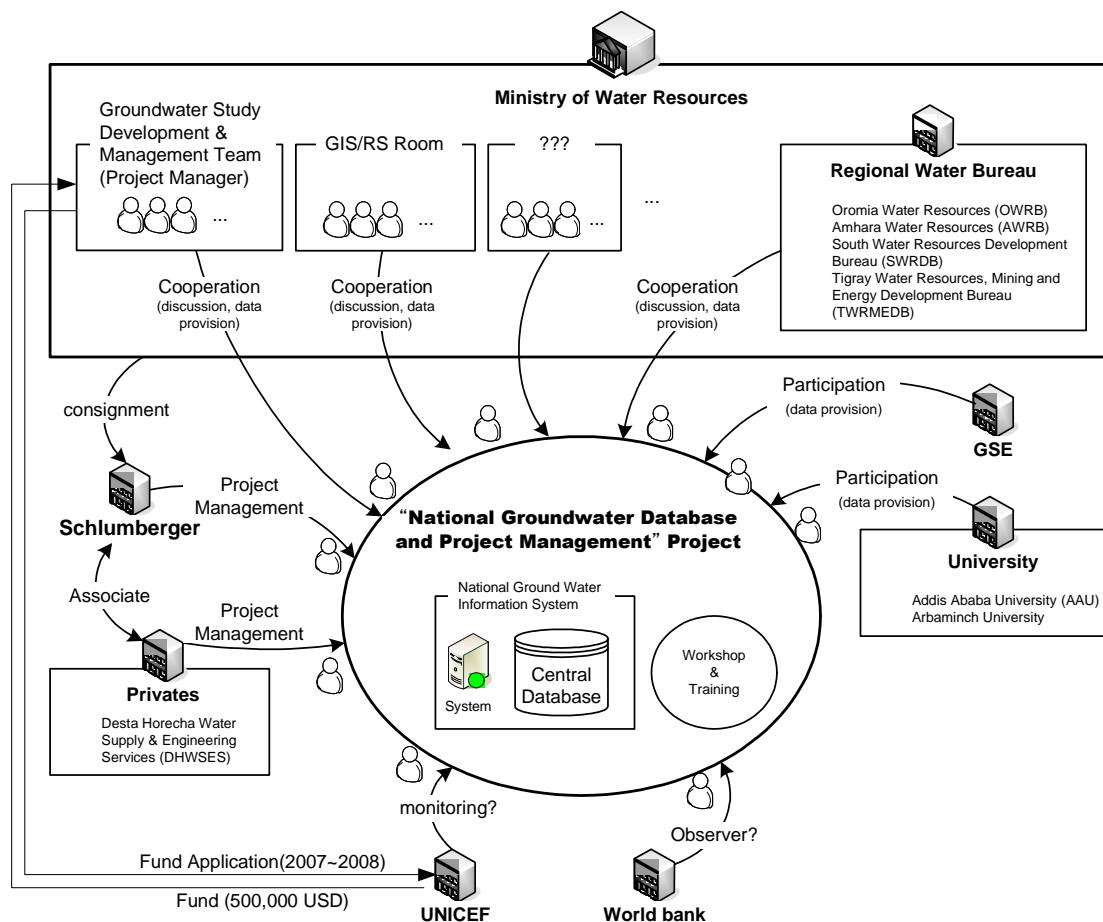
Figure 6.1: Structure of the ENGWIS Project

(hereafter referred to as “RWB”), Universities and UNICEF cooperated in provision of data. The ENGWIS project tried to compile the information held by these authorities, achievements of the research by Universities and outcomes of projects by UNICEF.

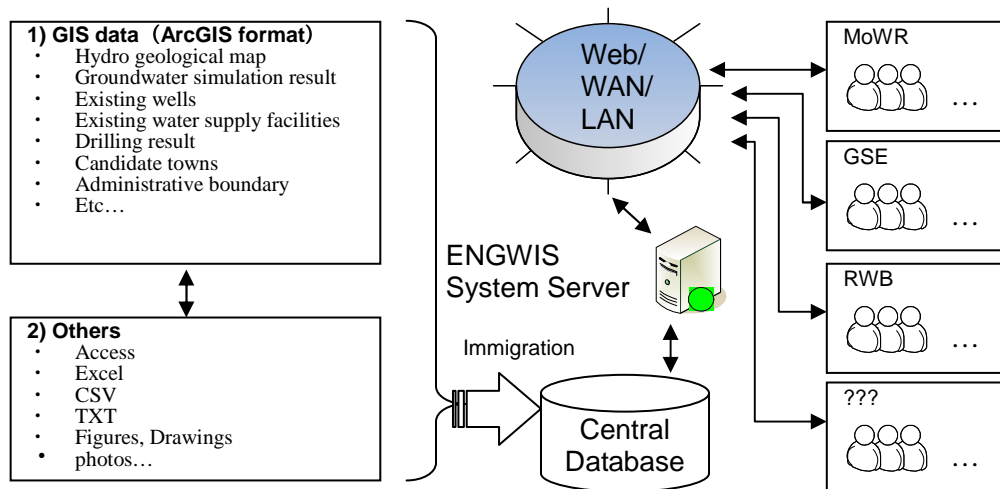
Figure 6.3: Conceptual Diagram of the Database by the Study

The database to be developed in this study will be designed to be linkable with the above two types of data. Figure 6.3 shows the conceptual diagram of the database by the study.
