**Federal Ministry of Power (FMP)  
Jebba Hydro Electric Plc. (JHEP)  
The Federal Republic of Nigeria**

**PREPARATORY SURVEY REPORT  
ON  
THE PROJECT FOR  
EMERGENCY REPAIR AND  
OVERHAUL WORKS FOR  
THE JEBBA HYDRO POWER STATION  
IN  
THE FEDERAL REPUBLIC OF NIGERIA**

**MARCH 2012**

**YACHIYO ENGINEERING CO., LTD.**

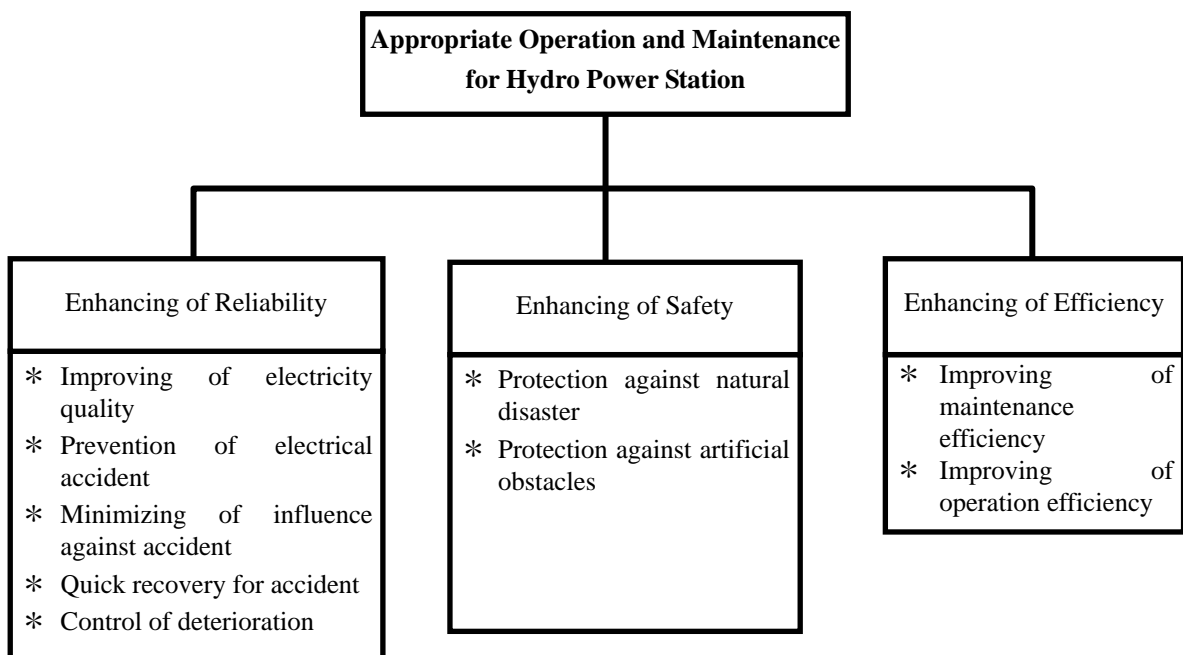
**Figure 2-4-1 Basic Thinking on Maintenance of Hydro Power Station**

Figure 2-4-1 shows the basic thinking regarding the maintenance of equipment and facilities in the hydro power station. According to this, it will be necessary to implement the maintenance of equipment procured and installed in the Project based on preventive maintenance.
