**DATA COLLECTION SURVEY  
ON IRRIGATION DEVELOPMENT  
IN NGOMA DISTRICT  
OF EASTERN PROVINCE  
IN RWANDA**

**Final Report**

**JAPAN INTERNATIONAL COOPERATION AGENCY (JICA)**

**Sanyu Consultants Inc.**

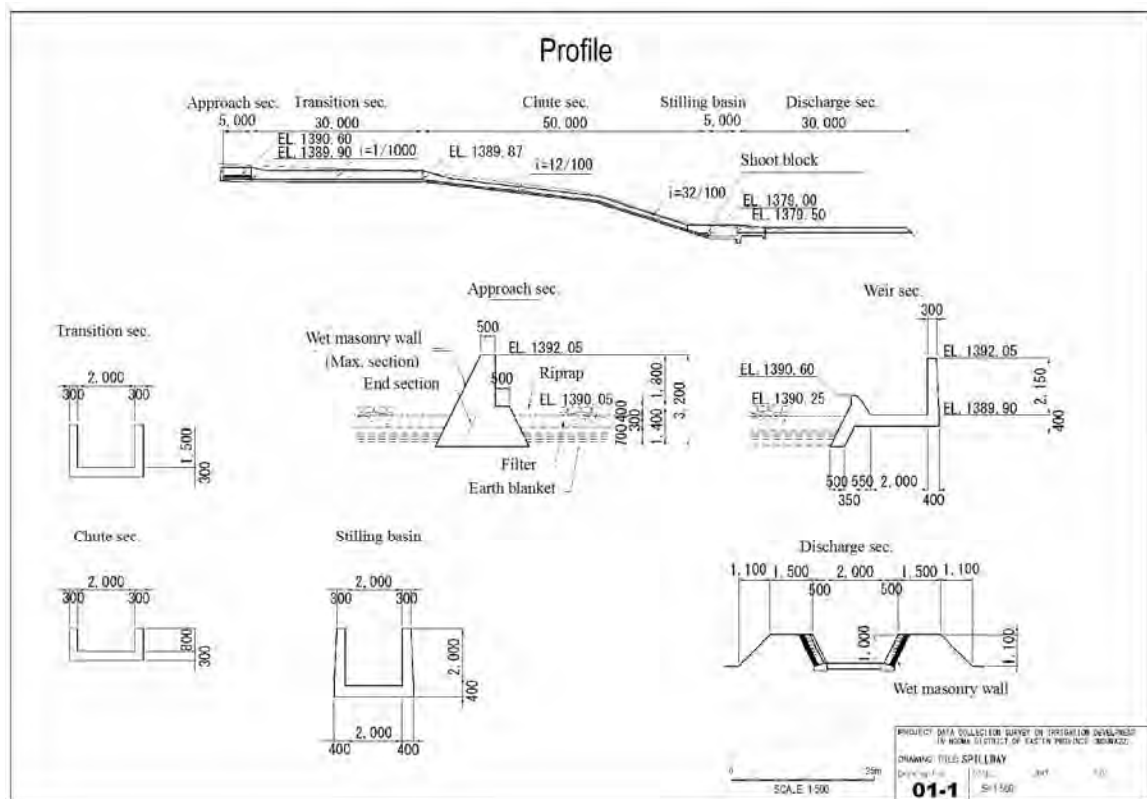
Fig. General Profile of Spillway

- Type of spillway : Side weir type
- Design flood discharge :  $2.2\text{m}^3/\text{sec}$  (50 years probability)
- Overflow depth :  $0.35\text{m}$  (= HWS  $1,390.95\text{m}$  - FWS  $1,390.60\text{m}$ )

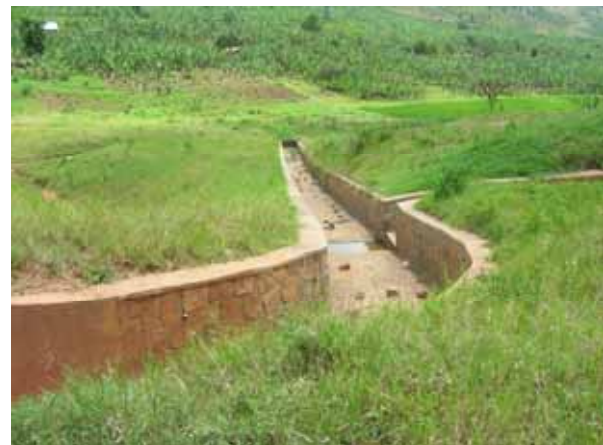
Spillway • chute canal

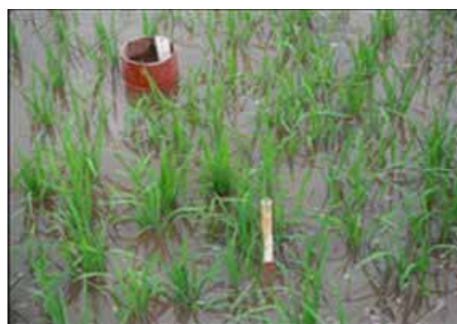
Picture-2.Cylinder and stick

- Seepage loss = measured descent by wooden stick  $\times 24/5.5$  (mm/day)  
(measured descent by wooden stick = leakage through ridges + vertical percolation)
- Evapo-transpiration = (transpiration + evaporation)  $\times 12\text{hours} \div 5.5 \times 1.15$  (mm/day)  
(estimated day time by FAO Irrigation paper No56)

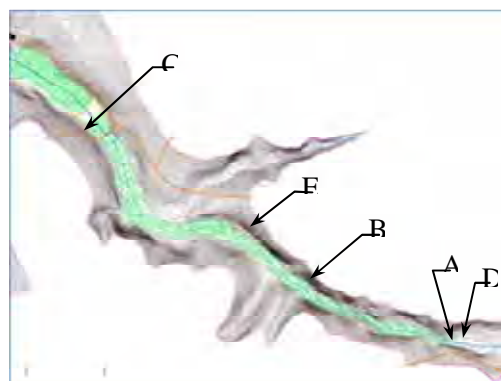
Fig. 3-5-2-1 Locations of Intake rate test

The survey locations are shown in (Fig.3-5-2-1). Point-D and point-E are the locations of reviewed tests to Point-A and Point-B of which basic intake rate values seemed to be too high. At the point-A and point-D, the test was carried out in the two conditions, one was the natural field condition and the other was the wet field condition.

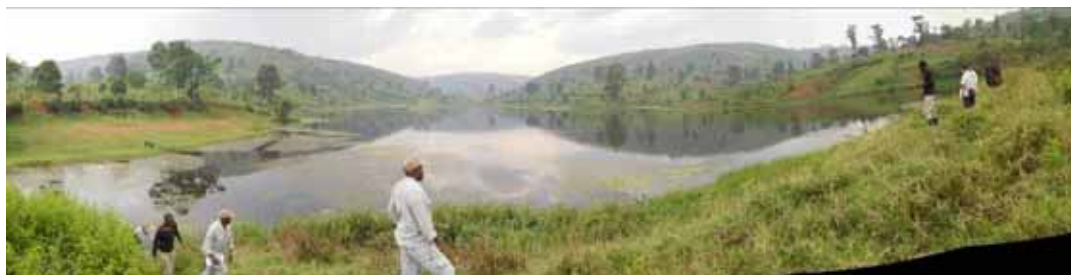
A dam constructed under Chinese supporting exists in the adjacent valley. The water leakage from the discharge gate that was observed at the visit of 2010 has not yet repaired.

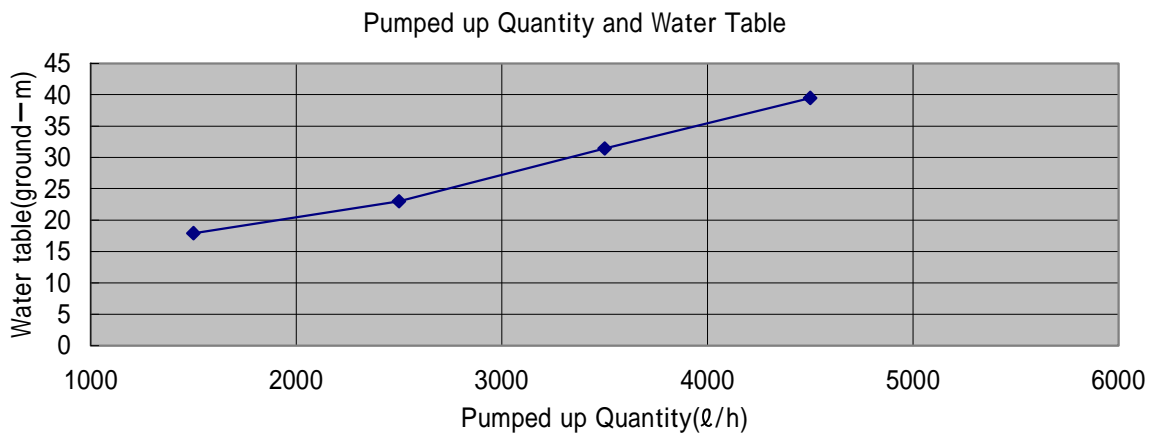
Fig. 3-6-2-5 Pumped up quantity and water table

In case of the pumped up quantity being small, the water table in the well is kept high. This water descends together with the increase of pumped up quantity (refer to the figure below). This relationship is considered to be kept till the water table goes down to the aquifer’s position. The maximum available quantity of pumped up water is assumed to be about 5,000 ℓ/hr as the aquifer’s position is 46m to 48m deep (refer to the Borehole Diagram).

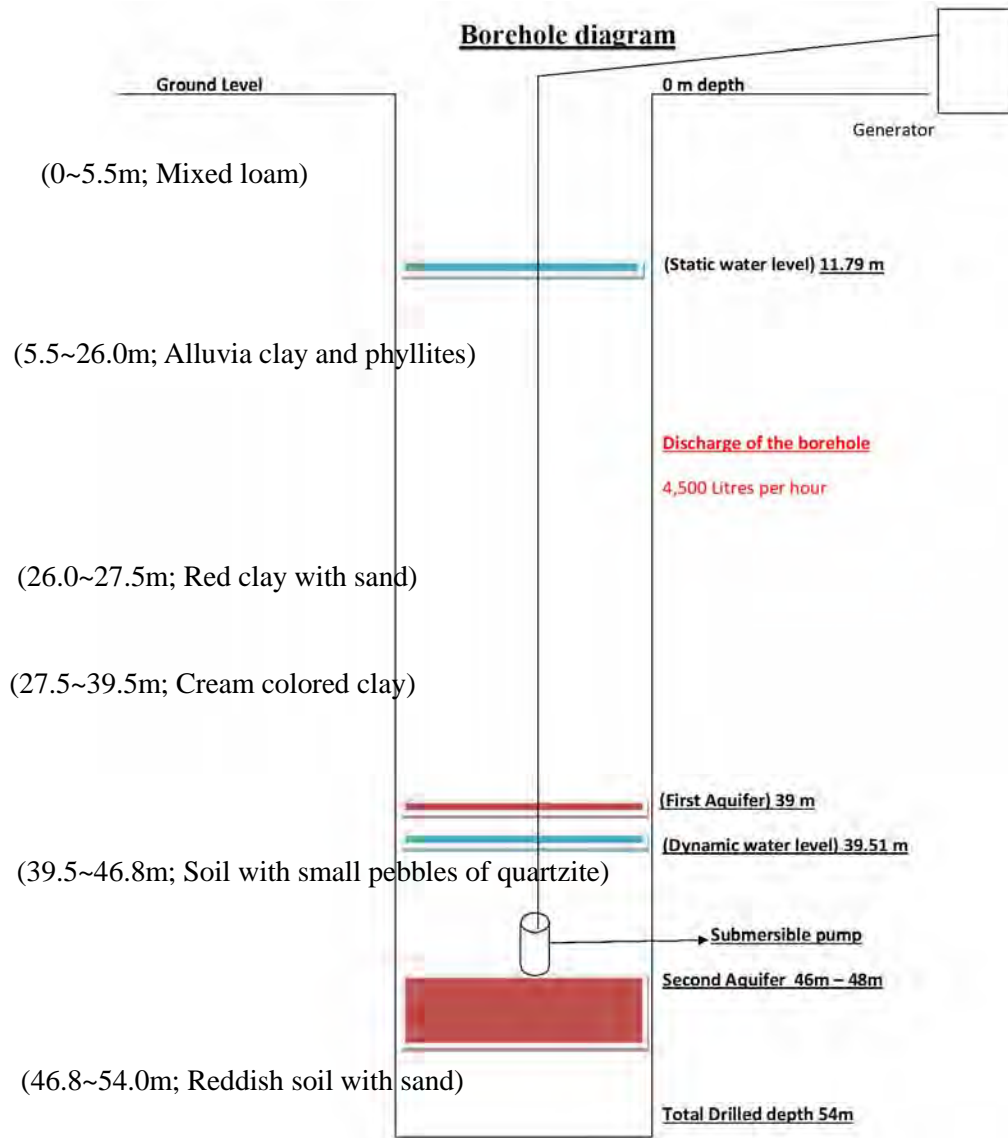
Fig. 3-6-2-6 Schematic hydrogeological test hole

The proximate hydro-geological conditions around the borehole are illustrated as follows. The pumped up water is originated from the aquifer 46m to 48m deep that is composed of red-colored soil layer with sand.
