**Ministry of Agriculture and Irrigation
The Republic of the Union of Myanmar**

**THE PREPARATORY SURVEY REPORT
ON
THE PROJECT FOR IMPROVEMENT OF
MACHINERY FOR REHABILITATION OF
POLDER EMBANKMENT IN AYEYAWADY DELTA
IN
THE REPUBLIC OF THE UNION OF MYANMAR**

AUGUST 2012

JAPAN INTERNATIONAL COOPERATION AGENCY

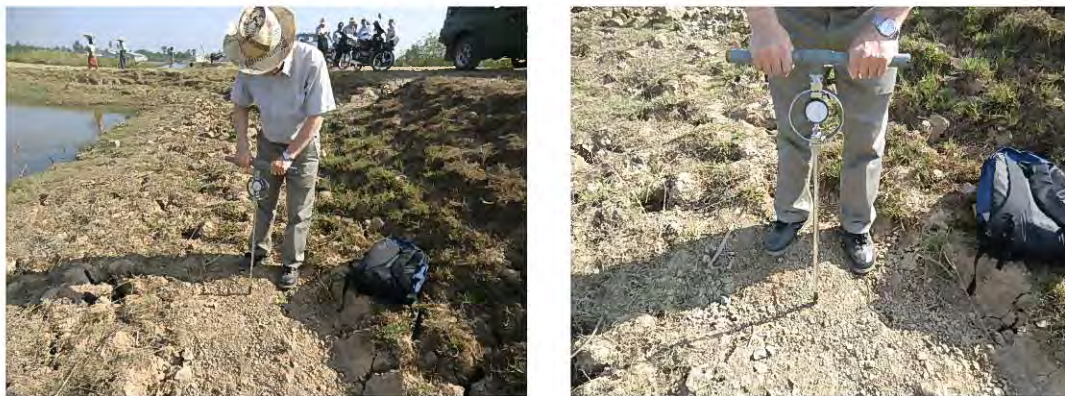
Photo-2-2-1 Cone penetrometer test

In this connection, a survey on bearing capacity was conducted by a cone penetration test in the 2nd site study. the result of the site study showed that cone index was measured at $qu=12 \text{ kg/cm}^2$ or higher value at the crest of the dike as well as at toe of slope inside and outside slopes of the dike, implying that traveling of back-hoe, bulldozer and dump truck is possible. Also, cone indices on used borrow-pit and the surface of paddy field were measured at $qu=8 \text{ kg/cm}^2$ or higher, also meaning that back-hoe and bulldozer is trafficable.

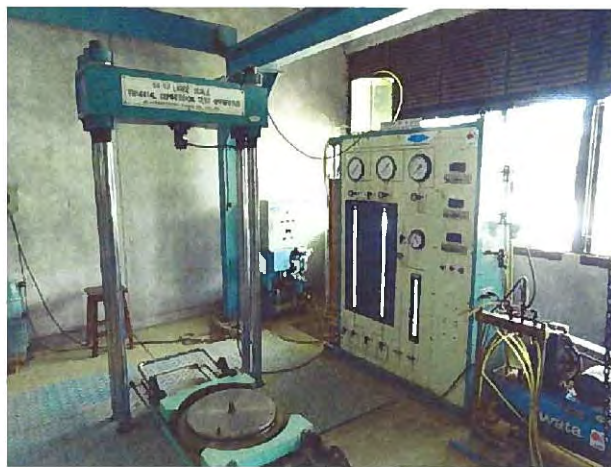
【Large Triaxial Machine】

Photo-2-2-6 Existing testing equipments of ITC

| No. | Testing equipments | Specification | State of those held by ITC | Testing purpose etc |
|---|---|--|---|---|
| 5 | Large triaxial machine | ϕ 300mm, attached with automatic rammer and mold for permeability test | Since it has been used for over 20 years, measurement of water pressure in soil pore is impossible by pore pressure gauge. Because if lack of regular evaluation inspection on stress, there is concern for degradation of measurement accuracy. Pore pressure meter is no more repairable. | This is used to test and identify strengths of materials for drain and filter in the work on polder embankment, and also in the tests for identifying strength of embankment materials of gravel mixture. |

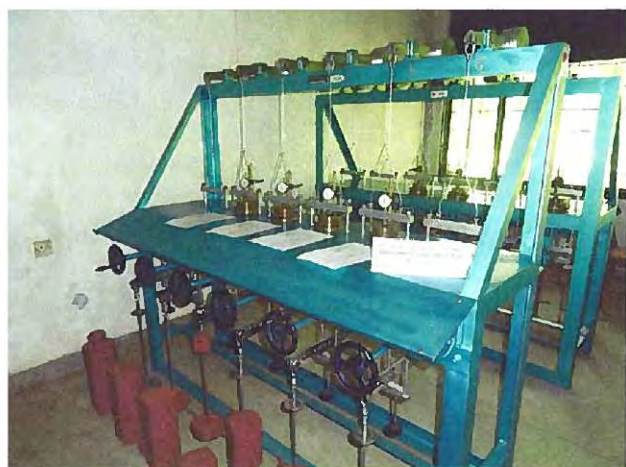
【Consolidation Apparatus】

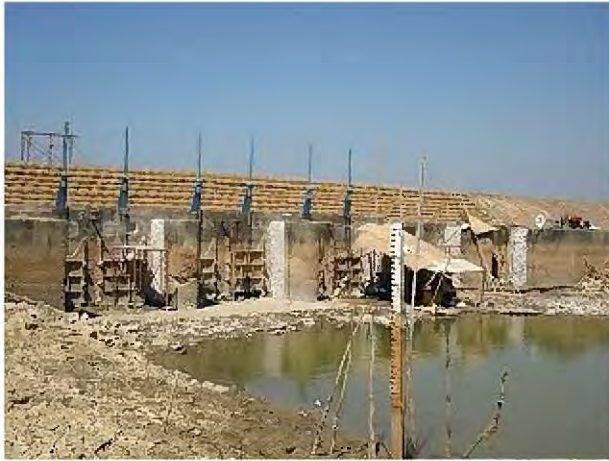
【Damaged sluice by cyclone “Nargis”】

Photo-2-2-7 Dike and sluice

During wet season, rainwater is accumulated inside the polder then water is drained to the river outside of the polder through the sluice gate. Existing sluice gates have become too old and damaged by cyclone Nargis. And many sluices are in the bad condition such as leakage, disappearance of gates, and breakage of switchgear of gates including basic concrete. At present, there are 32 sluices in 34 polders which need to remove and build including foundation structure.

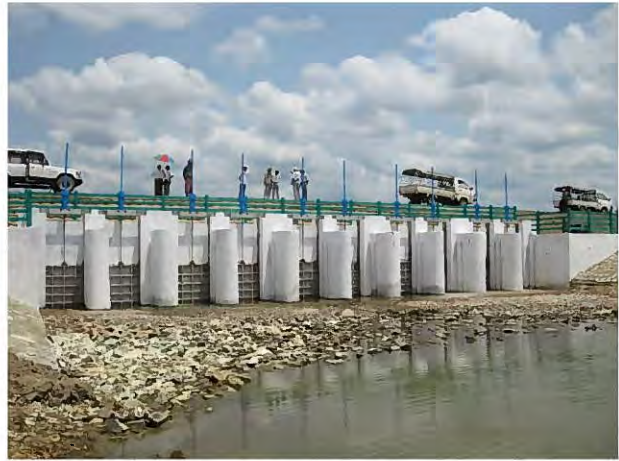
【Restored sluice (Pilot Project)】

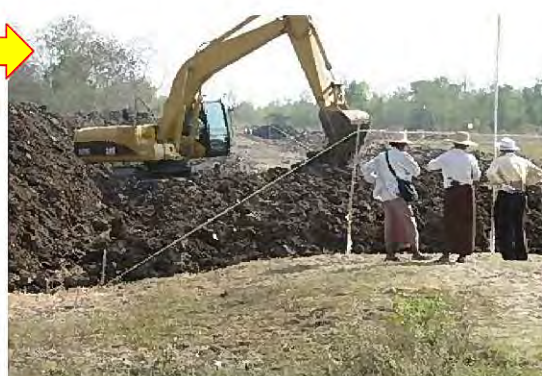
Temporary Placing (left side of back-hoe)

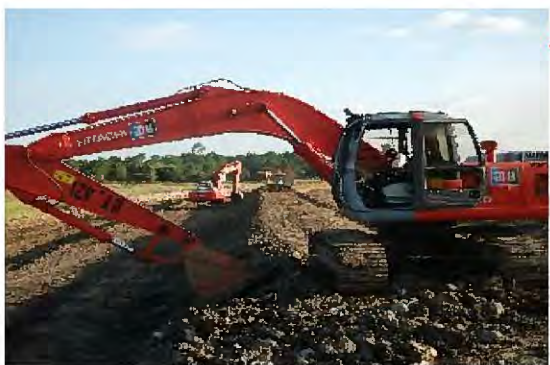
Slope finishing work by back-hoe

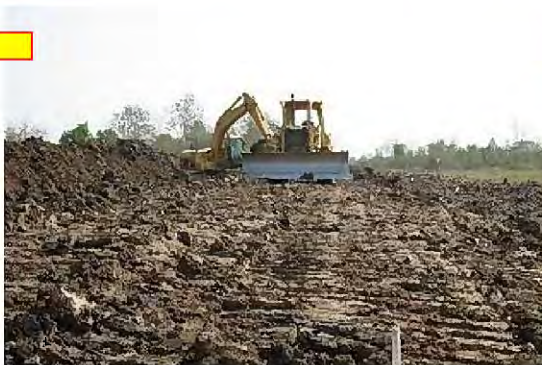
Stripping, leveling and compacting of polder embankment works by bulldozer

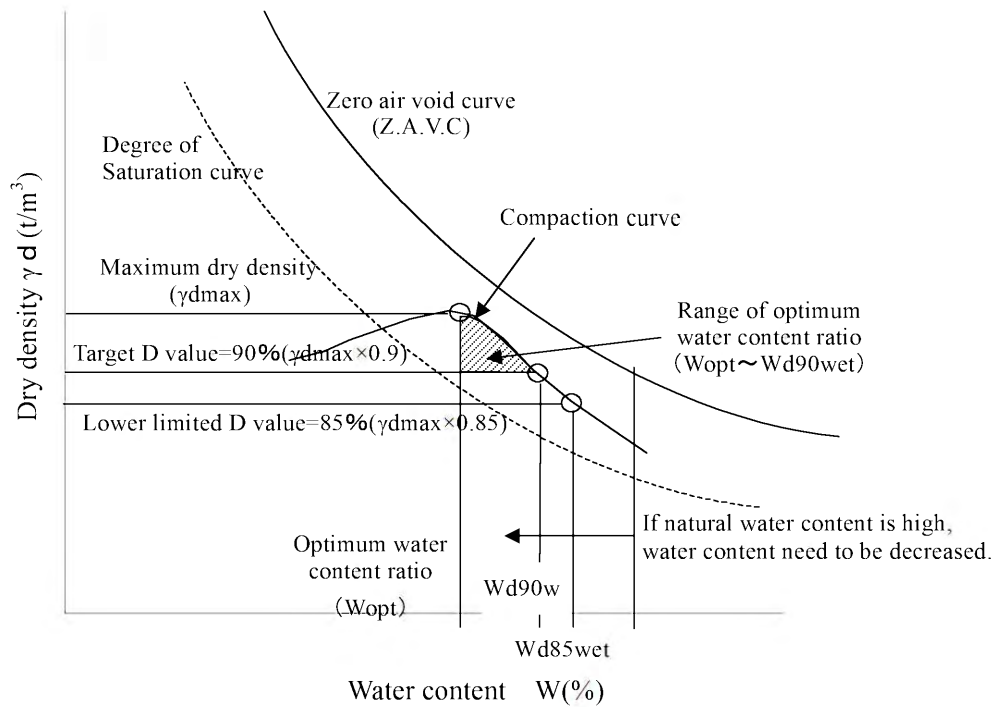
Fig. 2-2-4 Compaction curve

Quality control of embankment will be made employing the control of D value in compaction curve (a curvilinear relationship between soil moisture ratio versus soil density) as shown in Fig. 2-2-4 as a base. D value is indicated as a rate between embanked soil density and the maximum density obtained by laboratorial compaction tests, and D value = 90% is employed as a standard control value to be applied to general road foundation and reservoir dikes. This value was also employed in the embankment works in the verification project, yielding favorable result on quality control without arising any particular problem. From this experience, D value = 90% will be adopted as a target value in hereafter quality control. In this context, for the sections where manual works are required, D value = 85% will similarly be employed as the lower limit value for quality control as employed in the verification project.

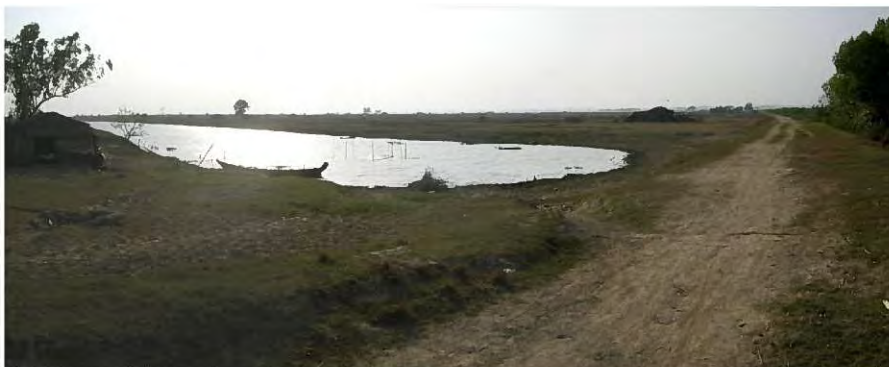
Photo-2-2-8 Enclosed site of tributary flow near Danechaung Water gate

In implementing polder rehabilitation works, it is necessary to work embankment by installing drain over old stream bed or on weak foundations (refer to photo-2-2-8). Gravel materials are utilized for coarse grade materials to provide drain. Such gravel materials are available at a quarry located at 1 mile east of the middle point between Labutta and Myaungmya (refer to photo-2-2-9, -2-2-10). In the case of working for embankment using these gravel materials, it is required to identify their quality by means of a large triaxial machine.

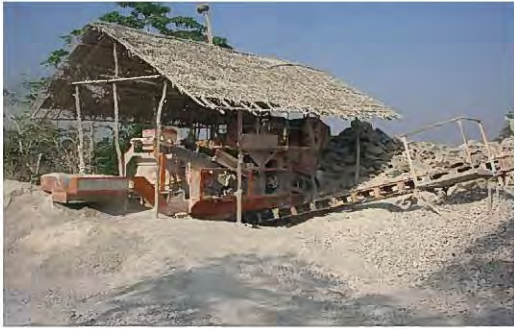
Photo-2-2-9 A quarry (crusher made in Japan)

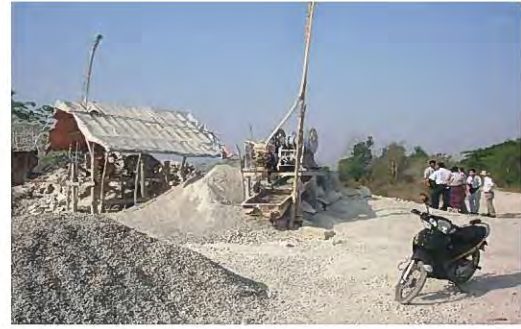
Photo-2-2-10 A quarry (sieving machine)

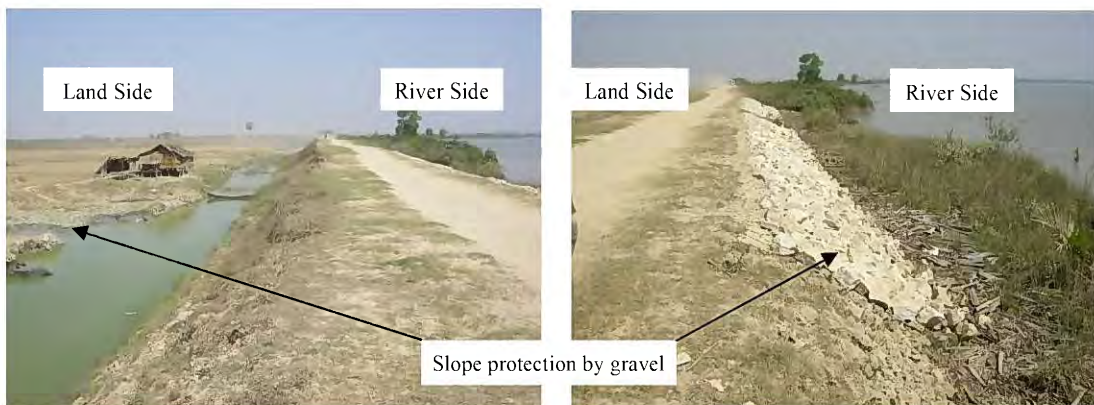
Photo-2-2-11 Reinforcement of embankment with gravel materials

Fig. 2-2-5 shows an example of section in the case of construct drain with gravel materials, while Fig. 2-2-6 illustrates an example of work without drain. Similarly, reinforced embankment with gravel materials is applied to the dikes contacting with flowing water (refer to photo-2-2-11).
