**PREPARATORY STUDY
FOR
THE PROJECT ON INTERNATIONAL
MULTI MODAL PORT AT STAR WHARF IN
PORT VILA
IN
THE REPUBLIC OF VANUATU
(ENVIRONMENTAL STUDY)**

FINAL REPORT

JANUARY 2012

JAPAN INTERNATIONAL COOPERATION AGENCY

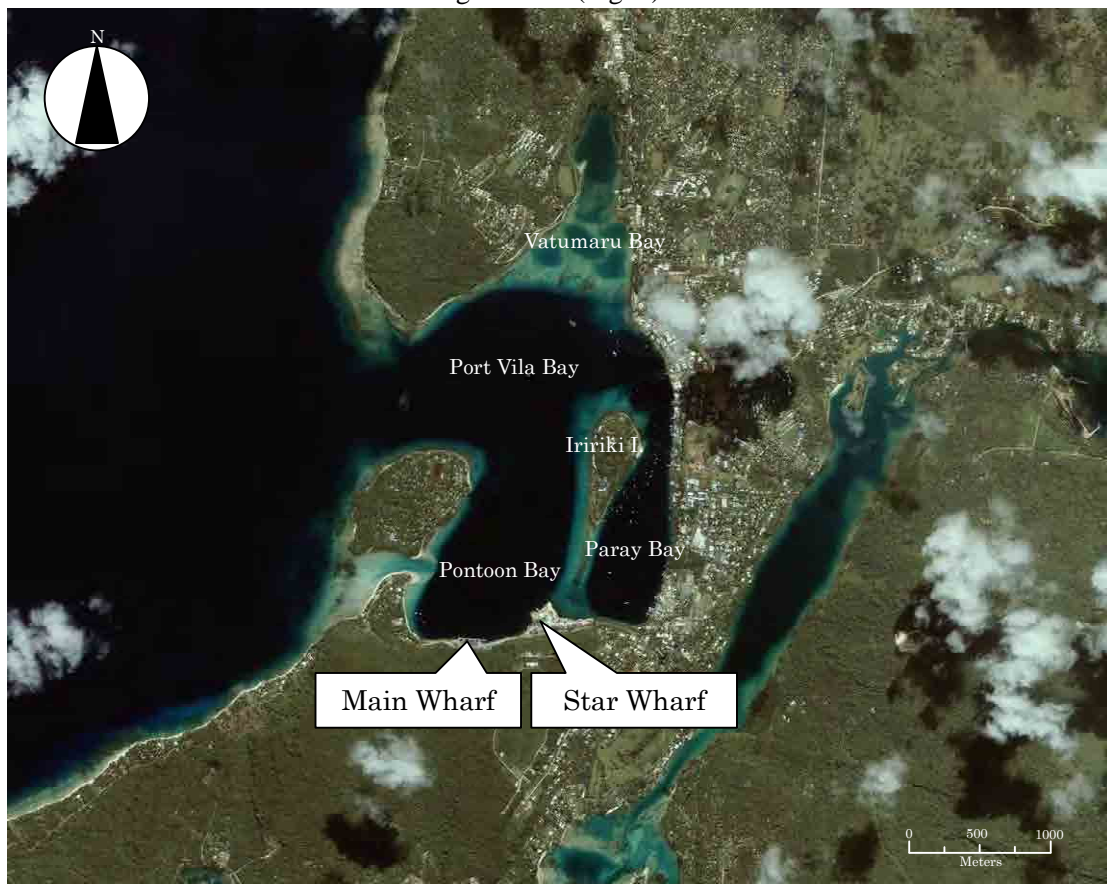
Fig. 1 Study Area

Star Wharf in Port Vila and its surrounding sea area (Fig. 1)

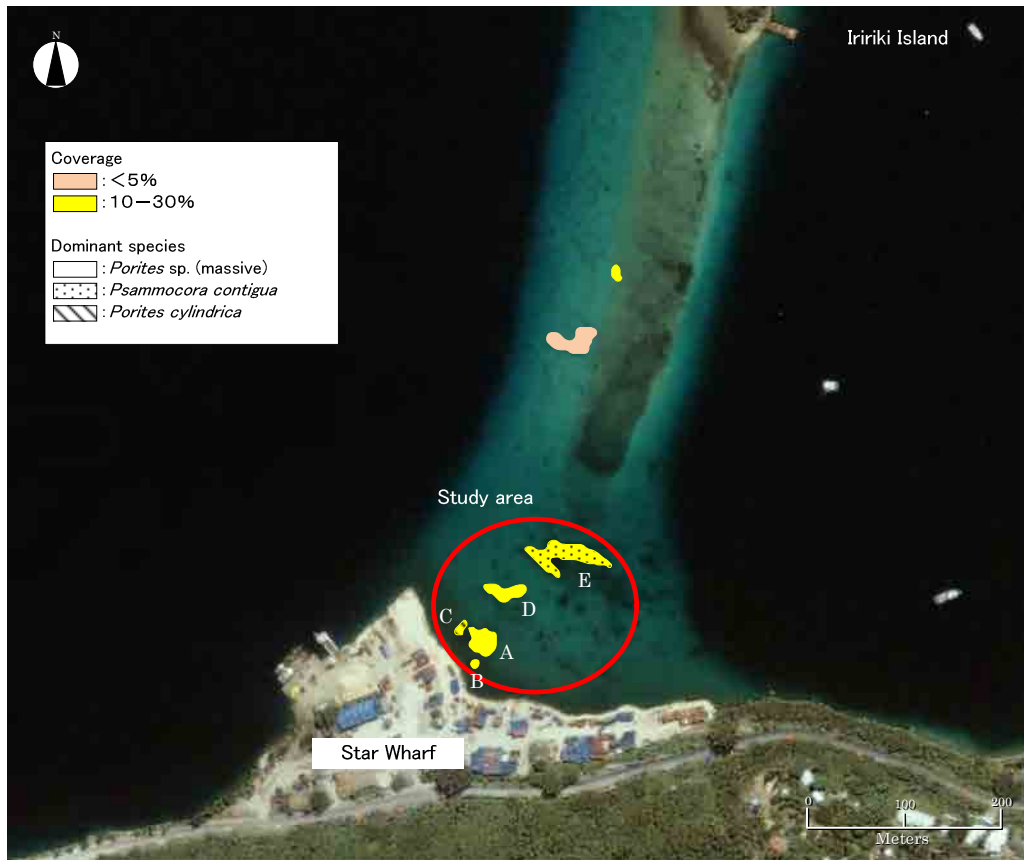
Fig. 3 Distribution of corals to be transplanted near planned reclamation area

The coral communities near the planned reclamation area that are to be transplanted was split into five groups A to E that exist in the depth range from 1.5 to 2.1m (Fig. 3). For the community of Massive *Porite* group A, 122 Massive *Porite* colonies were recognized, of which colonies as large as over 3m were found. For the community of Massive *Porite* group B, 5 Massive *Porite* colonies that are in the range from 1m to less than 2m were recognized. For the community of *Porites cylindrica* group C, five communities of which area is approximately 4 m² was recognized. For the community of Massive *Porite* group D, 97 colonies of which coral size is less than 3m were recognized. For the community of *Psammocora contigua* group E, the one with area of approximately 310 m² was recognized.

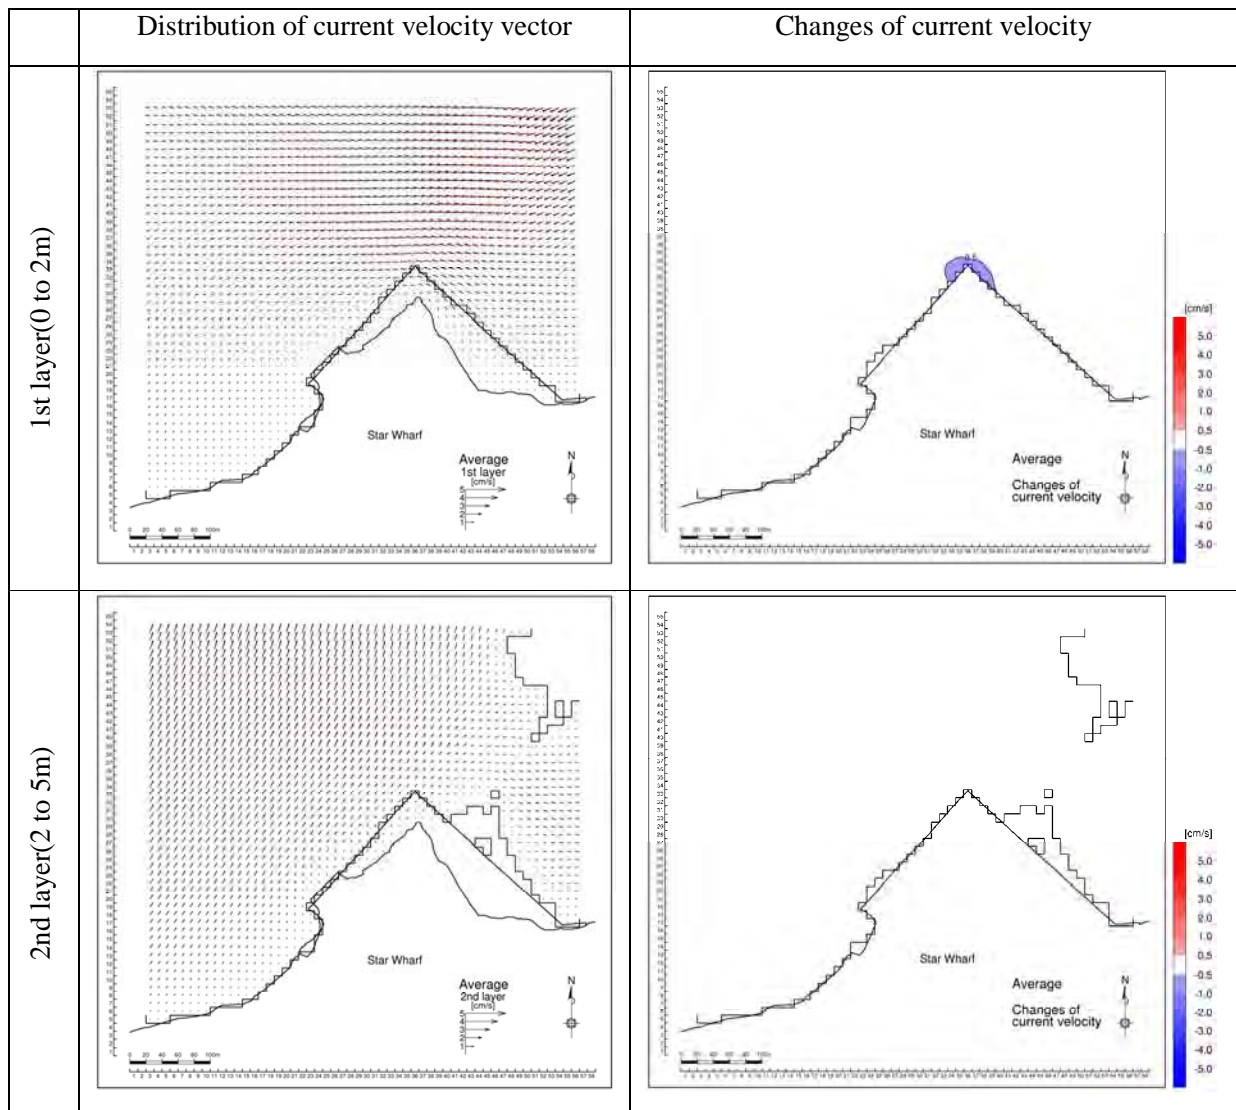
Fig. 4 Changes of current (mean current, small region, 1st layer and 2nd layer)

Change of the current velocity occurs only in the 1st layer near the reclamation of Star Warf with the reduction of 1cm/s. There is a tendency that the range of change of the current velocity becomes wider during the falling tide and at the low tide. The range of changes of current velocity becomes narrower during the rising tide, and the change exceeding $\pm 0.5\text{cm/s}$ cannot be observed at the high tide. For the changes of current velocity of mean current, local reduction of the current velocity of 0.5cm/s was observed near the reclamation area (Fig. 4).

Though a little change of current direction is observed due to existence of the reclaimed land, no situation that changes the current direction under the present condition are seen.

(Black arrow: Result of replication of current state, Red arrow: Result of future prediction)

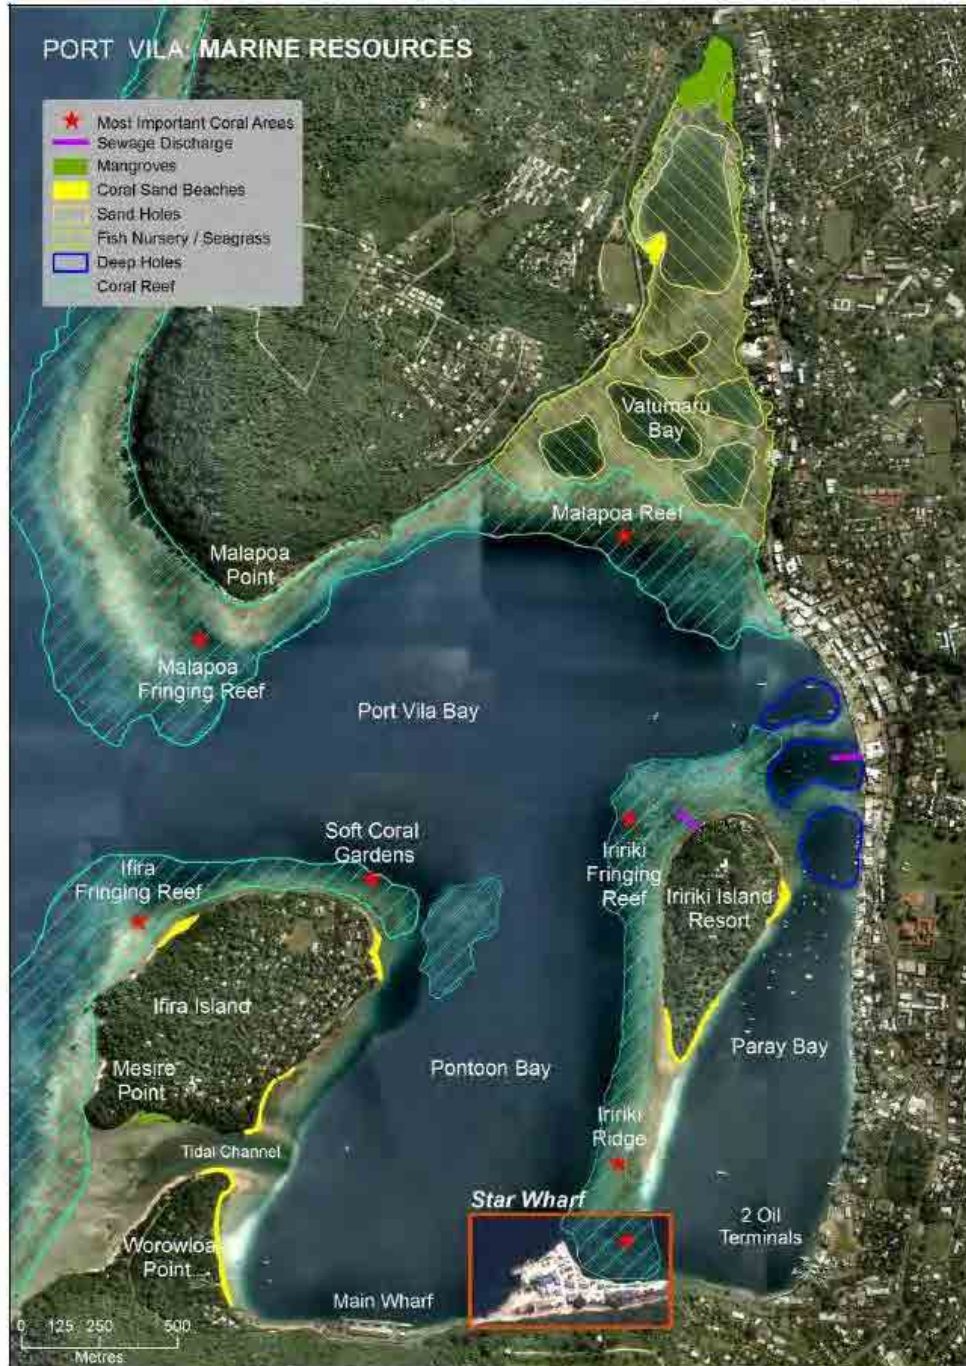
Fig. 3.3.2-1 Location of the Most Important Coral Areas

According to the EIA report by the AusAid issued in April 2010, five coral communities in Port Vila are described as the Most Important Coral Areas (Fig. 3.3.2-1). Those are;

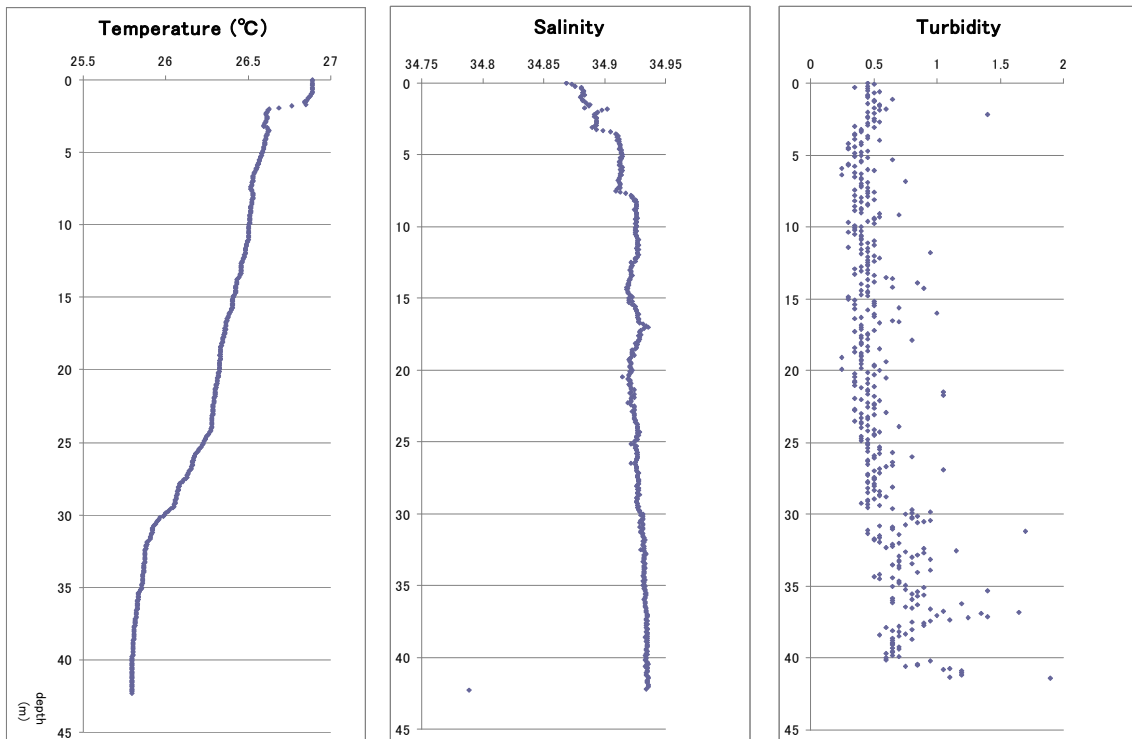
Fig. 3.4.2-1 Vertical change of water quality in the central point of Paray Bay

Countermeasure to environmental impact from land is planning through ADB assistance. In order to control water quality of Port Vila Harbor, trace of countermeasure through enforcement of monitoring should be carried out. For realizing that, observation buoy measuring water temperature, salinity, turbidity, Chlorophyll and dissolved oxygen at surface and bottom layers in the central point of Paray Bay should be installed.

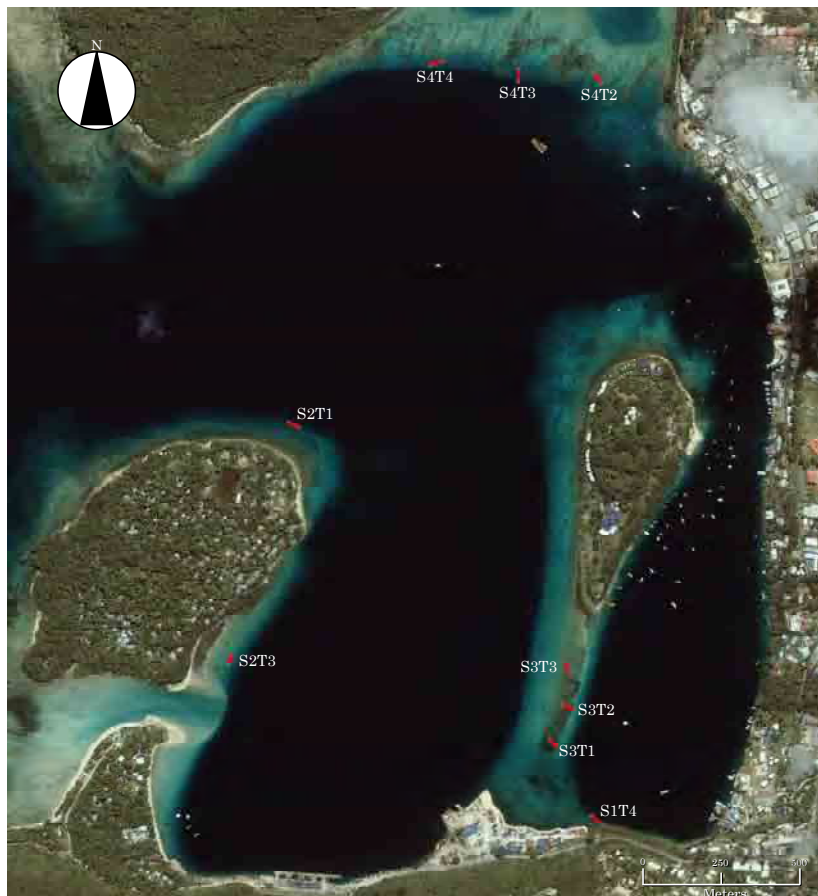
Fig. 5.1.2-1 Location of Transect Survey Sites

Following the method used in the EIA, 0.5 m x 0.5 m quadrats were placed at 5 m intervals along 40 m transects identified at each survey site. Observations were conducted on corals, major marine plants and benthic animals. Videos were taken to include a 0.5 m area around both ends of the transect.

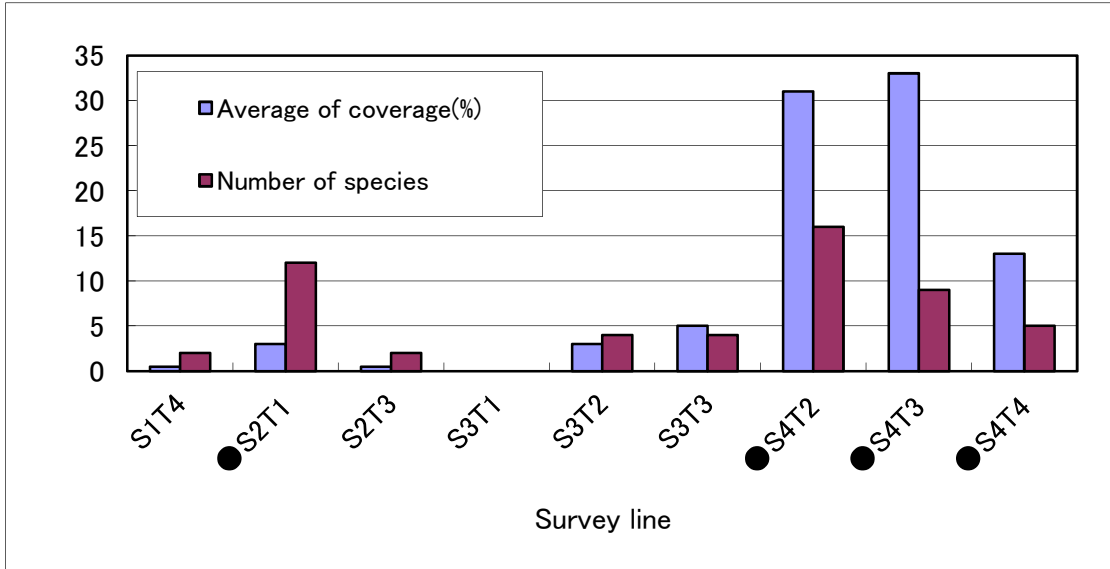
Fig. 5.1.2-2 Coral coverage in transects

: Survey line at the mouth of the bay.

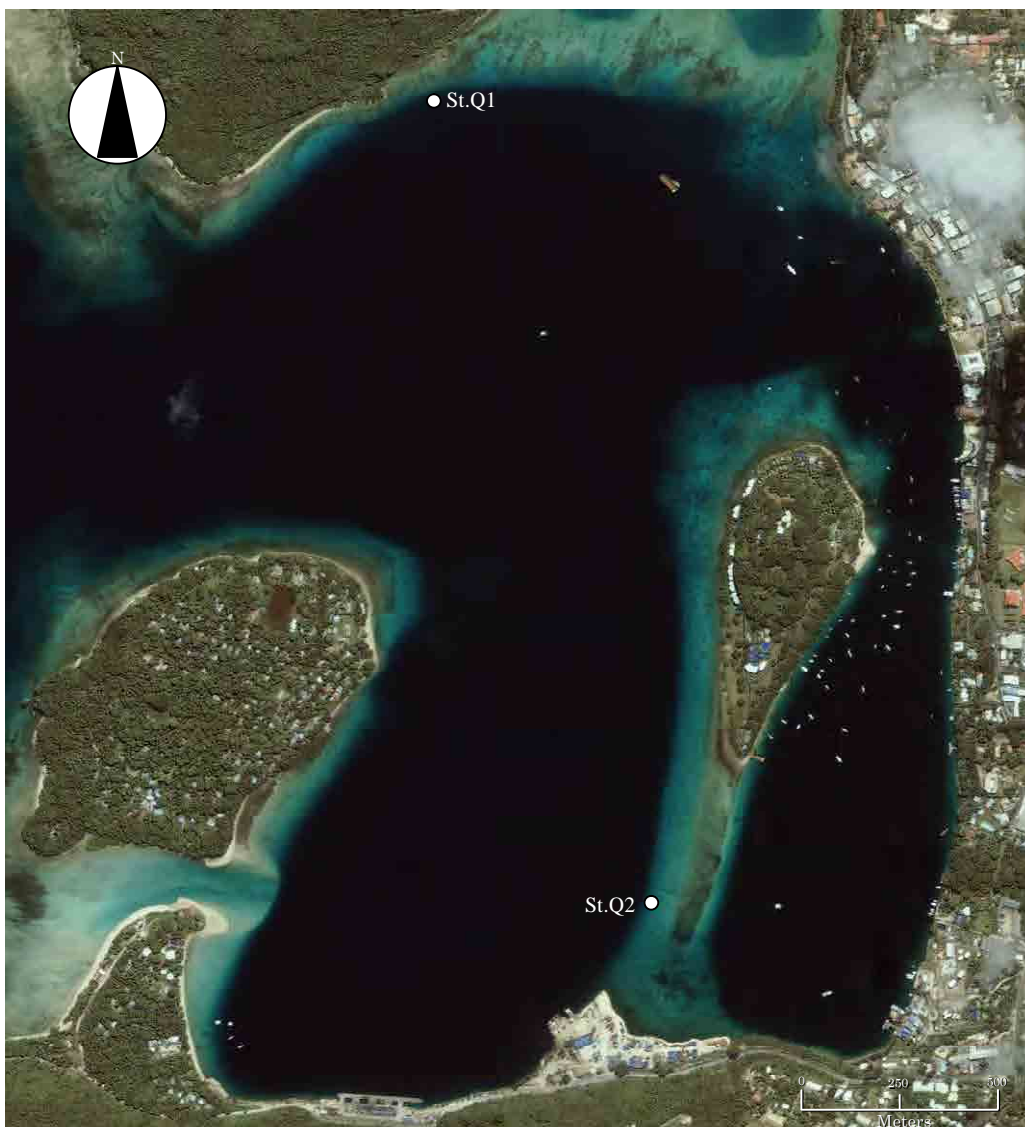
Fig. 5.1.3-1 Location of Survey Points on Coral Habitat Environment

Survey points were established within two coral habitats near the Star Wharf and at the mouth of the bay (Figure 5.1.3-1, Table 5.1.3-1).

From October 20 to November 15, 2011, data loggers (manufactured by JFE Advantech Co.) were installed on the ocean floor at each survey point (Photo 5.1.3-2) to record turbidity every hour, and temperature and salinity every 10 minutes.

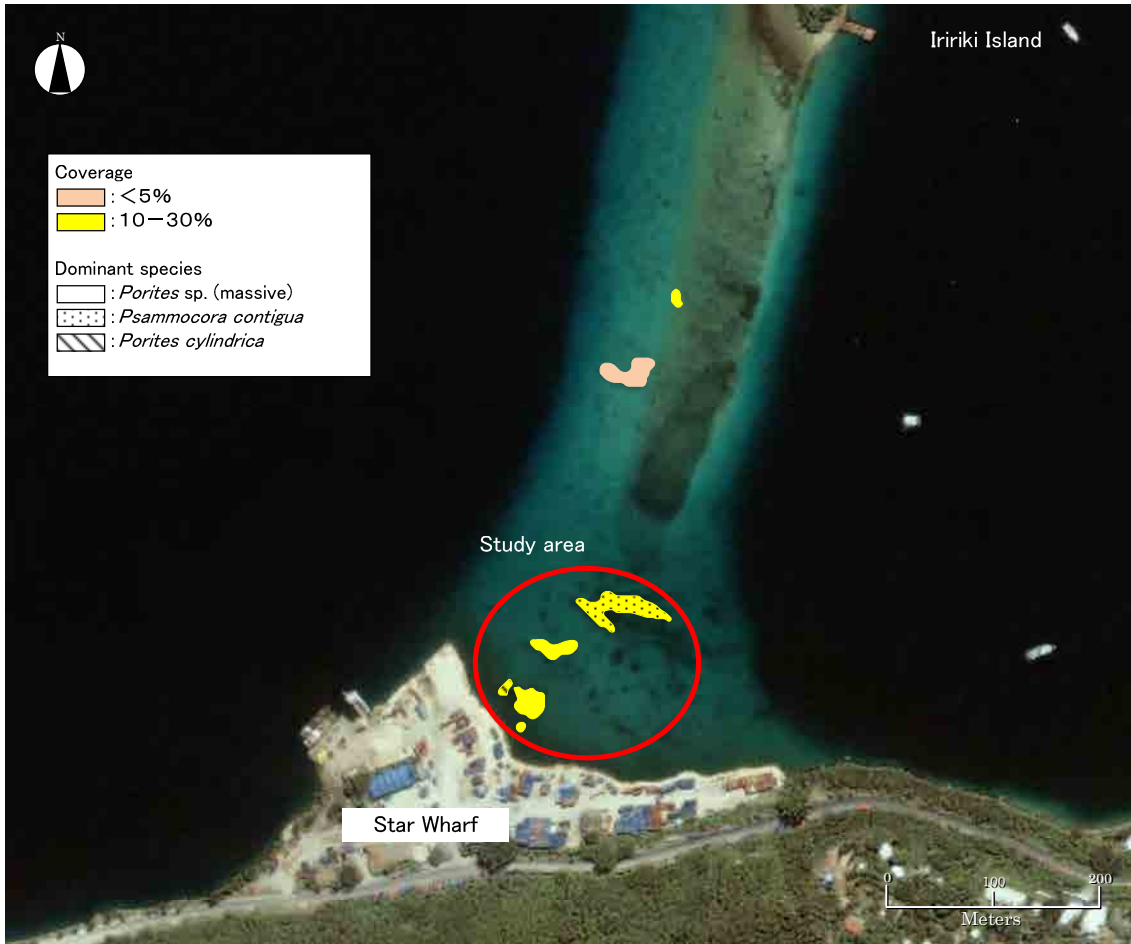
Fig. 5.1.4-1 Study area of coral distribution on relocation

At the current coral habitat, the major coral species were observed for population, colony size, and their locations, based on the results of the coral reef distribution map survey conducted at the proposed project site and the surrounding areas. Habitat water depth and substrate were also surveyed.

- A: Genus *Porites* (massive type) community. One colony of ≥ 3 m, 5 colonies of ≥ 2 m to < 3 m, 19 colonies of ≥ 1 m to < 2 m, and 97 colonies of < 1 m were observed.
- B: Genus *Porites* (massive type) community. Five colonies of ≥ 1 m to < 2 m were observed.
- C: *Porites cylindrica* community. Five coral colonies of approximately 4 m² were observed.
- D: Genus *Porites* (massive type) community. Three colonies of ≥ 2 m to < 3 m, 9 colonies of ≥ 1 m to < 2 m, and 85 colonies of < 1 m were observed.
- E: *Psammocora contigua* community. A colony of some 310 m² was observed.

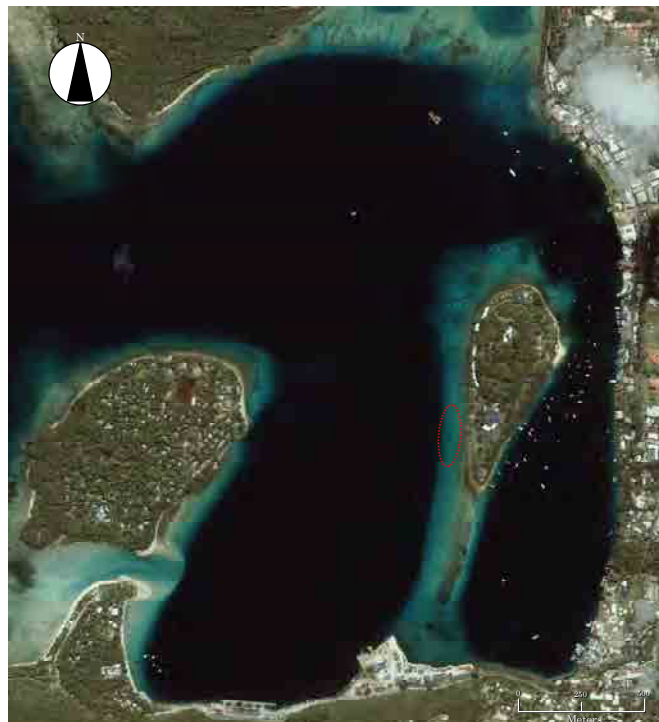
Fig. 5.1.4-2 Candidate site of coral relocation

At the candidate relocation site, 20-minute diving surveys were conducted to observe the coral species and coverage, coral-eating animals and diseases that affect corals. Habitat water depth and substrate were also surveyed.

The dominant species observed in the current habitat, Genus *Porites* (massive type), *Porites cylindrica* and *Psammocora contigua*, were also found at the candidate relocation site (Table 5.1.4-3). Other conditions are also similar to the current habitat: the substrate is primarily bedrock and sand, and water depth is 2.0 m. There were no coral-eating animals or coral diseases in the surrounding waters.

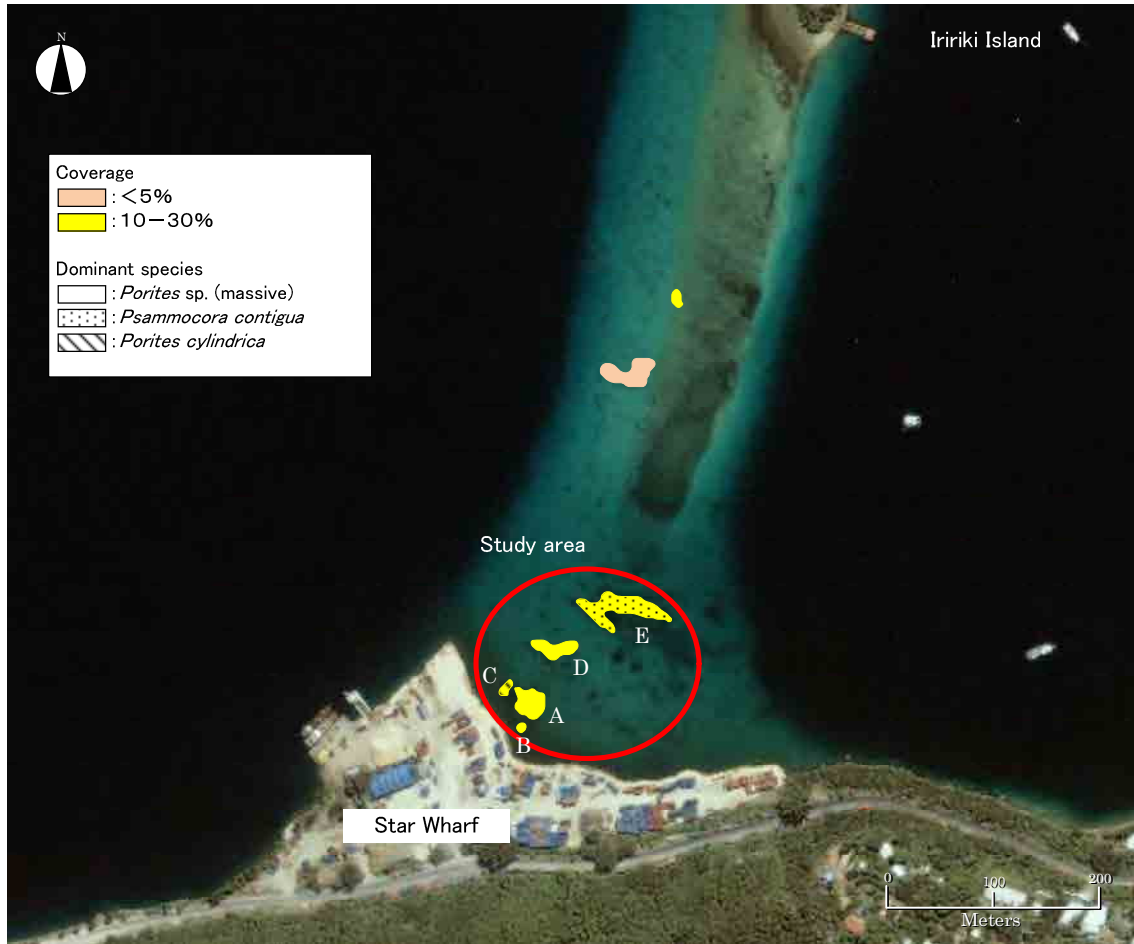
Fig. 5.1.4-3 Coral communities in the predicted reclamation and its adjacent area

Distribution area	C	E
Dominant species	<i>Porites cylindrica</i>	<i>Psammocora contigua</i>
Community size	About 20m ²	About 310m ²

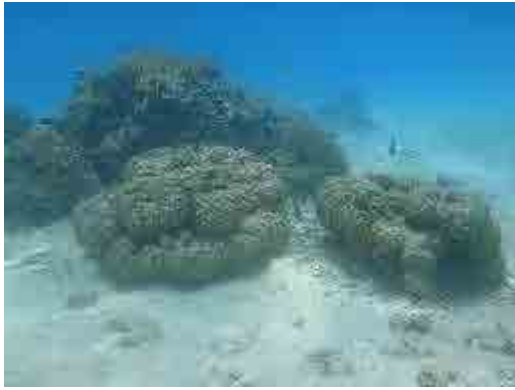
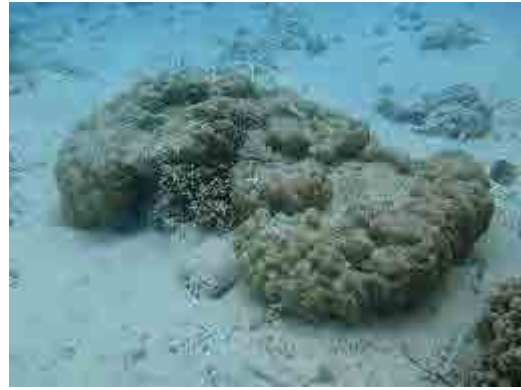
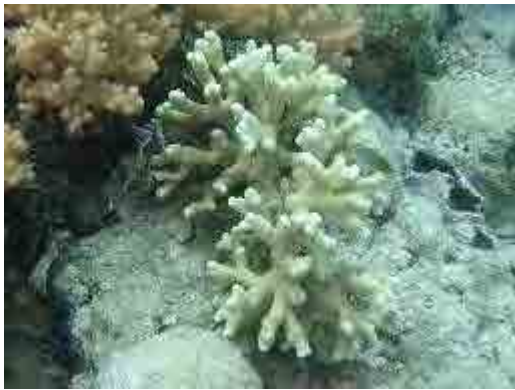
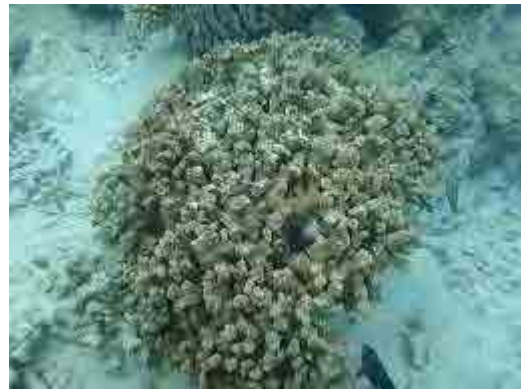
Photo 5.1.4-3 Dominant coral species in candidate site for relocation

Porites sp. (massive)

Porites cylindrica

Psammocora contigua

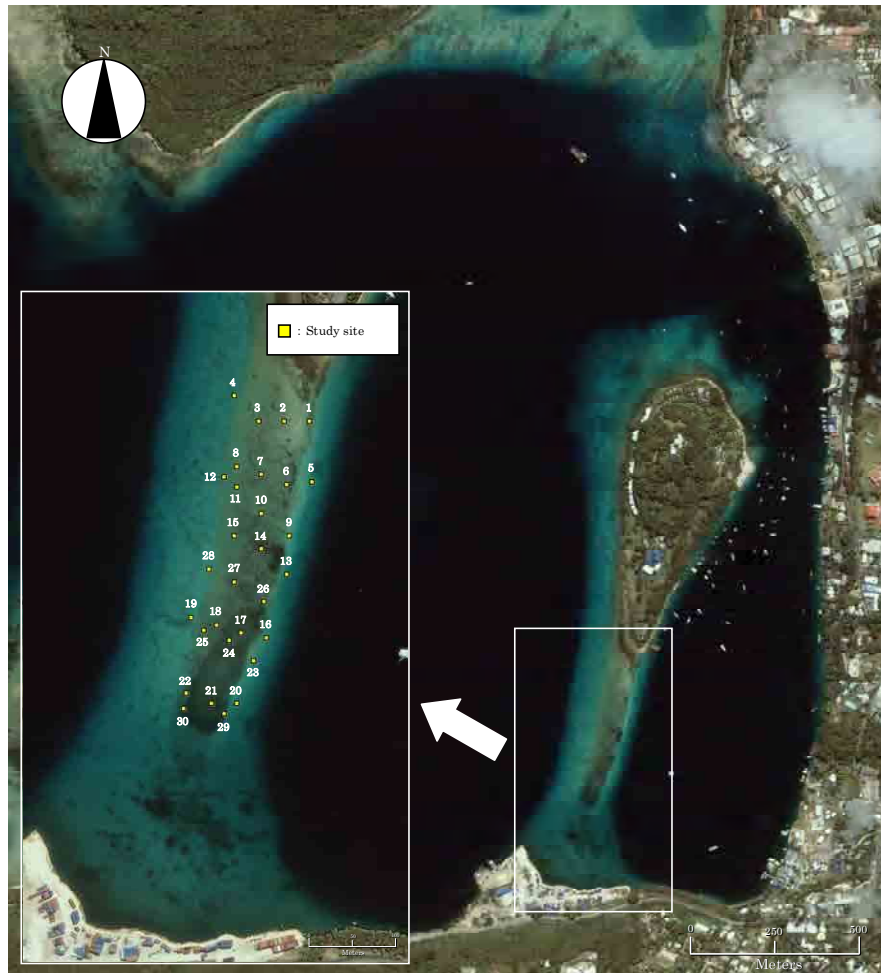
Fig. 5.2.1-1 Study sites for sounding

Survey was carried out at 30 points from October 21 to November 15, 2011 using line and lead (Fig.5.2.1-1, Table 5.2.1-1). Data was compensated by tidal data and depth from datum level was calculated (Fig.5.2.1-2).

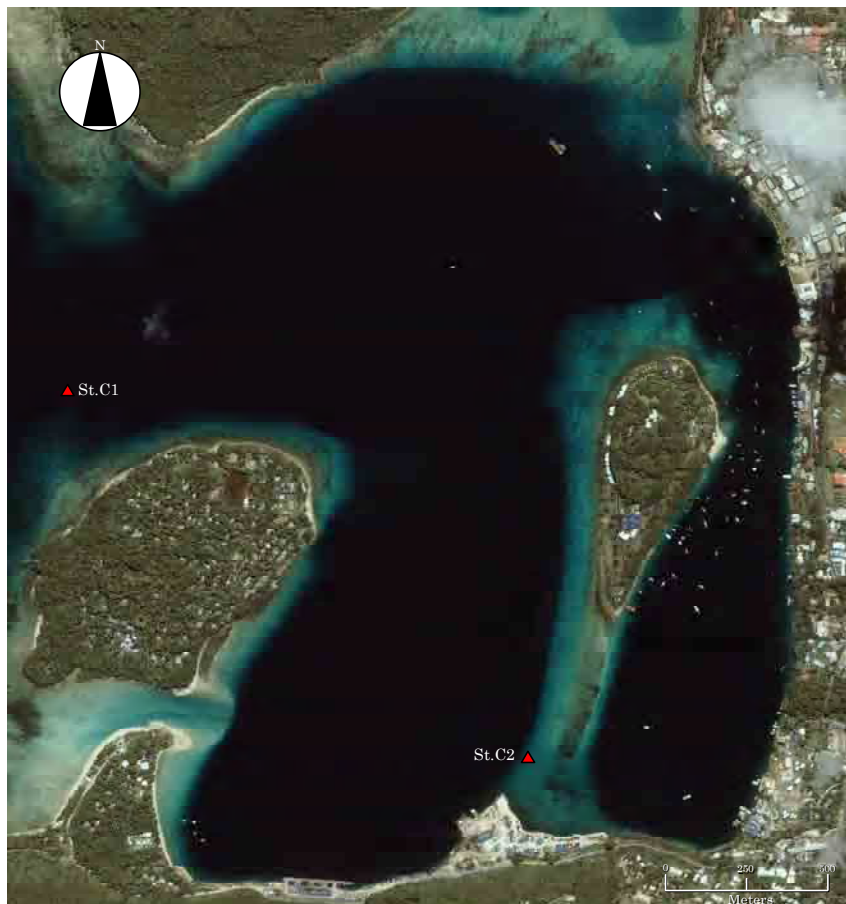
Fig. 5.2.2-1 Location of current survey sites

In the bay mouth, the loggers deployed at upper (3.1m in ddep) and bottom layers (19.9m in deep) using underwater buoyancy buoy (Fig. 5.2.2-2). In the bay head, logger was done in bottom layer only because of shallow (2.2m in deep). The logger in the bay head was fixed by a stainless stake (Fig. 5.2.2-2).

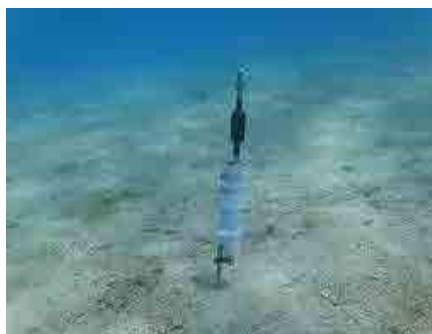
Fig. 5.2.2-2 (3) Current meter at St.C2

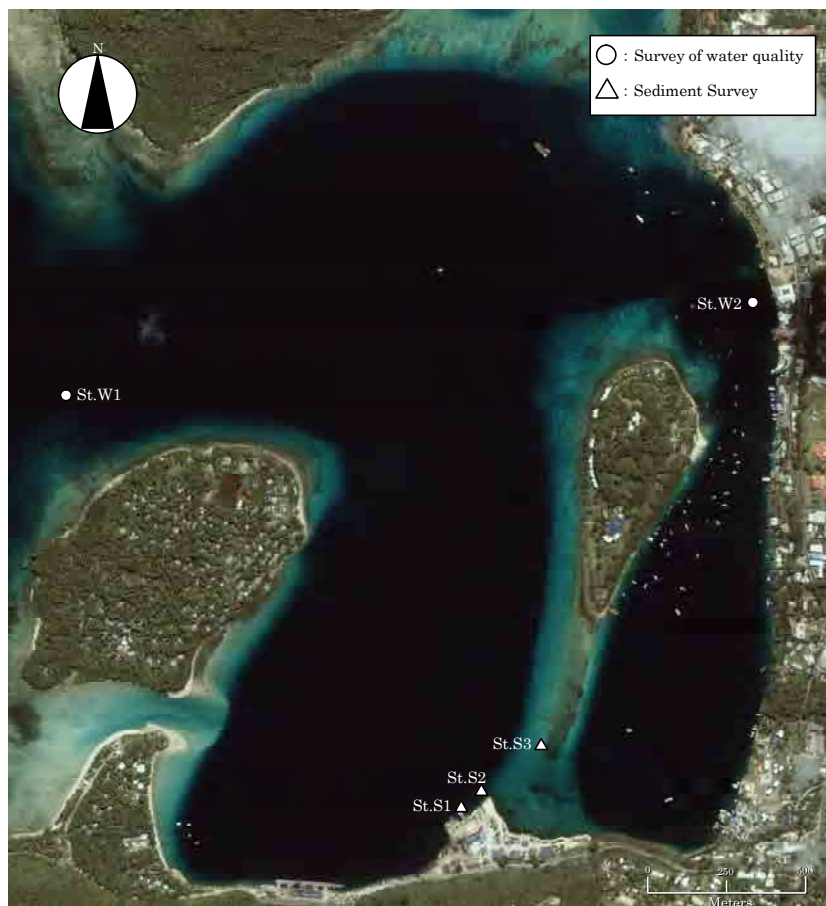
Fig. 5.2.3-1 Location of current survey

Data sampling on water temperature, salinity and turbidity was carried out in 3 sites of the mouth and head of bays using multi-parameter water quality meter vertically between October 20 and November 15, 2011 (Fig. 5.2.3-1, Table 5.2.3-1). Water sampling was also done simultaneously for analyzing SS at laboratory.

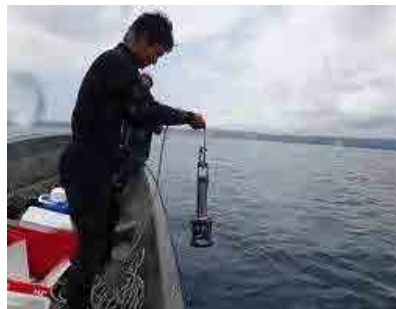
Fig. 5.2.3-2 (1) Measurement by Multi-parameter water quality meter

A thermocline is observed around 2 m depth at Star wharf(St.S2), but water temperature is almost uniformly distributed in vertical in other cases. Vertical distribution of salinity shows a tendency that surface concentration is lower than bottom at the bay mouth station(St.W1) during the neap tide and this may be attributed to precipitation. Turbidity shows slightly high concentration in the lower layer offshore market of Paray bay coast.

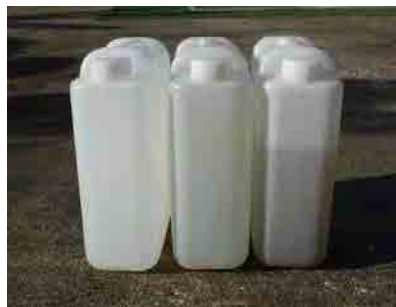
Fig. 5.2.3-2 (2) Collect water sample for SS (left: St.W1, middle: St.W2, right: St.S2)

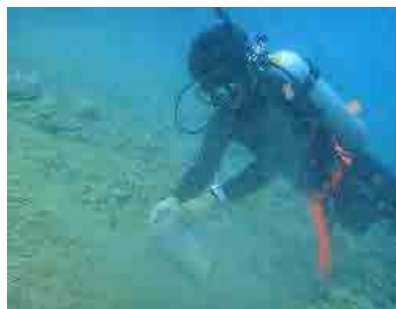
Sediment samples were collected in 3 sites near Star Wharf for analyzing grain size at laboratory. Sediment sample in St.S2 mixed with sea water was measured for turbidity and analyzed for SS.

Fig. 5.2.3-2 (3) Collecting sediment sample
