管路給水施設水源井戸調査結果

管路給水施設用の水源井戸の調査は、掘削地点を決めるための水平電気探査と垂直電気探査、試掘調査、既存井戸の揚水試験を実施した。これらの結果から、計画給水量に見合う井戸を選定し、それを元に給水施設の設計が行われた。

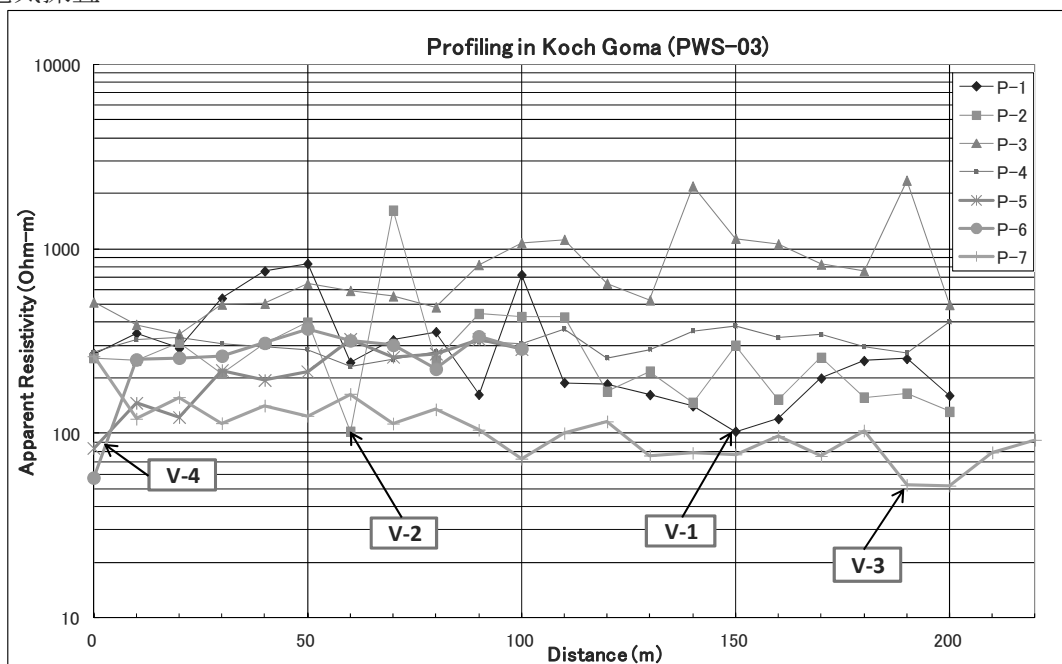
P-1、P-2、P-5、P-7 測線の中から、それぞれの最も比抵抗の低い地点で垂直電気探査を実施した。P-3、P-4、P-6 測線は全体的に比抵抗が高く、目立った低比抵抗が無かった。

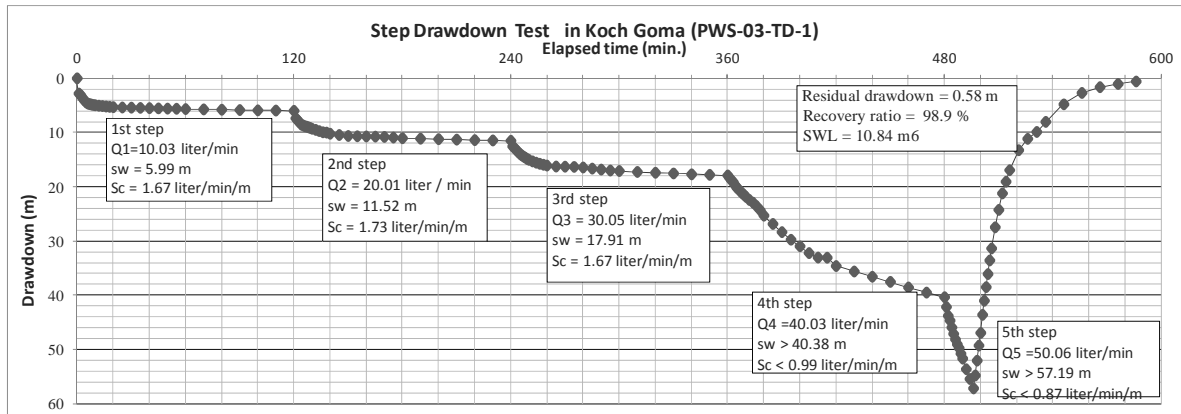
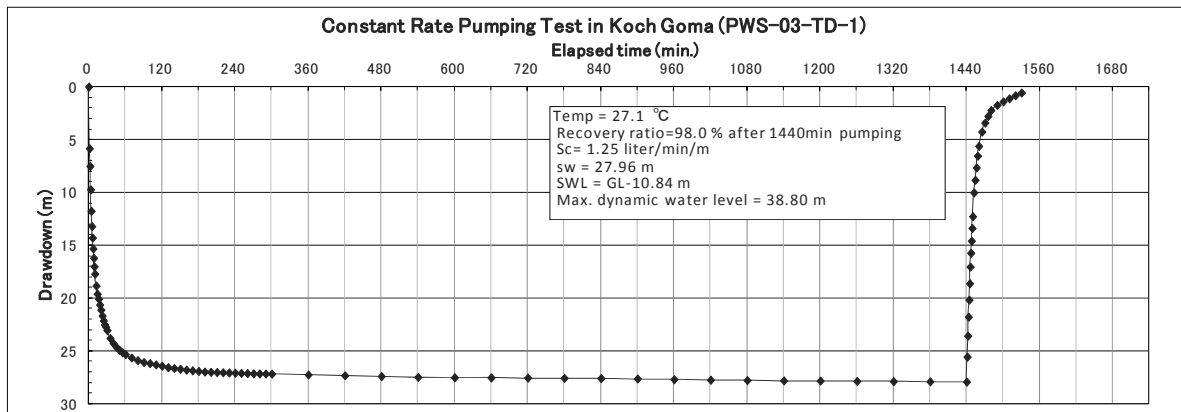
この井戸の揚水試験結果を以下に示す。上段は段階揚水試験の水位降下曲線、中段がその解析結果で、下段が連続揚水試験並びに回復試験の水位降下曲線を示している。

これらの結果より、安全揚水量を 1.8m³/hr(30 リットル/分) と判断した。

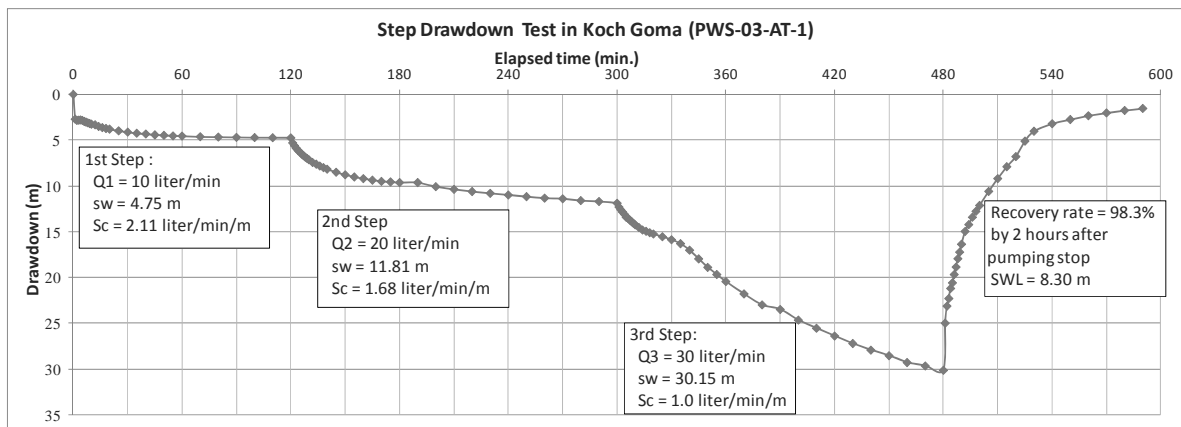
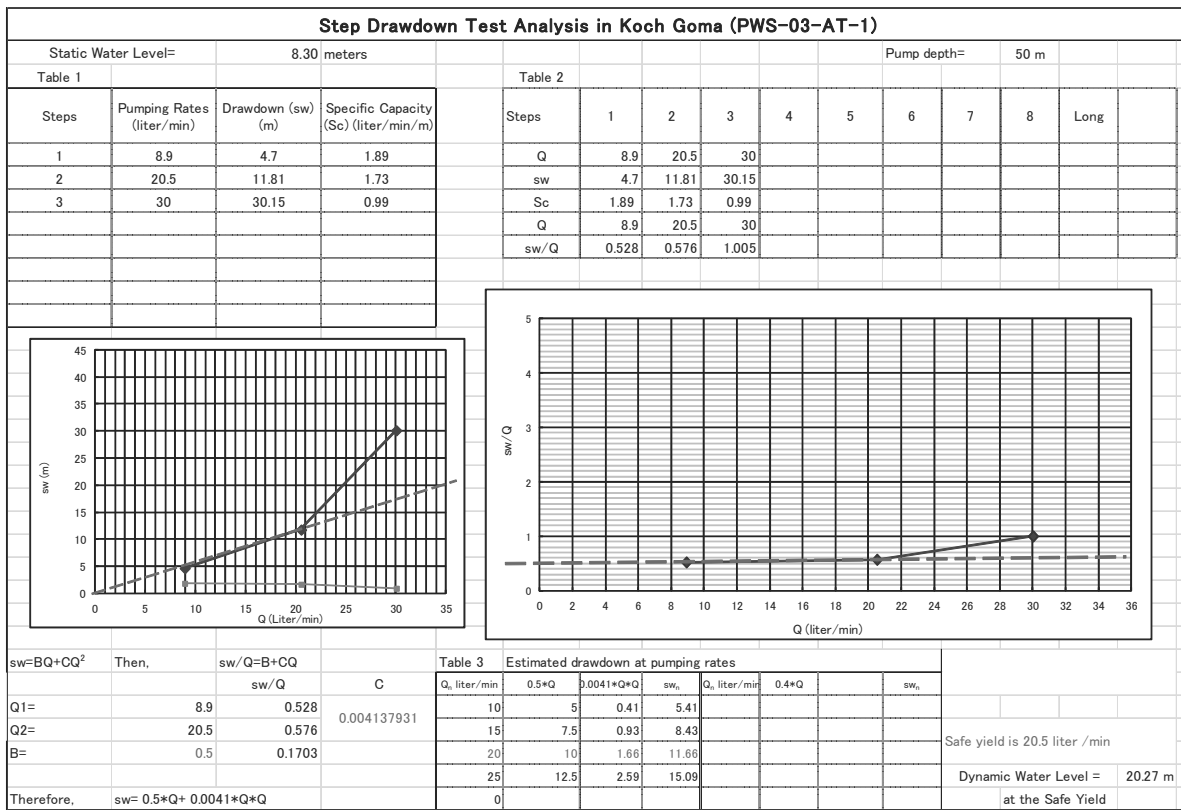
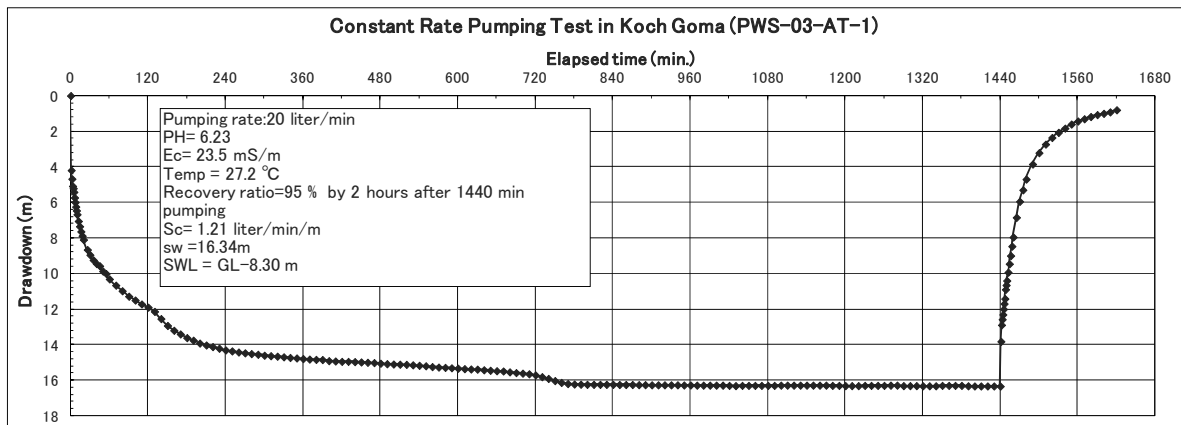
揚水試験の結果を以下に示す。上段は段階揚水試験の水位降下曲線、中段がその解析結果で、下段が連続揚水試験並びに回復試験の水位降下曲線を示している。

この結果から、安全揚水量は 1.2m³/hr (20 リットル/分) と判断した。また、PWS-03-AT-2 では期待したほどの揚水量は得られなかった。

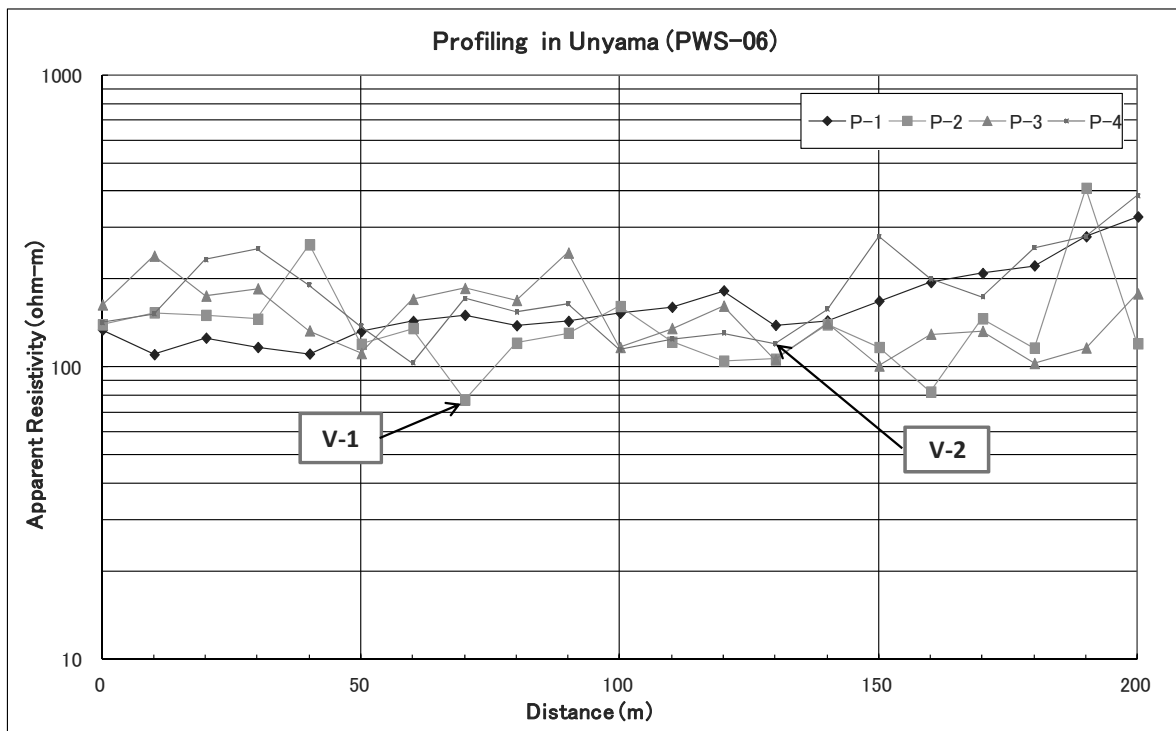
P-1、P-2、P-3 は一本の線上に設定した。その3測線の中で最も比抵抗の低い地点を V-1 として、P-4 測線では地形的に若干低く、かつ、比抵抗の低いところを V-2 として選定した。

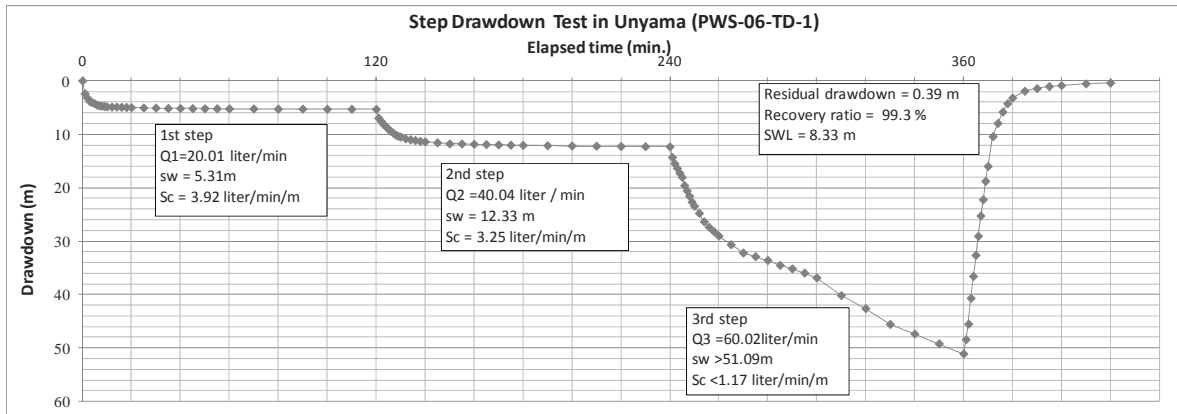
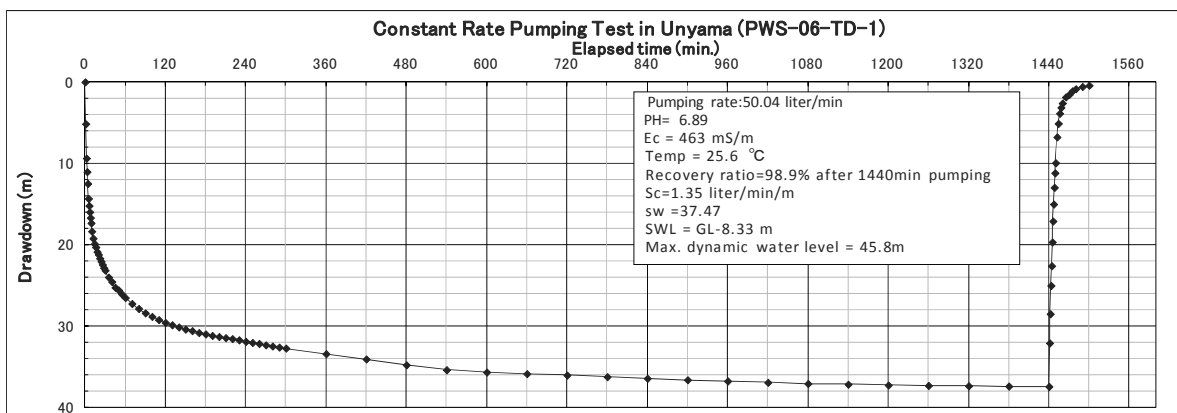
この井戸の揚水試験結果を以下に示す。上段は段階揚水試験の水位降下曲線、中段がその解析結果で、下段が連続揚水試験並びに回復試験の水位降下曲線を示している。

これらの結果より、安全揚水量を 2.4m³/hr (40 リットル/分) と判断した。

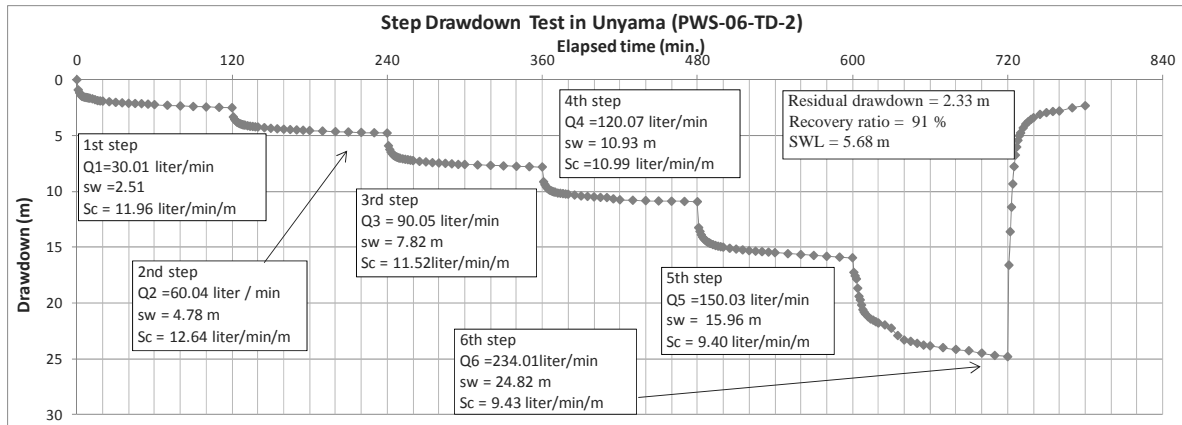
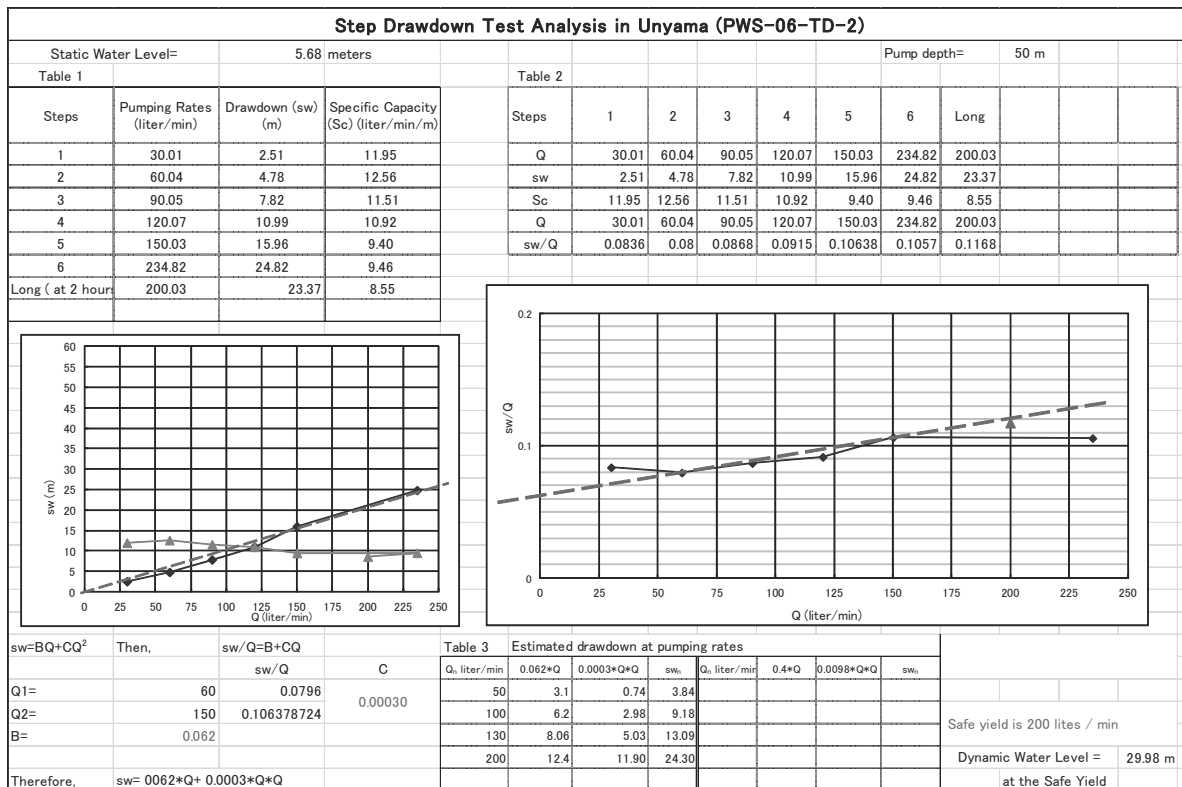
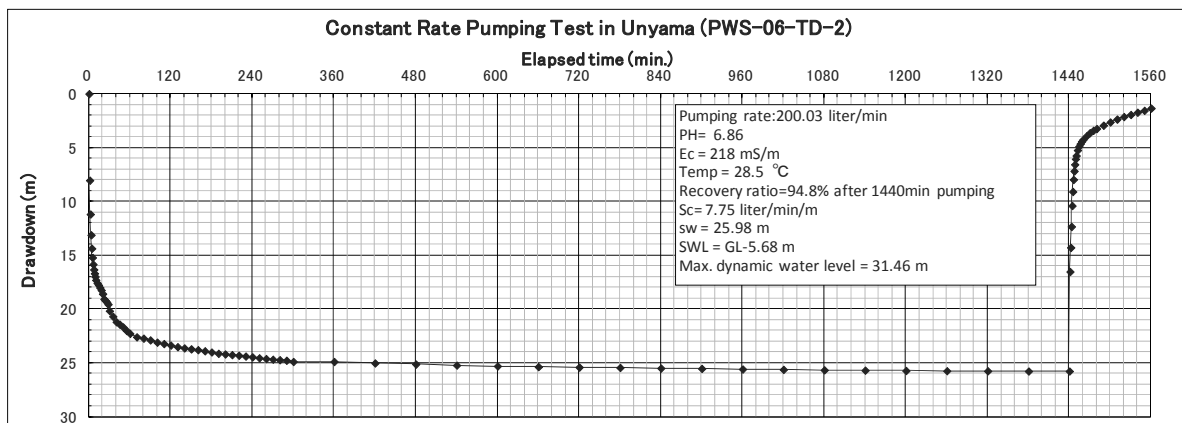
この井戸の揚水試験結果を以下に示す。上段は段階揚水試験の水位降下曲線、中段がその解析結果で、下段が連続揚水試験並びに回復試験の水位降下曲線を示している。

これらの結果より、安全揚水量を 12m³/hr (200 リットル/分) と判断した。

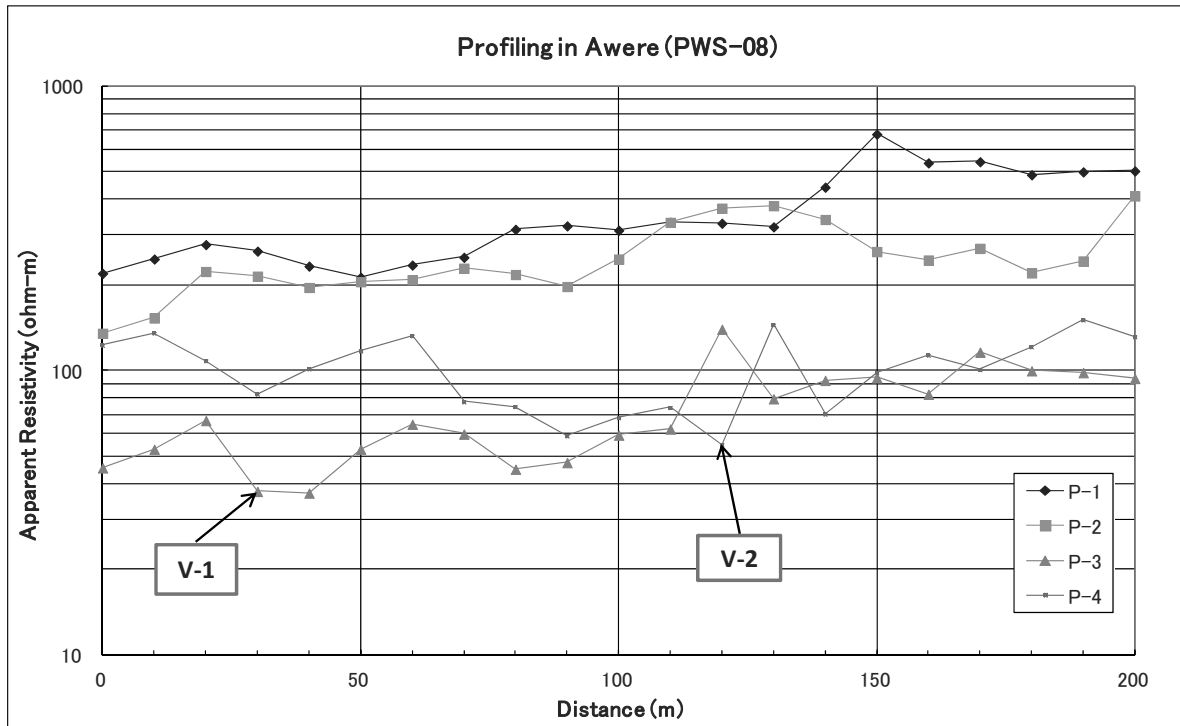
P-1、P-2 測線は全体的に比抵抗が高く、目立った低比抵抗地点が無かったため、P-3 と P-4 の中で最も比抵抗の低い地点で垂直電気探査を実施した。

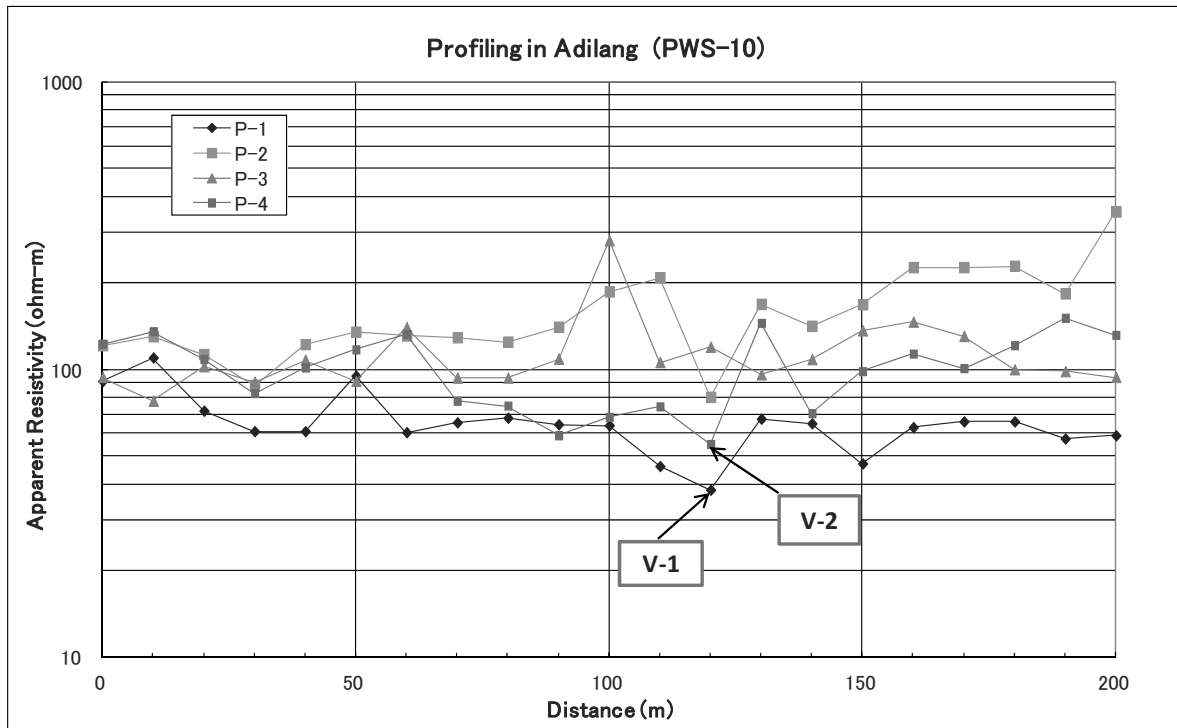
Adilang RGC の東側には標高差 800m 程度の山が連っており、RGC 内は西に向かって緩やかに傾斜する平坦な地形を呈している。東側の岩山の状況から、基盤岩はさほど深くないと推定されたが、地下水涵養が見込めるのは山に近い場所と考えた。したがって、水平電気探査の測線は RGC の東側に設定し、見掛比抵抗が低い地点を狙って掘削をすることを方針とした。

水平電気探査の結果では、山よりの P-2、P-3 測線は P-1、P-4 測線の比抵抗よりも高く、基盤岩が浅いことが推測された。したがって、P-1 と P-4 の中から垂直電気探査の地点を選ぶこととし、その中でも最低の比抵抗を示した 2 点を選定した。

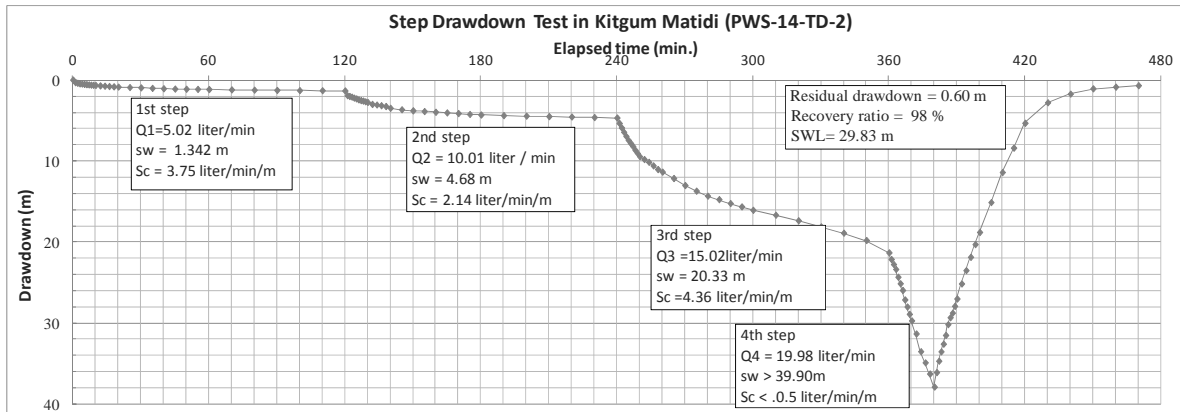
この井戸の揚水試験結果を以下に示す。上段は段階揚水試験の水位降下曲線、中段がその解析結果で、下段が連続揚水試験並びに回復試験の水位降下曲線を示している。

これらの結果より、安全揚水量を 0.6m³/hr(10 リットル/分) と判断した。
