5. Technical Inputs

Purpose: Final Report of Survey

Report of the basic survey and the method on the cultural resources
 - For carrying out Ecomuseum and developing the community in Salt -

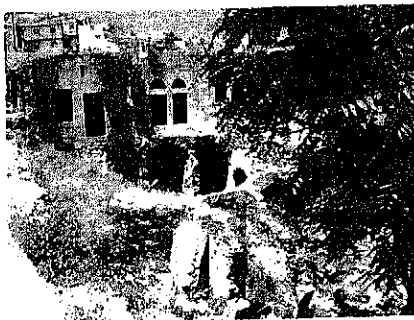
Condition of historical buildings

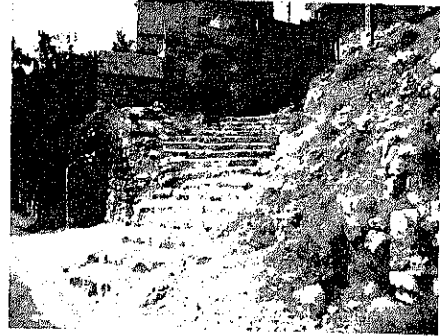
Historical Stairs

Stairs

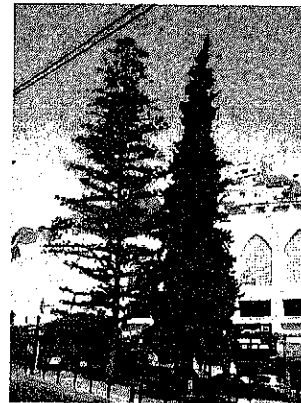
Trees

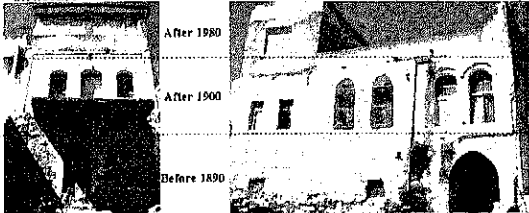
● **Addition**
 New parts on the side or on the top, using the original structure

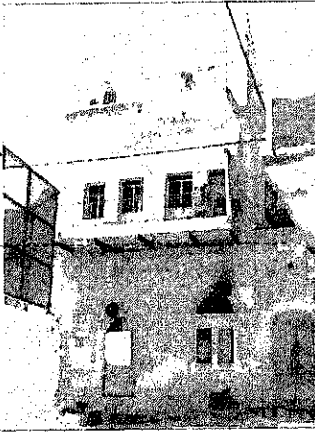
2) Feature of using

- Used by the owner
- Rented by the owner's relative

↑ Additional parts

↓ Traditional parts

- Rented by foreign laborer
- Storage
- Vacant

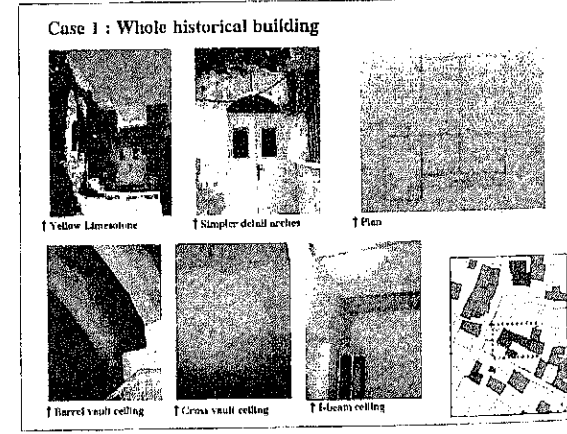
Case 1 : Whole historical building

- ↑ Yellow Limestone
- ↑ Simpler detail arches
- ↑ Plan
- ↑ Barred vault ceiling
- ↑ Gross vault ceiling
- ↑ Ebeah ceiling

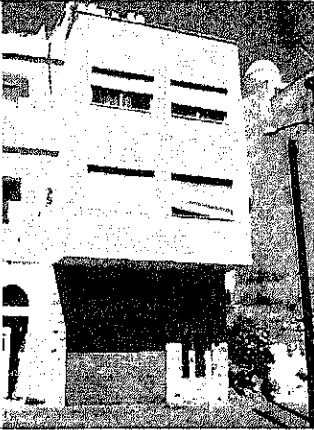
No.121 in Municipality

②-1: Case of new buildings
 "Replaced with the concrete"

There was a cross vault ceiling and courtyard.
 The owner destroyed the historical building and rebuilt new one in 1990's.

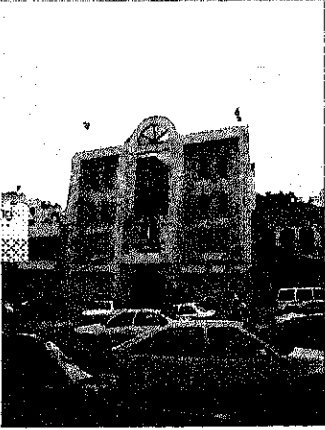
No. 498 in Maydan

②-1: Case of new buildings
 "The old building is an old building"

The present building is totally new in 2009.
 But they used the old stone foundation to build foundation for it.

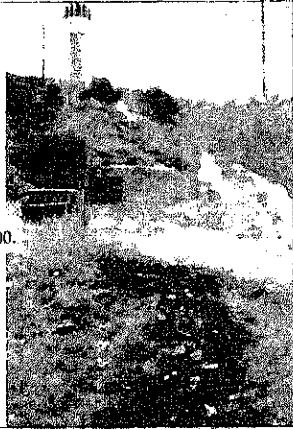
No.309 in Qala'a

There were 2rooms buildings.
 But it was destroyed in 1995-2000.

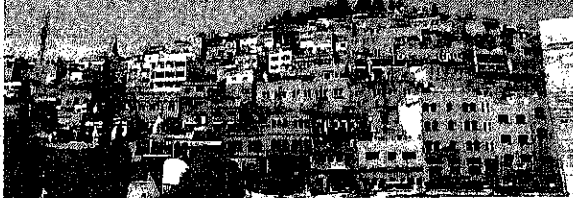
2) Repair and Restoration of Heritage Buildings

b) Restoration of heritage buildings whose value are not visually evident (hidden).

Restoration of the townscape by re-exposing finishing of Salt stones that are constructed by traditional construction technologies.

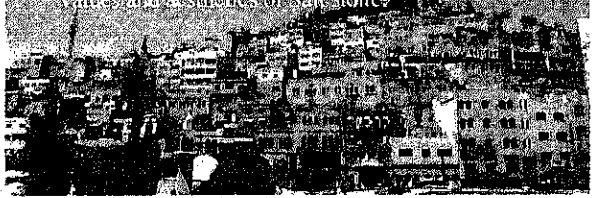
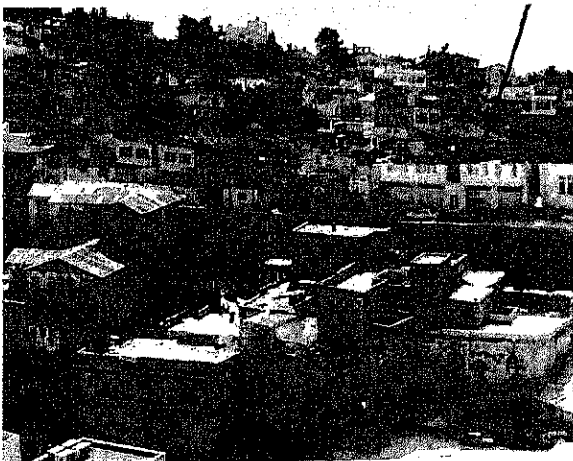
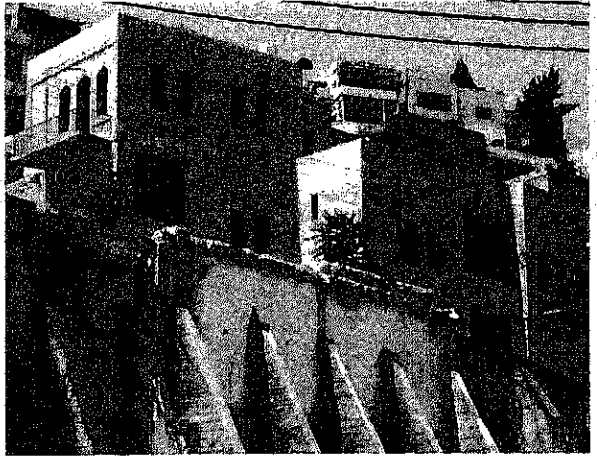
(2) Repair and Restoration of Heritage Buildings

c) Restoration of heritage buildings whose value are not visually evident (hidden).

To repair, preserve and restore Salt stone ruins of walls and arches with additional new construction materials to make that ruin back to a complete building and expose value and aesthetics of Salt stone.
