## Chapter 3 Ground Survey

### 3.1 Drilling, Laboratory Tests

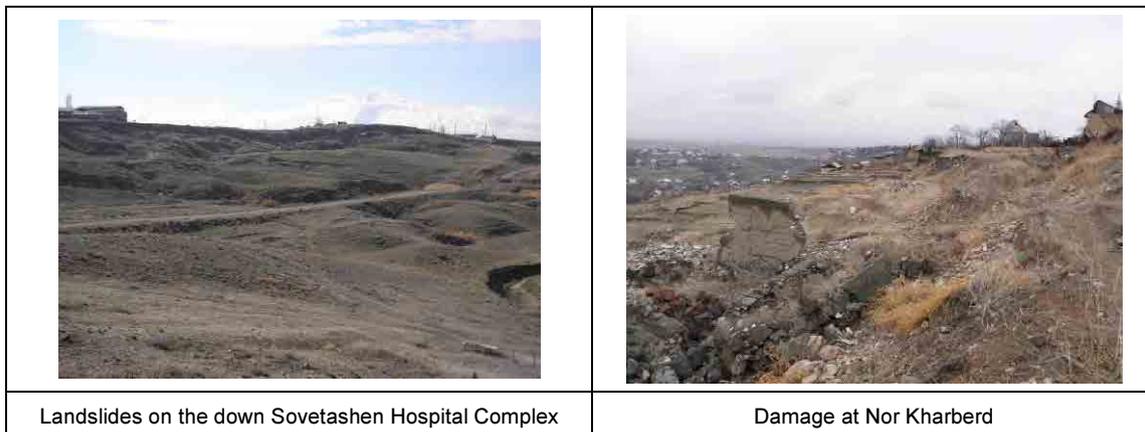
Figure 3.6-2 Landslides and damage

After satellite photo interpretation, landslide micro landforms, such as, main scarps, cracks, steps, depressions and mounds, and damage to houses, buildings and infrastructures were observed in the field

Landslides in Group 3 “Hrazdan Landslide Group”, are exist mainly on the right and left banks of Hrazdan river gorge, and are associated with sites of exposed clay and marly rocks, on which thick basaltic lavas are bedded and the boundary of which is always water-saturated. Therefore, not only the basalts and basaltic andesite, but also the residual and creeping units, covering the clayey suite, are capable of landslide.

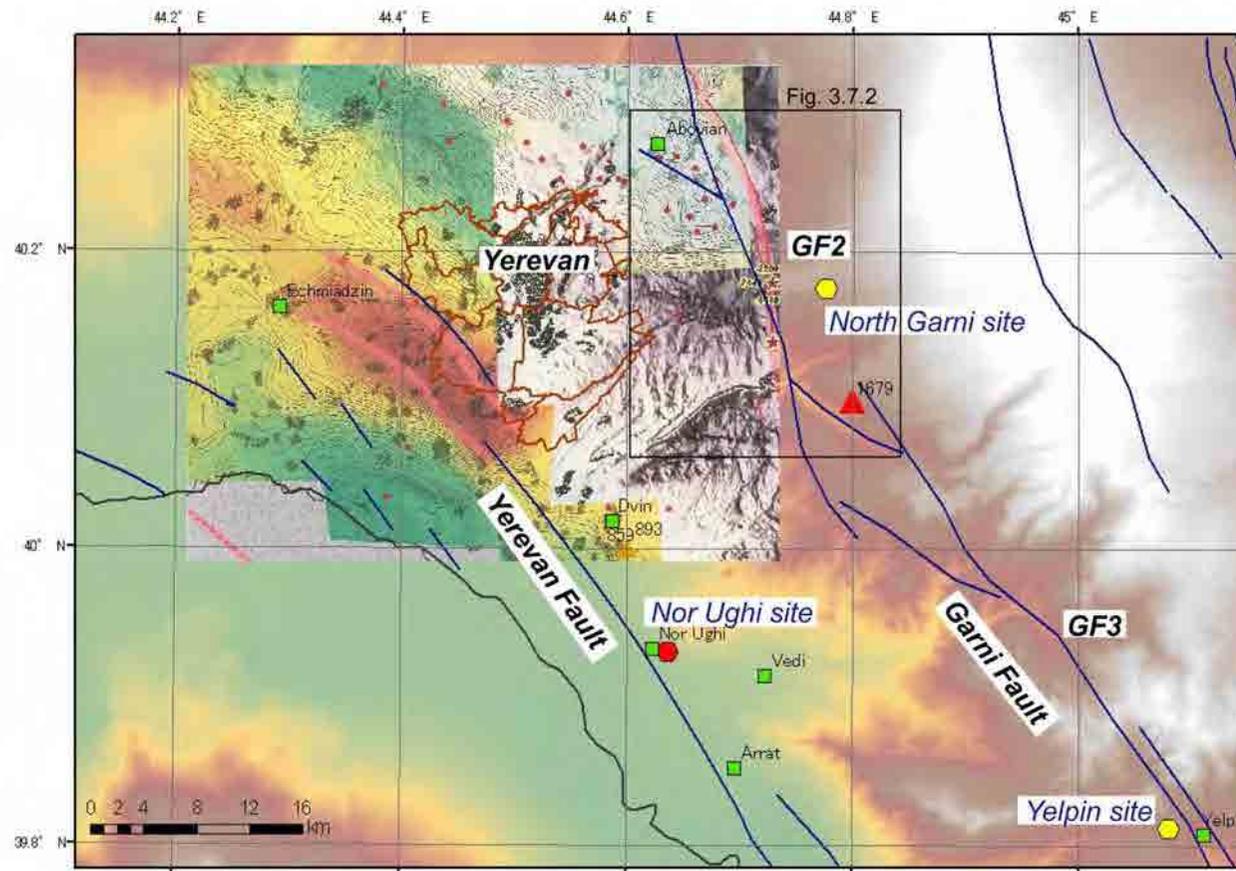
Figure 3.7-1 Active fault map around Yerevan City after Georisk report. The gravity anomaly data are shown in the area including Yerevan City. The segments GF2 and GF3 of the Garni Fault pass through the east of Yerevan City. The Yerevan Fault is inferred on both sides of the northeastern and southwestern edges of high gravity anomaly which is shown in red color.

Aslanyan(1954, 1958) and Gabrielyan(1959, 1981) carried out the gravity survey around Yerevan City and found out the NW-SE extending high gravity anomaly on the south of Yerevan City. They suggested active faults on the southwestern and northeastern edges of the high gravity anomaly and called these faults as Parakar north fault and Parakar south fault (red thick solid lines in Figure 3.7-1). These faults represent the central segment of the YF. The mineral springs and travertine are recognized at Dvin and Vedi located on the southeast of Yerevan City. These hot spring processes are inferred to be phenomenon accompanied with the activity of the YF. Aslanyan(1954, 1958) and Gabrielyan (1959, 1981) inferred the southeastern extension of the YF as shown in Figure 3.7-7. The pilot trench at Nor Ughi Village is located on the fault trace after Gabrielyan (1959, 1981). Georisk collected and analyzed deep borehole data, and revealed that bedrocks composed of crystalline schist lie at shallow place in depth where the high gravity anomaly is recognized. And the length of the YF is suggested to be 33 km at the maximum based on the structure of Ararat basin (Georisk report). Dvin of ancient capital in Armenia suffered severe damaged from the 863 and 893 earthquakes (Figure 3.7-1). The source of these earthquakes may have been generated by the YF or the GF. According to the mechanism analysis of small to moderate earthquakes around Yerevan City, the reverse fault type is dominant (Tovmasyan, 2008)

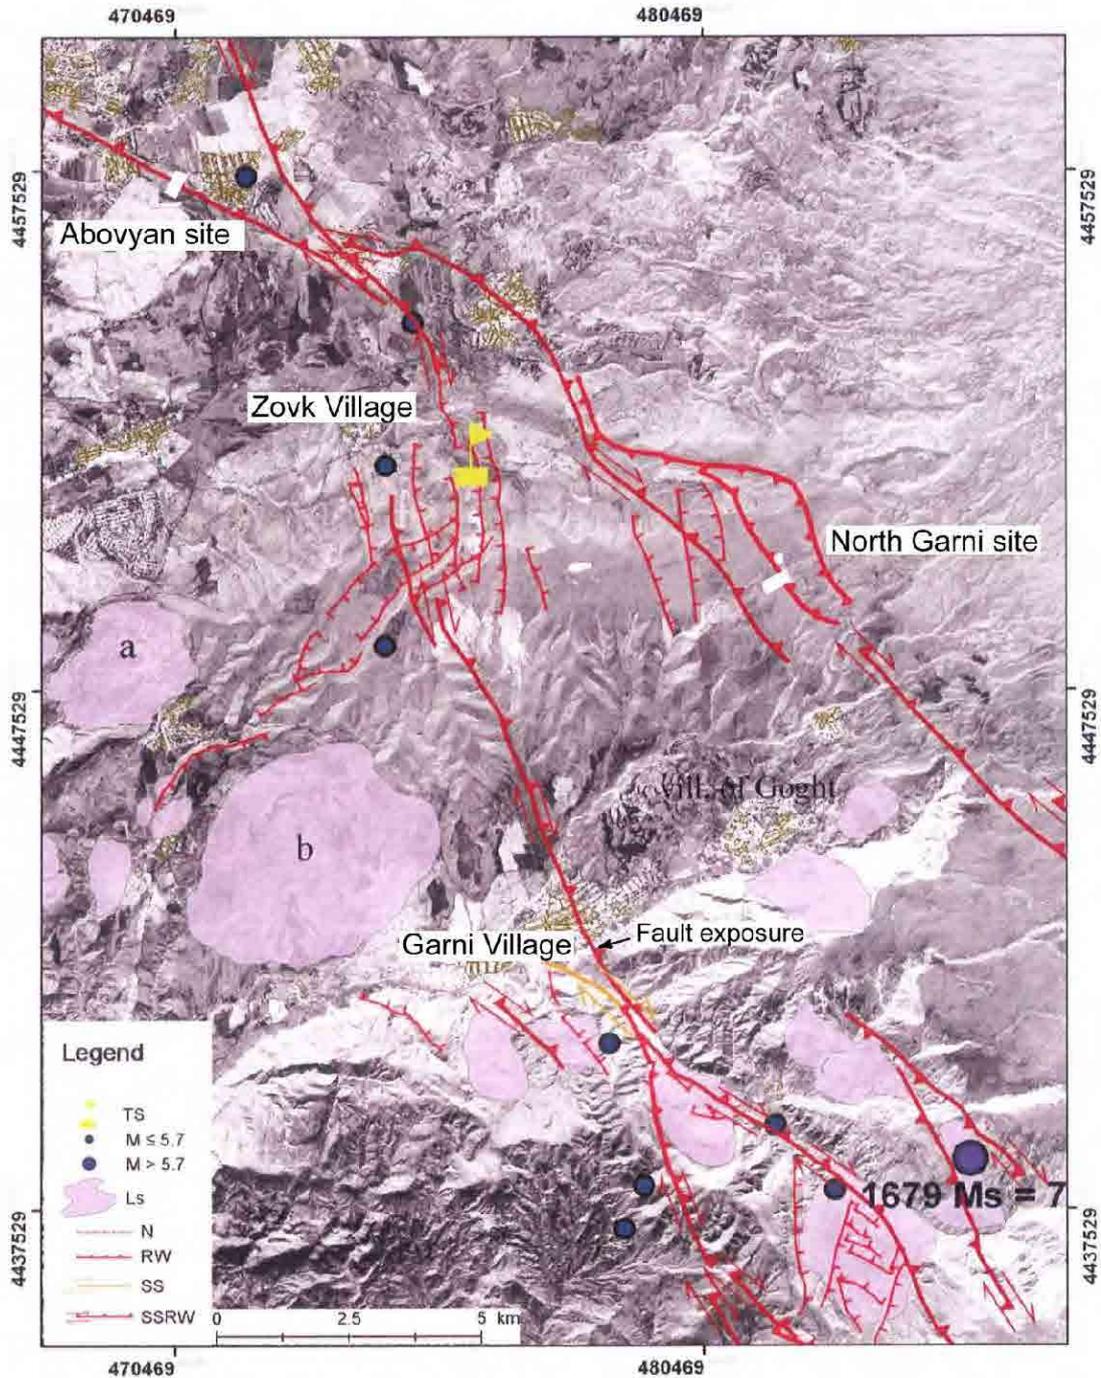
Figure 3.7-2 Detailed active fault traces of GF2 segment of the Garni Fault from Abovyan to Garni Village (Georisk report). The only simplified thick solid lines in Figure 3.7-2 are shown in Figure 3.7-1. The trenches at Abovyan site and North Garni site (white rectangles) were performed for this project, however, an active fault was not confirmed at Abovyan site. The yellow flag is a trench site carried out by Georisk.

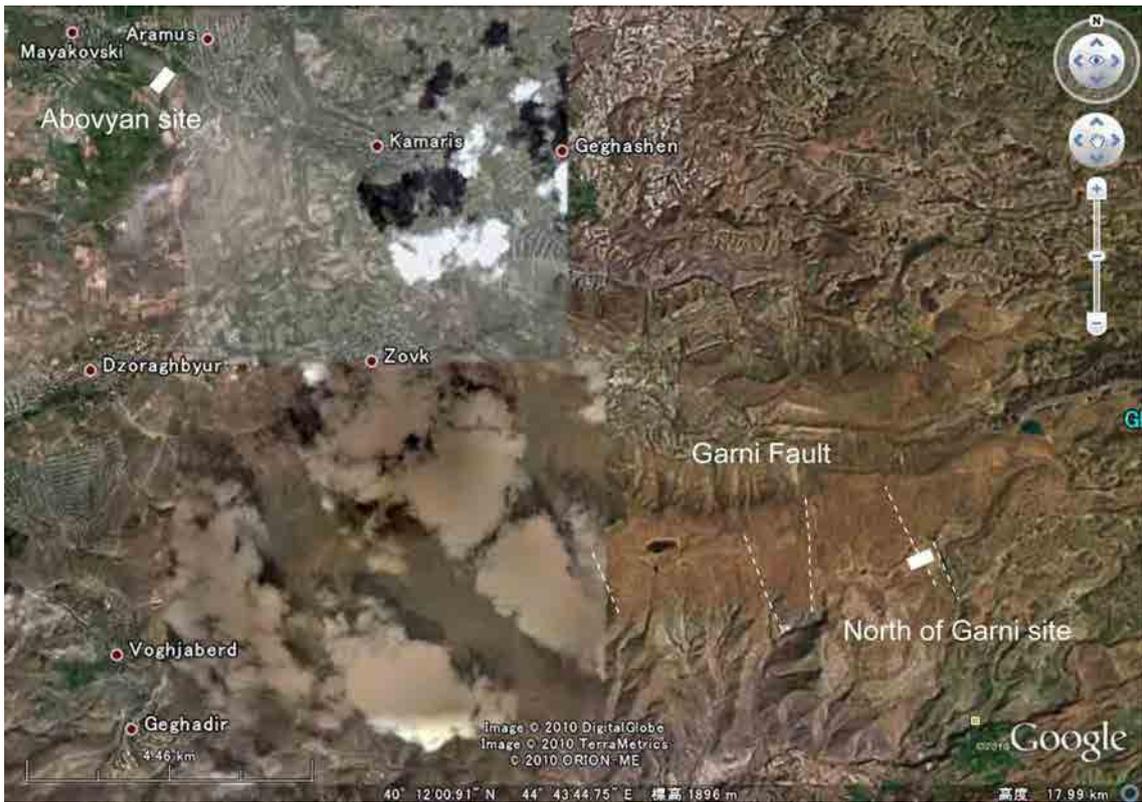
Figure 3.7-3 Active fault traces (white broken lines) on the top of the mountain at the north of Garmistepan Village. At least five N-S trending active faults are inferred.

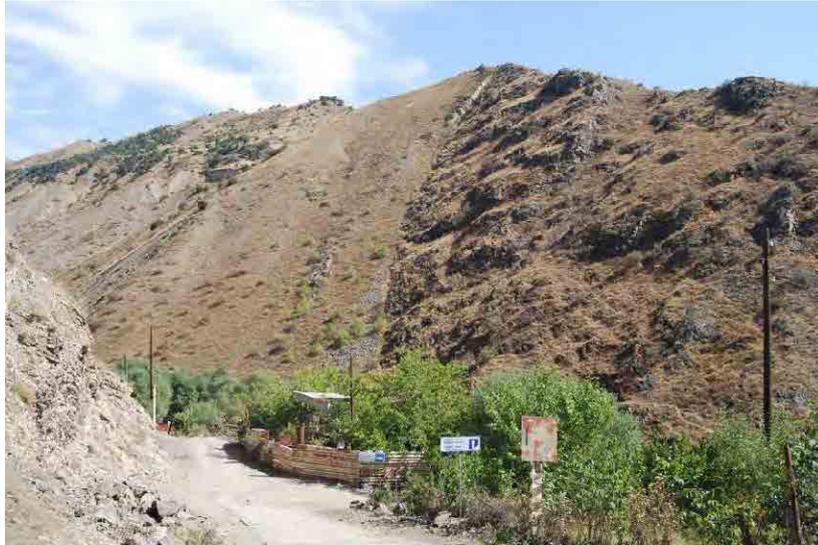
Figure 3.7-4 Fault exposure of the Garni Fault on the southern wall of the valley, south of Garni Village. The location is shown in Fig. 3.7-2. The fault is clear, however, the fault topography (e.g. a low fault scarp) is not confirmed on the top of the mountain.

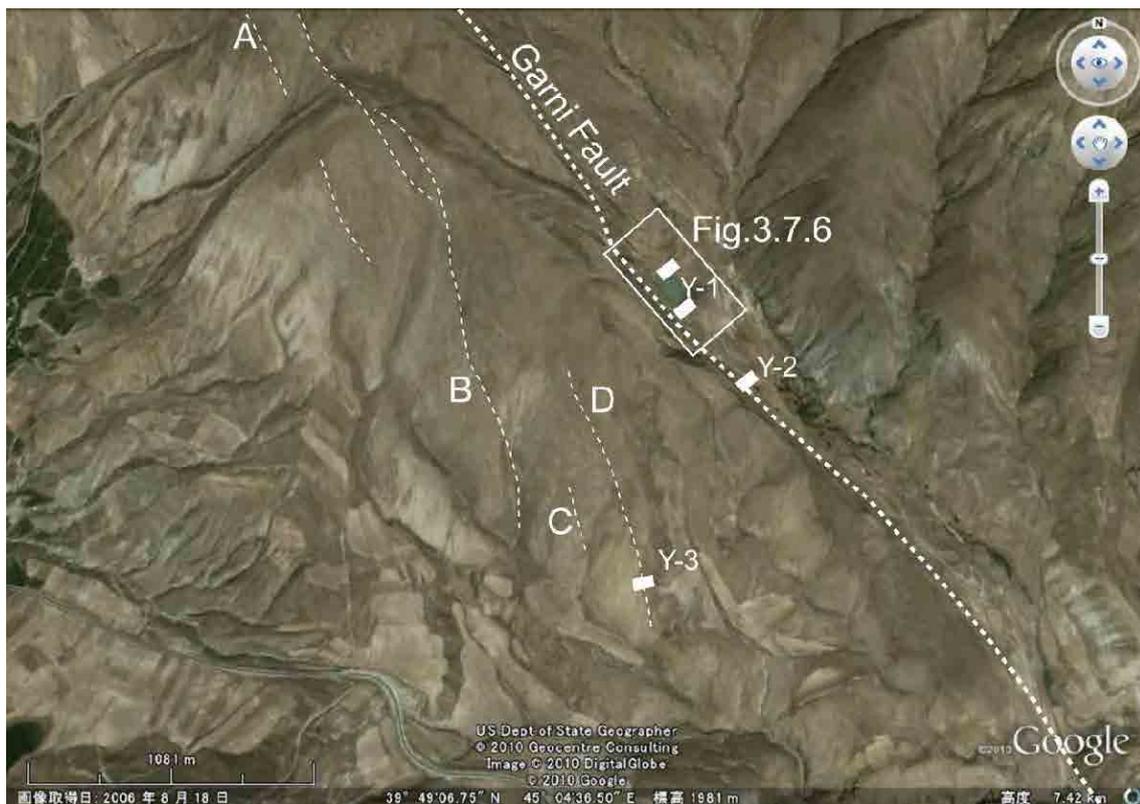
Figure 3.7-5 Active fault traces of the Garni Fault at Yelpin. The thick broken line is a major fault. Three trenches at Y-1 and Y-2 sites were excavated. However, an active fault was not confirmed. Small faults A to D are developed on the west of a major fault. An active fault was identified at Y-3 site.

The location of Yelpin Y-3 site is shown in Figure 3.7-5. The photographs of the geomorphology around Y-3 site are shown in Figure 3.7-21 to Figure 3.7-23. The NNW-SSE trending low fault scarp is observed on the mountain with poor vegetation. The low fault scarp is clear and can be found even on Google Earth Image. The straight low fault scarp with height of ~1 m is recognized at Yelpin Y-3 site. The fault exposure was found out on the road cutting which was built for the construction of pipeline of natural gas. As shown in Figure 3.7-24, The western and eastern sides of the fault are composed of the Paleogene Limestone and the Quaternary deposits respectively. The Quaternary deposits are weakly consolidated by the cementation due to dry. Fissure-filled deposits (V-shape depression) are recognized on the top of the cutting wall. Unconsolidated gravels are sunk to the fissure (Figure 3.7-25). The vertical slickenside is recognized on the fault plane of the Paleogene Limestone (Figure 3.7-26).

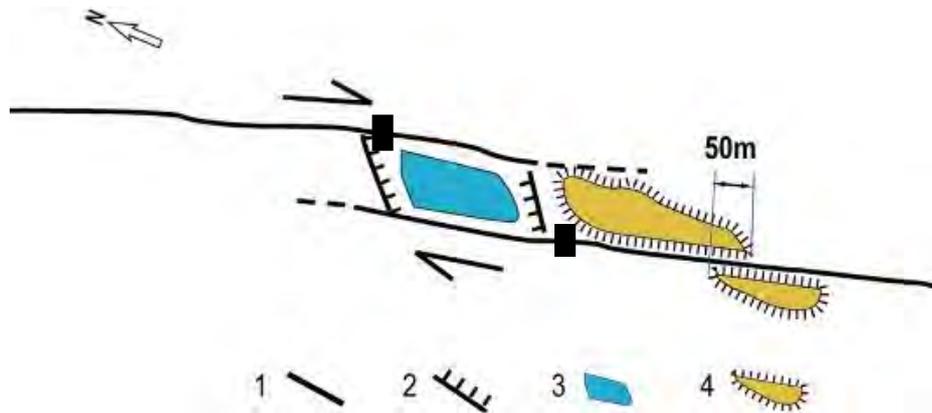
Figure 3.7-6 Active fault traces of the Garni Fault and the location of trench sites (black rectangles). The location is shown in Figure 3.7-5. The figure is after Georisk report. The space with light blue color was suggested to be a sag pond formed by faulting. However, an active fault was not confirmed.

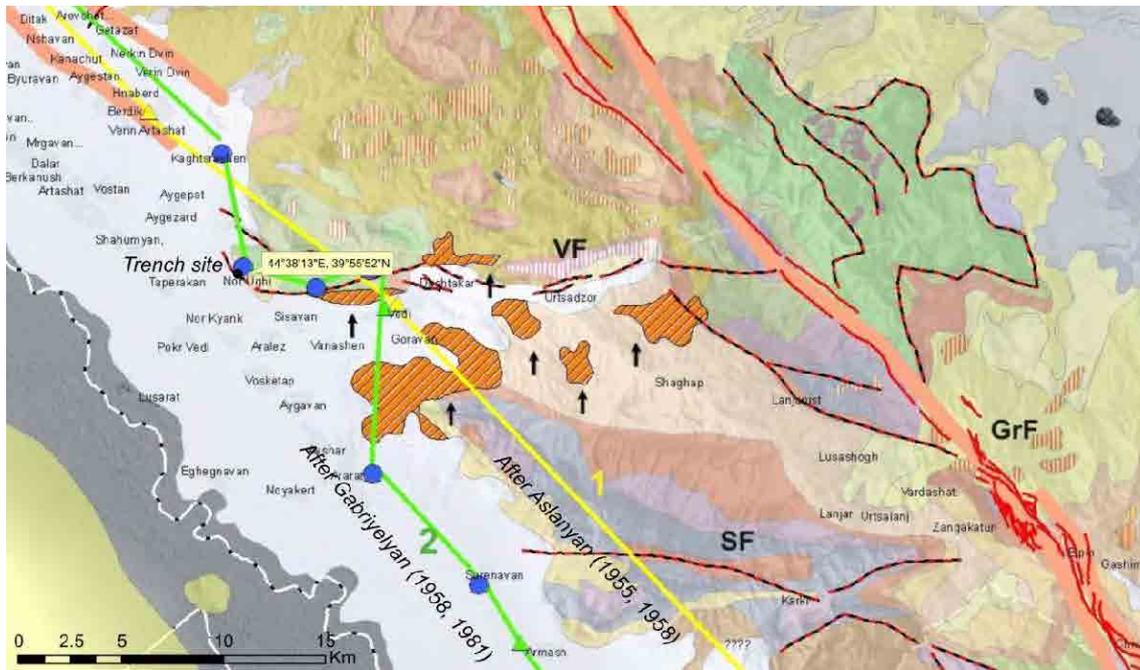
Figure 3.7-7 Active fault traces of the Yerevan Fault around Vedi and Ararat, southeast of Yerevan City after Aslanyan (1954, 1958) and Gabrielyan (1959, 1981). Blue circles and arrows represent the location of mineral springs and travertine respectively. The pilot trench at Nor Ughi is located on the fault trace suggested by Gabrielyan (1959, 1981). The Vedi Fault (VF) is overlapped on the trench site.

The location of the pilot trench at Nor Ughi site across Vedi Fault is shown in Figure 3.7-7 and Figure 3.7-8. Nor Ughi Village is situated near the northeastern margin of Ararat basin, 30 km southeast from Yerevan City. The Google Earth image around Nor Ughi Village is shown in Figure 3.7-30. The straight low scarp was found on the north of Nor Ughi Village. The geomorphology in this region is severely modified by agriculture. However, the low scarp that makes the topographic boundary between the hill and uplifted surface is clear. The low scarp was indicative of a fault scarp. So we carried out the field survey along the low scarp and found out the fault exposure (Figure 3.7-31 and Figure 3.7-32).

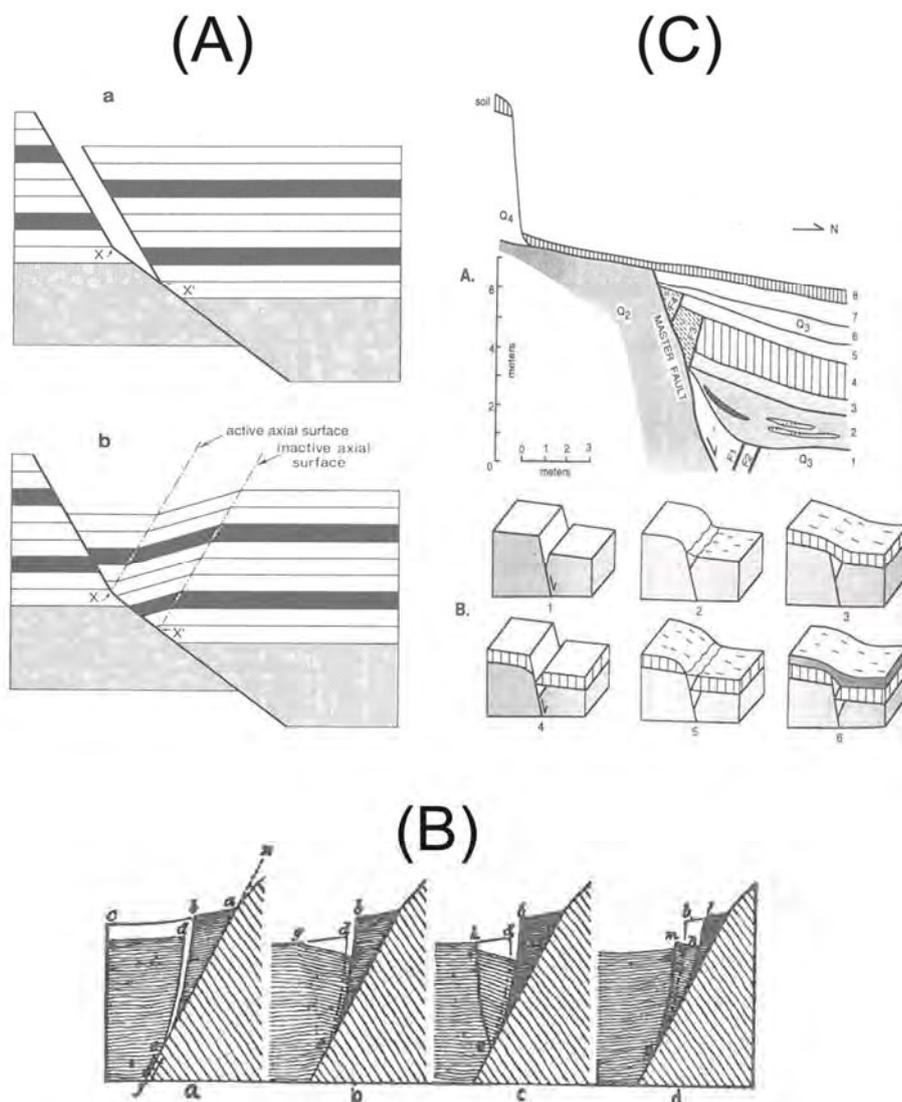
Figure 3.7-10 Deformation of normal fault. A: The hanging wall are separated from the fault scarp and sink down to the open crack due to the decrease of fault dip at deep place (Xiao and Suppe, 1992). B: Diagrams show the deformation of normal fault. ( Gilbert, 1890). C: Diagrams shown the creation of two fissure-filled wedges (Wang and Deng, 1988).

The deformation of layers accompanied with normal faulting is shown in Figure 3.7-10. Diagram (A) illustrates the deformation of layers on the hanging wall of "listric fault" which decreases the dip angle at deep place. The hanging wall slips along the fault and is separated from the fault scarp, and the layers on the hanging wall sinks down to the open crack. Even if the fault is not a listric one, the surface on the base of fault scarp will be separated by normal faulting, since the fault plane of normal fault is not straight with undulations. Diagram (B) represents the features of fault scarps of normal

fault, i.e. b: bend on the hanging wall, c: formation of fissure-filled deposit. The fissure-filled deposit is called V-shape depression in Japan. Diagram (C) shows the formation process of multiple fissure-filled deposits.

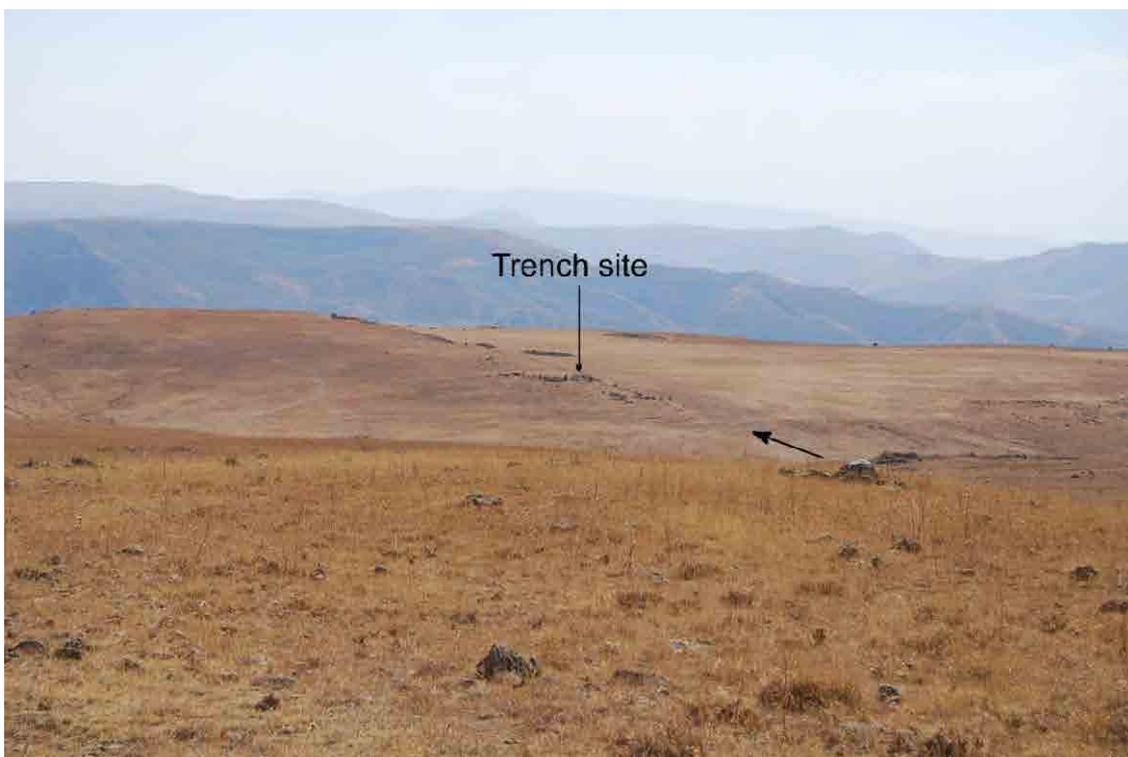
Figure 3.7-12 Geomorphology around North Garni site. The arrow represents an active fault. The fault scarp with height of 4-5 m is clear. View to the south.

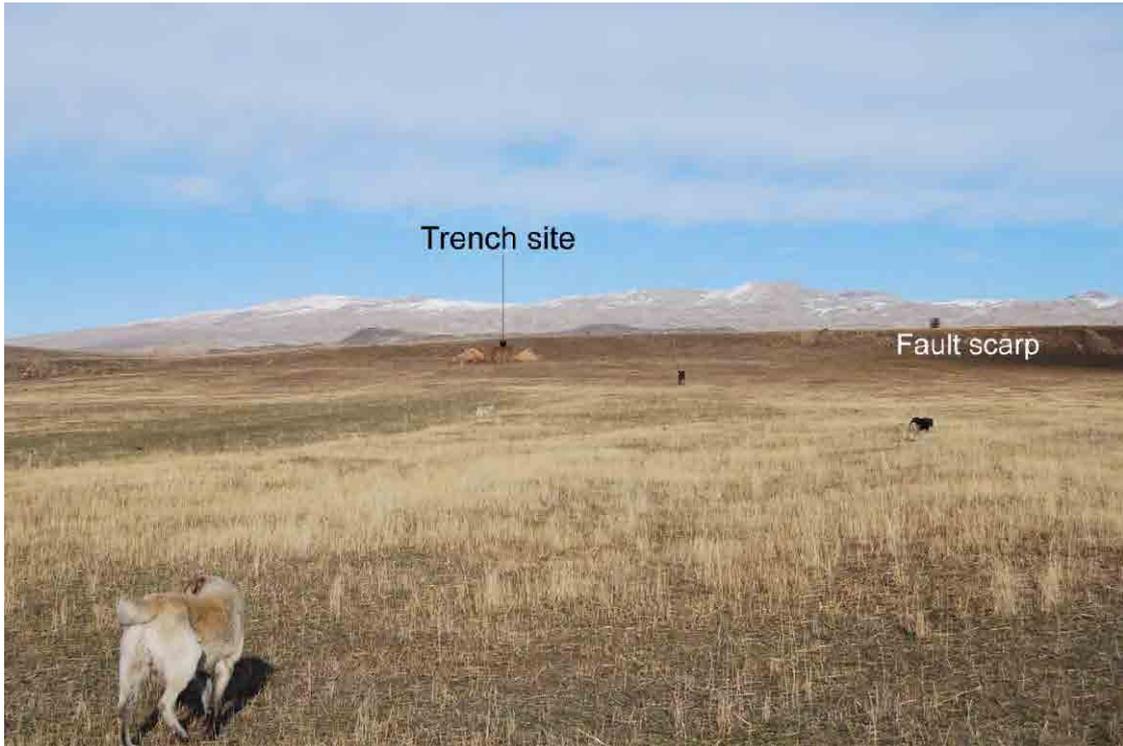
Figure 3.7-13 View of the low fault scarp to the east. The ground surface on the hanging wall (downthrown side) is gently inclined to the east (to the low fault scarp).

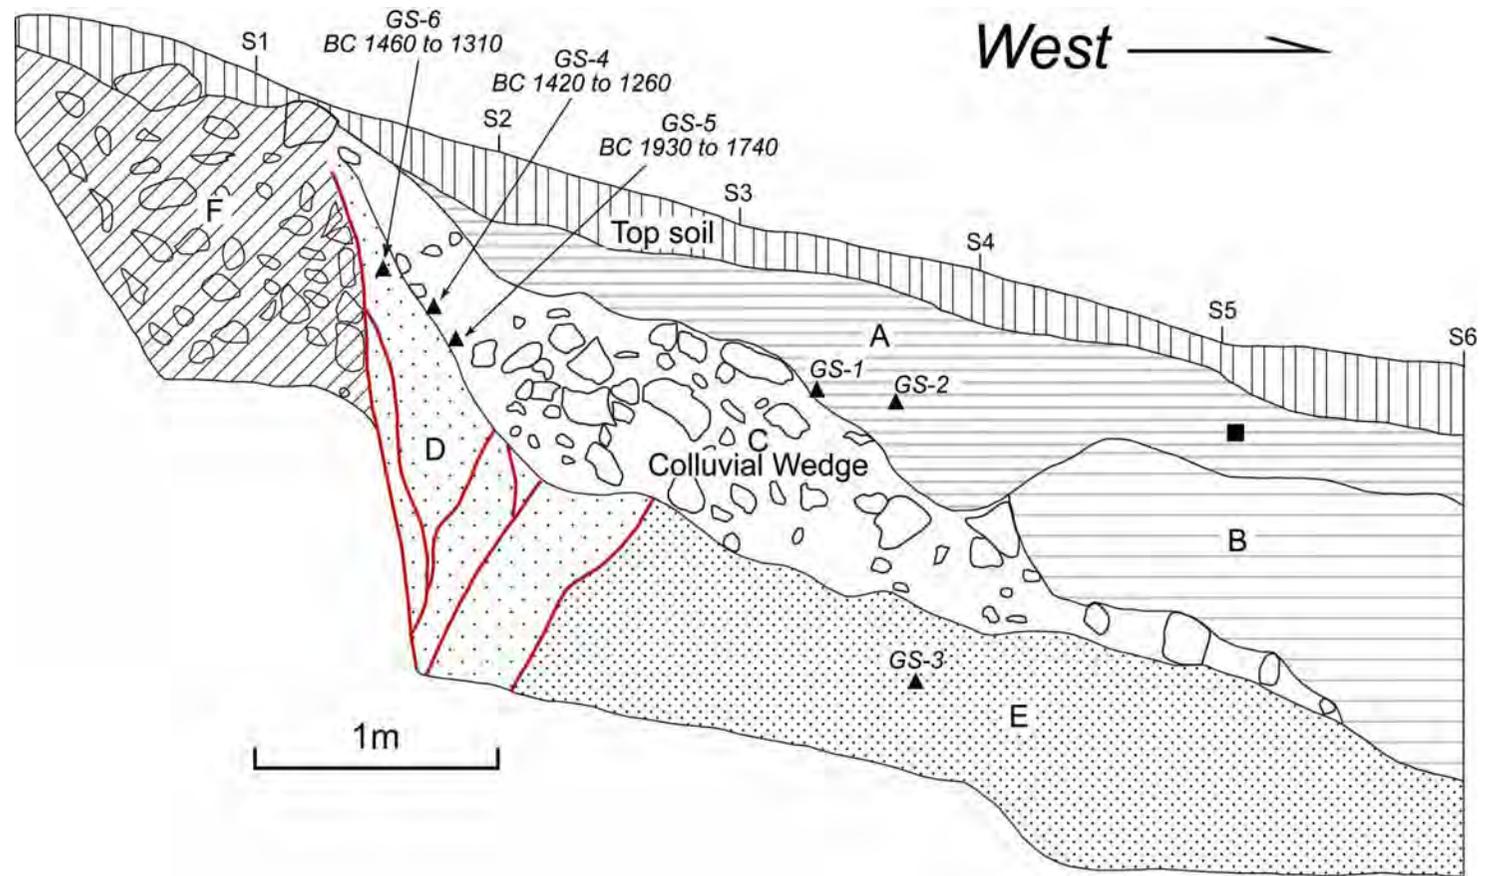
Figure 3.7-14 Log of the south wall at North Garni site. Red solid lines represent active faults. The sedimentary succession in the trench is divided into units A to F. The faults displace units D to F, and are covered by unit C. Unit C is “colluvial wedge” which was deposited by the collapse of the fault scarp just after earthquake. Unit D is a fissure-filled deposits with V-shape. Unit E is weakly consolidated. Triangles and square represent the location of  $^{14}\text{C}$  dating and a fragment of pottery respectively.

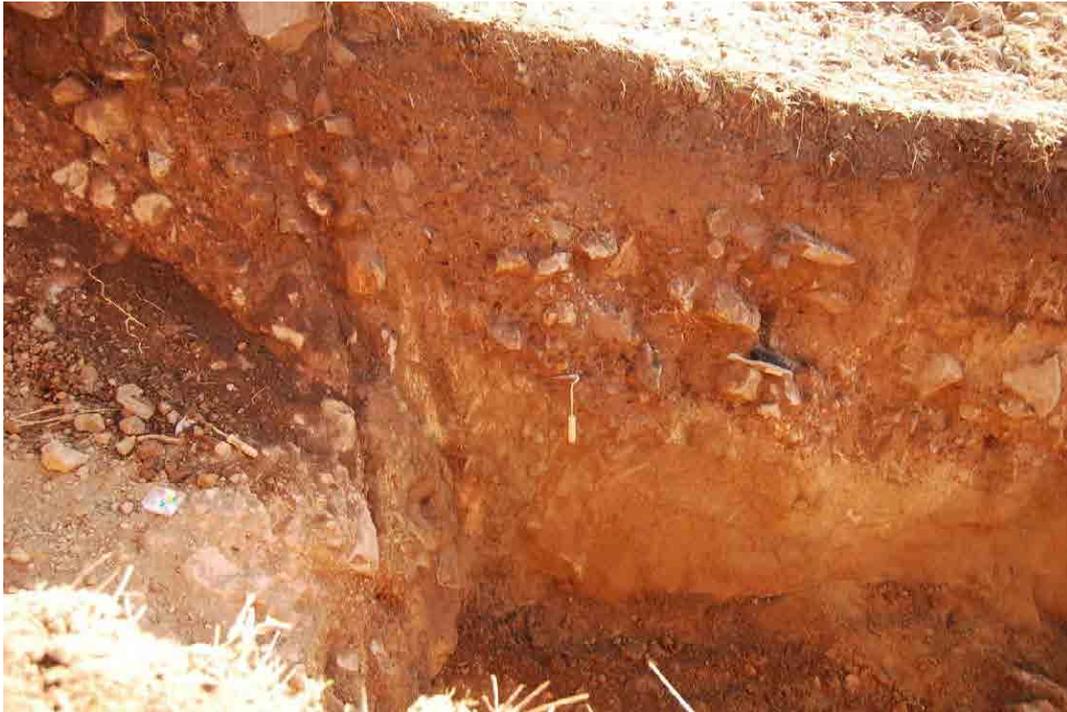
Figure 3.7-18 A fissure-filled deposit with V-shape and a colluvial wedge at North Garni site.

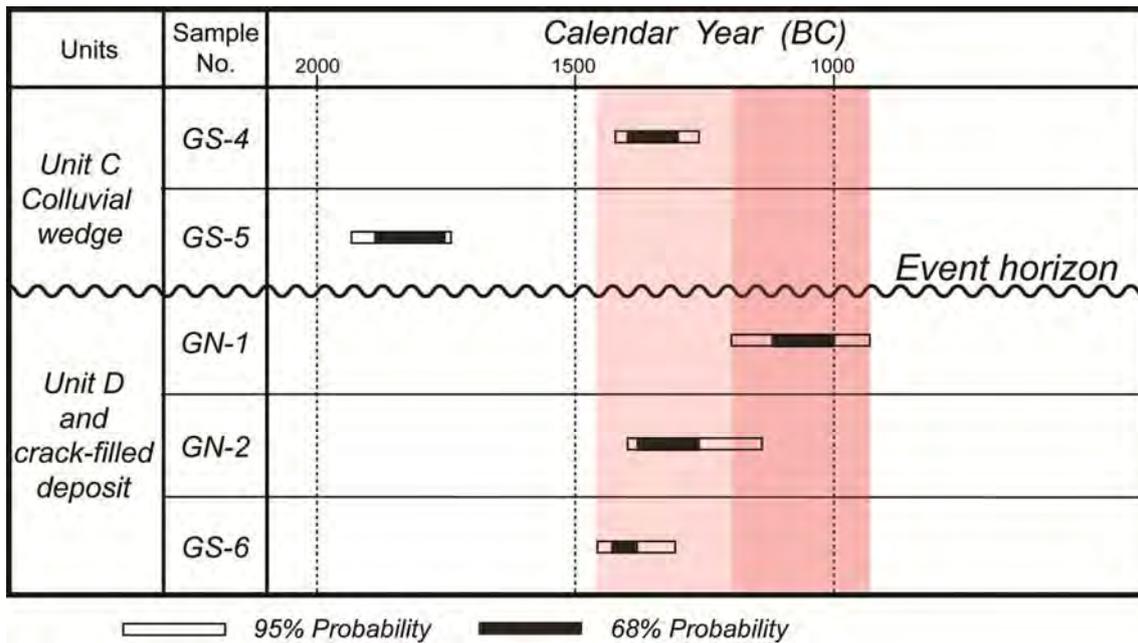
Figure 3.7-19 Time of seismic event identified in the trench of North Garni site. The seismic event occurred after the deposition of units D and E, and before the deposition of unit C. The crack on the fault scarp of the north wall was created just after the seismic event, and the existing top soil filled the crack. So the seismic event is inferred to have occurred just after the deposition of a crack-filled deposit.

One time seismic event is identified in the trench. Before the seismic event, units D and E covered unit F. By the faulting the east side was uplifted and the fault scarp was created. At the same time, fissures were formed on the base of the fault scarp and unit D was fallen down into the fissures. And the fault scarp was collapsed and the “colluvial wedge” (unit C) was deposited. Continuously the fault scarp was eroded, and units A and B covered unit C.

Judging from this sedimentary process, the seismic event has occurred after the deposition unit D and before the deposition of unit C. The crack on the north wall is filled by organic soils which are older top soil covering the surface just before earthquake. The crack-filled deposits represent the

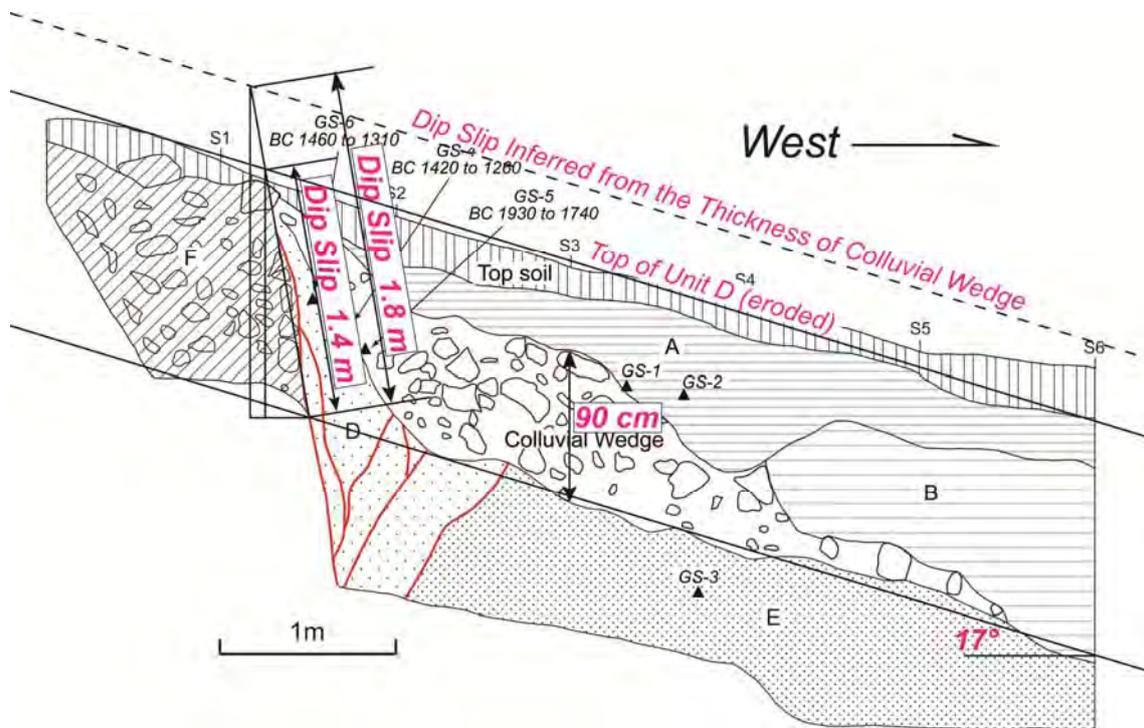
Figure 3.7-20 The amount of dip slip for a single seismic event inferred on the south wall of North Garni site. The top on the footwall is eroded. The displacement for a single seismic event is over 1.4 m. The colluvial wedge is formed by the collapse of the fault scarp. The height of the fault scarp is at least two times of the thickness of the colluvial wedge. The maximum thickness of the colluvial wedge is 90 cm, so the displacement is inferred to be ~1.8 m.

The amount of displacement for a single seismic event is shown in Figure 3.7-20. Because units D and E on the footwall are eroded, the displacement cannot be directly estimated. The amount of displacement is more than 1.4 m. The colluvial wedge is formed by the collapse of the fault scarp. The height of original fault scarp is suggested to be at least twice the thickness of the colluvial wedge (McCalpin edited, 1996). The maximum thickness of the colluvial wedge is 90 cm, so the amount of the displacement is ~1.8 m.

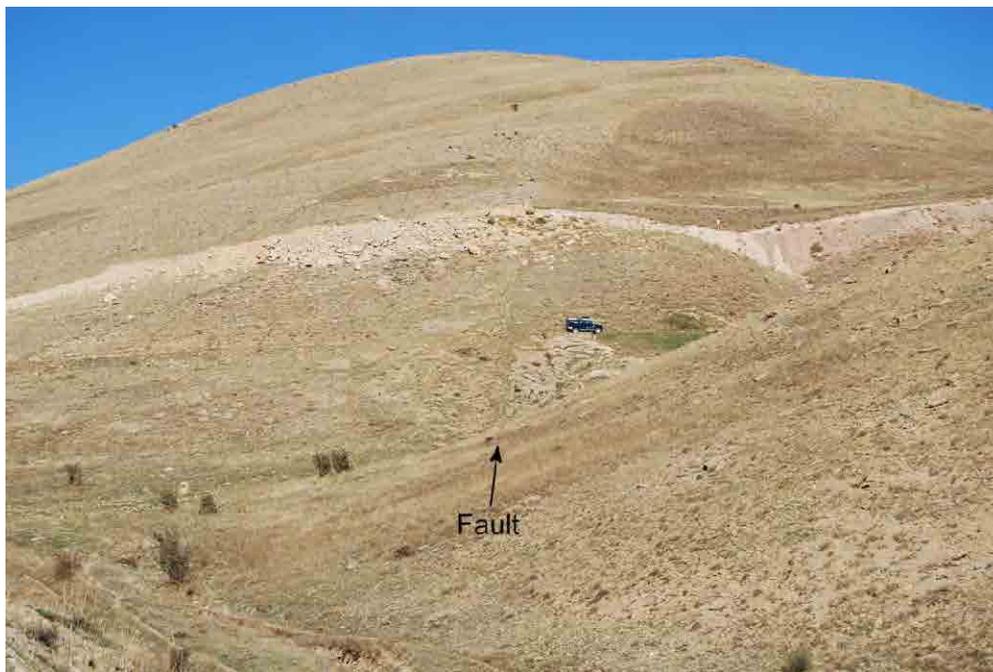
Figure 3.7-21 Active fault trace at Yelpin. View to the north.

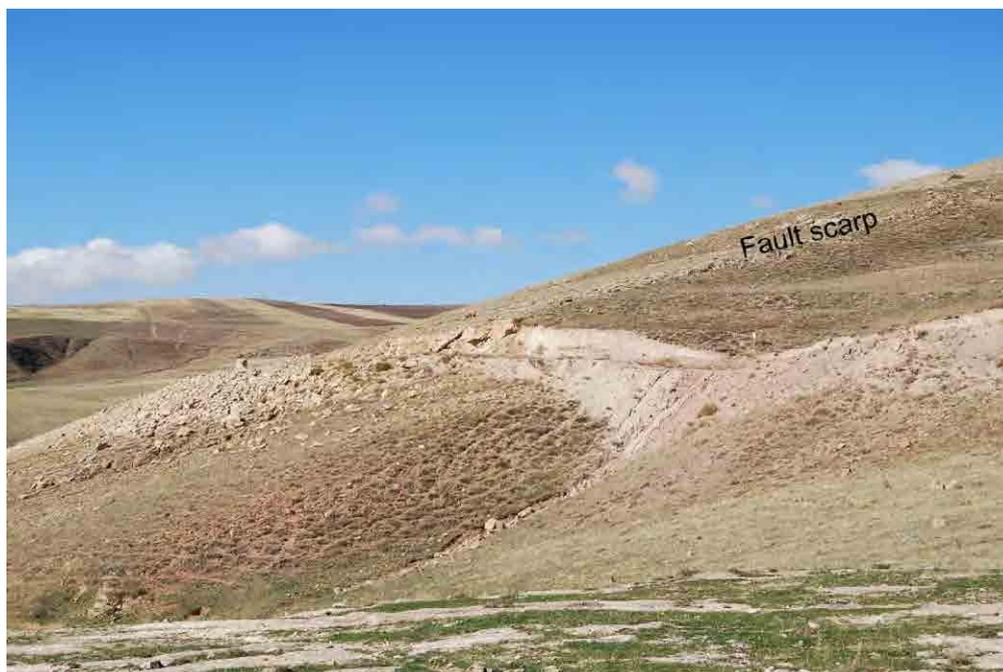
Figure 3.7-22 Low fault scarp at Yelpin. The fault exposure was found out on the road cutting. View to the west.

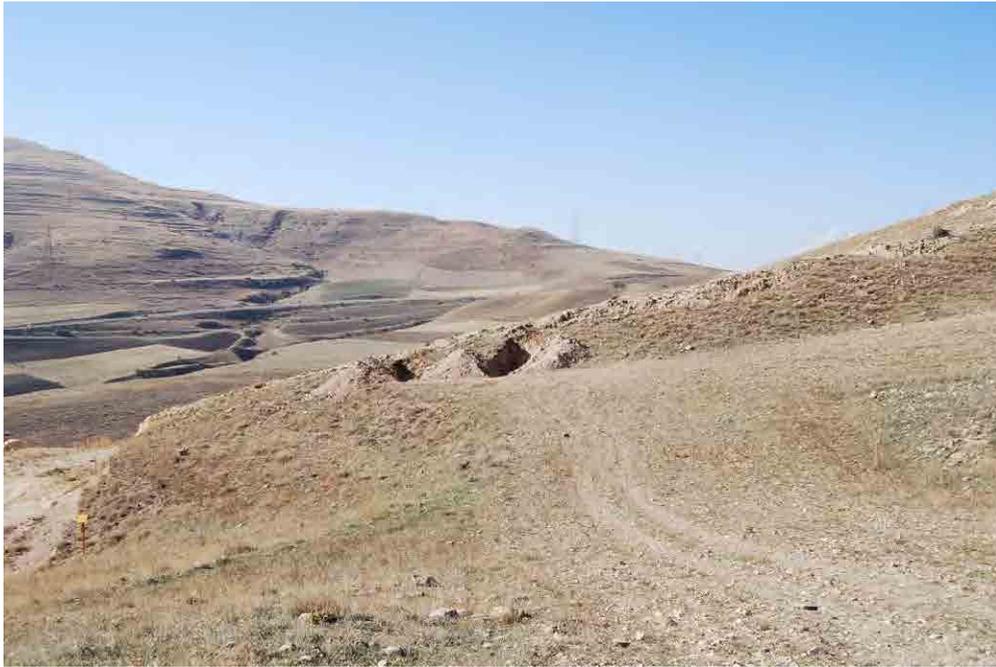
Figure 3.7-23 Two trenches were excavated across the low fault scarp.

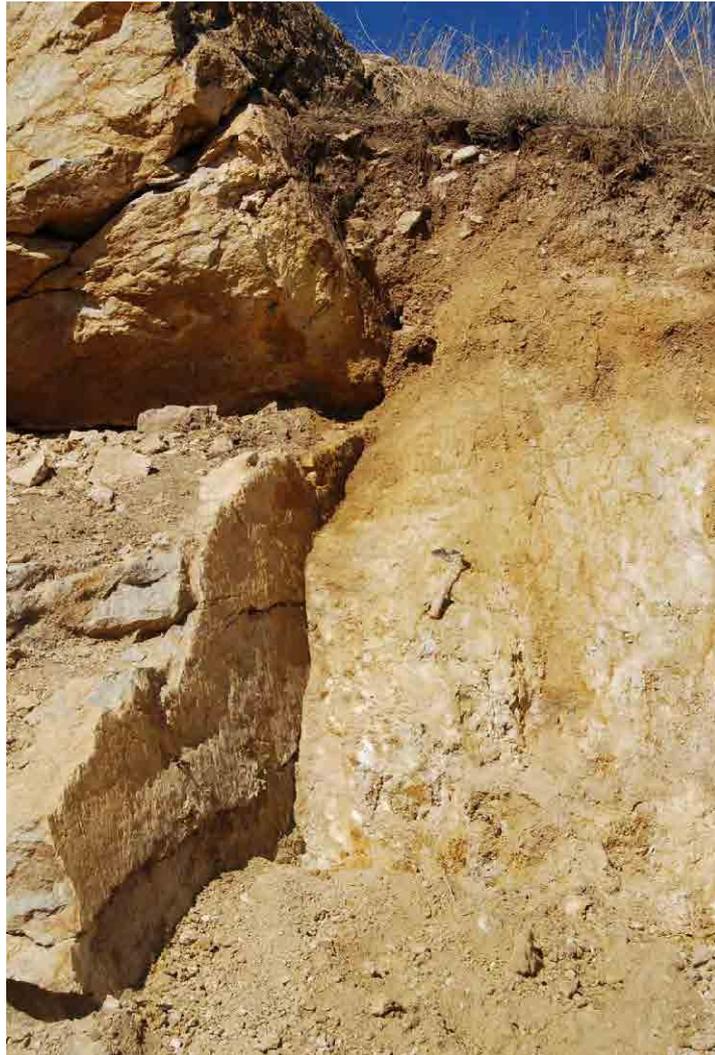
Figure 3.7-24 Photograph of fault exposure. The left side and right side are composed of the Paleogene Limestone and the Quaternary deposits respectively.

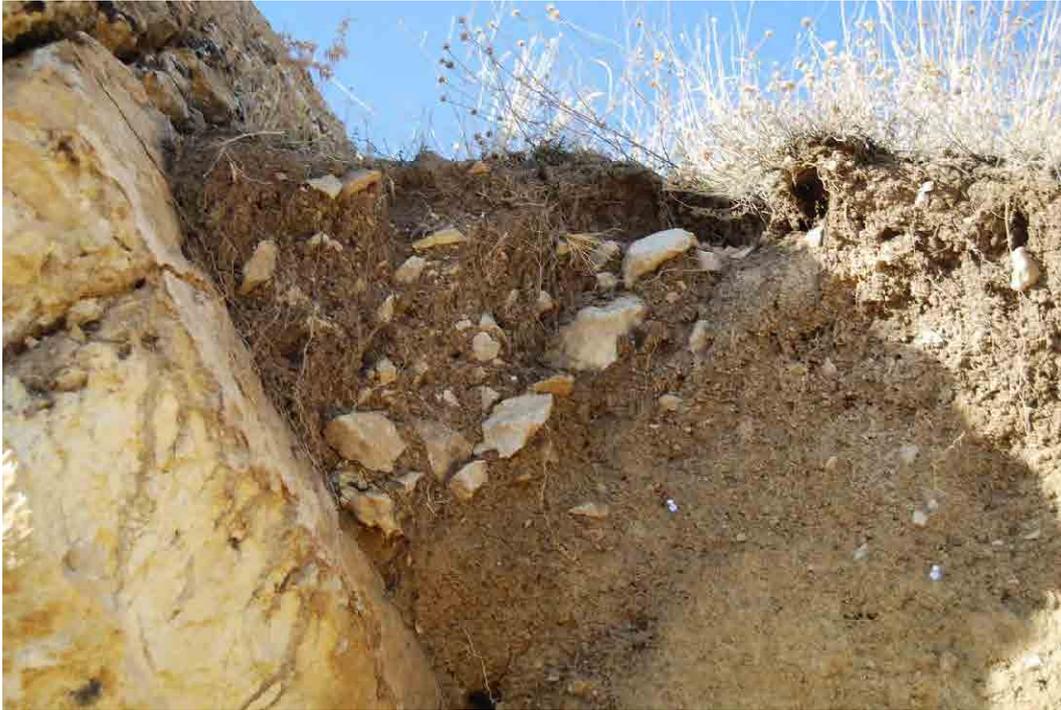
Figure 3.7-25 Fissure-filled deposits with V-shape on the top of road cutting. The deposits are composed of unconsolidated gravel with cobbles.

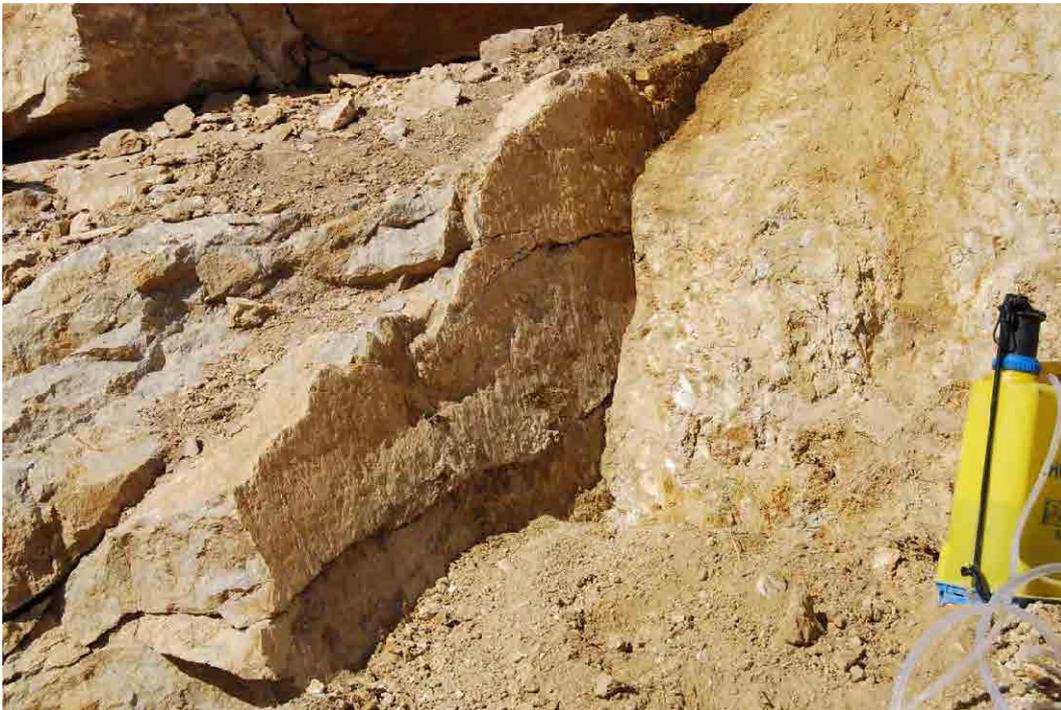
Figure 3.7-26 Vertical slickenside is recognized on the fault plane. This indicates a normal fault.

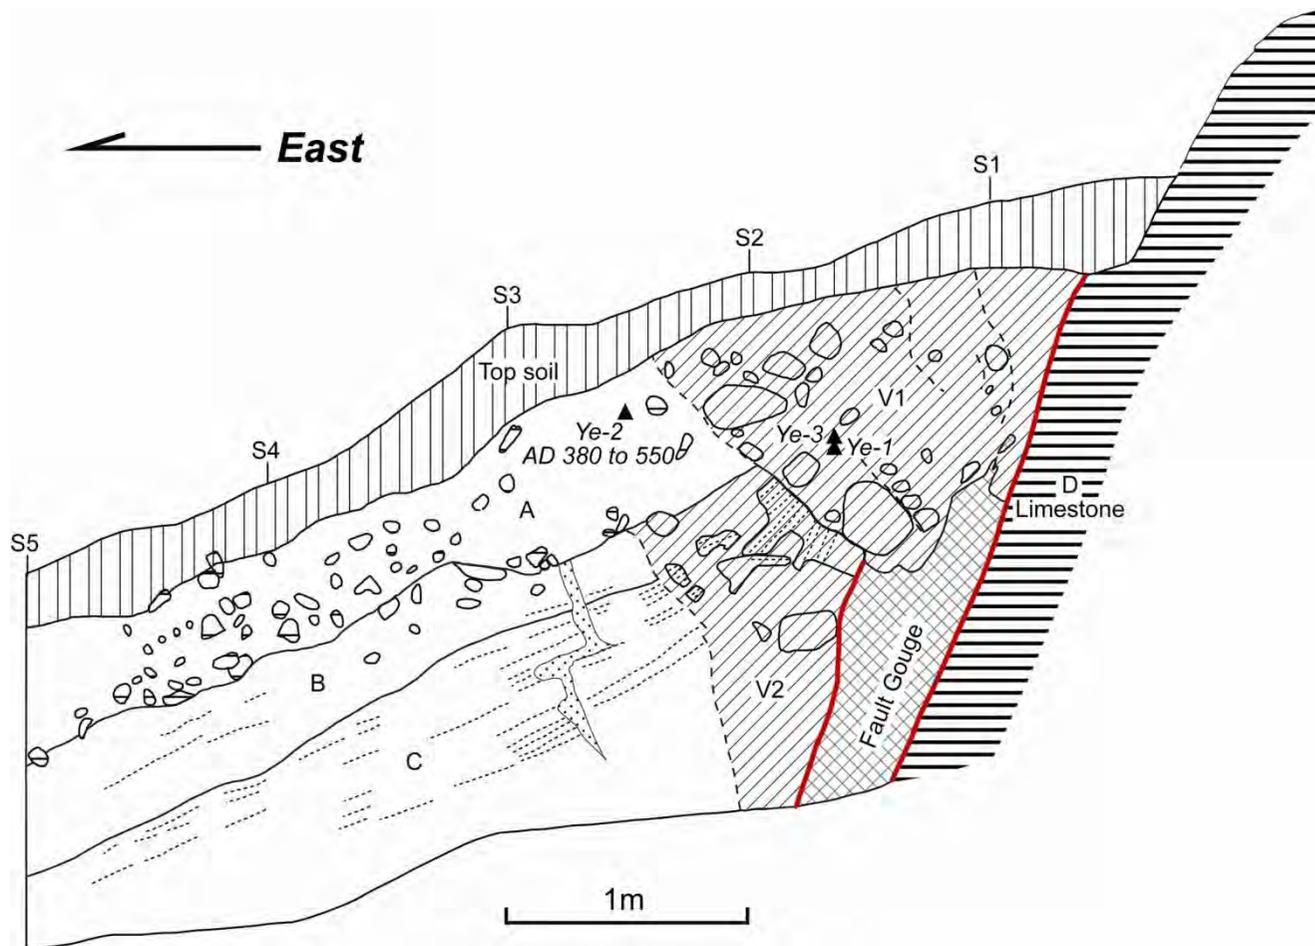
Figure 3.7-27 Log of south wall at Yelpin Y-3 site. Red lines represent active faults. Two V-shape depressions, V1 and V2, are recognized in the trench. Triangles represent the location of <sup>14</sup>C dating.

The height of fault scarp shown in the right top of Figure 3.7-27 is 50 cm to 1m. This represents the amount of displacement for a single seismic event.

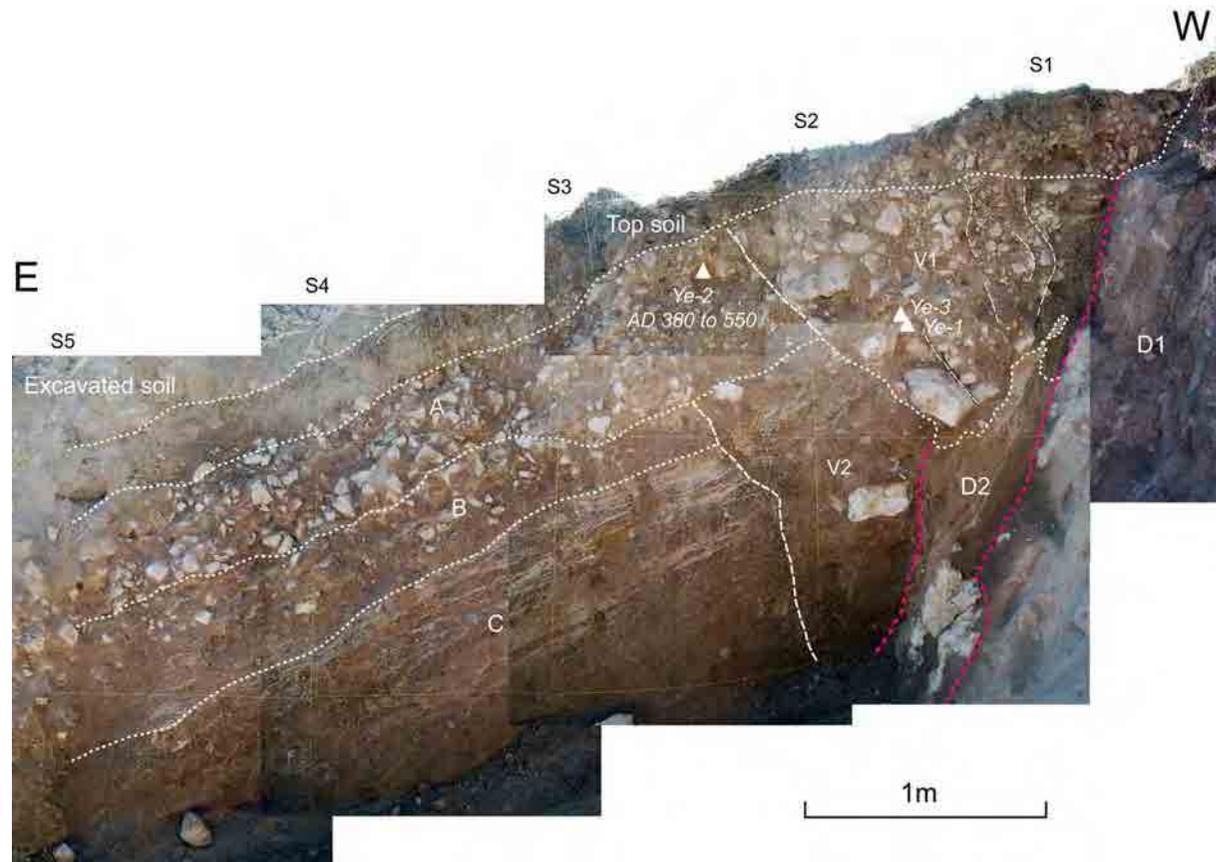
Figure 3.7-28 Mosaic photo of south wall at Yelgin Y-3 site. D1: Limestone, D2: fault gouge of Limestone.
