## Chapter 3 Ground Survey

### 3.1 Drilling, Laboratory Tests

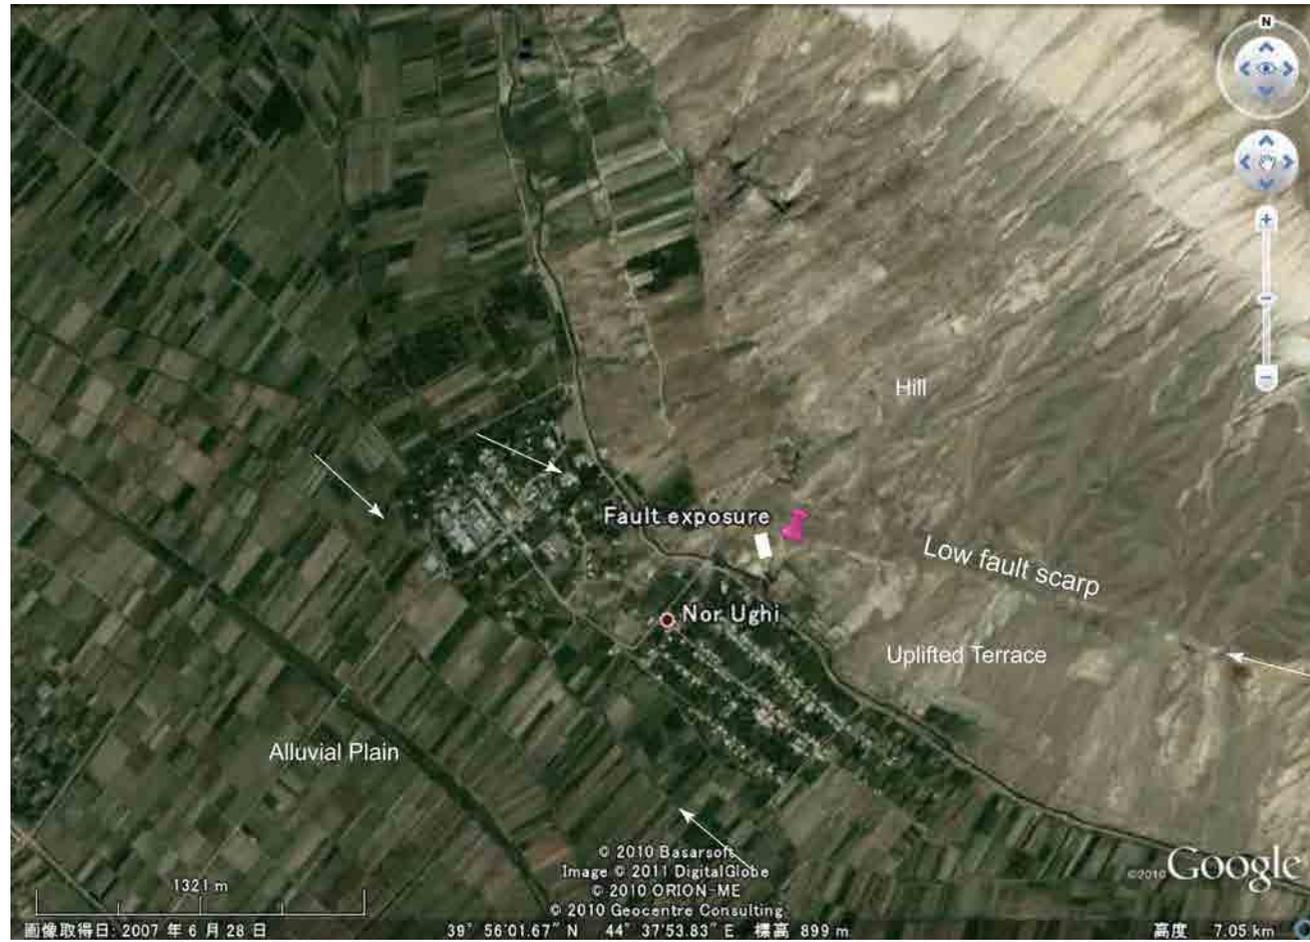
Figure 3.7-30 Fault exposure (pink pin) on the north of Nor Ughi Village and the location of a pilot trench (white rectangle). A straight low fault scarp is clear on the topographic boundary between the Hill and uplifted terrace. However, a major fault is inferred on the topographic boundary between the uplifted terrace and the Alluvial Plain, since the terrace around Nor Ughi Village is uplifted.

end, during the supplementary survey for Yerevan Fault on site, an outcrop of fault was found at Nor Ughi site (Figure 3.7-30). The pilot trench at Nor Ughi 1-1 point, west of the fault outcrop, confirmed a clear reverse fault (Figure 3.7-33 and Figure 3.7-34).

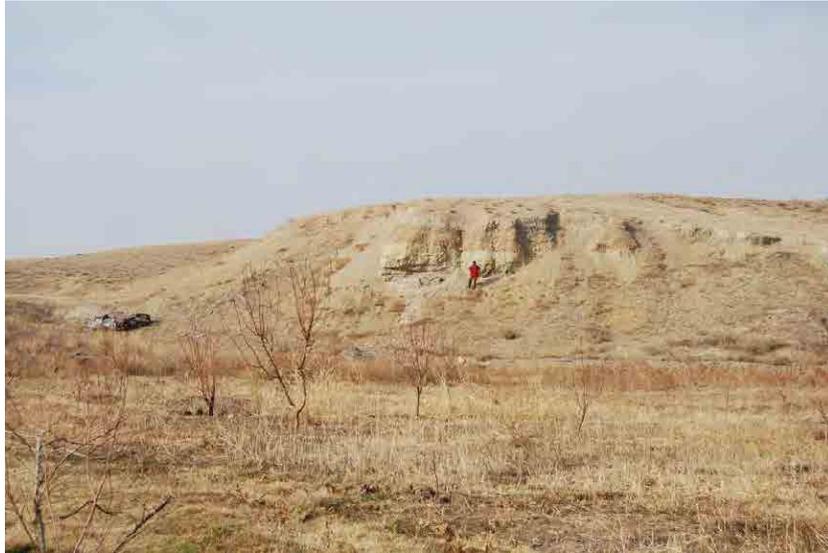
Figure 3.7-31 Fault exposure at the north of Nor Ughi Village where a person is standing. The fault overlies the Mesozoic sediments on the Quaternary deposits. The pilot trench was excavated at the left side of the exposure.

The location of the pilot trench at Nor Ughi site across Vedi Fault is shown in Figure 3.7-7 and Figure 3.7-8. Nor Ughi Village is situated near the northeastern margin of Ararat basin, 30 km southeast from Yerevan City. The Google Earth image around Nor Ughi Village is shown in Figure 3.7-30. The straight low scarp was found on the north of Nor Ughi Village. The geomorphology in this region is severely modified by agriculture. However, the low scarp that makes the topographic boundary between the hill and uplifted surface is clear. The low scarp was indicative of a fault scarp. So we carried out the field survey along the low scarp and found out the fault exposure (Figure 3.7-31 and Figure 3.7-32).

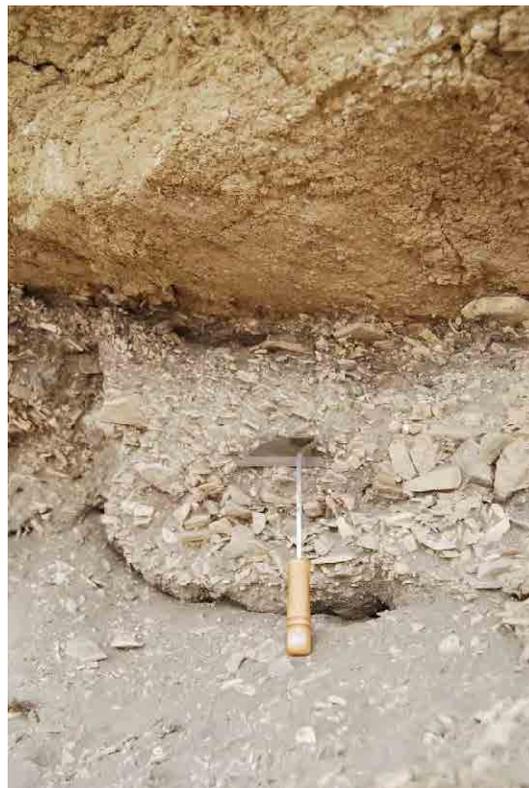
Figure 3.7-32 Photograph of the fault. The upper part and lower part are the Mesozoic sediments and the Quaternary deposits respectively. The Quaternary deposits are composed of unconsolidated gravel. The strike and dip of the fault is  $N62^{\circ}W$ ,  $17^{\circ}NE$  and the direction of slickenside is  $N20^{\circ}E$ .

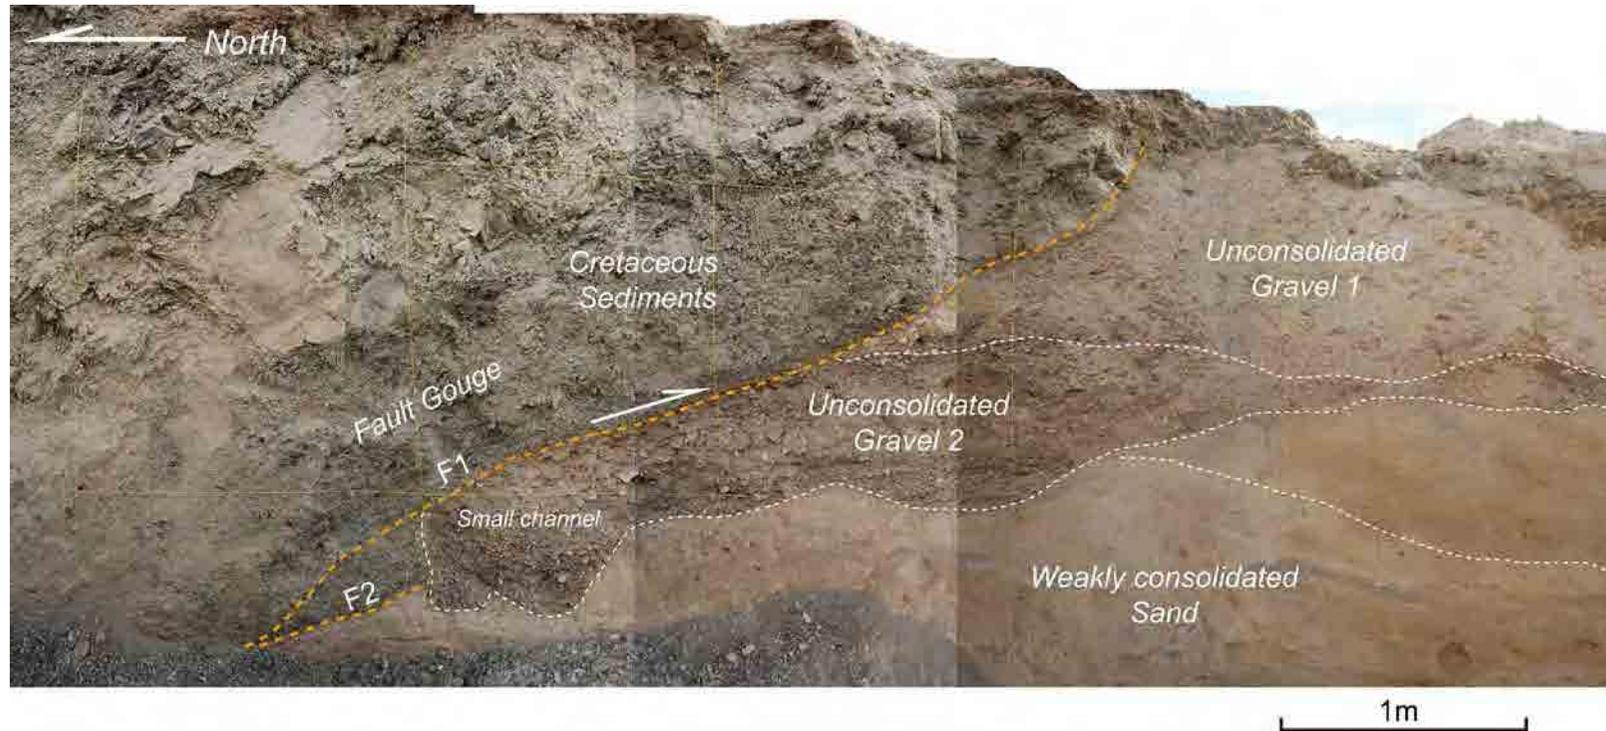
Figure 3.7-33 Mosaic photo of east wall at the pilot trench site of Nor Ughi. The Mesozoic sediments are overlain on the Quaternary deposits by a low-angle reverse fault. The Quaternary deposits are divided into weakly consolidated Sand, unconsolidated Gravel 2, and Gravel 1. Two fault strands F1 and F2 are recognized and twice seismic events are inferred. F2 fault strand displaces Sand and is covered Gravel 2. F1 fault strand displaces all layers.

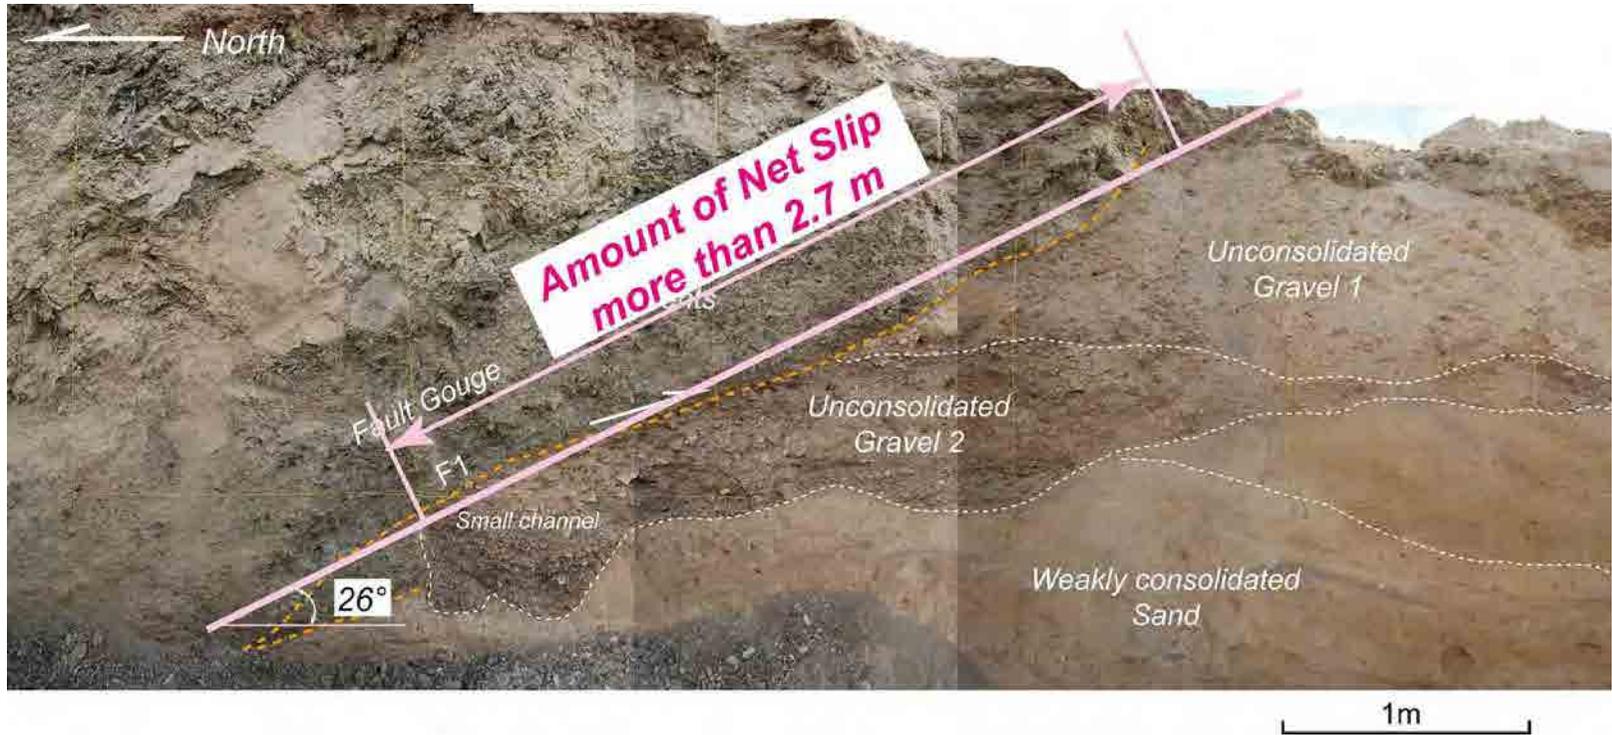
Figure 3.7-34 Amount of net slip along F1 fault. The top on the hanging wall is eroded. The amount of the net-slip is more than 2.7 m.

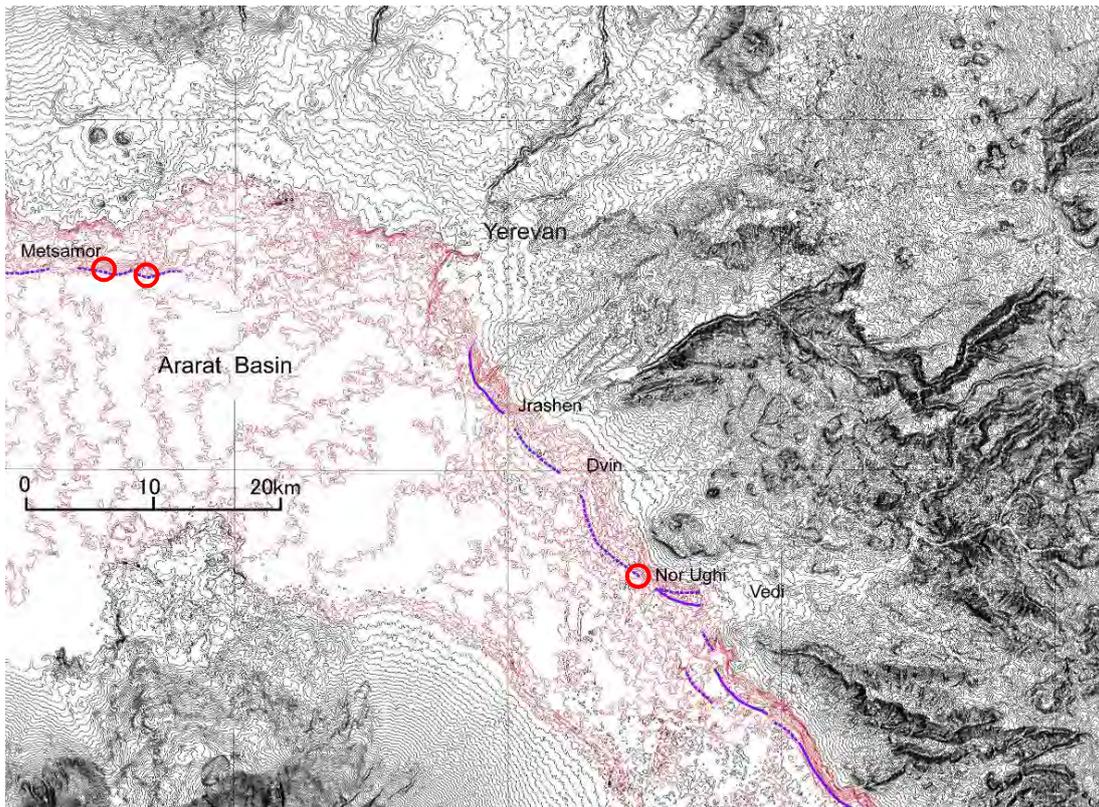
Figure 3.7-35 Estimated low scarp by satellite images along north edge to southeast edge of Ararat Basin (purple line) 3 trenches, 2 at Metsamor, 1 at Nor Ughi across Yerevan Fault were conducted (red circles).

As per the initial plan for the project, the trench survey at Yerevan Fault (see Figure 3.7-35) was judged difficult, because the fault would be a blind fault. For that reason, the trench survey, targeted mainly Garni Fault, was conducted at the two sites and then the fault evidences were found. However, at 2010

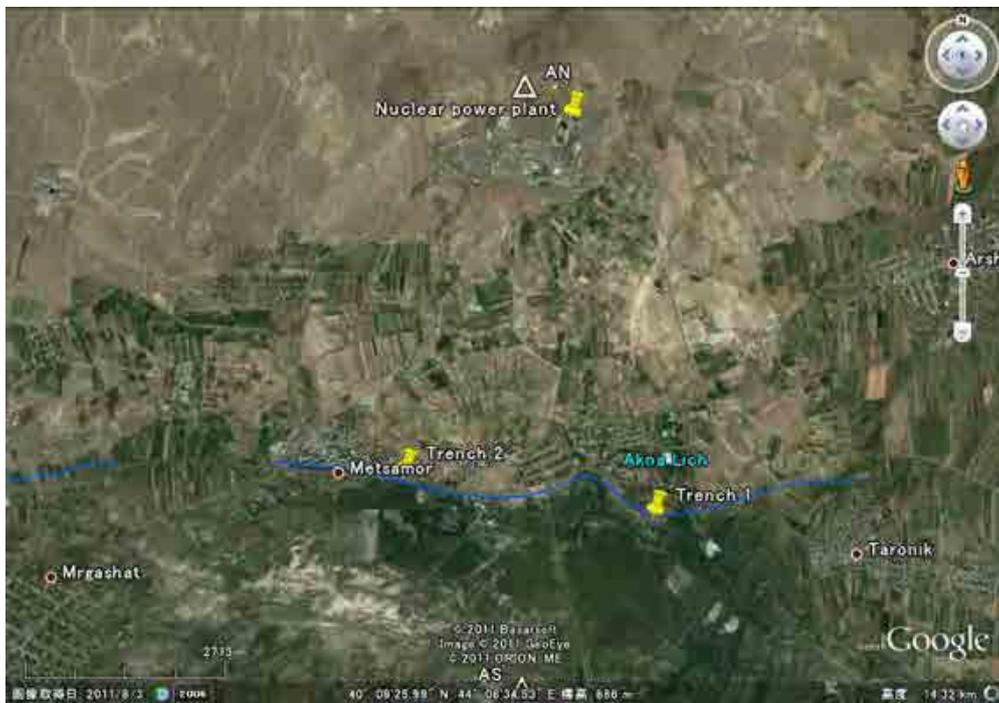
Figure 3.7-36 Trenches at Metsamor site. Blue line is estimated Yerevan Fault. Two trenches were conducted, but Yerevan Fault could not be identified.

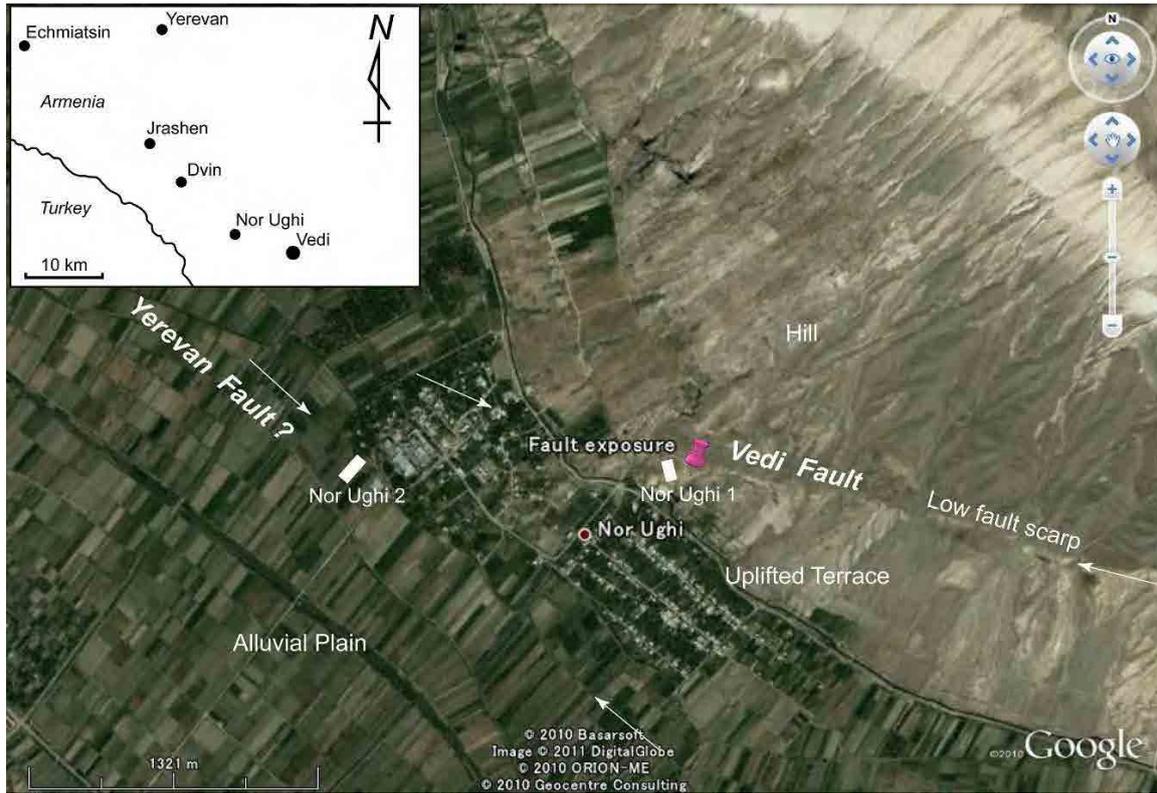
Figure 3.7-37 Location of trenches at Nor Ughi site. Two trenches at Nor Ughi 1 (Vedi Fault). And one trench at Nor Ughi 2 (Yerevan Fault) where Yerevan Fault could not be identified.

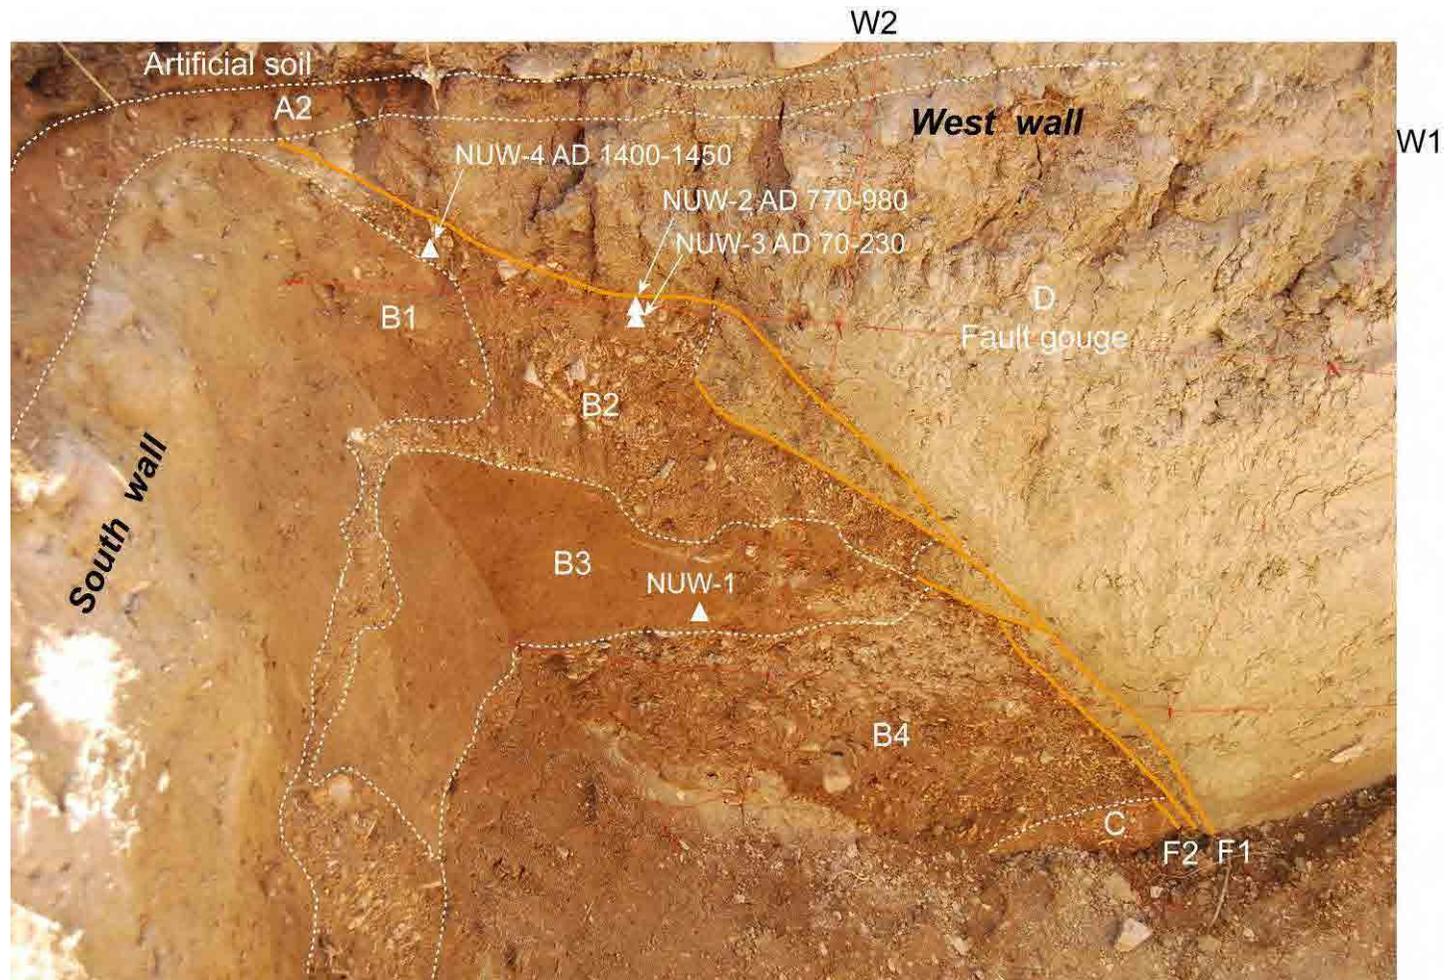
Figure 3.7-39 A photo of west wall at trench of Nor Ughi 1-2 point. A Tertiary layer overlies unconsolidated gravel layers of B1 to B4 and C. F1 fault moved after AD 70-980 (NUW-2) or after AD1400-1450 (NUW-4).

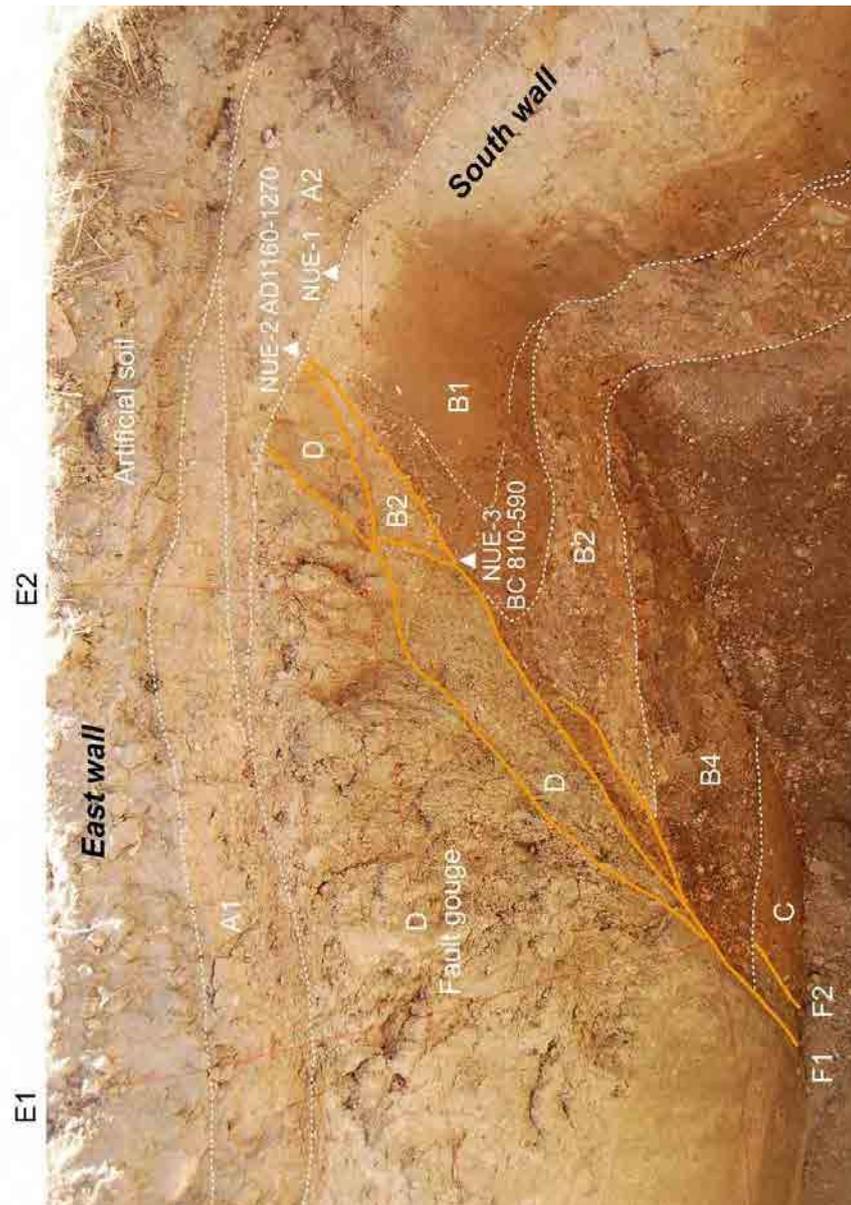
Figure 3.7-40 A photo of east wall at the trench of Nor Ughi 1-2 point. The fault F1, covered by layers of A1 and A2, is estimated to move between BC 810-590 and AD 1160-1270.
