Chapter 4 Seismic Hazard Assessment

4.1 Modeling of Ground Conditions

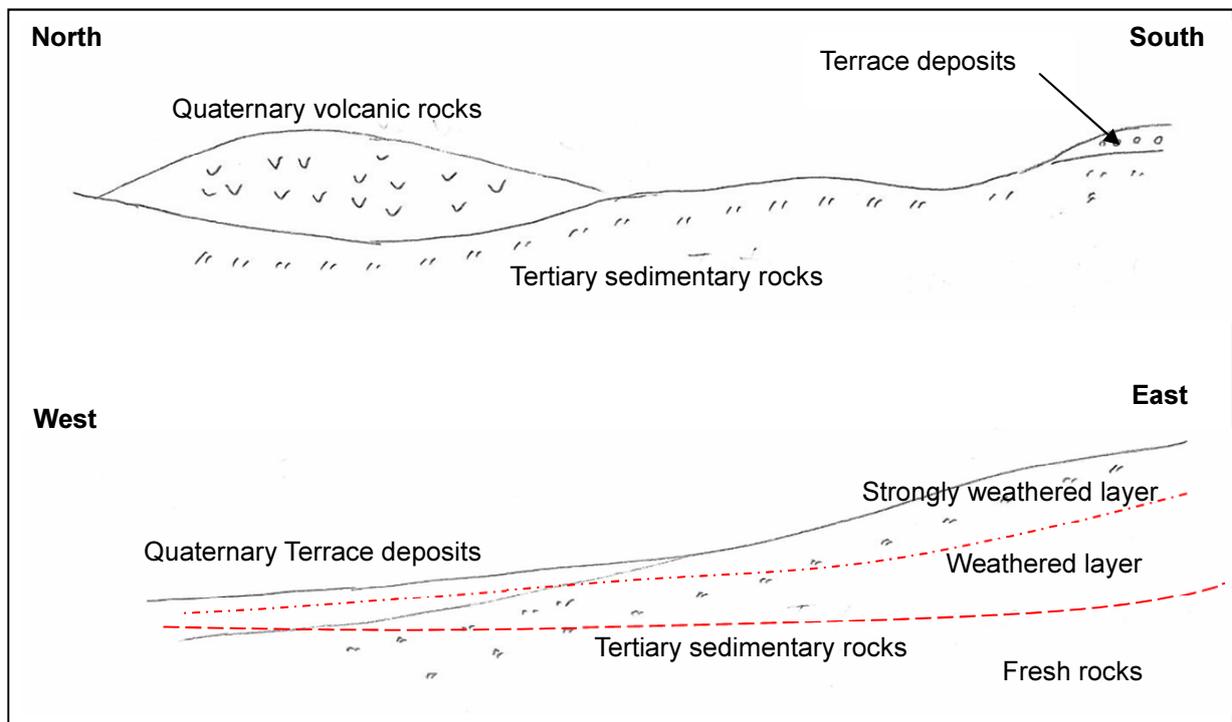
The shallow ground of Yerevan city is composed by volcanic rocks, sedimentary rocks and terrace deposits. The surface layer is composed by cracked volcanic rock (basalt) in north area, by weathered sedimentary rock in south east area and by terrace deposits in south and west area. The properties of rocks are deeply influenced by the weathered condition. The schematic geological cross sections in Yerevan city are shown in Figure 4.1-1.

Figure 4.1-1 Schematic geological cross section in Yerevan city

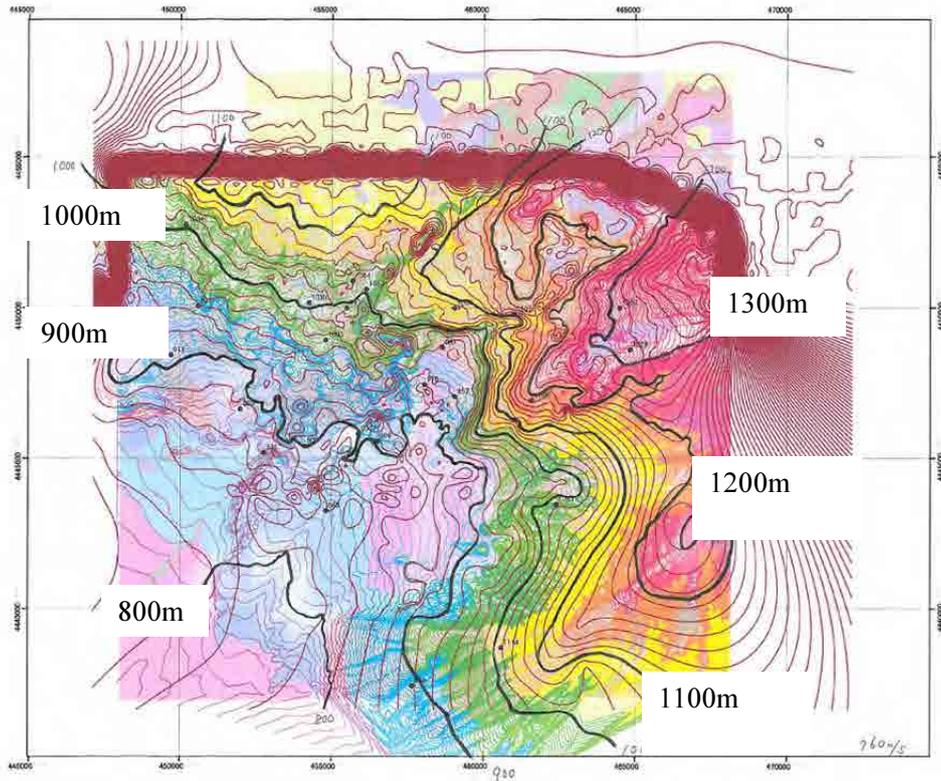
Figure 4.1-3 Altitude of the upper end of Vs~760m/sec layer

The ground model for hazard assessment is created for each 250m x 250m square grid based on Figure 4.1-3 to Figure 4.1-5 and Table 4.1-4. The type of the ground of each 250m grid is shown in Figure 4.1-11.

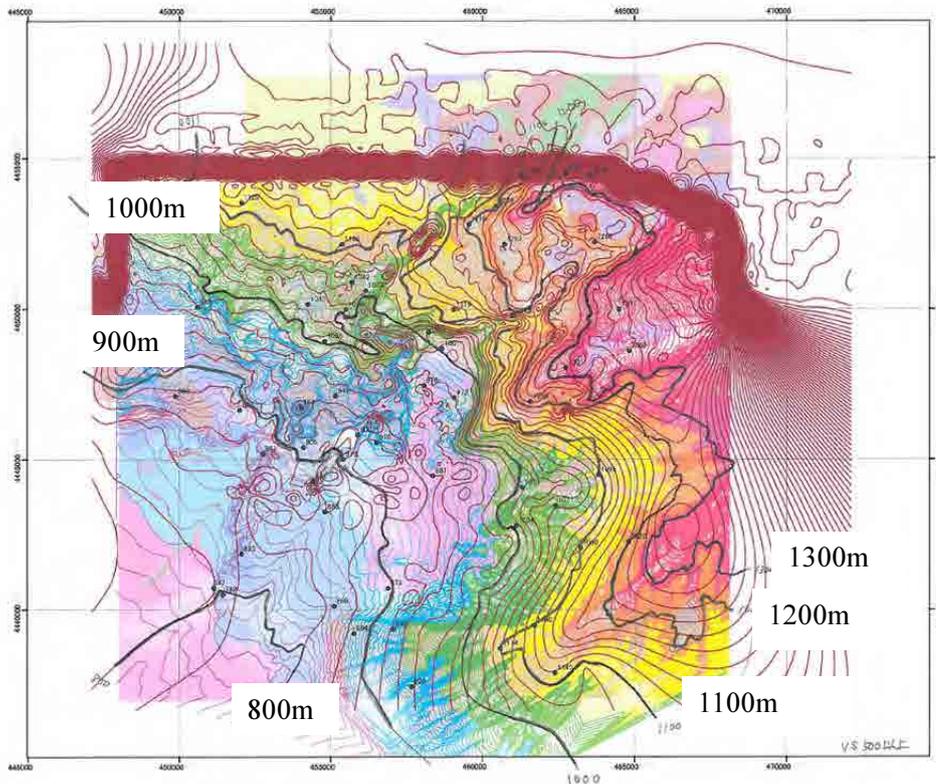
Figure 4.1-4 Altitude of the upper end of Vs~500m/sec layer

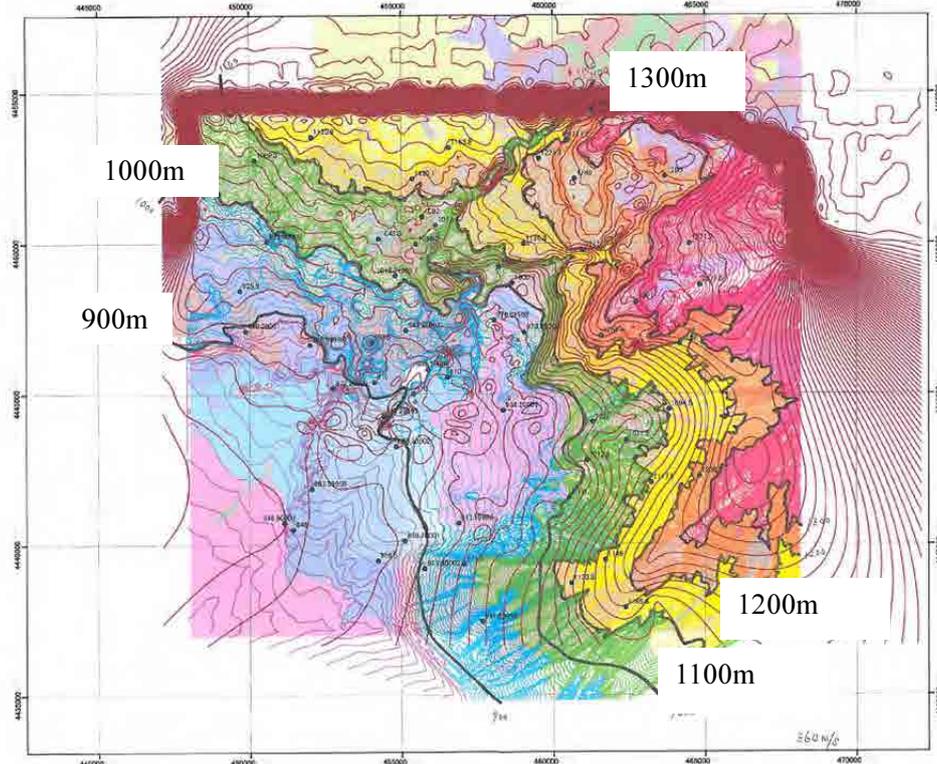
Figure 4.1-5 Altitude of the upper end of Vs=360m/sec layer

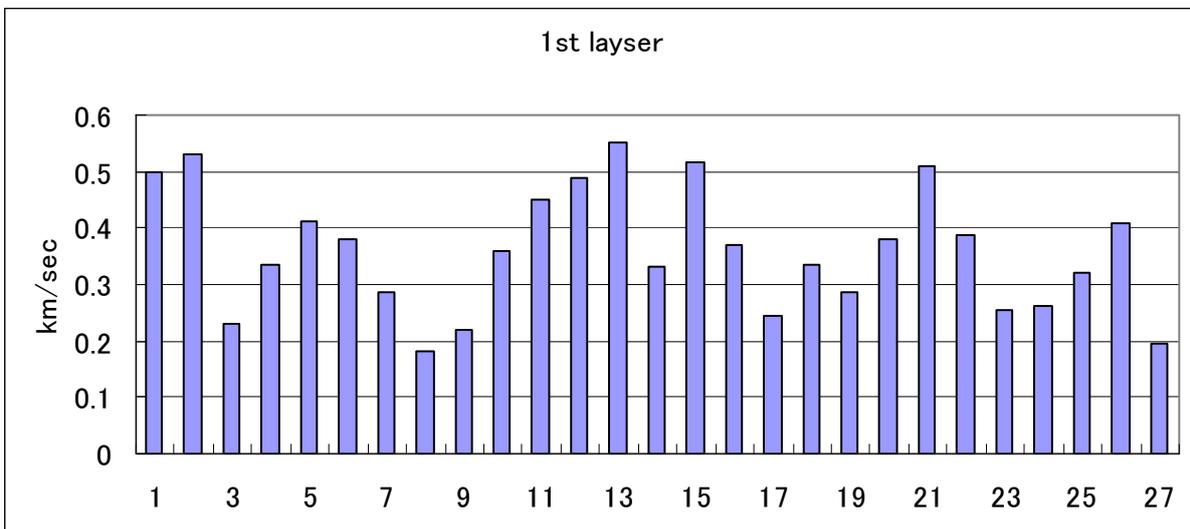
Figure 4.1-6 V_s of first layer of Type 1**(2) Type 2**

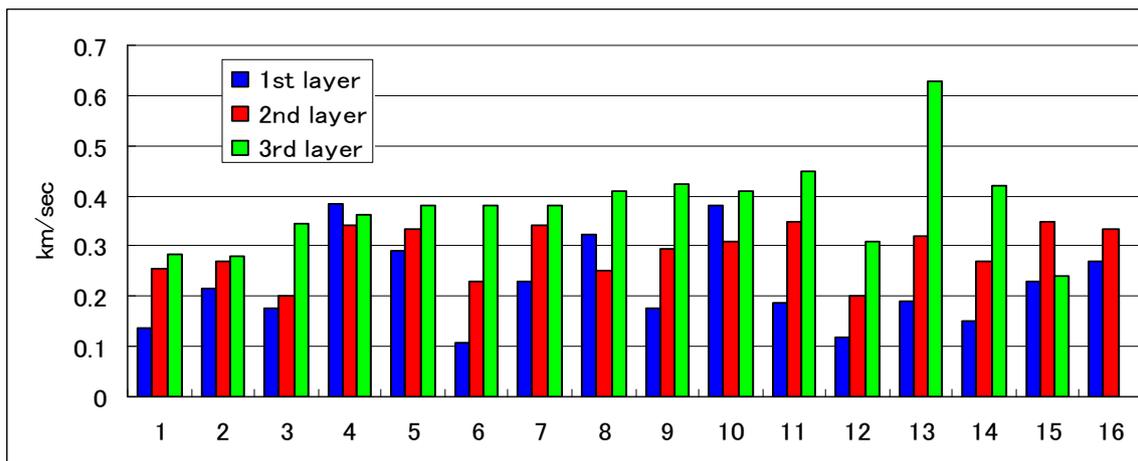
Figure 4.1-7 Vs of first, second and third layers of Type 2

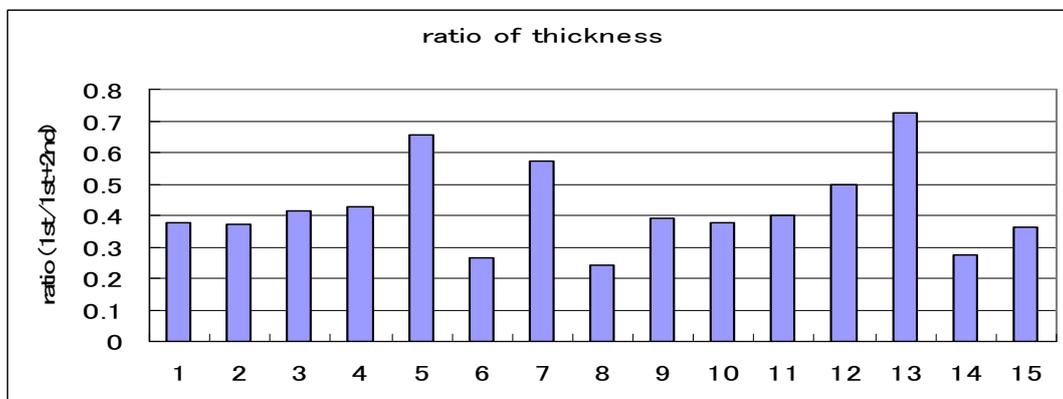
Figure 4.1-8 Ratio of the thickness of first layer to first + second layer (Type 2),
No16 is not used because third layer is not detected

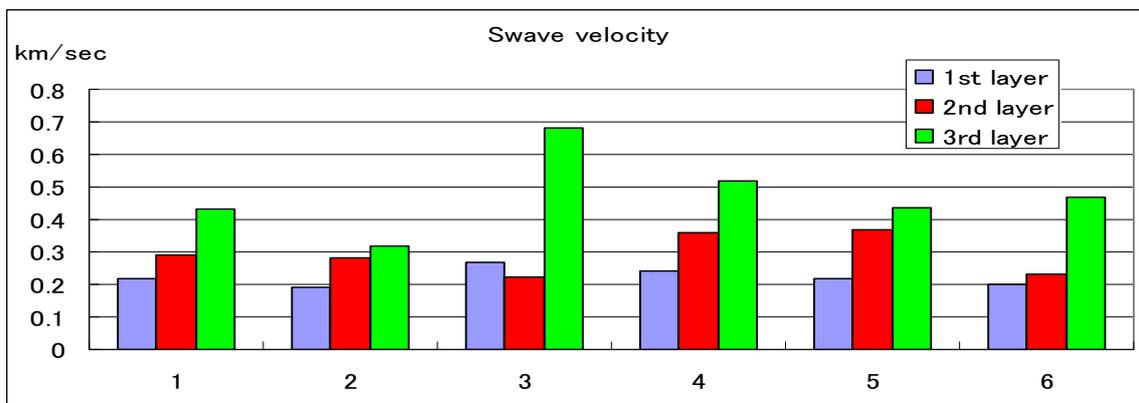
Figure 4.1-9 Vs of first, second and third layers of Type 3

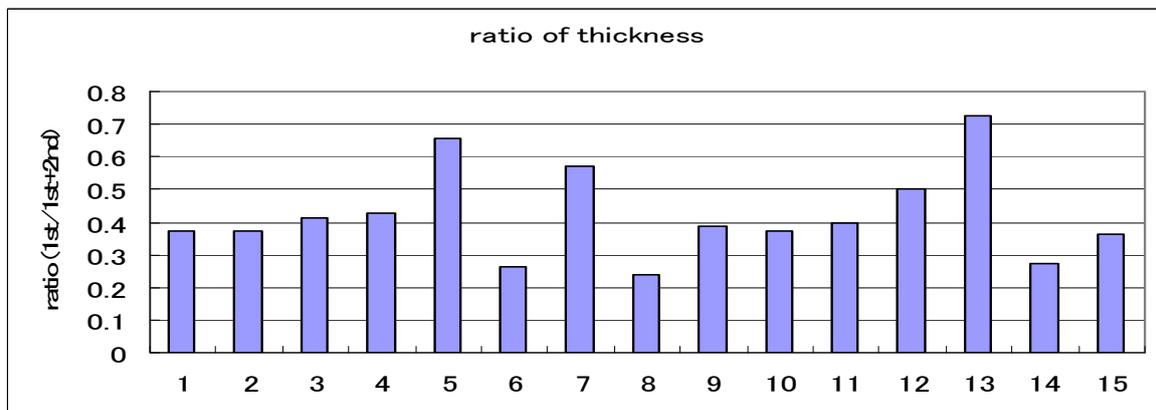
Figure 4.1-10 Ratio of the thickness of first layer to first + second layer (Type 3)

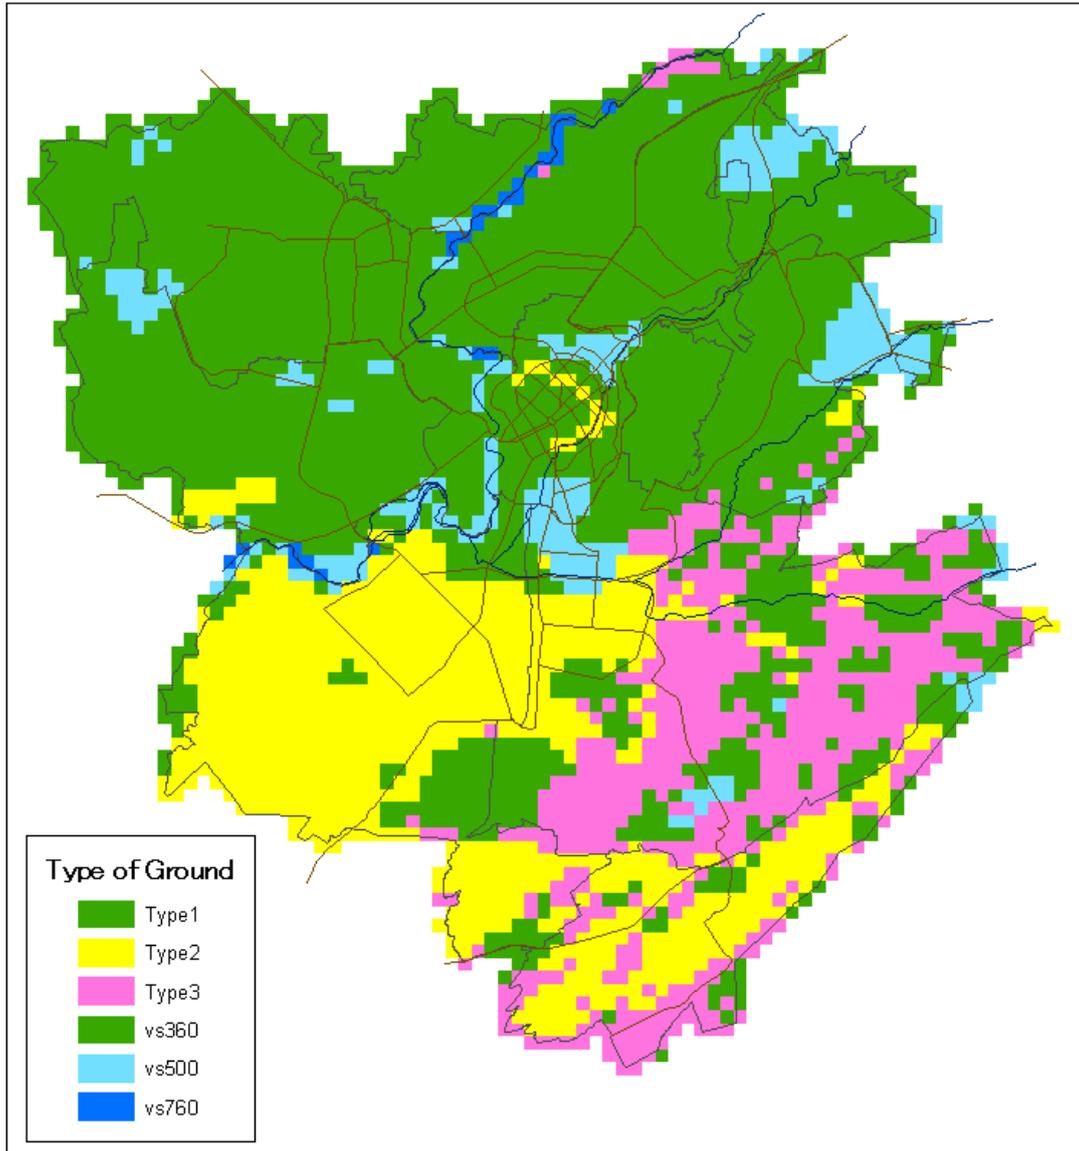
Figure 4.1-11 Type of ground; Vs360, Vs500, Vs760 means outcrop of corresponding rock layer

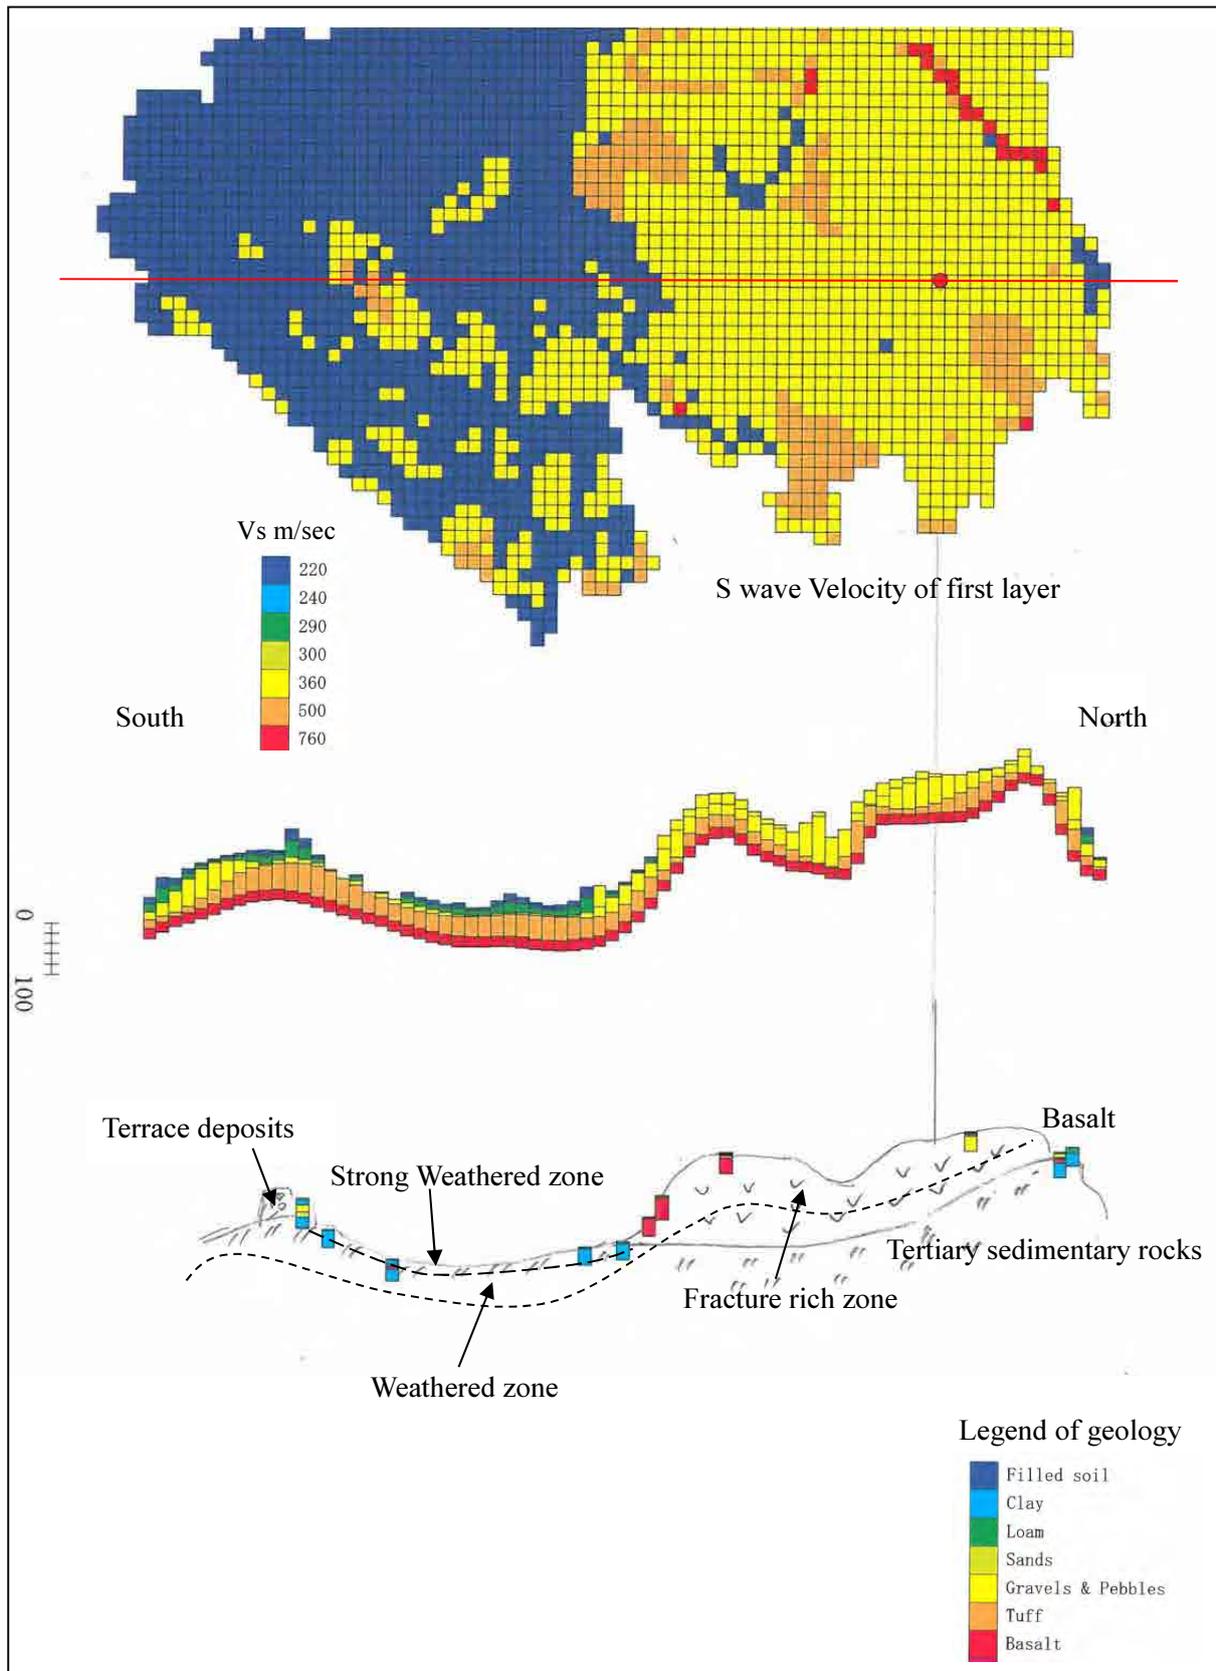
Figure 4.1-12 Comparison of S wave velocity section with the geology section
- N-S direction -

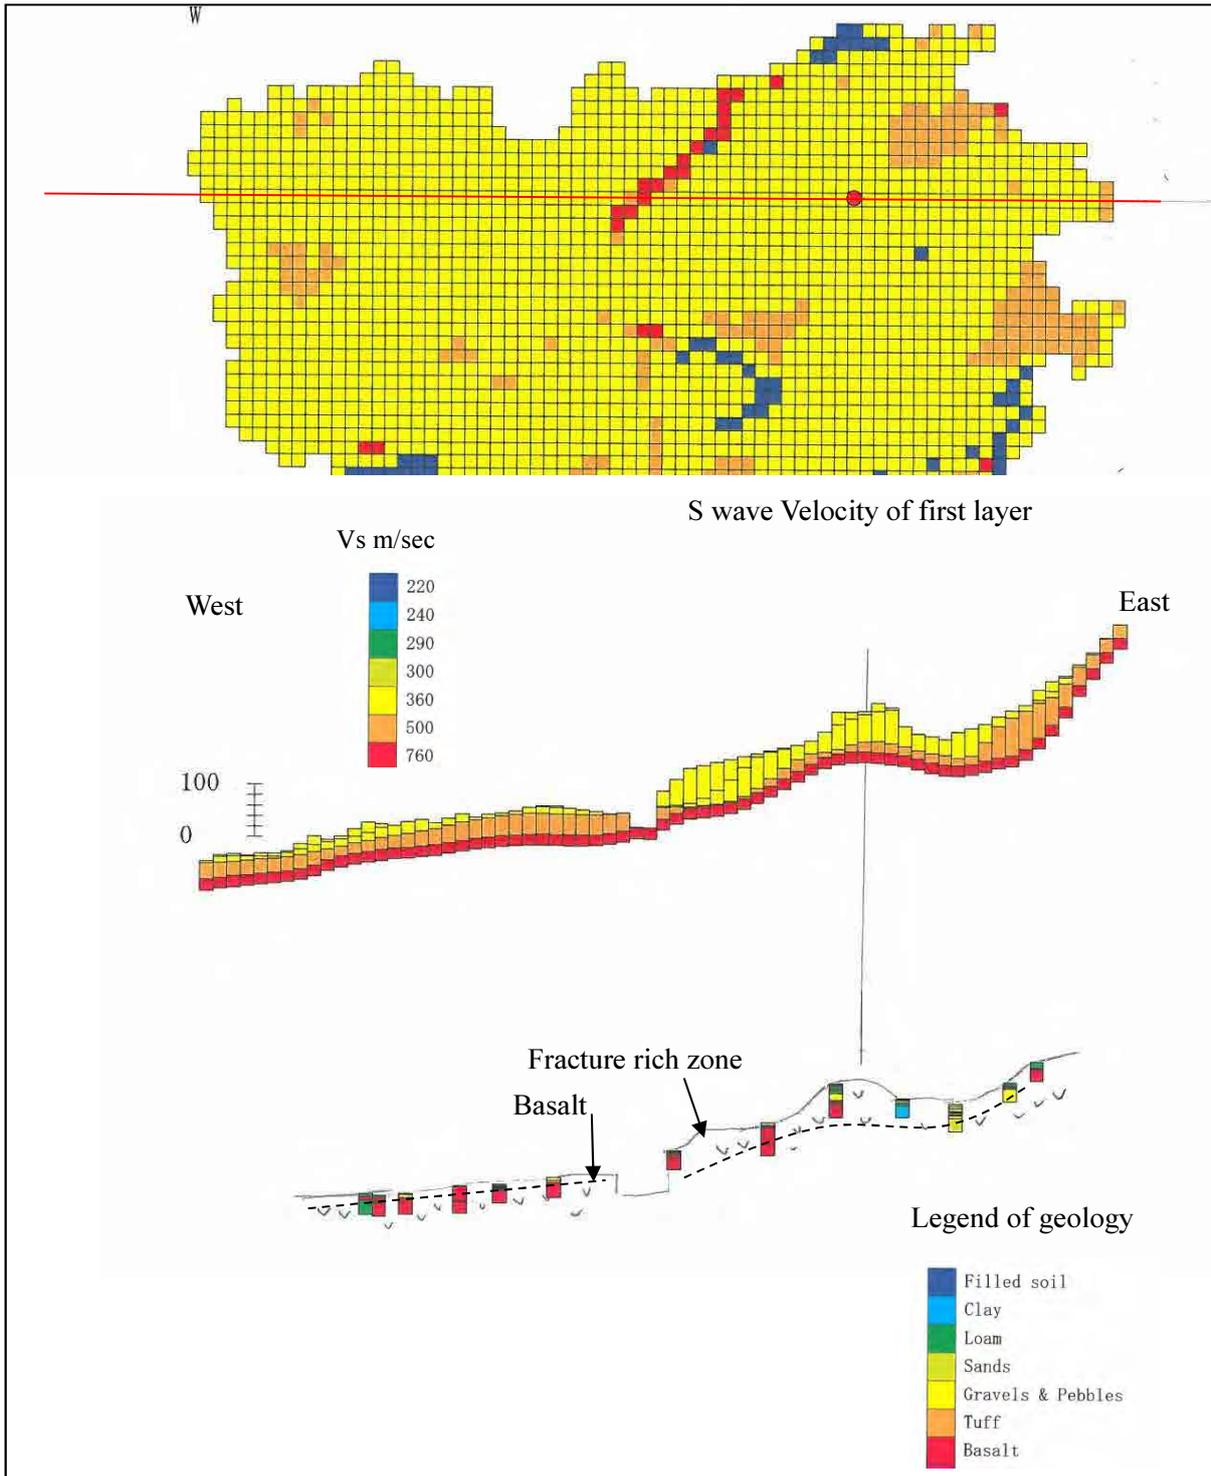
Figure 4.1-13 Comparison of S wave velocity section with the geology section
 - E-W direction in the north of Yerevan -

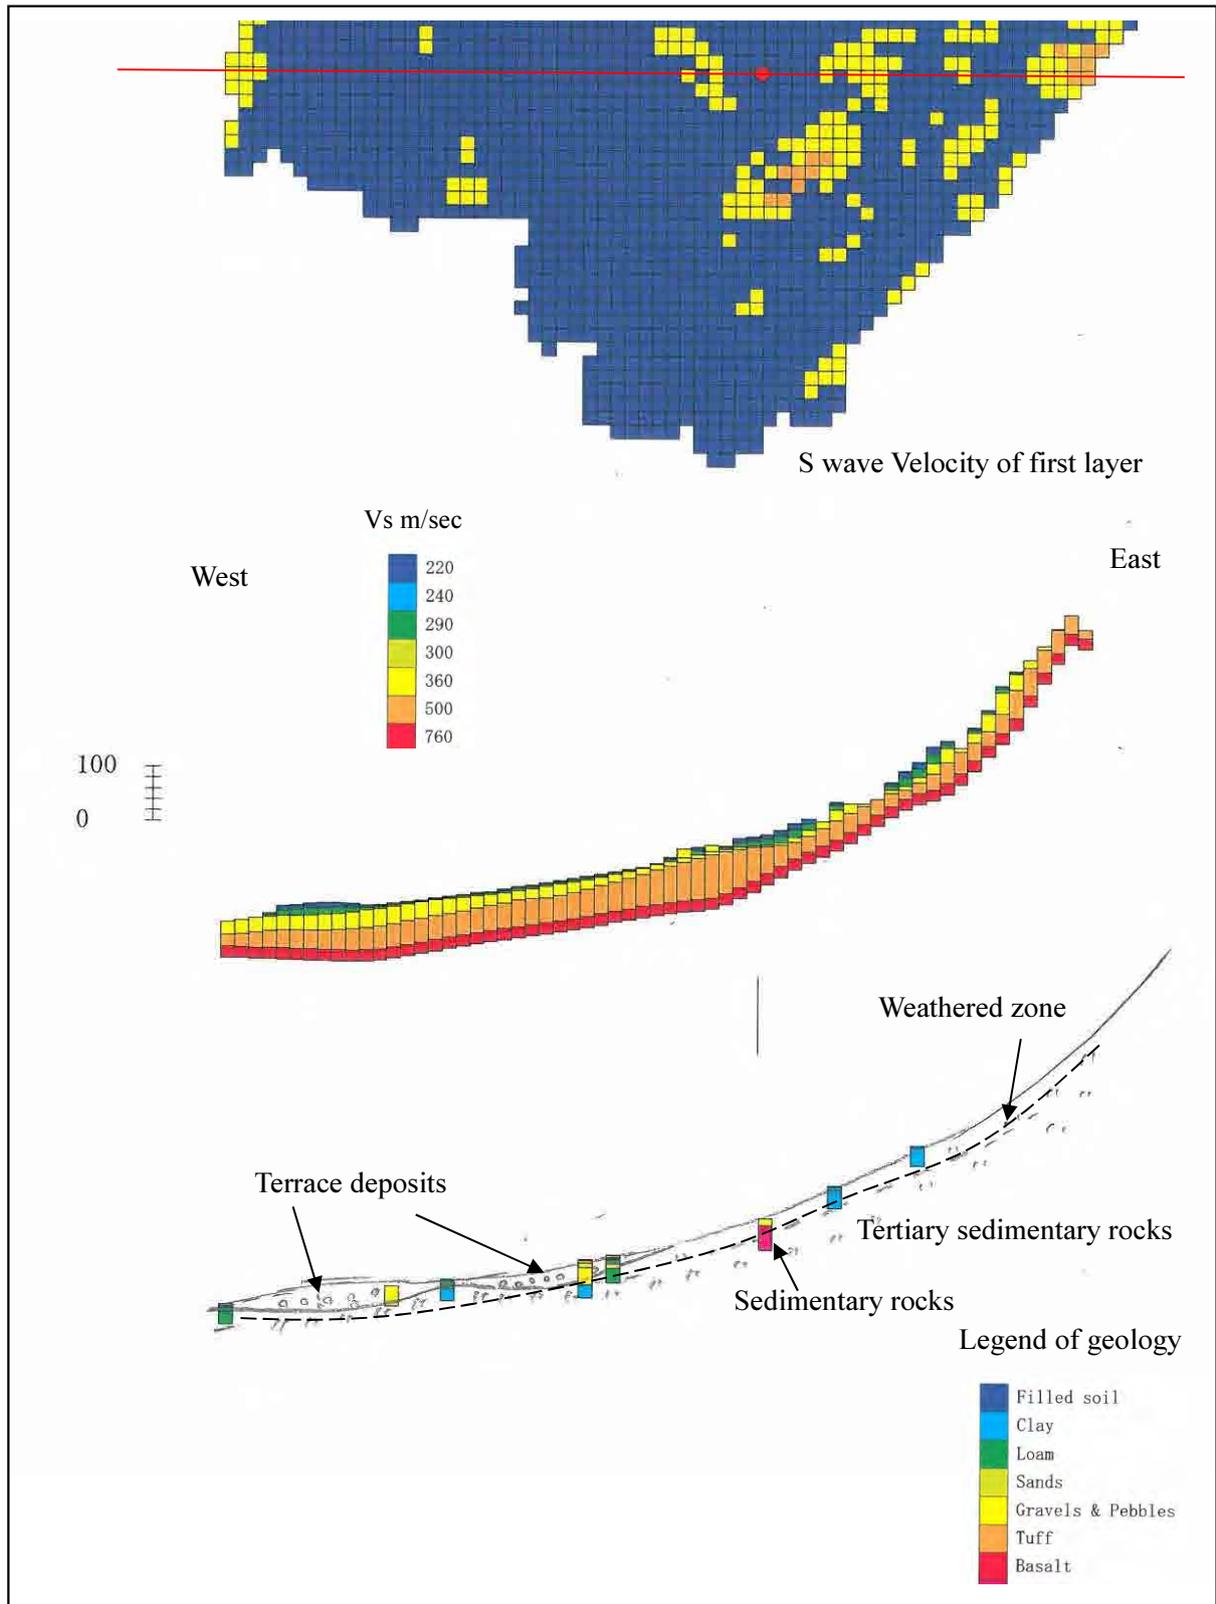
Figure 4.1-14 Comparison of S wave velocity section with the geology section
- E-W direction in the south of Yerevan -

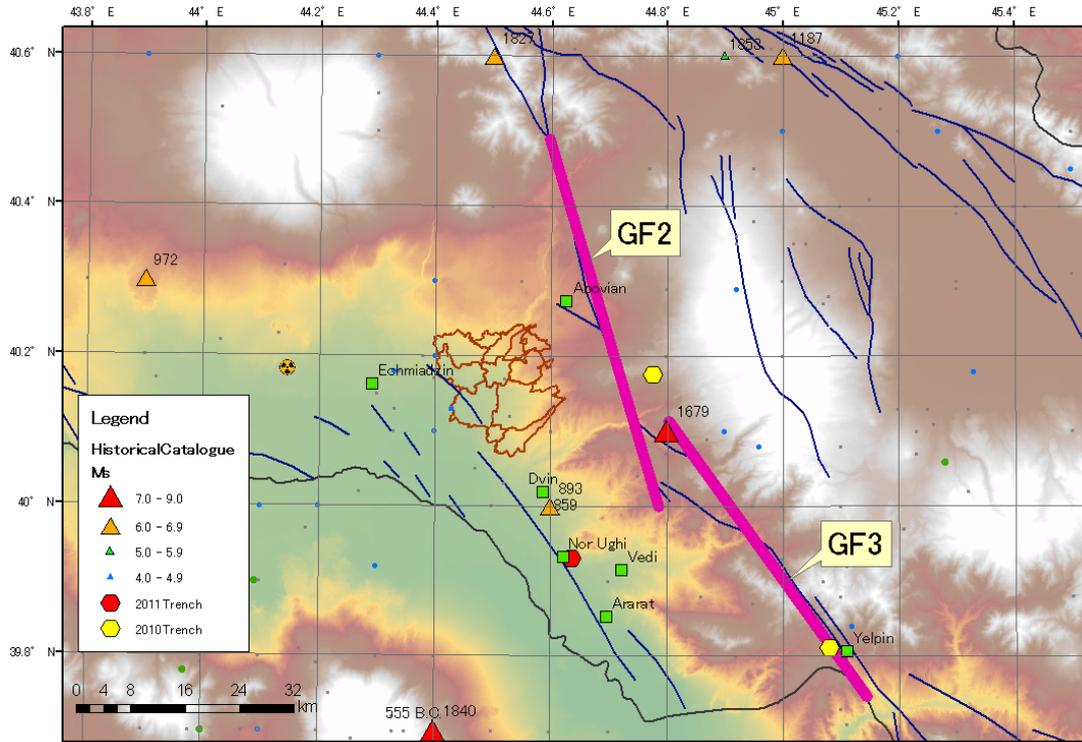
- Segment 2 of Garni Fault (GF2 in Figure 4.2-1)
- Segment 3 of Garni Fault (GF3 in Figure 4.2-1)

Figure 4.2-1 Fault Models of Scenario Earthquakes

The lines in Figure 4.2-1 are supposed rupture area of the scenario earthquakes. The segment 2 in the existing reports about Garni Fault by GEORISK extends to north over the northern end of GF2 in this study; however an earthquake with magnitude 7 occurred in 1827 at the northern end in segment 2 and this area is supposed to have ruptured already and released energy by this earthquake. Therefore, the northern end of GF2 is set to the point of divergence of Garni Fault just south of 1827 earthquake epicenter. The location of GF3 is set following existing information.

The dip of the GF2 and GF3 segment of Garni Fault is supposed steep because their mechanism is normal fault. Actually, the fault found at the trench site of Garni north and Yelpin showed large dip angle. The dip angle of the scenario fault model of Garni Fault is set to 90 degree because the dip direction shows east or west dipping site by site.

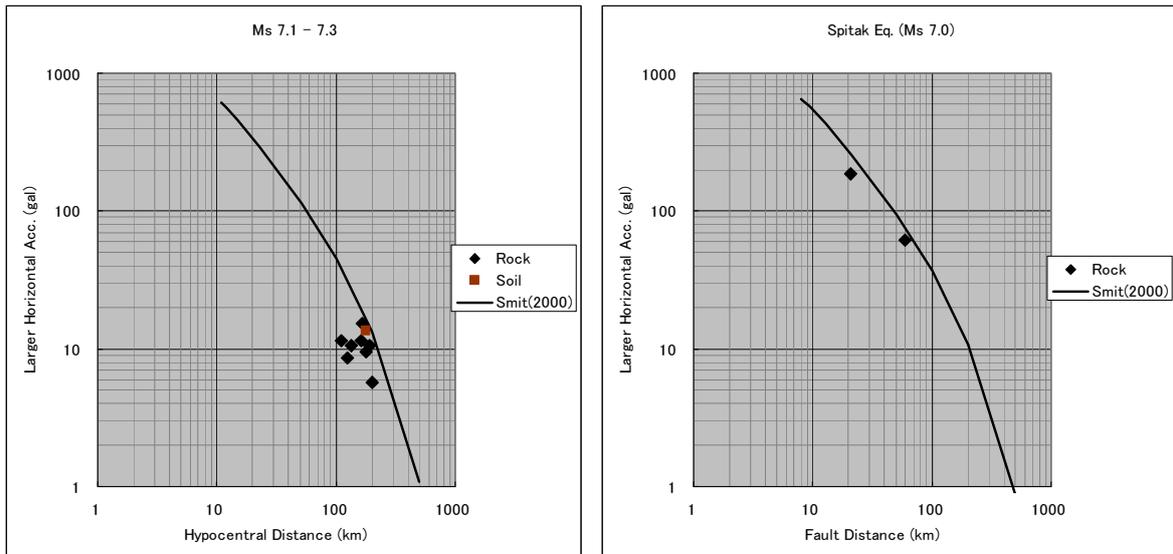
The comparisons are shown in Figure 4.3-1. The results for the formula 1) are separately shown because the definition of the PGA of formula 1) is different from the others. Formula 2) AB10, 4) BA08 and 6) CY08 are selected based Figure 4.3-1. The calculated PGA by the formula 1), Smit et al. (2000), meets the observed records but couldn't adopted because it can't consider the fault as a surface and also it overestimates in case of short distance to the fault.

Figure 4.3-1(1) Comparison of observed records with attenuation formula(1)

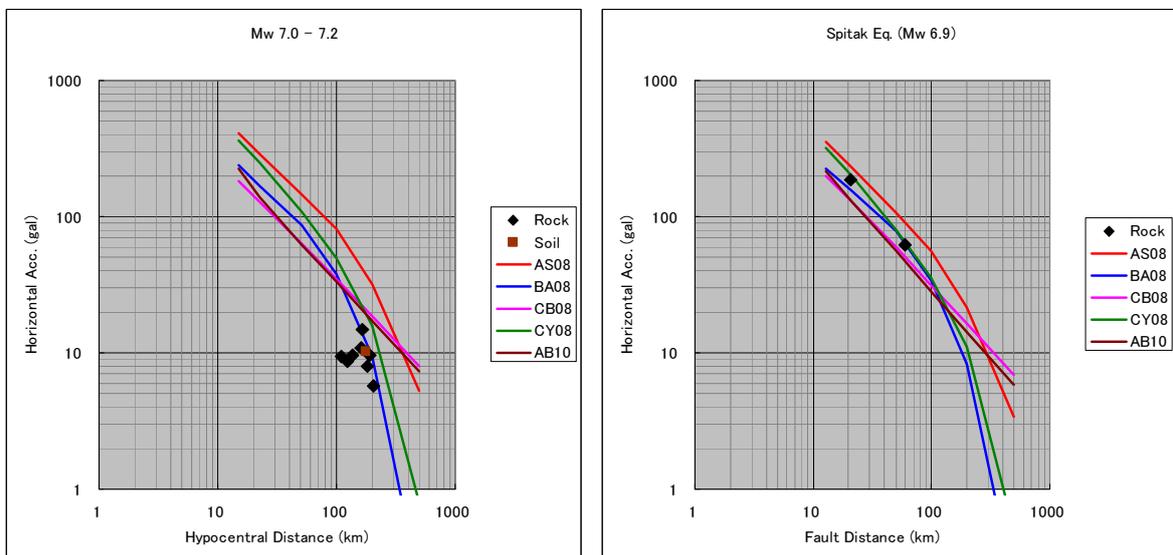
Figure 4.3-1(2) Comparison of observed records with attenuation formula(2)

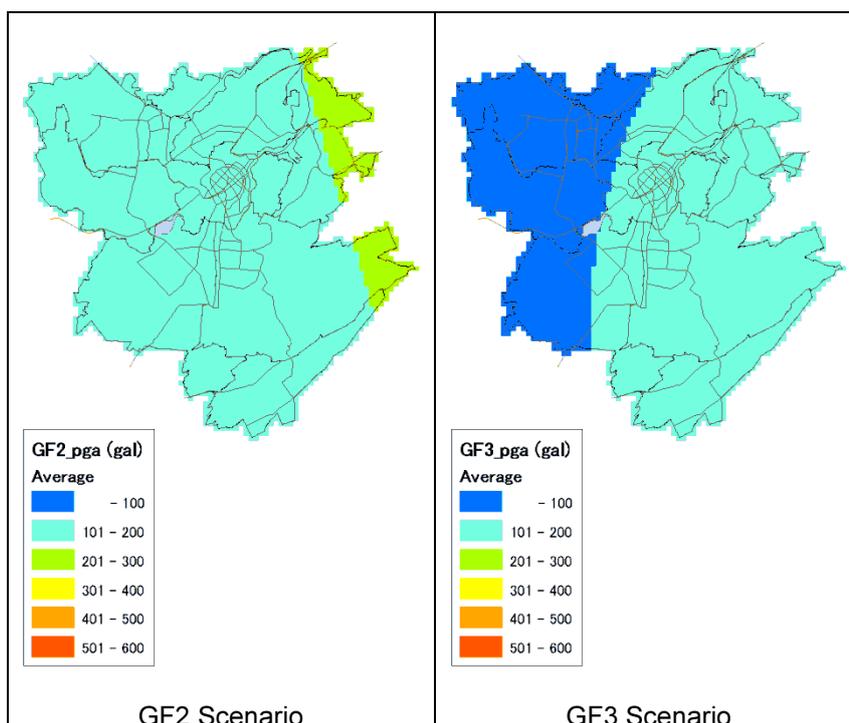
Figure 4.3-3 Acceleration distribution at engineering seismic baserock

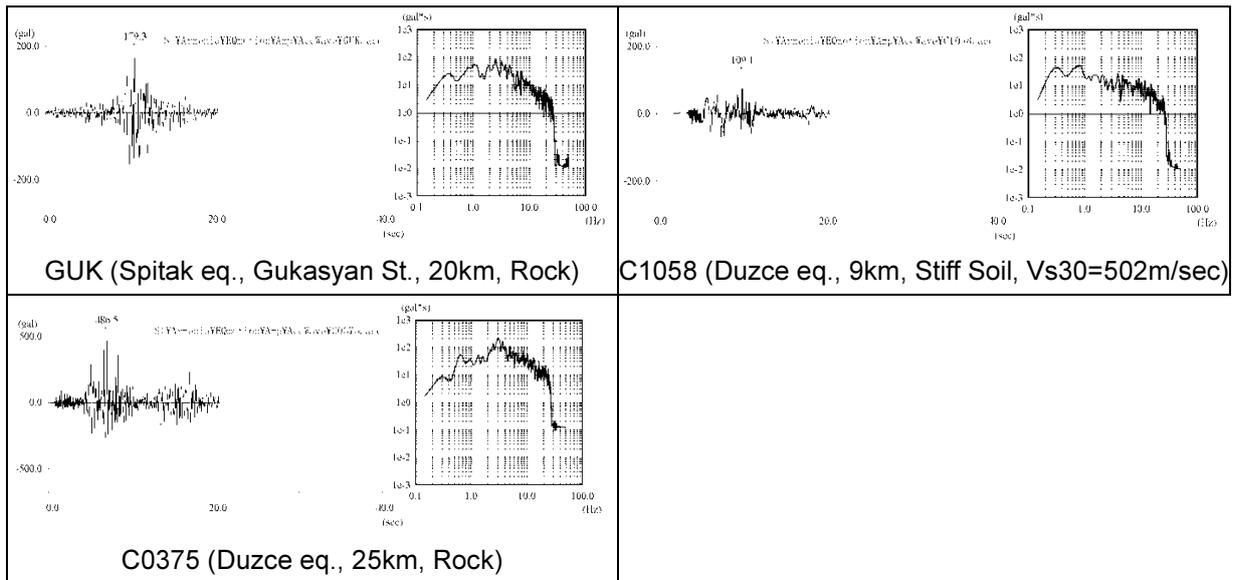
The 1988 Spitak Earthquake ($M_w=6.9$) wave observed at Gukasyan, whose shortest distance from surface fault by Bommer and Ambraseys (1989) is 20 km, is available to meet the criteria a). Two records observed near fault are selected from 1999 Duzce Earthquake in Turkey ($M_w=7.2$) to meet the criteria b). The wave forms are shown in Figure 4.3-5.

Figure 4.3-5 Input Wave Forms for Response Analysis

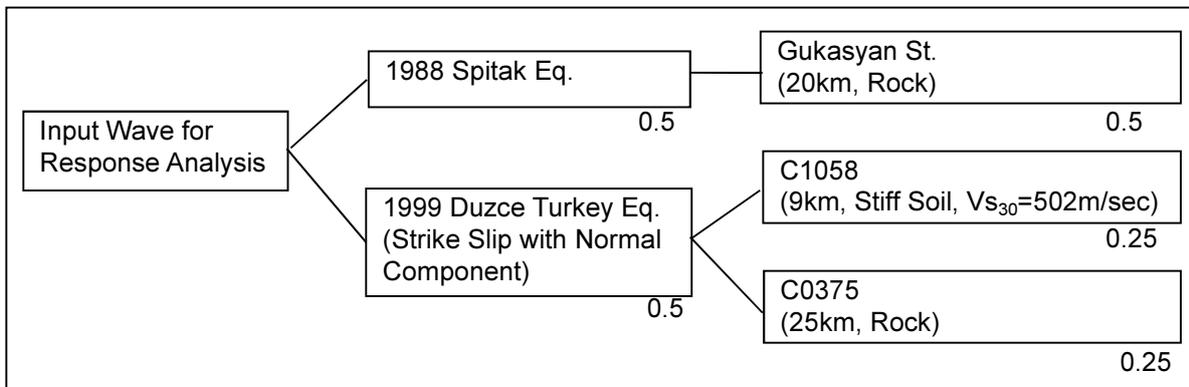
The response analysis was conducted using 3 waves. The calculated accelerations at surface are averaged following the weights in the logic tree which is shown in Figure 4.3-6. The calculated results are shown in Figure 4.3-7.

Figure 4.3-6 Logic tree for input wave form

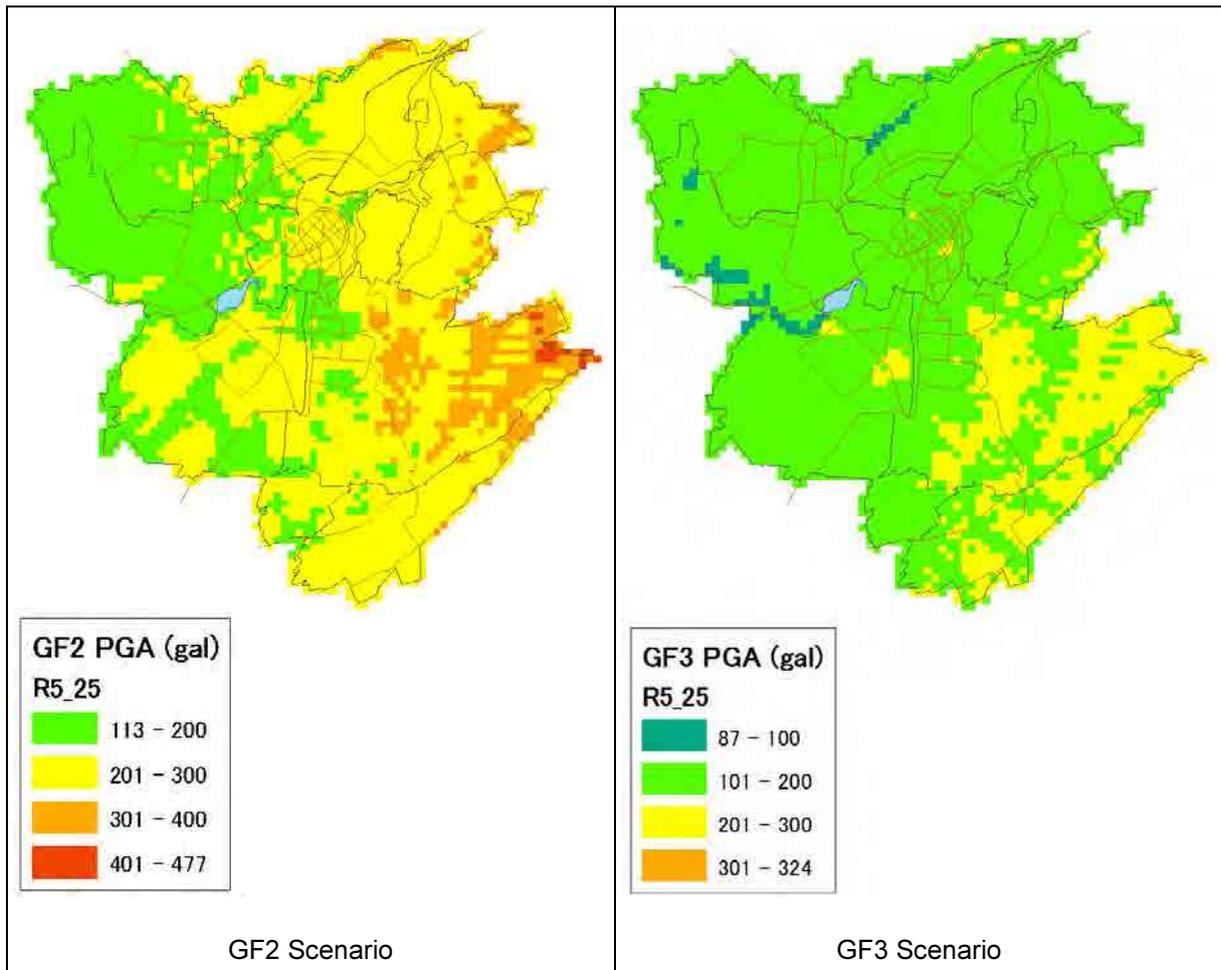
Figure 4.3-7 Acceleration distribution at ground surface

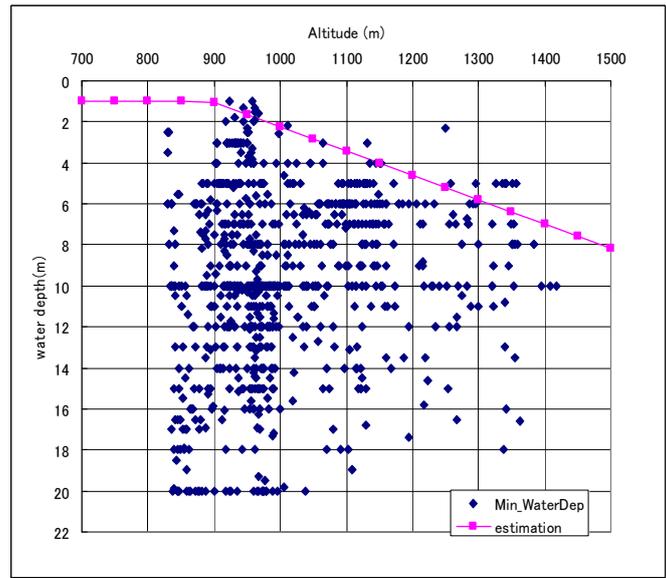
The ground water level in Yerevan city is estimated from the information of water depth included in the existing borehole database. If several water depth data are included in one borehole, the shallowest data is adopted. As the ground water depth has strong relation with topography in general, the relation between ground water depth and the altitude is studied and shown in Figure 4.3-8. From this figure, the highest ground water level in rainy season is set by red colored line for the liquefaction analysis. Because the observed data include the deviation by observation error, difference of season, change of the situation of pumping for industrial use etc., the shallowest data is used to estimate the most severe condition. Figure 4.3-9 shows the ground water depth distribution for liquefaction analysis.

Figure 4.3-8 Relationship between ground water depth and altitude

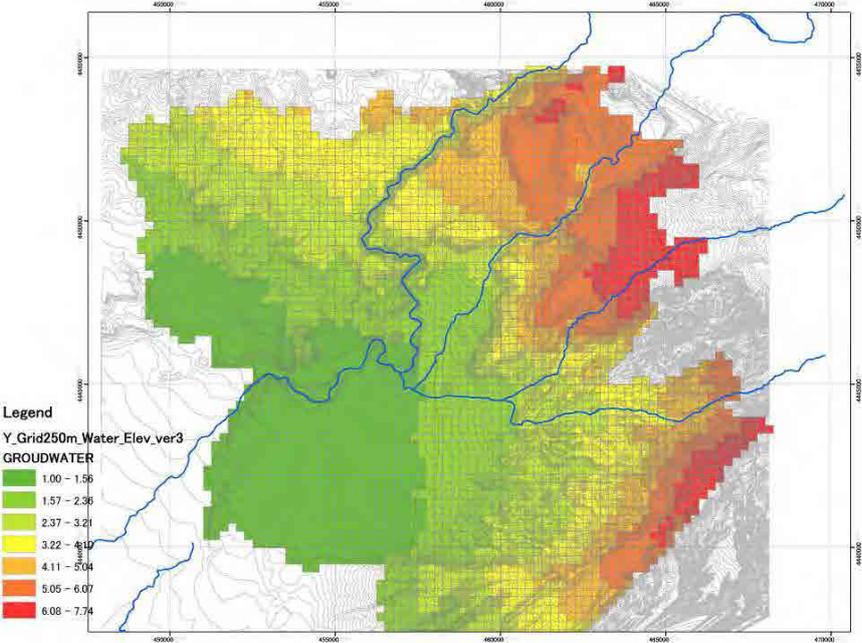
Figure 4.3-9 Estimated ground water depth

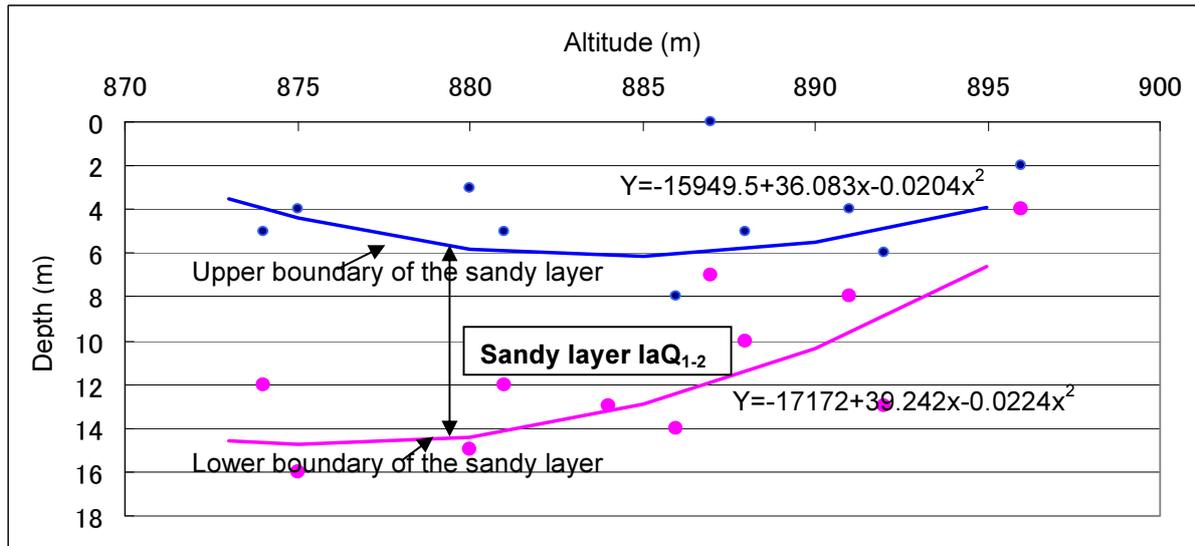
The sandy layer, which should be studied in Yerevan city, only included in the Ararat lowland deposits (IaQ₁₋₂). The distribution of sandy layer is estimated from the relation between the upper and lower depth of the sandy layer and the altitude as shown in Figure 4.3-10.

Figure 4.3-10 Relationship between the altitude and the upper/lower boundaries of sandy layers (IaQ₁₋₂, Ararat lowland)

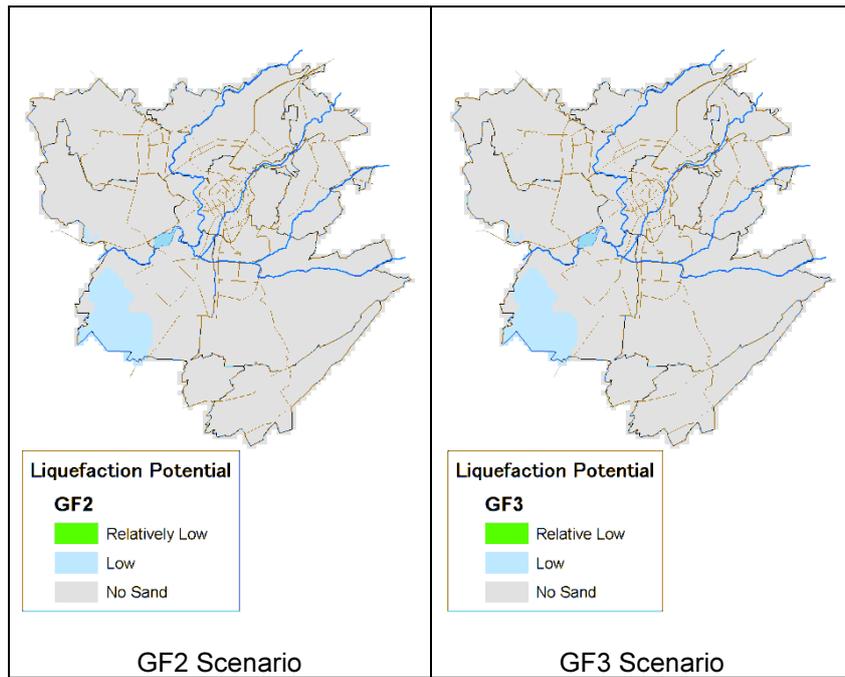
Figure 4.3-11 shows the liquefaction potential of each scenario earthquakes. According to these maps, fortunately, there are very little areas with sandy soil layers and the liquefaction potential in Yerevan is low.

Figure 4.3-11 Liquefaction potential

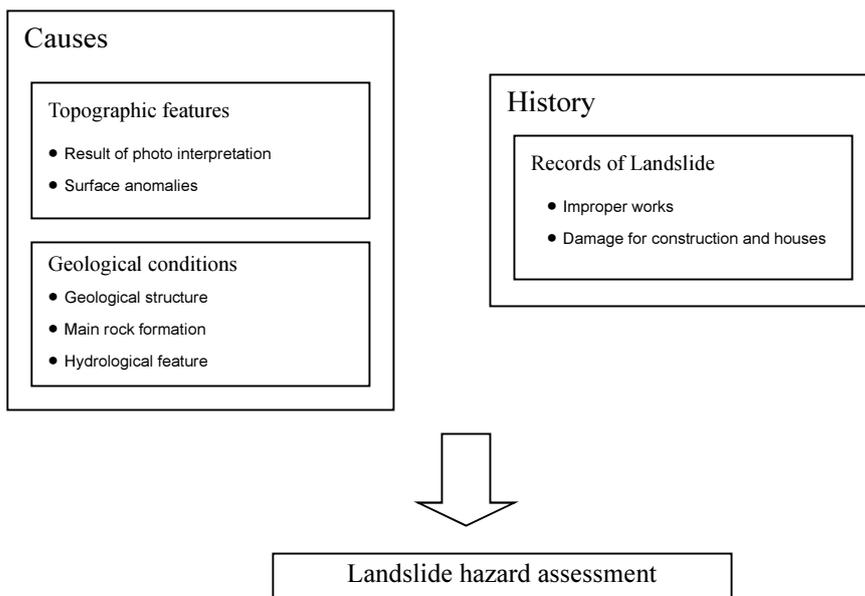
Landslide hazard is assessed by the factors of geomorphologic and geological observation, land deformation, hydrological features, and the state of damage. The method of the assessment is based on the scores of each category in Japan and inductive element of the landslides in the territory of Yerevan city.

Figure 4.3-12 Flowchart of landslide hazard assessment
