Chapter 4 Seismic Hazard Assessment

4.1 Modeling of Ground Conditions

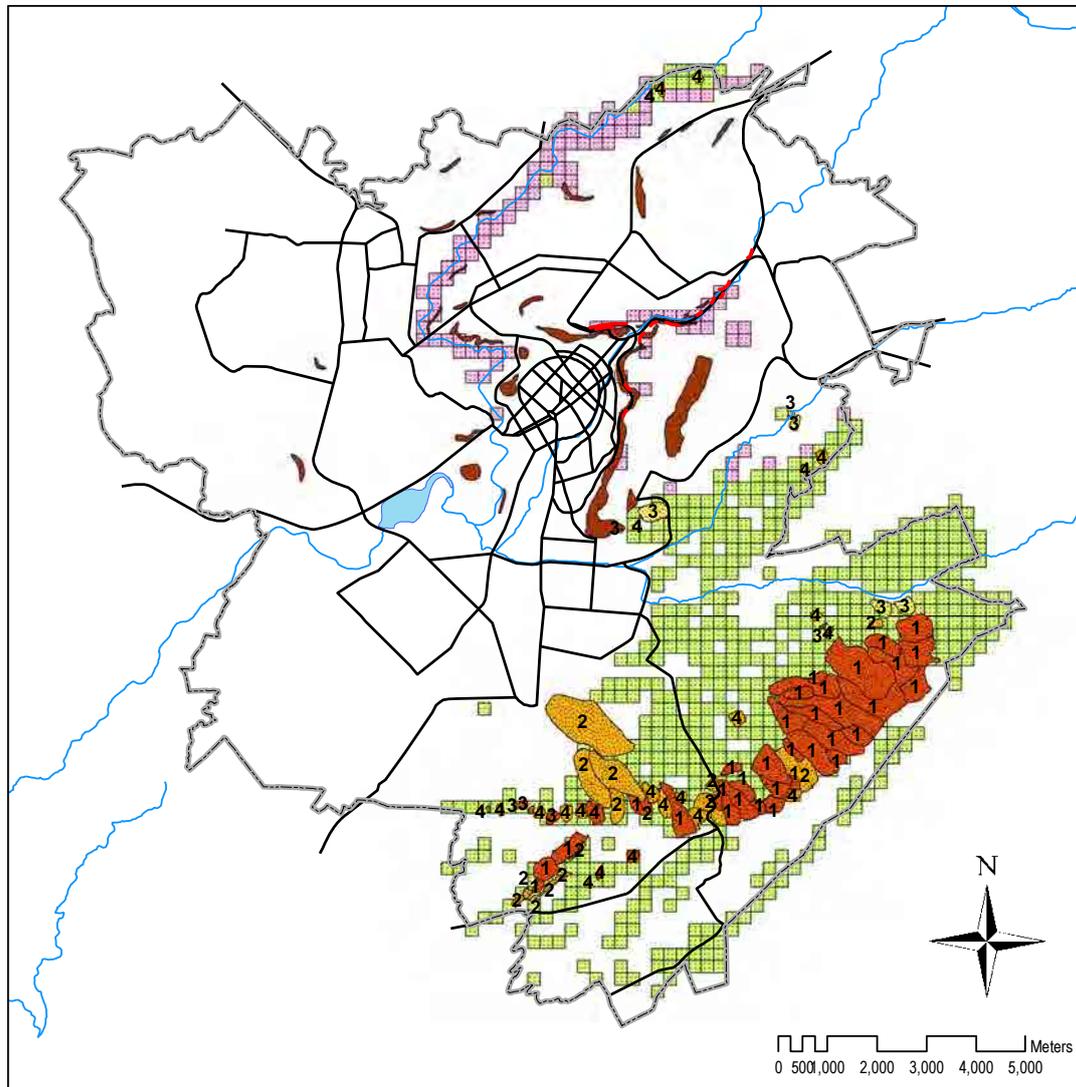
Figure 4.3-13 shows existing landslide hazard and risk, potential hazard areas of landslide and slope hazards in the territory of Yerevan city. Most of the high hazard landslides belong to Shorakhpiur-Nubarashen (Sovetashen) Landslide Group. The landslides on east slope of Erebuni district (north-western slope of Nubarashen terrace) and slopes in Nor Kharberd are high hazardous landslides. Because most of those landslides are near or in the village or infrastructures existing areas (roads, water pipes, gas pipe, power lines, etc.), those landslides are also high risk.

Figure 4.3-13 Landslide hazard and risk map

In Figure 4.3-13, “Slope Failure and Rock Fall for Buildings and Houses”, “Slope Failure and Rock Fall for Main Roads” are shown.

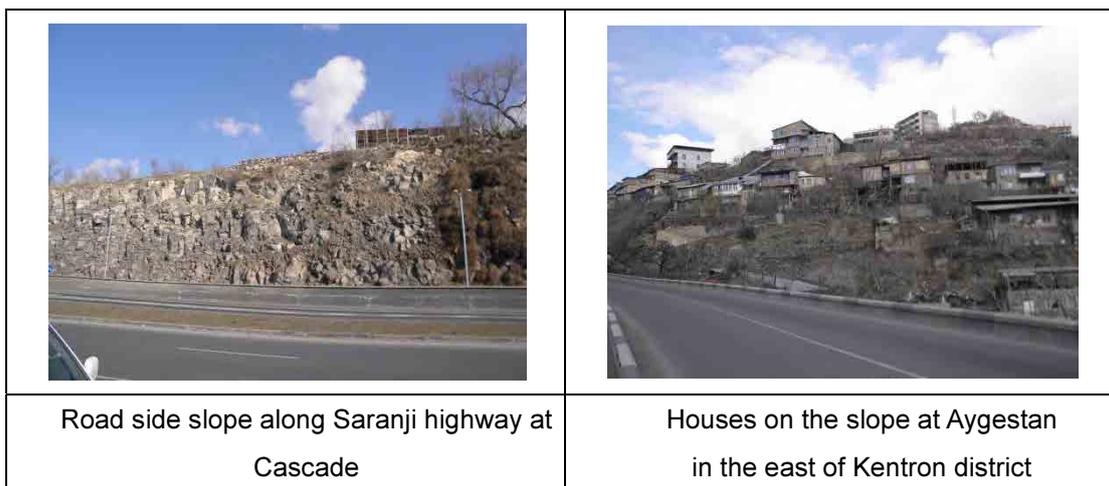
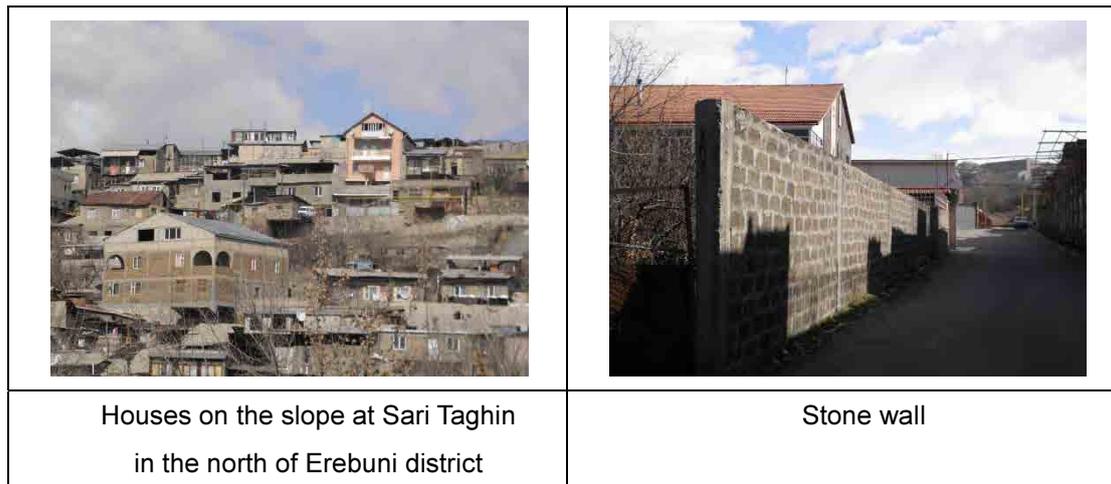
In the territory of Yerevan city, road side slope along Saranji highway at Cascade, Alexander Myasnikyan avenue, Nork-Sari-Tagh road and others are high hazard for rock fall. Those sections are consist of basalt and basaltic andesite with many cracks and at unstable conditions.

Stone walls are also dangerous in case of earthquake. Many of the stone walls are 2m or more high and supported by pillar with steel bar. But the intervals between pillars are 2 or 3m, that is not enough to support the wall in case of earthquake. Stone walls do not exist so many in commercial areas and business areas, but exist many in the suburb and rural areas.

Figure 4.3-14 Road side slope , houses on the slope and stone wall

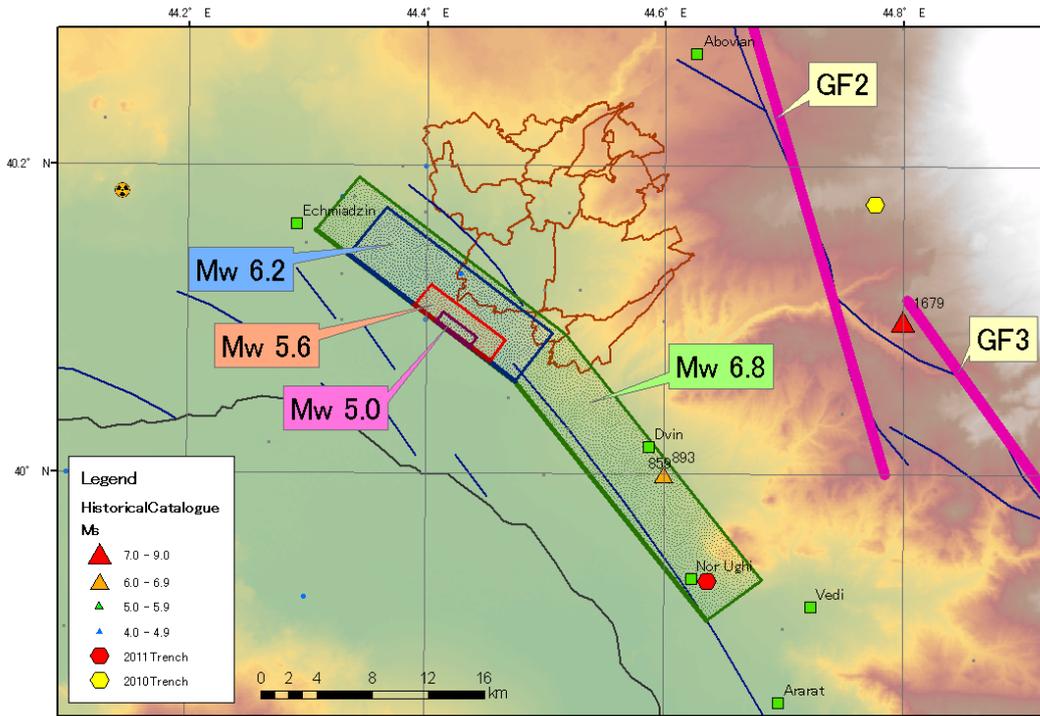
Yerevan Fault			
Moment Magnitude (Mw)	6.8	6.2	5.6	5.0
Fault Type	Reverse Fault			
Length (km)	40	15	6.7	3.0
Dip (degree)	55 (to north-east)			
Depth(Upper - Lower) (km)	5 - 12	5 - 11	5 - 8	5 - 6
Width (km)	8.6	7.5	3.3	1.5

Figure 4.4-1 Source Fault Models of Yerevan Fault

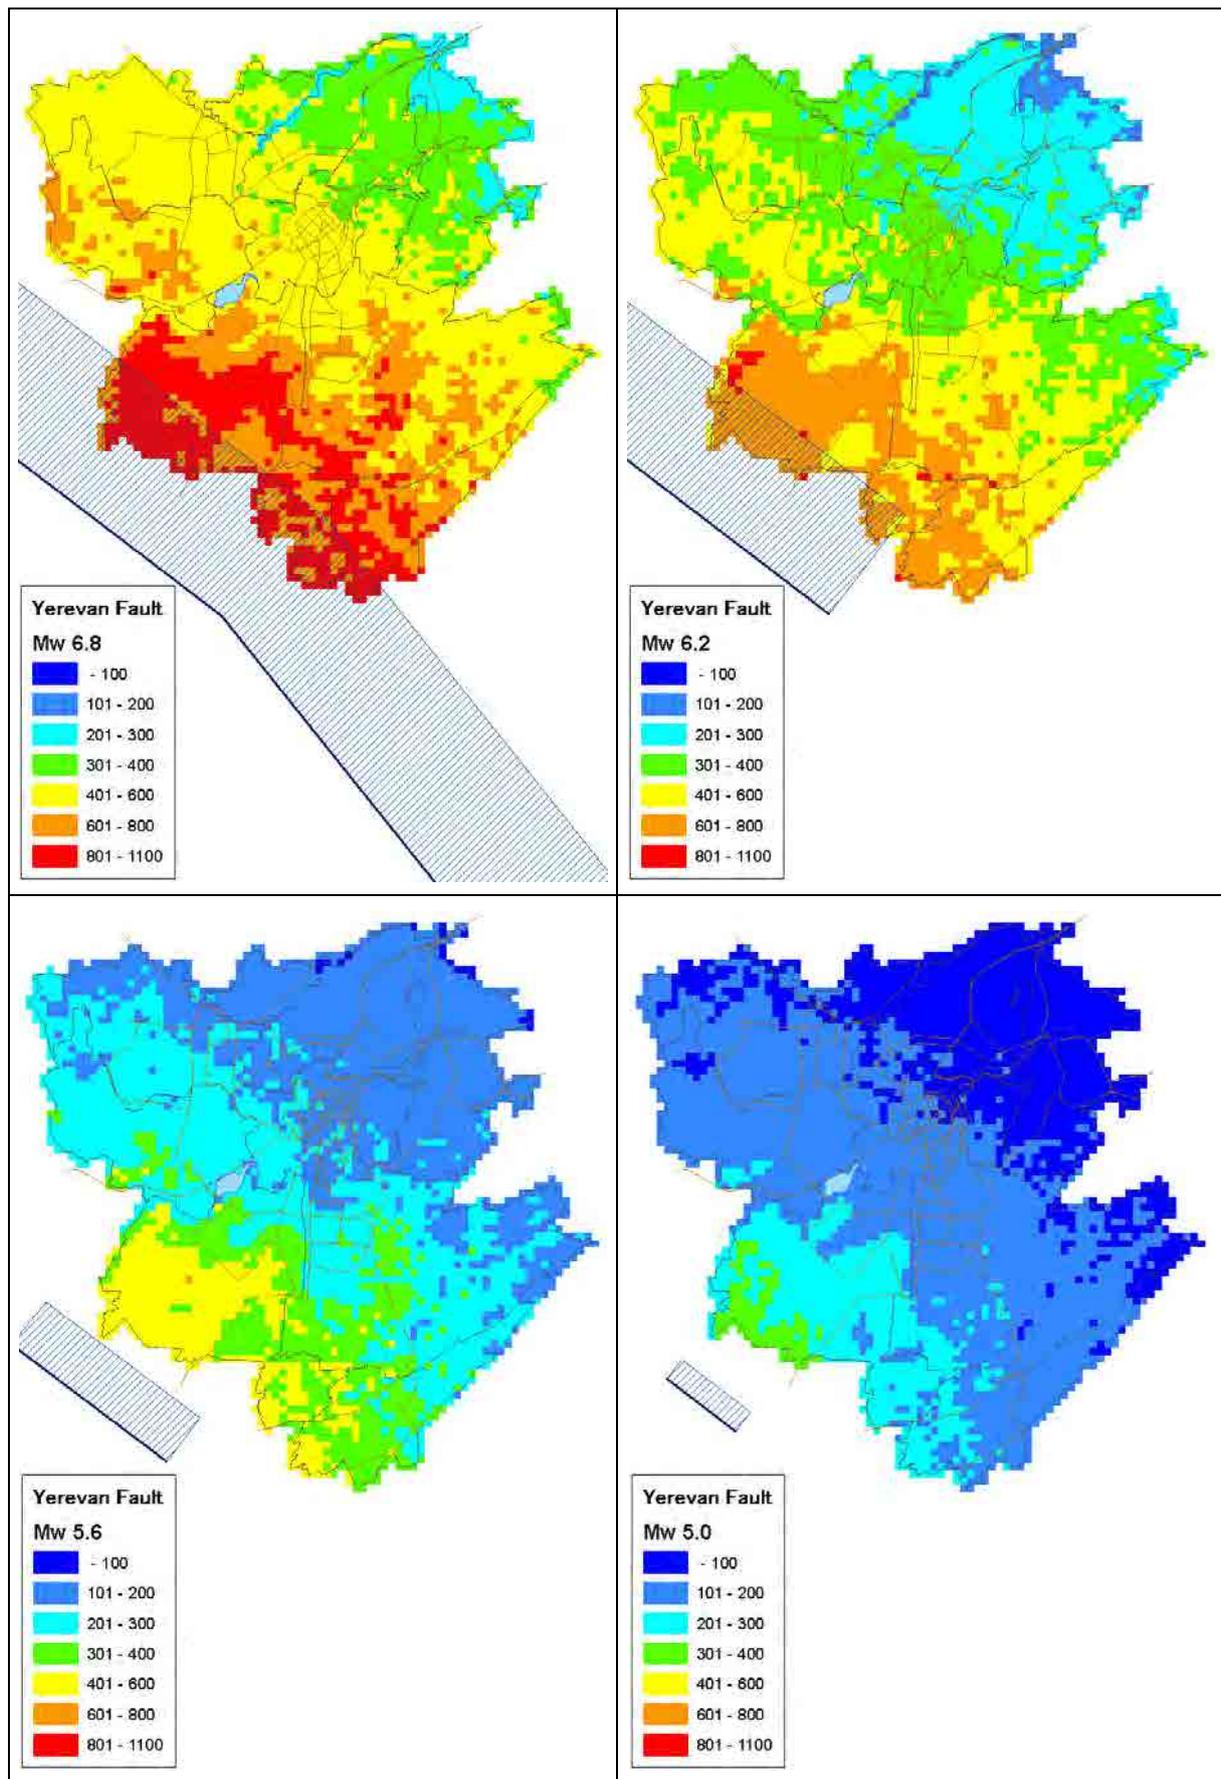
Figure 4.4-2 Acceleration distribution at ground surface by Yerevan Fault

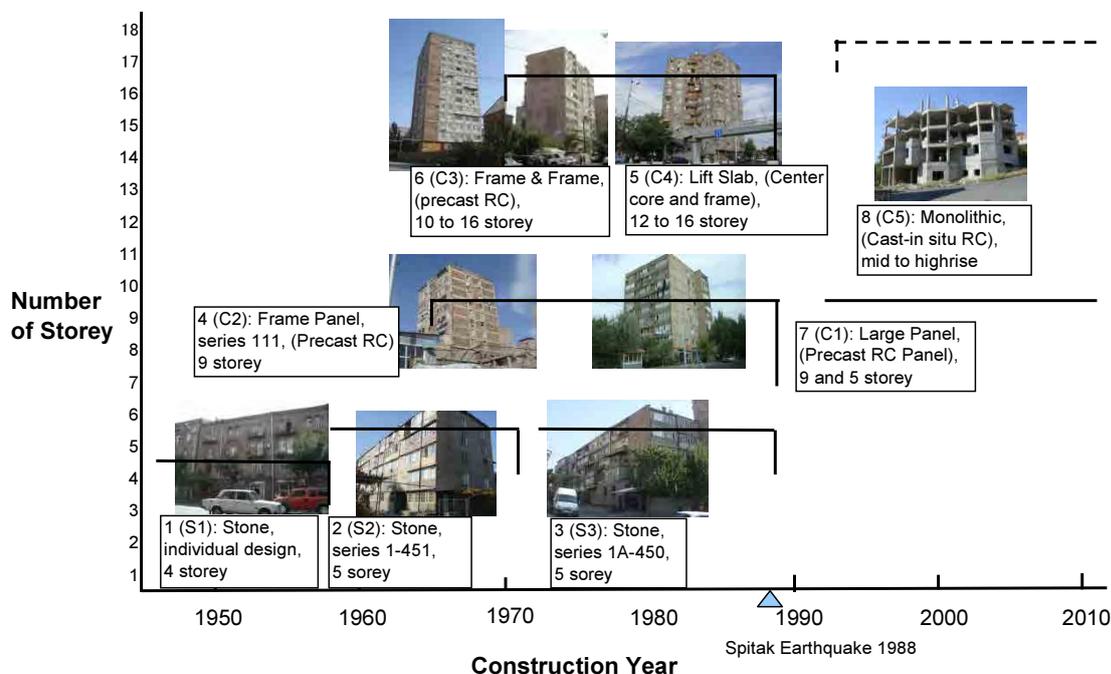
Constructed year and number of story is summarized and is shown in Figure 5.1-1. Design and construction based on ‘series’ has started in 1960s. Fabrication of precast members has started at factories in mid. of 1960s, and was developed in 1970s. Monolithic is commonly designed and constructed after the Spitak earthquake in 1988, and based on new code RABC in 1994.

Figure 5.1-1 Constructed year and number of story

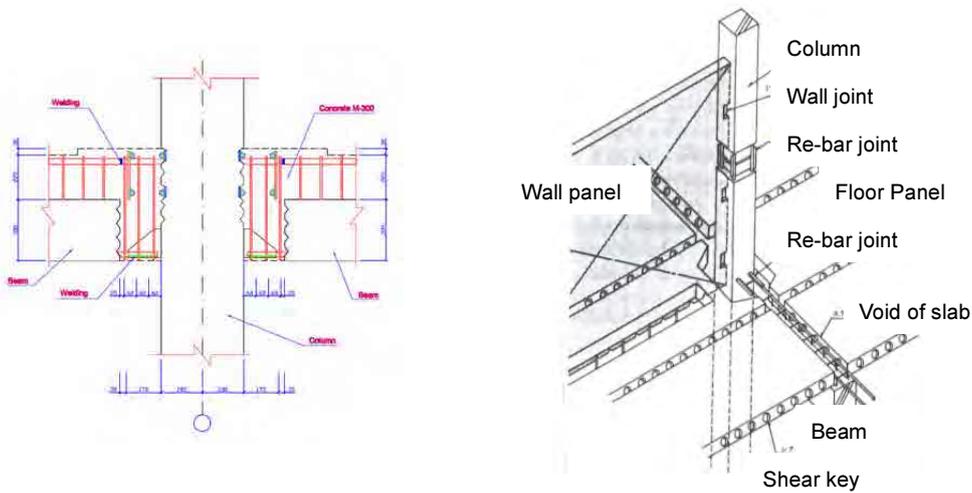
(a) Joint of beam and column (b) Joints of members (ref.2)

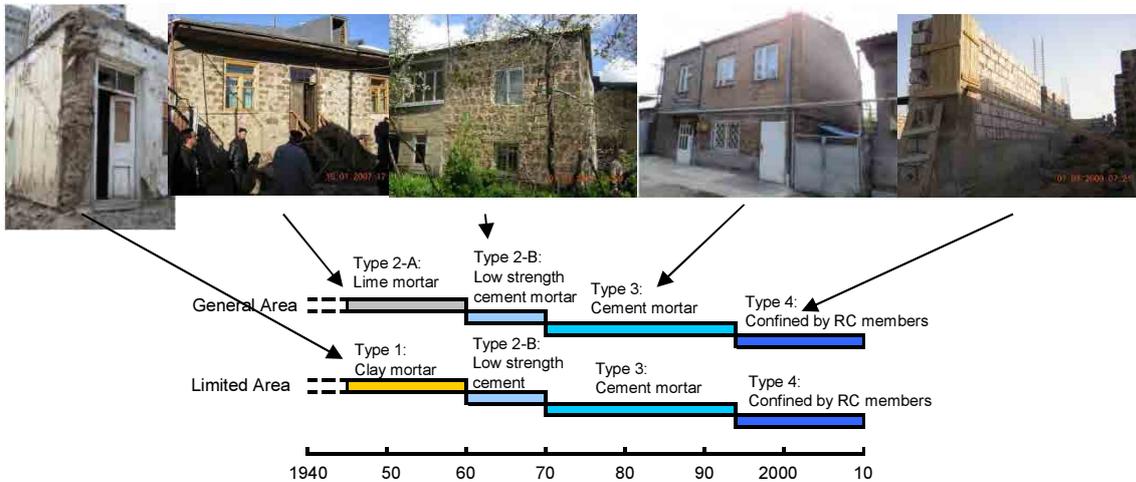
Almost all individual houses are stone houses. Structural category based on type of material for stone joints of wall is proposed. There is correlation between type of joint and constructed year. Proposed structural category and supposed constructed year is shown in Figure 5.1-16.

Figure 5.1-16 Proposed structural category and supposed constructed year

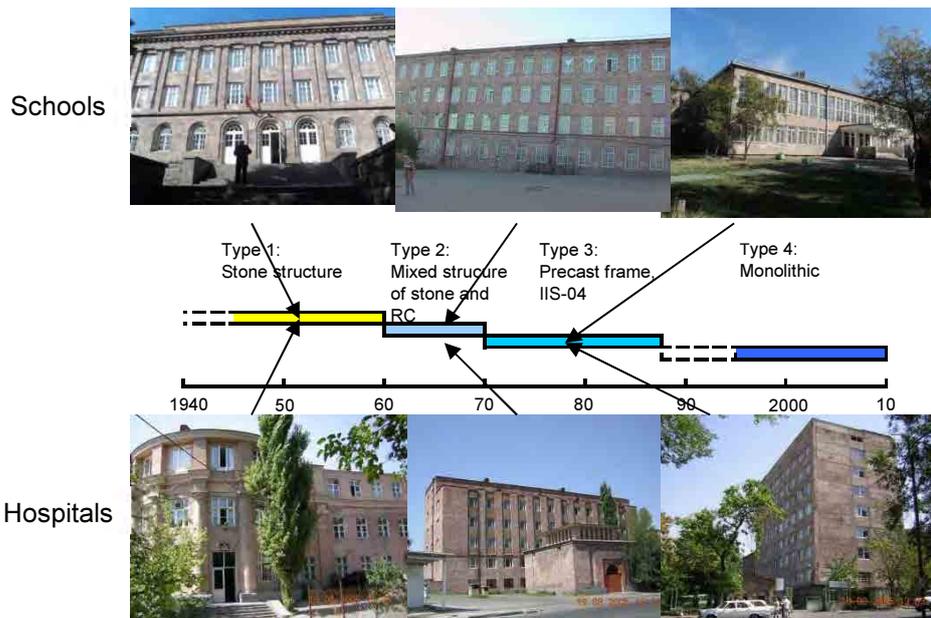
Four types of structural category, stone structure, mixed structure of stone and RC, precast frame of IIS-04 and monolithic are proposed for schools and hospitals. Proposed structural category and supposed constructed year is shown in Figure 5.1-17.

Figure 5.1-17 Proposed structural category and supposed constructed year

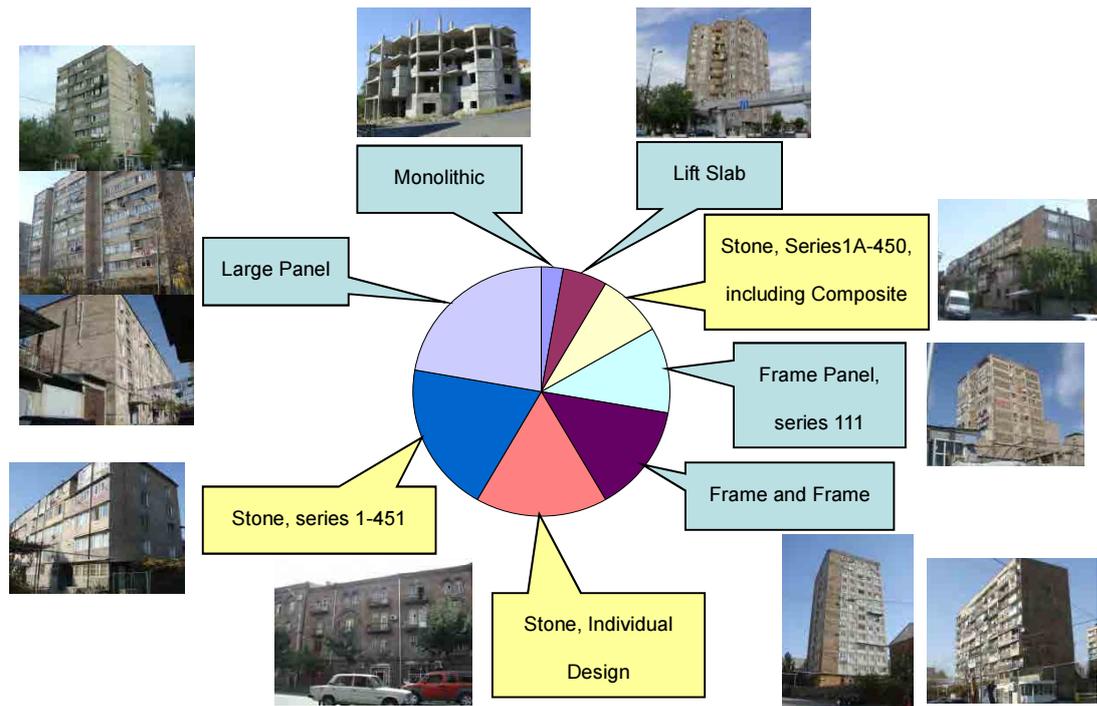
Stone buildings by individual design are located at Kentron and Shengavit district mainly. Stone buildings, series 1-451 are located at Kentron, Shengavit and north side of the city. Stone buildings, series 1A-450 are distributed uniformly as shown. ‘Monolithic’ is located at Kentron and Arabkir district.

Figure 5.2-1 A ratio of each structural type

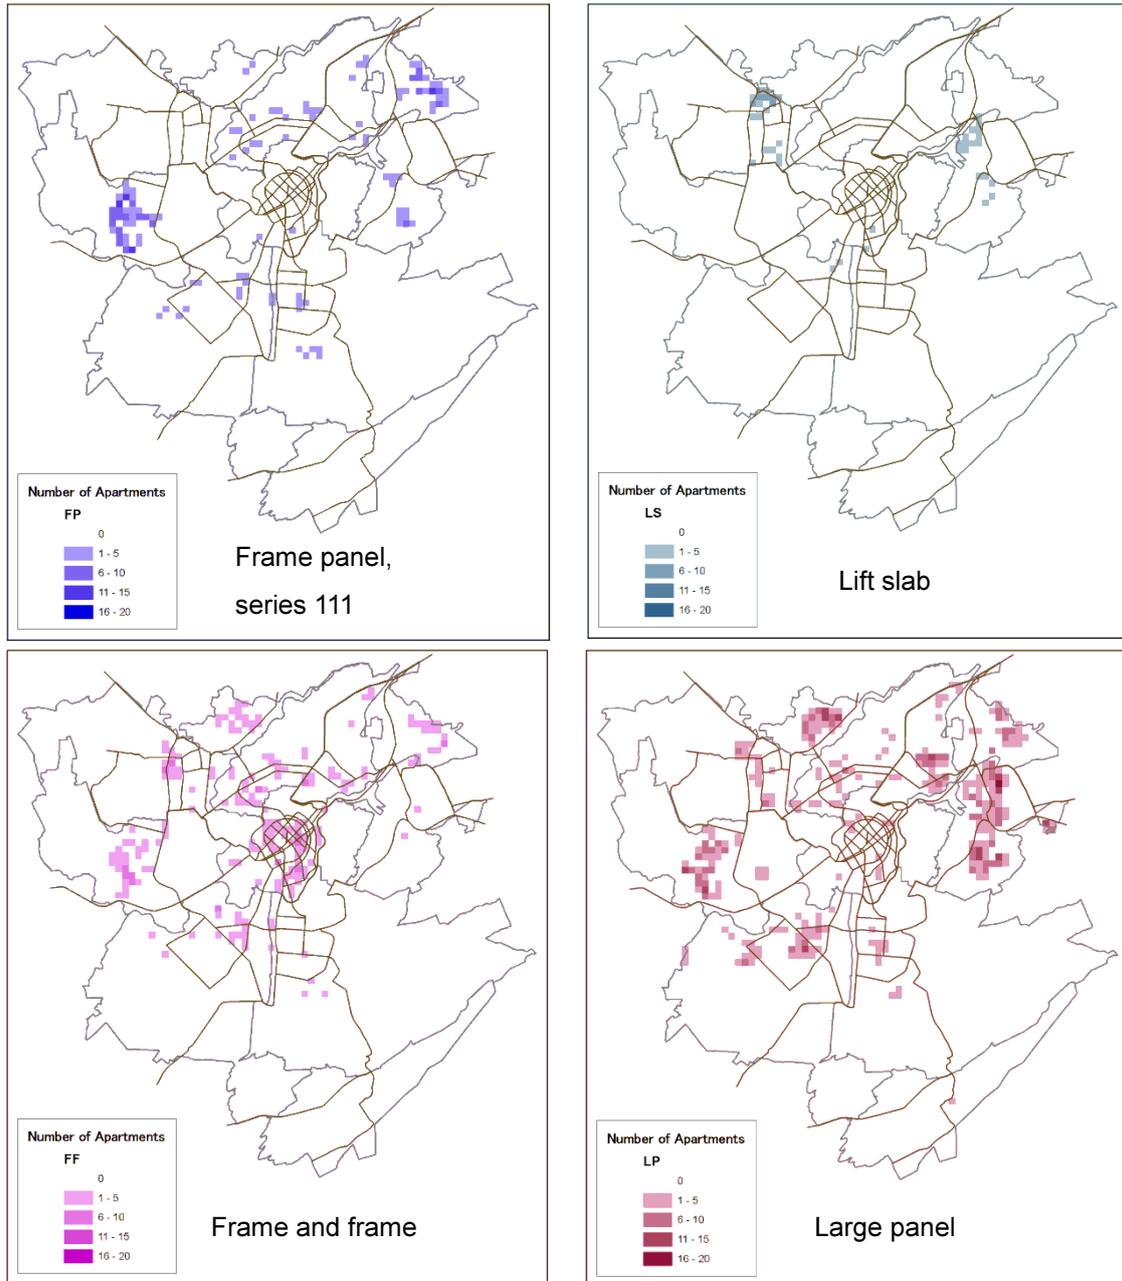
Figure 5.2-3 Number of existing multi-story residential buildings for each structural type per grid of 250m x 250m (1)

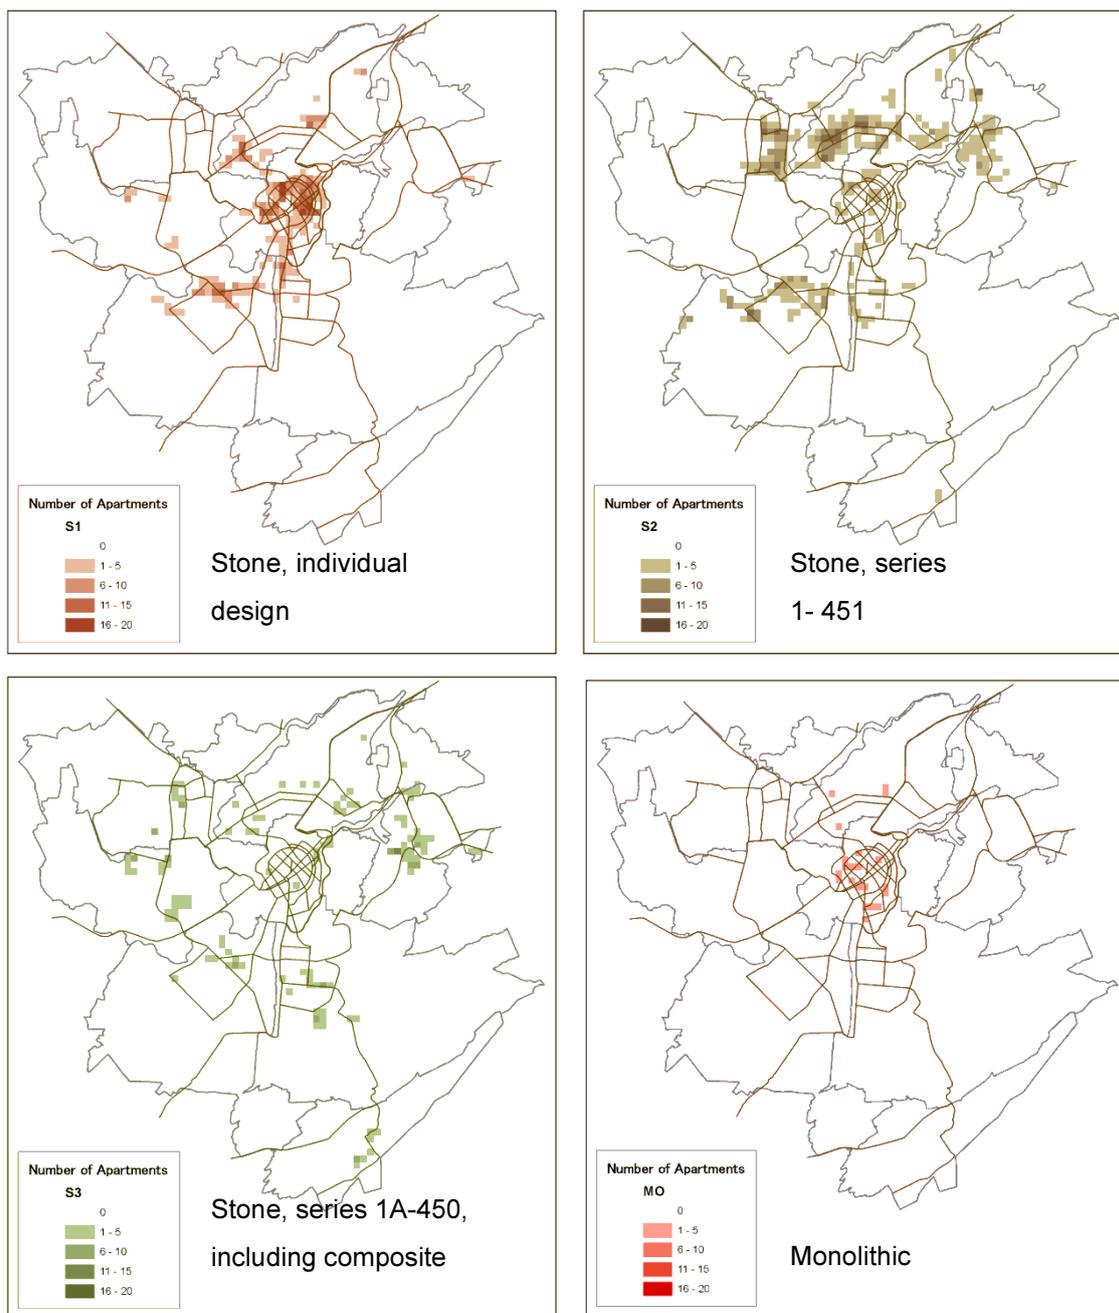
Figure 5.2-4 Number of existing multi-story residential buildings for each structural type per grid of 250m x 250m (2)

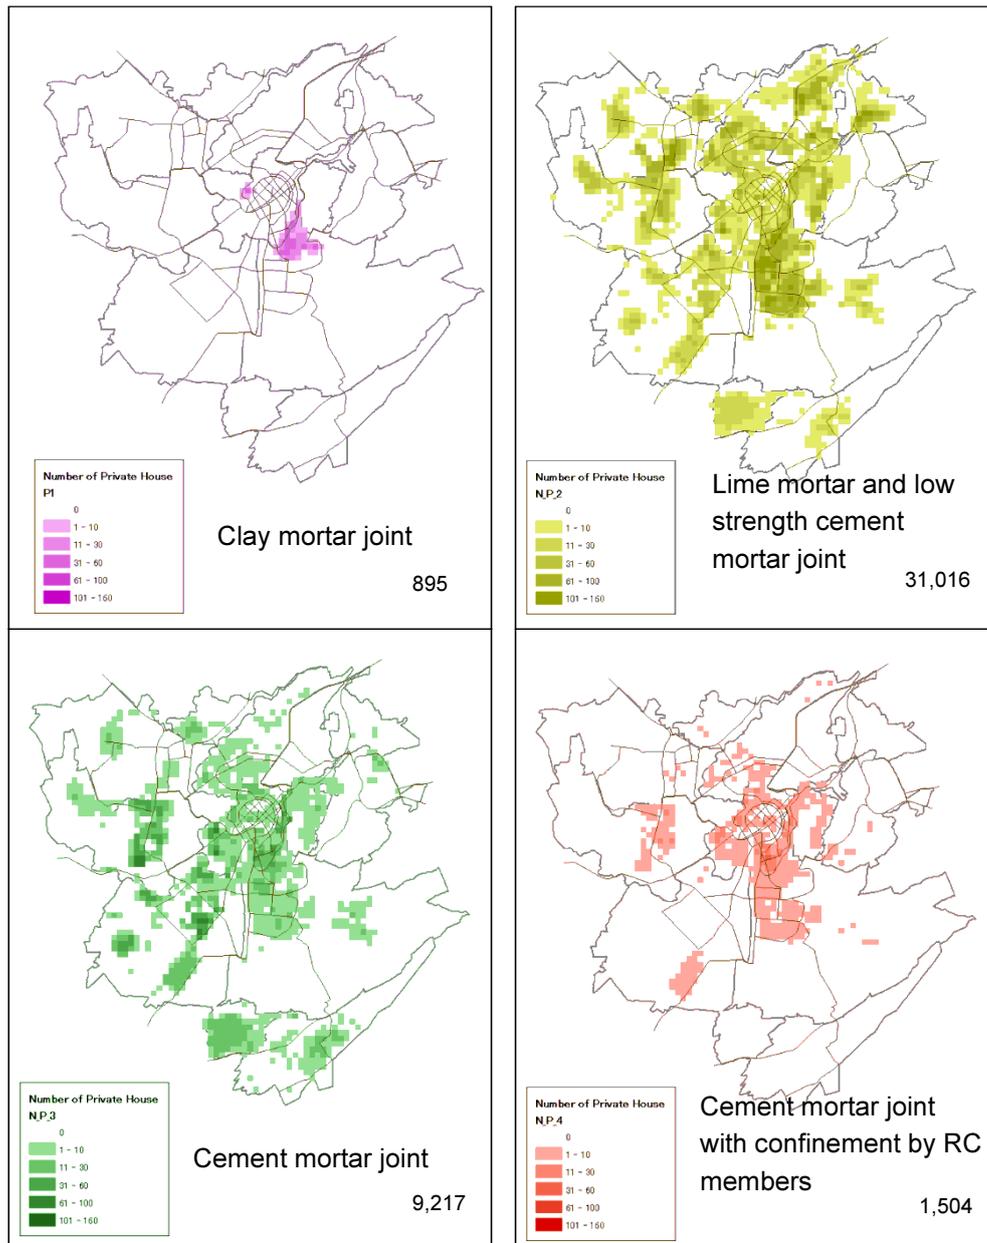
Structural type of individual houses was categorized by the material of joint mortar for stone walls. Structural type of individual houses was evaluated from the information of constructed year of houses by RS, which covers approximately 40% of existing houses. A ratio of structural type for a known area was applied to an area of unknown area that has similar historical formulation of the area through empirical evaluation. In addition, clay mortar joints were supposed for houses constructed in 50s at ‘Kond’ and ‘Saritagh’ areas. Supposed number of individual houses for each structural type per grid of 250m x 250m is shown in Figure 5.2-5.

Figure 5.2-5 Supposed number of Individual houses for each structural type per grid of 250m x 250m

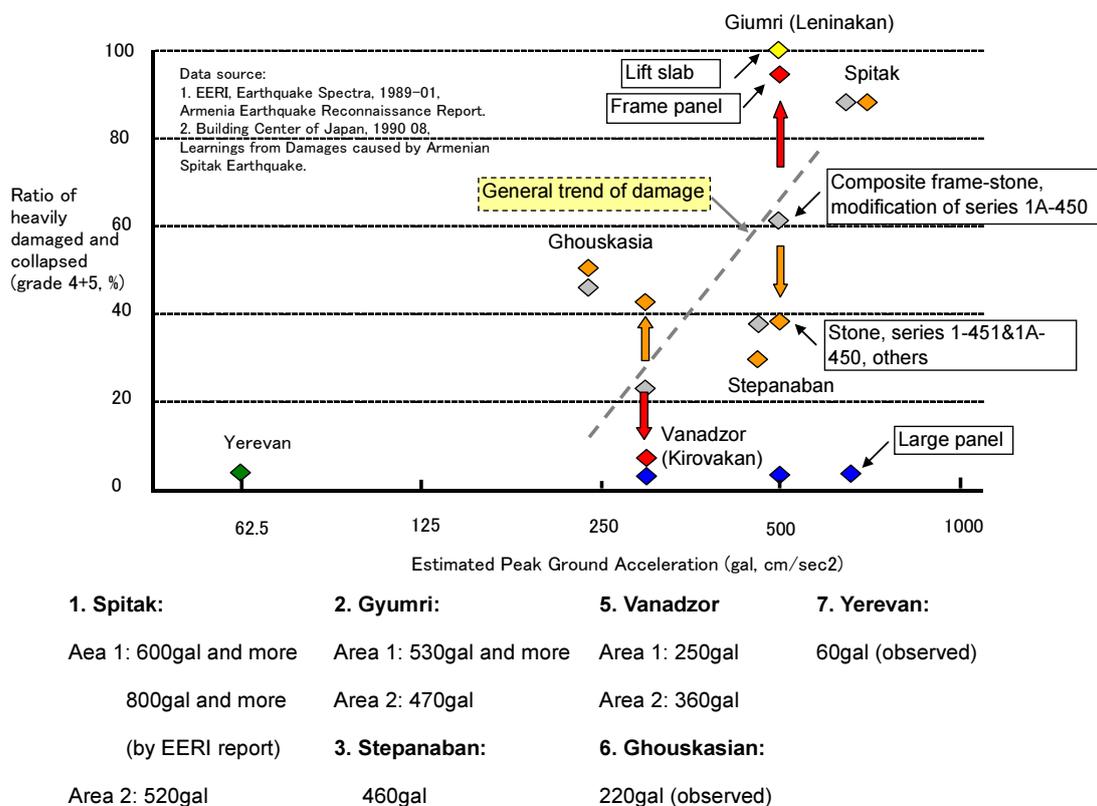
Figure 5.3-2 Observed damage ratio and estimated acceleration at Spitak earthquake in 1988

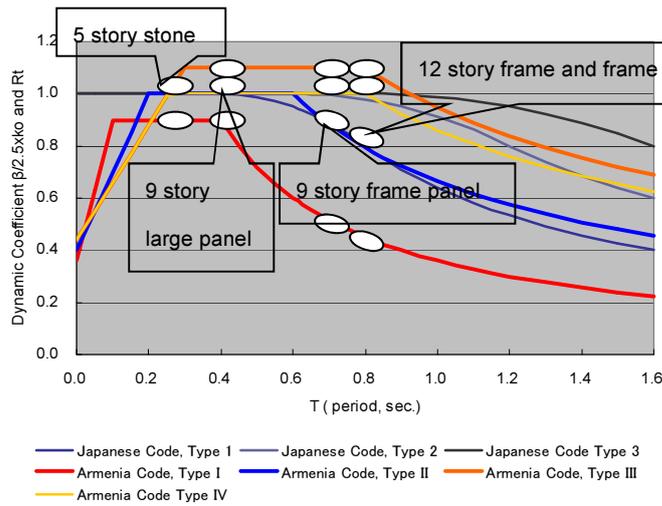
Response amplification factor for short period range, supposing stone buildings of series 1-450, was studied applying three earthquake waves, with damping constant 5% for reference (Figure 5.3-4). As a result, response by Ghoukasian wave observed at the Spitak earthquake was higher than others by 10 to 30 %.

Figure 5.3-3 Response coefficient by soil type and vibration period of buildings

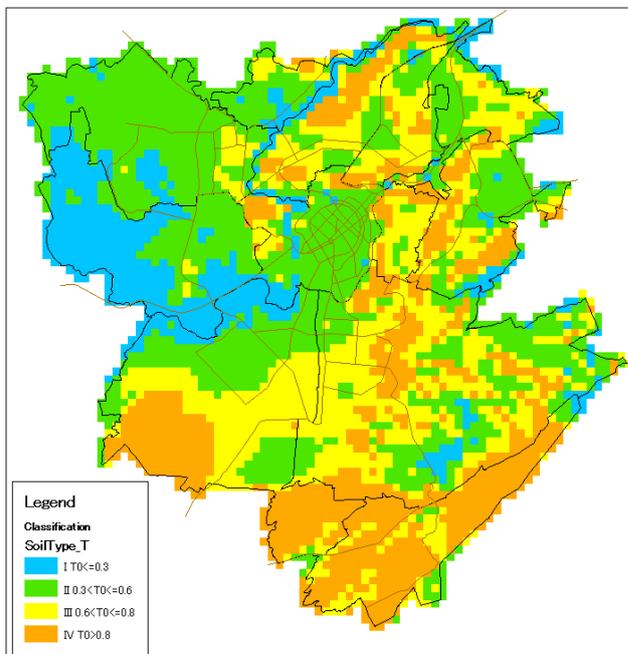
There is no official map for practical use showing soil category in Yerevan. Four categories of soil in RABC are indicated but it was evaluated that two category divided by ground predominant period of around 0.6sec is reasonable for developing vulnerability function taking into consideration both building response for each type and limitation of resolution of vulnerability function. Four soil categories in Yerevan have been revealed and two soil categories for vulnerability function has been proposed by JST based on predominant period, and is shown in Figure 5.3-5.

Figure 5.3-5 Proposed soil category in Yerevan by JST

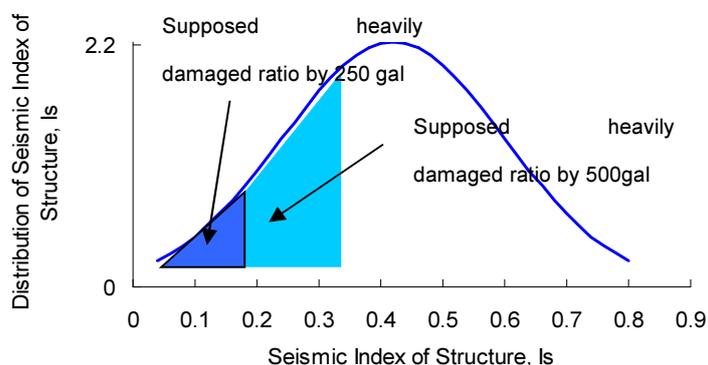
Figure 5.3-6 Supposed heavily damage ratio and distribution of 'Is'

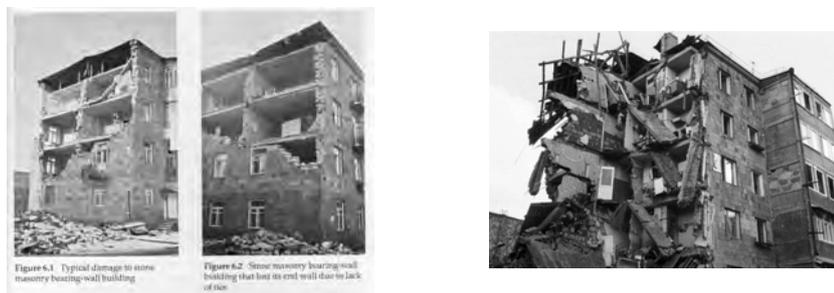
(a) Out-of-plane collapse of stone walls (ref. 1) (b) Partial collapse of building at Gyumri (by NSSP EEC)

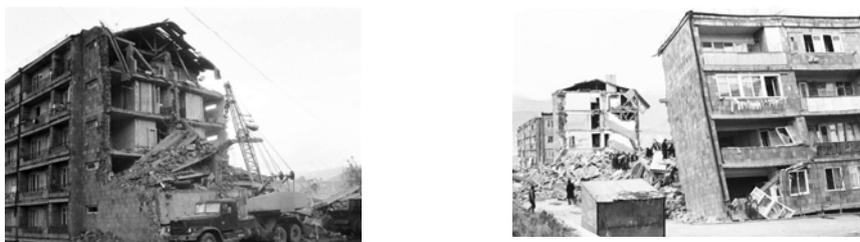
(a) Collapse of side portion at Gyumri (by NSSP EEC) (b) Collapse of center portion at Gyumri (by NSSP EEC)

Figure 5.3-8 Damages of stone buildings, series 1A-450, at the Spitak earthquake

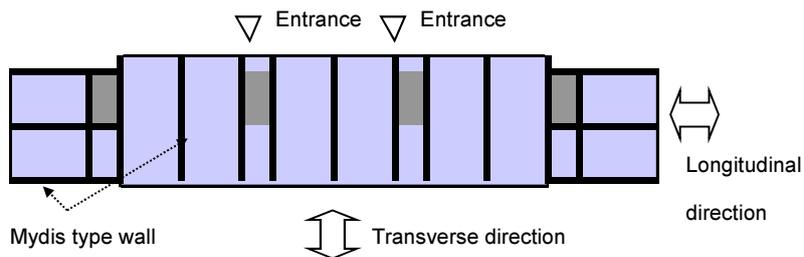
Figure 5.3-9 Layout of stone bearing walls for series 1A-450

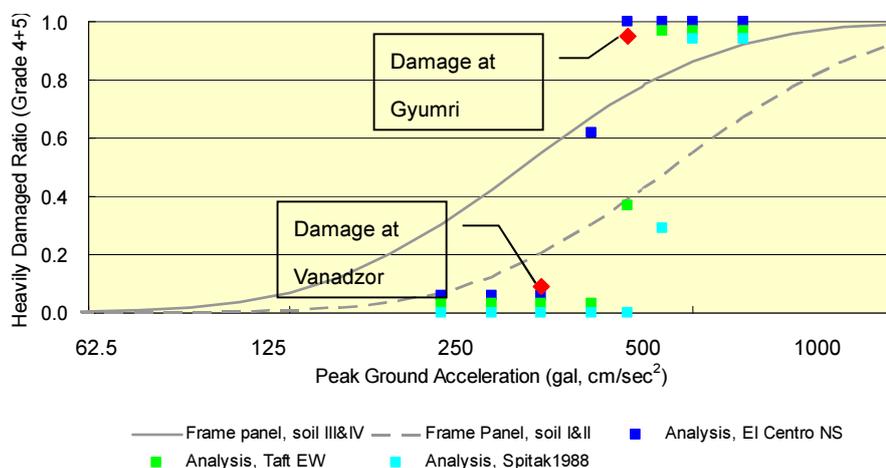
Figure 5.3-10 Proposed damage function and damage ratio by time history analysis

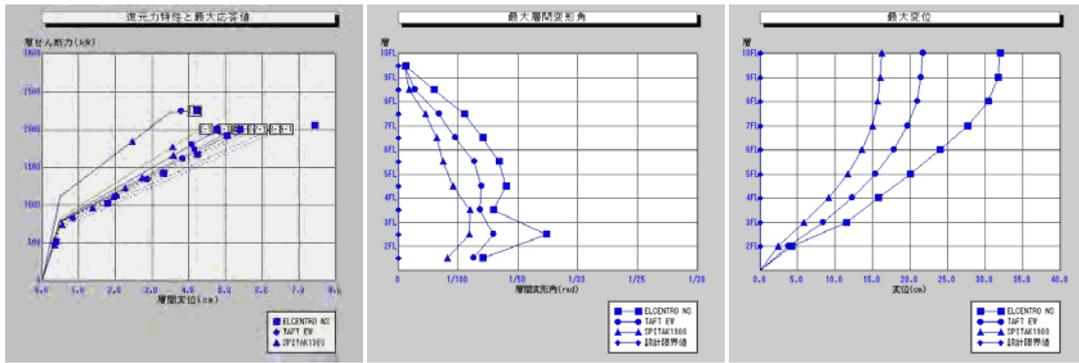
a) Story shear force – story deflection b) Story deflection angle c) Deflection at each story

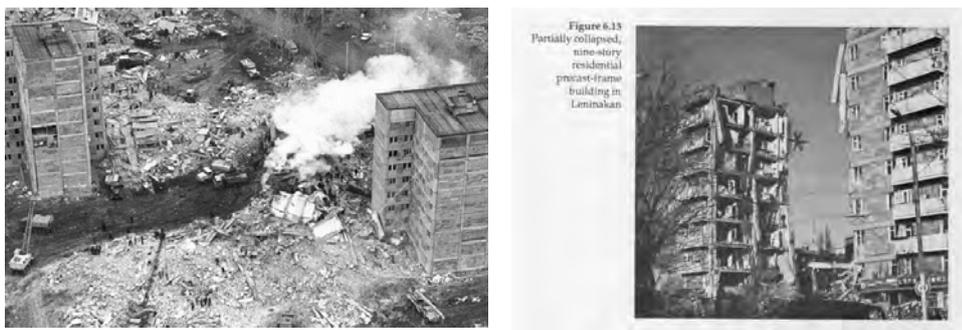
Damages of ‘frame panel’ buildings at the Spitak earthquake in 1988 are shown in Figure 5.3-12.

(a) Collapsed ‘frame panel’ at Gyumri (by Nssp EEC) (b) Partially collapsed ‘frame panel’ at Gyumri (ref. 1)

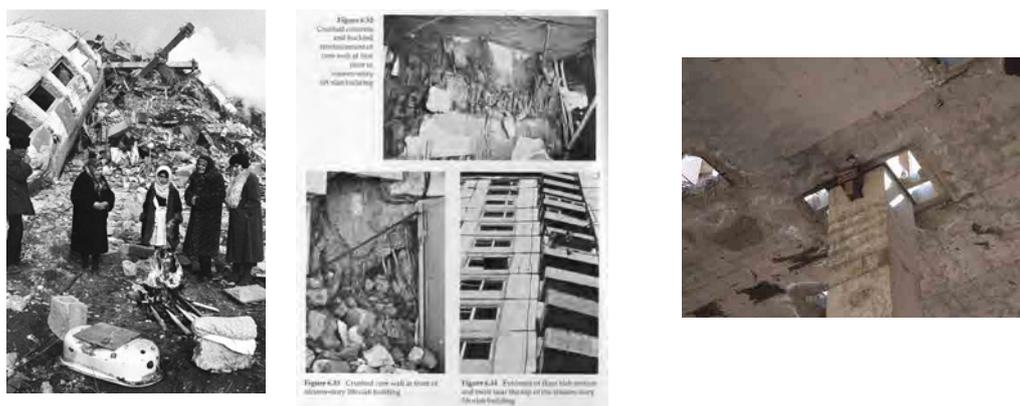
(left) Collapsed 10-story 'lift slab' at Gyumri (provided by NSSP EEC)
 (center) Heavily damaged 16-story 'lift slab' at Gyumri (ref.1)
 (right) Precast column and cast-in-situ flat slab of an abandoned building (in Yerevan by JST)
 Figure 5.3-13 Damages of 'Lift slab' at Spitak earthquake and joint of column and slab

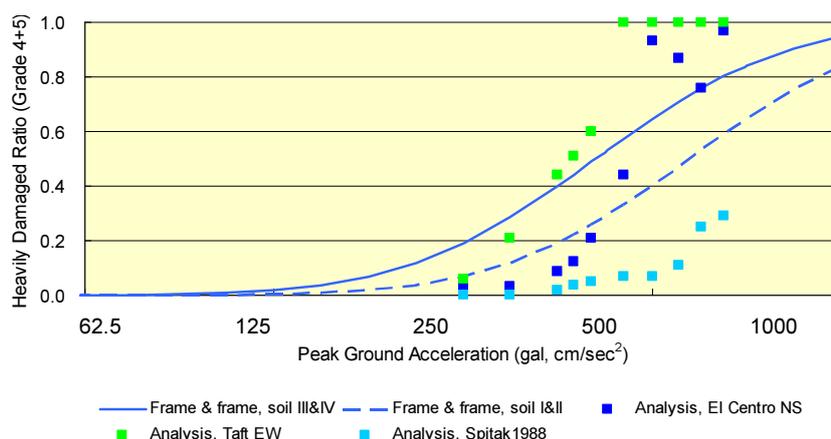
Figure 5.3-14 Proposed damage function and damage ratio by time history analysis

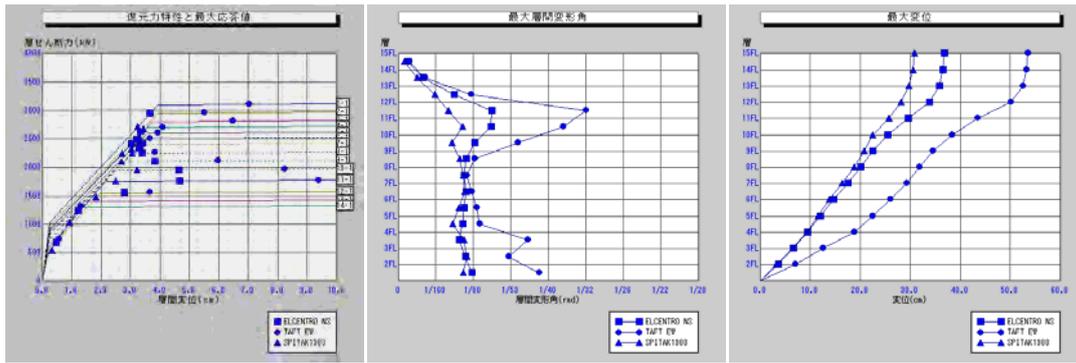
a) Story shear force – story deflection b) Story deflection angle c) Deflection at each story

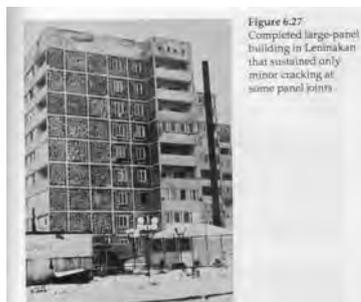
Figure 6-27 Completed large-panel building in Leninakan that sustained only minor cracking at some panel joints.

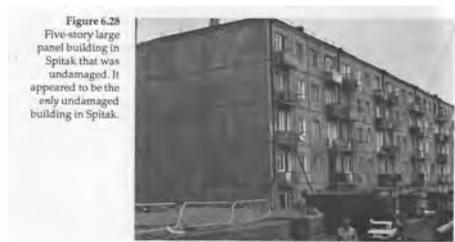
Figure 6-28 Five-story large panel building in Spitak that was undamaged. It appeared to be the only undamaged building in Spitak.

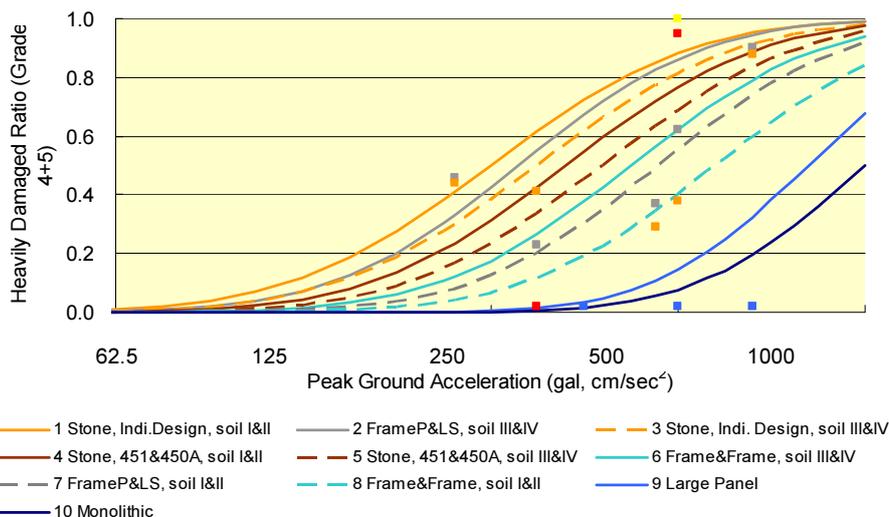
Figure 5.3-17 Proposed damage function for multi-story residential buildings

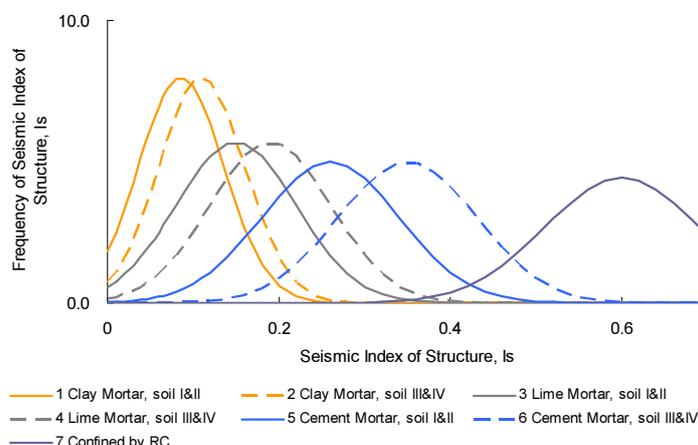
Figure 5.3-18 Assumed distribution of seismic index of structure, ‘Is’

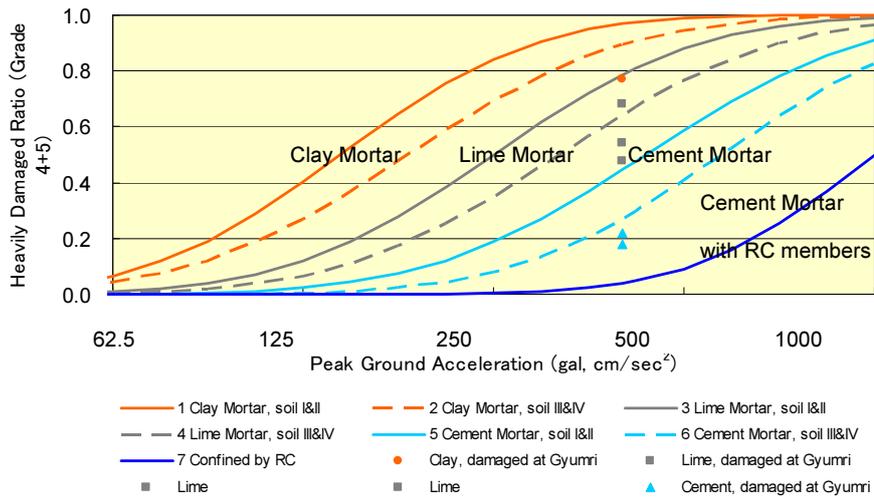
Figure 5.3-19 Proposed vulnerability function for individual houses

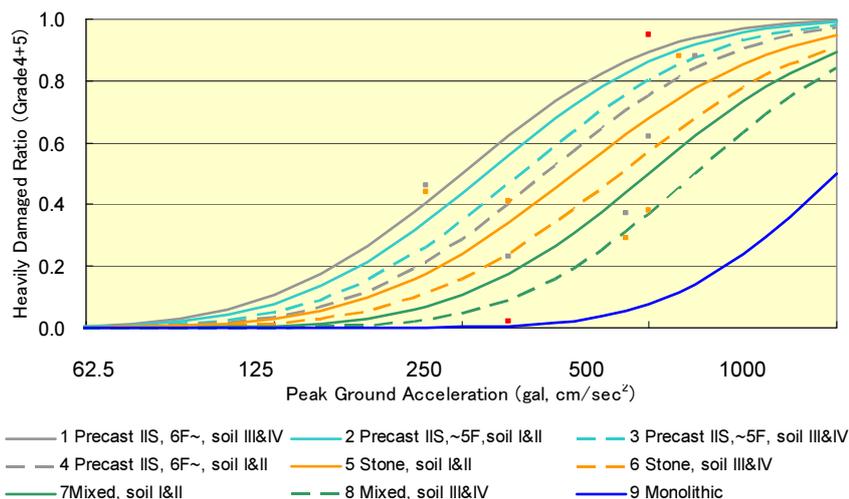
Figure 5.3-20 Proposed vulnerability function for schools and hospitals

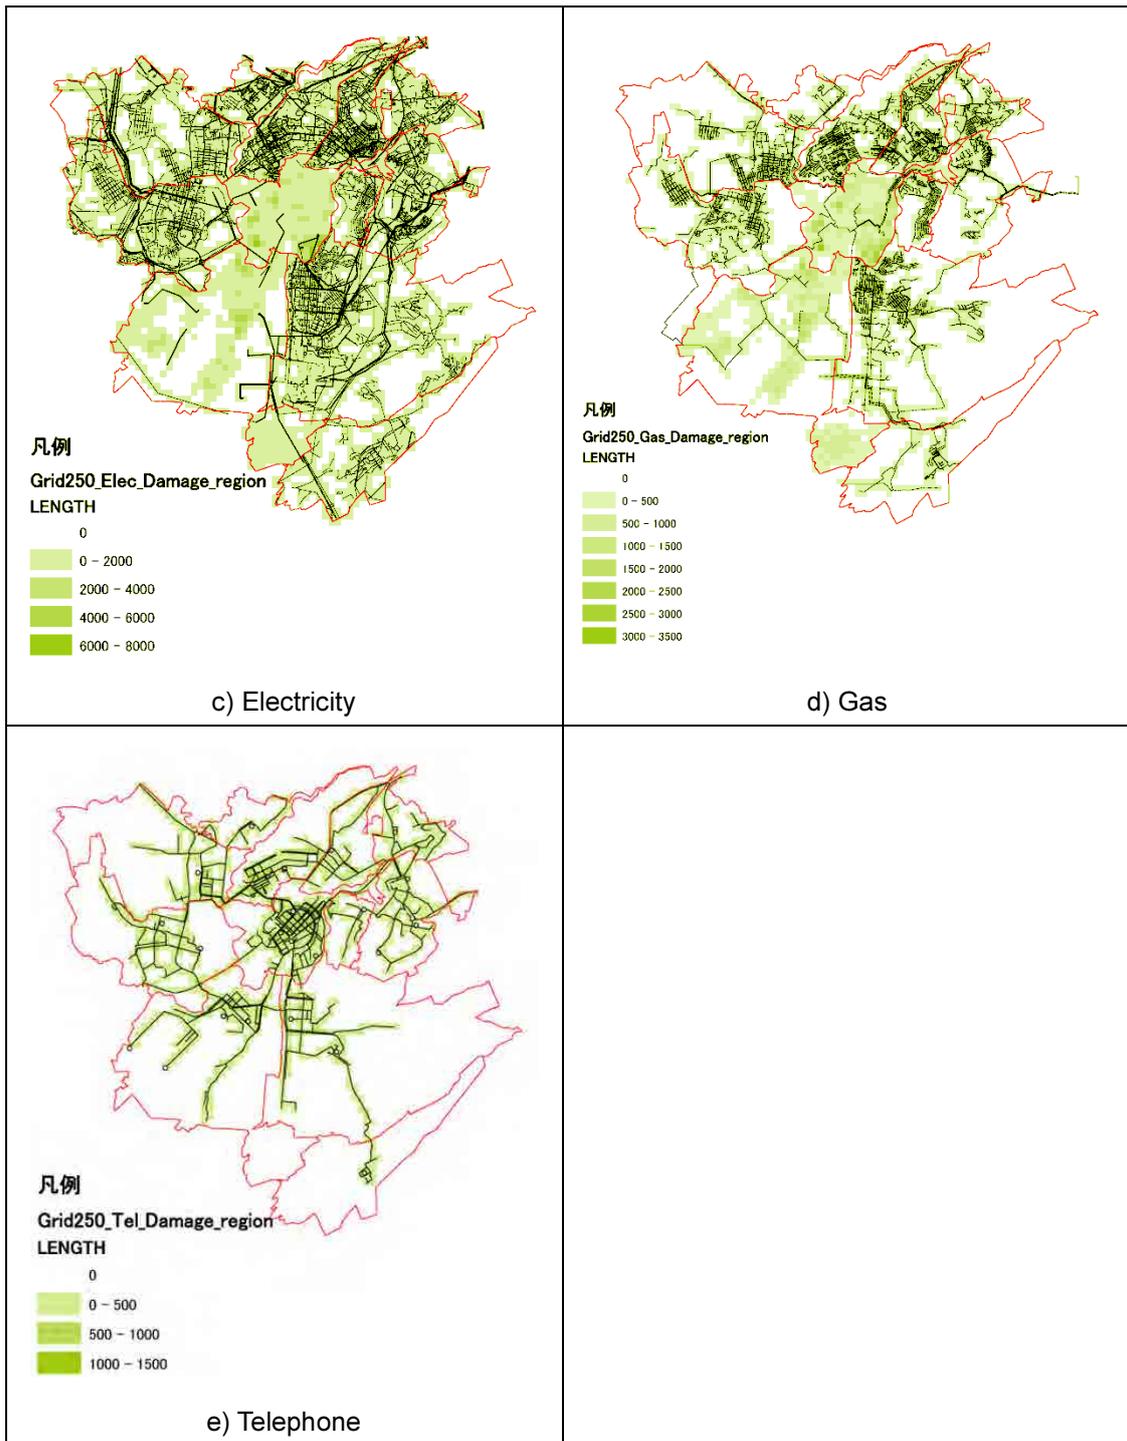
Figure 5.6-1 Distribution of lifeline network, lines show the pipelines or cables by GIS data and color shows the length in 250m grid
