Chapter 4 Seismic Hazard Assessment

4.1 Modeling of Ground Conditions

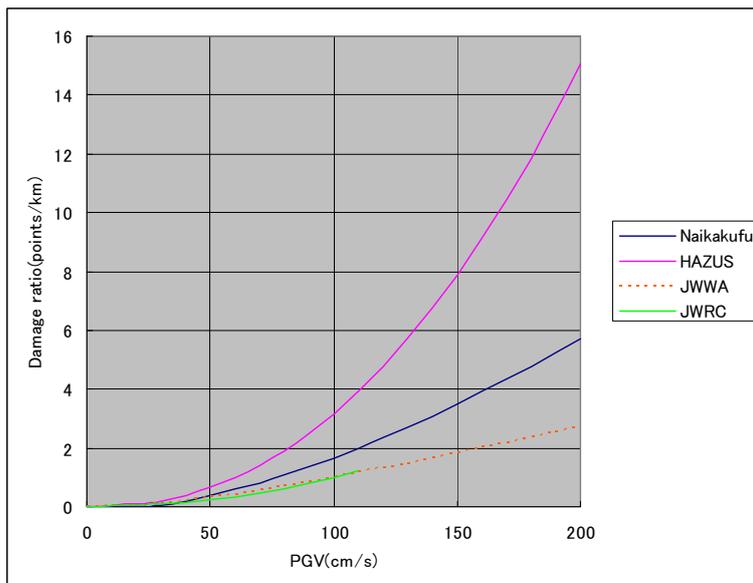
Figure 5.7-1 Standard damage rate of water supply pipes

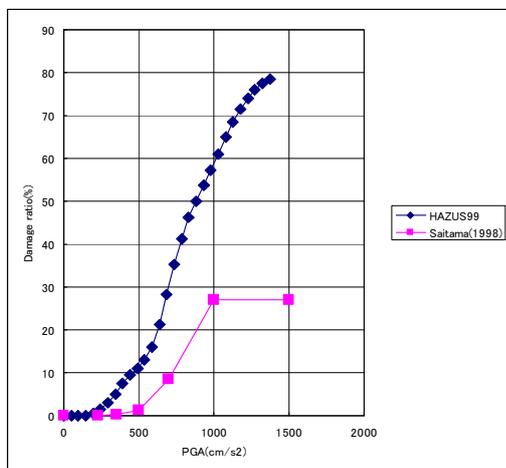
Figure 5.7-2 Damage function of aerial cable

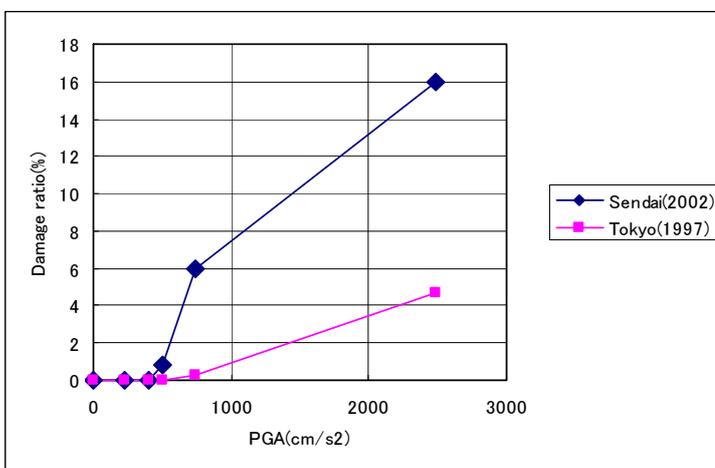
Figure 5.7-3 Damage function of underground cable

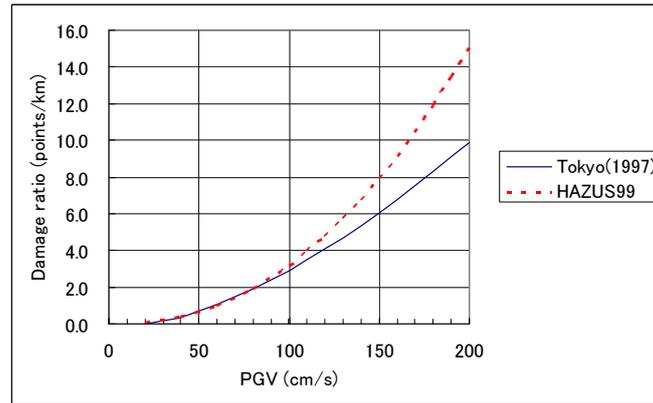
Figure 5.7-4 Standard damage rate of gas underground pipe

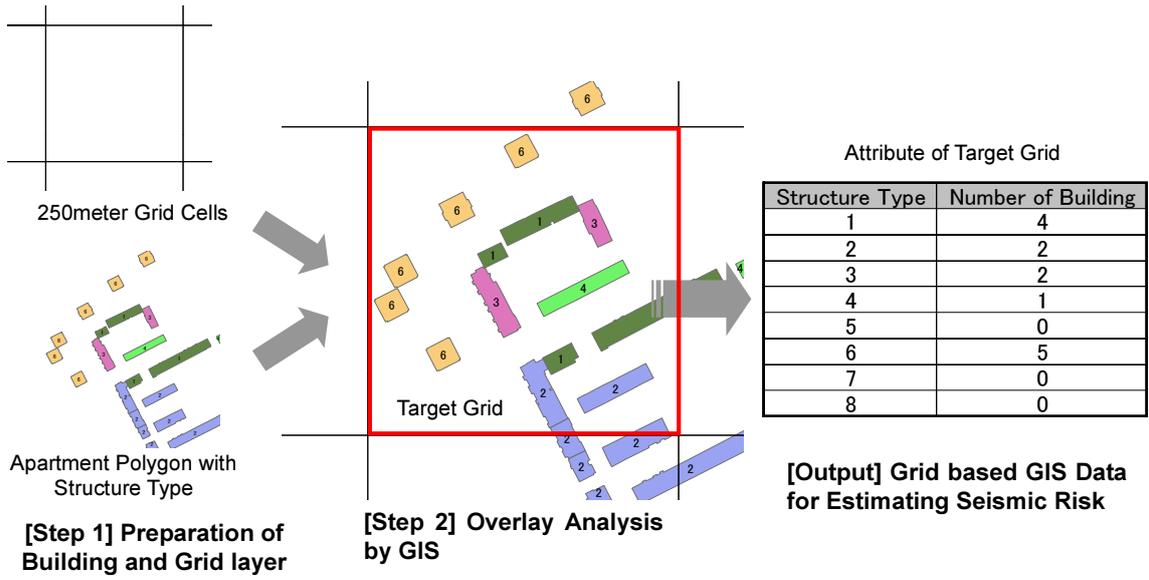
Figure 5.8-1 Steps of creating grid base inventory data, in the case of apartment
