2. Pilot Activities in Borella

THE CAPACITY DEVELOPMENT PROJECT FOR NRW REDUCTION IN COLOMBO CITY

Borella Area

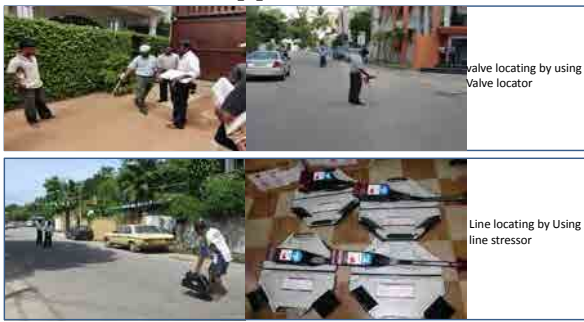
Detecting buried lines & valves by using metal locator and pipe locator

valve locating by using Valve locator

Line locating by Using line stressor

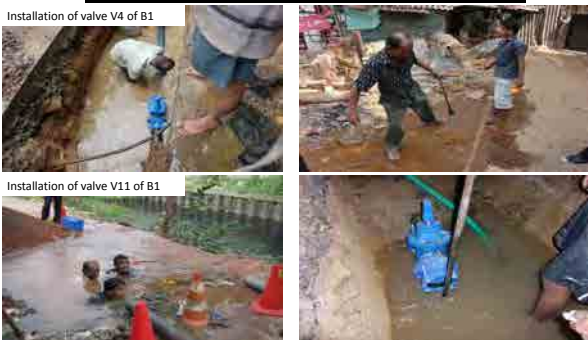
Valve Installation & Zone Isolation

Installation of valve V4 of B1

Installation of valve V11 of B1

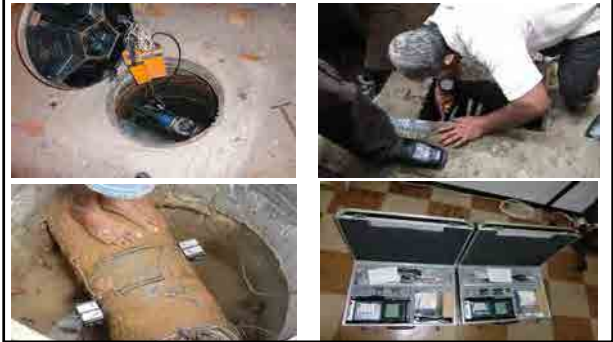
Initial Inflow & Pressure

- Some selected valves will be closed (without interrupting water to zone) to minimize the feeding points.
- All feeding points are metered or converted into accessible positions (Installation of meter chamber) to fixed mobile meters (Ultrasonic meters) when it is required.

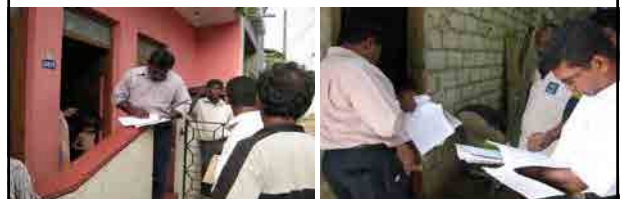
Customer List and Meter Condition Survey

Customer list should be prepared and all meter condition should be checked.

Summery of the Survey

zone name	B1	B2	B3	B4	B5	B6	B7	B8	B10	Total	%	B9
No. of consumers	584	624	360	453	814	1109	307	186	191	4628	100	623
Commen taps	2	6	0	27	11	7	1	2	0	56		2
No. of working meters	543	596	289	435	762	891	287	160	164	4127	89.17459	77
No. of unmeter detected	12	3	1	17	6	9	0	1	3	52	1.123596	148
No. of defective detected	15	2	13	15	28	25	5	4	3	110	2.376837	360
No. of difficult to read	0	0	2	0	4	5	0	2	0	13	0.280899	38
No. of disconnected premises	0	0	3	0	12	155	3	12	9	194	4.191876	0
No. of houses closed	7	23	47	12	8	24	12	7	12	152	3.284356	0
No. of illegal rectified	8	15	25	13	14	190	1	9	4	279	6.028522	90

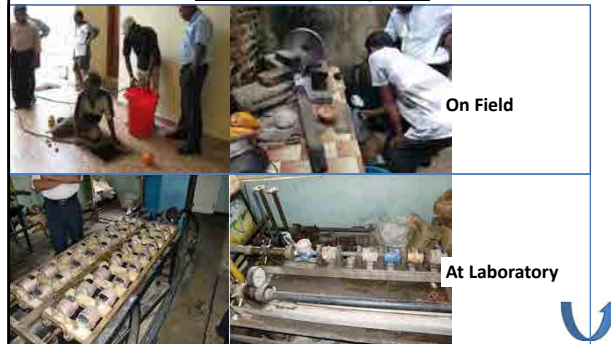
Meter Accuracy test

- Out of total, at least 10% of water meters were tested randomly at site with the help of calibrated(50l) bucket (Ex. 60 meters for zone B1)
- Additionally, another few meters (mostly doubted once) were checked through meter testing unit

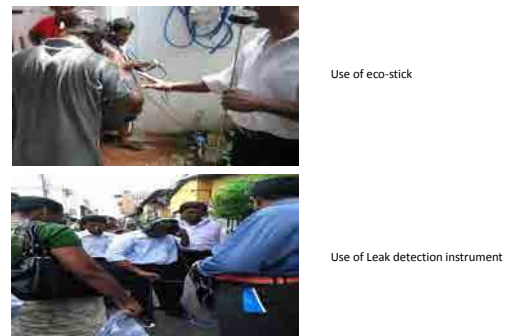
Leak Detection

- The portion between ferrule to house meter point will be checked by using **Eco-stick**.
- All other areas will be checked by using **Leak Detection Instrument** some times by correlator.
- Pin-point or confirmation survey can be introduces if required.

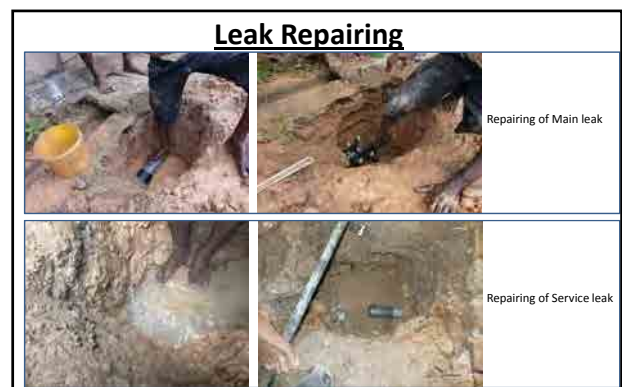
Leak Recording System after repairing

Leakage Record Sheet

Date of survey: 27/10/2010		Street No.:	
Account No.:	House No.:		Point of Fix:
Pipe/Type:	GP, CP, Other:	Location:	Pipe, Connection, Valve, Other:
Diameter:	mm	Condition:	Pipe, Crack, Straddle, Friction, Loose, Other:
House Connection:	PVC, GP, Other:	Cause:	Corrosion, Water pressure, Damaged, Hand, Straddle, Other:
Diameter:	19 mm	Location:	Pipe, Connection, Valve, Other:
Depth:	cm	Condition:	Pipe, Crack, Straddle, Loose Connection, Friction, Unknown, Other:
Leakage Size:	Slope (Medium)	Cause:	Corrosion, Water pressure, Leak Adhesive, Deterioration, Wrong Construction, Traffic load, Unknown, Friction, Other:
Leakage Date:		Depth:	Asphalt, Concrete, Gravel, Glass, Soil, Other:
Leakage Quantity (Measured):		Point of Leakage:	
Date of Repair: . . . 2010 Time/ . . . (H)		Material:	
Other Remarks:		Other Remarks:

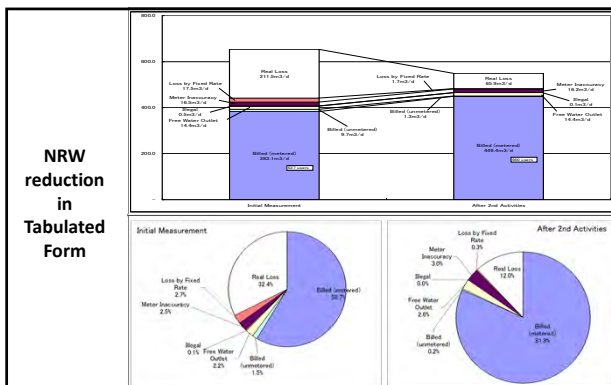
Details of NRW reduction in B1 (According to IWA water balanced sheet)

B1 Initial Measurement				B1 After 2nd Activities			
System Input Volume	407.1 m ³	42.7%	800.0%	465.1 m ³	44.7%	800.0%	800.0%
Billed Authorized Consumption	392.7 m ³	96.5%		450.1 m ³	96.8%		
Unbilled Authorized Consumption	14.4 m ³	3.5%		14.4 m ³	3.1%		
Unauthorized Consumption	0.0 m ³	0.0%		0.1 m ³	0.0%		
Water Losses	34.5 m ³	8.5%		18.0 m ³	4.3%		
Apparent Losses	16.5 m ³	4.0%		16.2 m ³	3.5%		
Mater Inaccuracy	16.5 m ³	4.0%		16.2 m ³	3.5%		
Loss by Fixed Gate	0.0 m ³	0.0%		0.0 m ³	0.0%		
Non-Revenue Water	26.0 m ³	6.5%		17.9 m ³	4.2%		
Real Losses	211.5 m ³	51.9%		65.9 m ³	14.2%

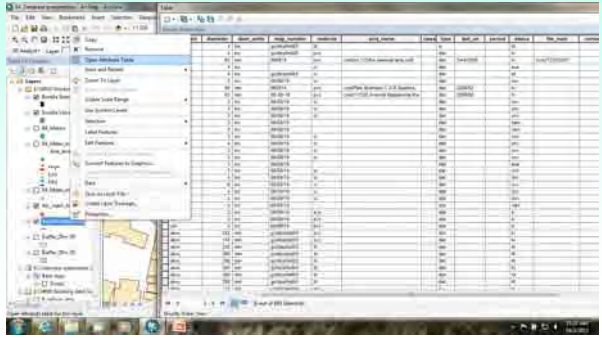
By attribute Table

Exploring pipe information

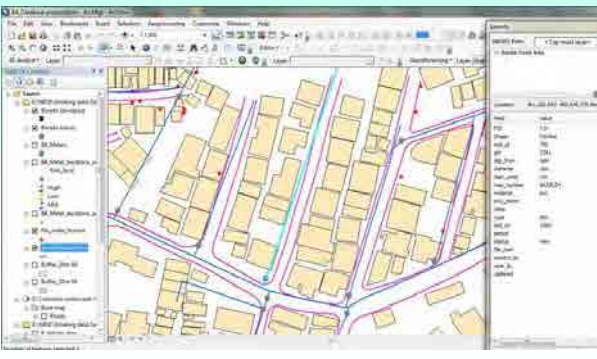
Selecting an object

Exploring pipe information

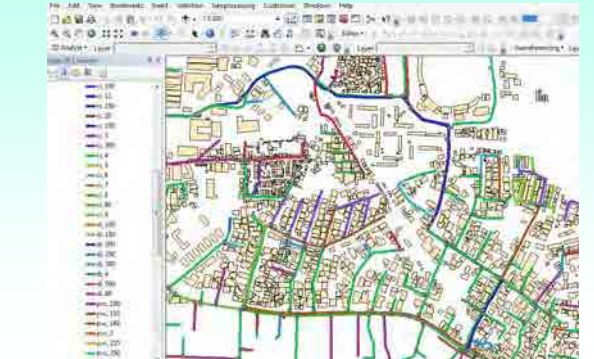
Querying Objects

Exploring pipe information

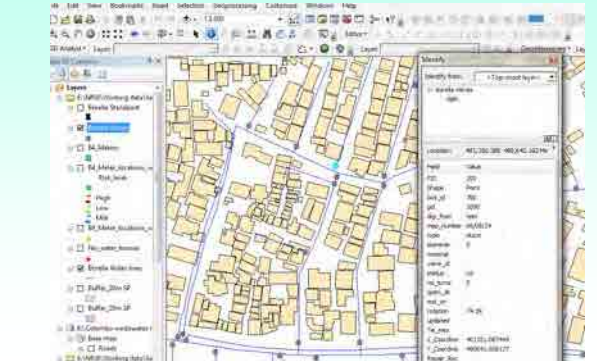
Same thing can be done as pipelines

Exploring Valve information

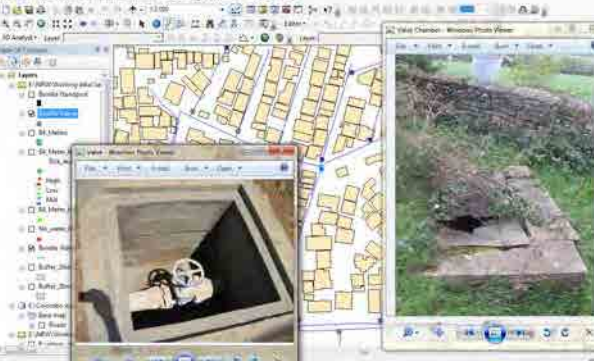
Link to Documents & Pictures

Exploring Valve information
