**(9) Presentation Materials for Public Seminar**  
**Held on 15th October, 2012**  
**Training Materials**

## THE CAPACITY DEVELOPMENT PROJECT FOR NRW REDUCTION IN COLOMBO CITY

## BRIEFING OF THE PROJECT AND RESULTS/FINDINGS

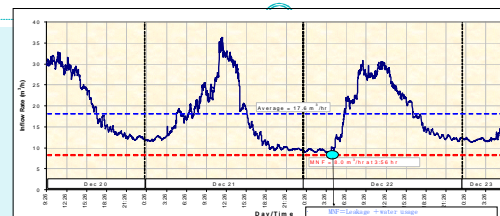
### Flow Measurement Survey Before the Activities

Measure the flow in the sub zone for 24 hours or more days.  
In the mid night, flow rate will be minimum. It may be close to leak volume.

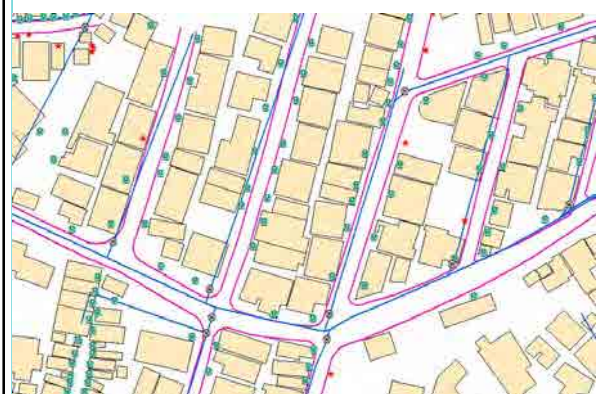
Field information on Base map

- Update Base Maps
- Location of Customer Meter
- Asset Management
- Record Leak Repair
- Record Unauthorized Consumption
- Use/update of GIS by Zone officers

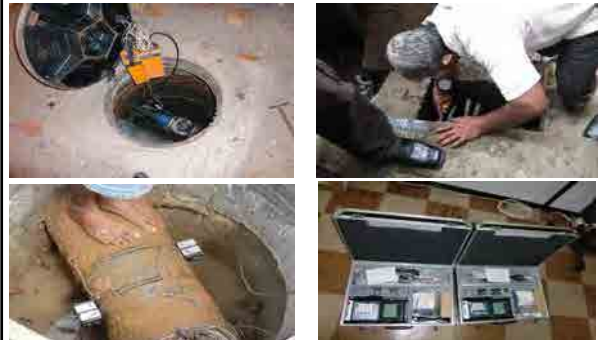
### Initial Inflow & Pressure

- Some selected valves will be closed (without interrupting water to zone) to minimize the feeding points.
- All feeding points are metered or converted into accessible positions (Installation of meter chamber) to fixed mobile meters (Ultrasonic meters) when it is required.

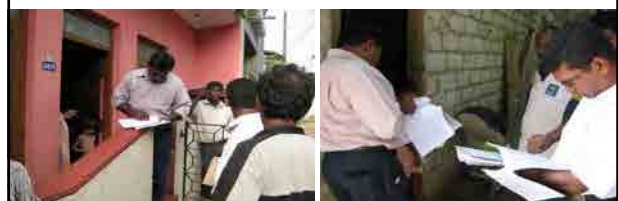
### Customer List and Meter Condition Survey

- Prepare the customer list of sub zone including the customer name, customer-ID, address and meter-conditions.
- Customer meter condition were checked one by one house based on the customer list.

Customer list should be prepared and all meter condition should be checked.

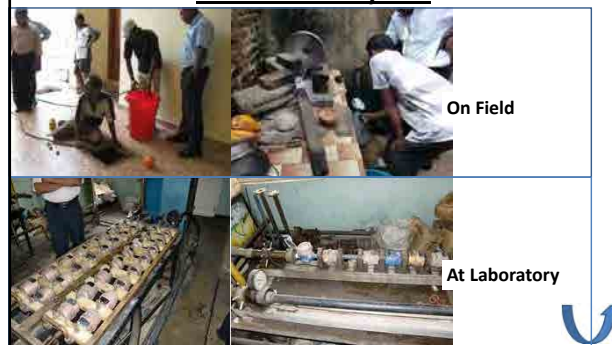
**Meter Accuracy test**

- Out of total, at least 10% of water meters were tested randomly at site with the help of calibrated(50l) bucket (Ex. 60 meters for zone B1)
- Additionally, another few meters (mostly doubted once) were checked through meter testing unit

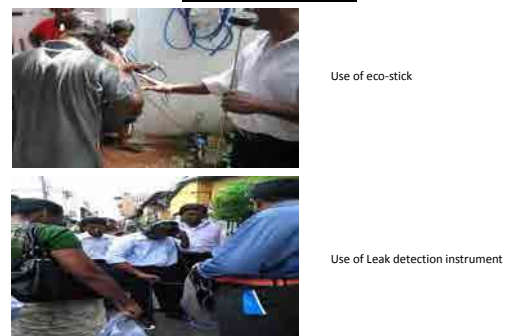
**Leak Detection**

- The portion between ferrule to house meter point will be checked by using **Eco-stick**.
- All other areas will be checked by using **Leak Detection Instrument** some times by correlator.
- Pin-point or confirmation survey can be introduces if required.

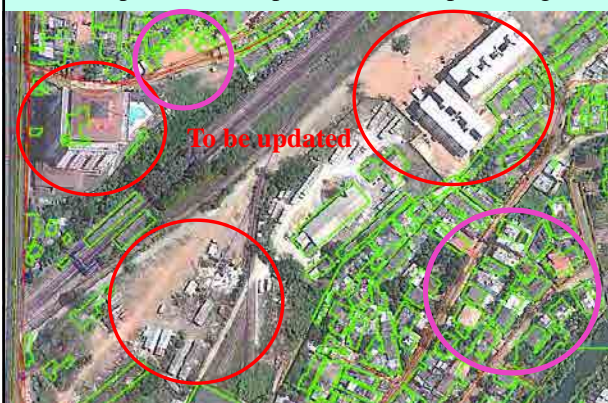
- **Base map**  
Developed under Norad Project using Year 2000 areal Photograph.
- **Water utility network**  
Developed under Norad Project using Norplan maps, As built data and field information. (2000 – 2006)

Base Map need to be updated due to rapid changes

Water utility network includes pipelines, Valves, Fire Hydrants, Standposts, Storages etc

There are several new objects and Information, which are not included in the GIS database and The database shall be updated.

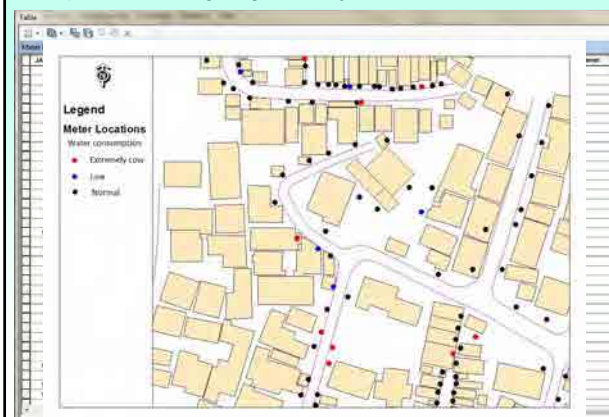
Example of selecting illegal survey locations in B4 area

Far from Public stand post

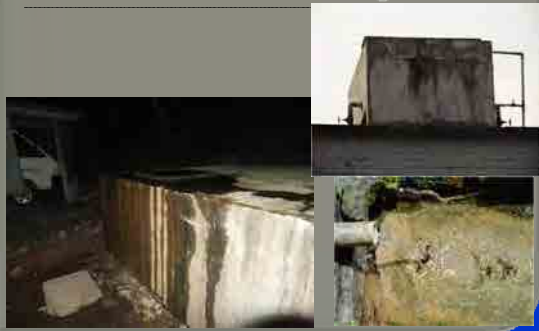
## Storage tanks

- Prepare list of tanks(sumps) and collect information
- Install bulk meter on all the inlet pipes
- The shortage to be arranged to charge from community or consumer

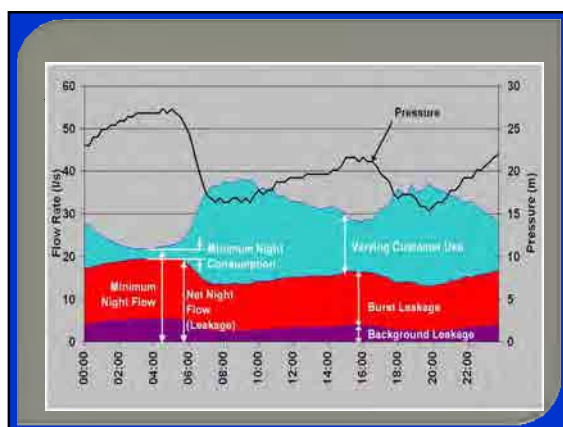
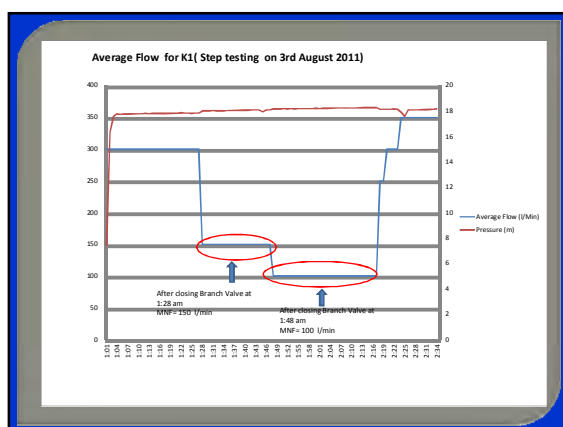
### Step Testing

- Step testing is a technique used to locate the areas of greatest leakage within a zoned distribution system.
- The test is undertaken at night during the period of minimum demand when leakage rates are highest.
- The areas identified with high leakage levels can then be given priority attention for leakage surveys.
