**PREPARATORY SURVEY FOR  
DHAKA-CHITTAGONG NATIONAL HIGHWAY NO.1  
BRIDGE CONSTRUCTION AND REHABILITATION PROJECT**

**THE KANCHPUR, MEGHNA, GUMTI 2ND BRIDGES CONSTRUCTION  
AND EXISTING BRIDGES REHABILITATION PROJECT)**

**FINAL REPORT  
VOLUME 1 : MAIN REPORT**

**March 2013**

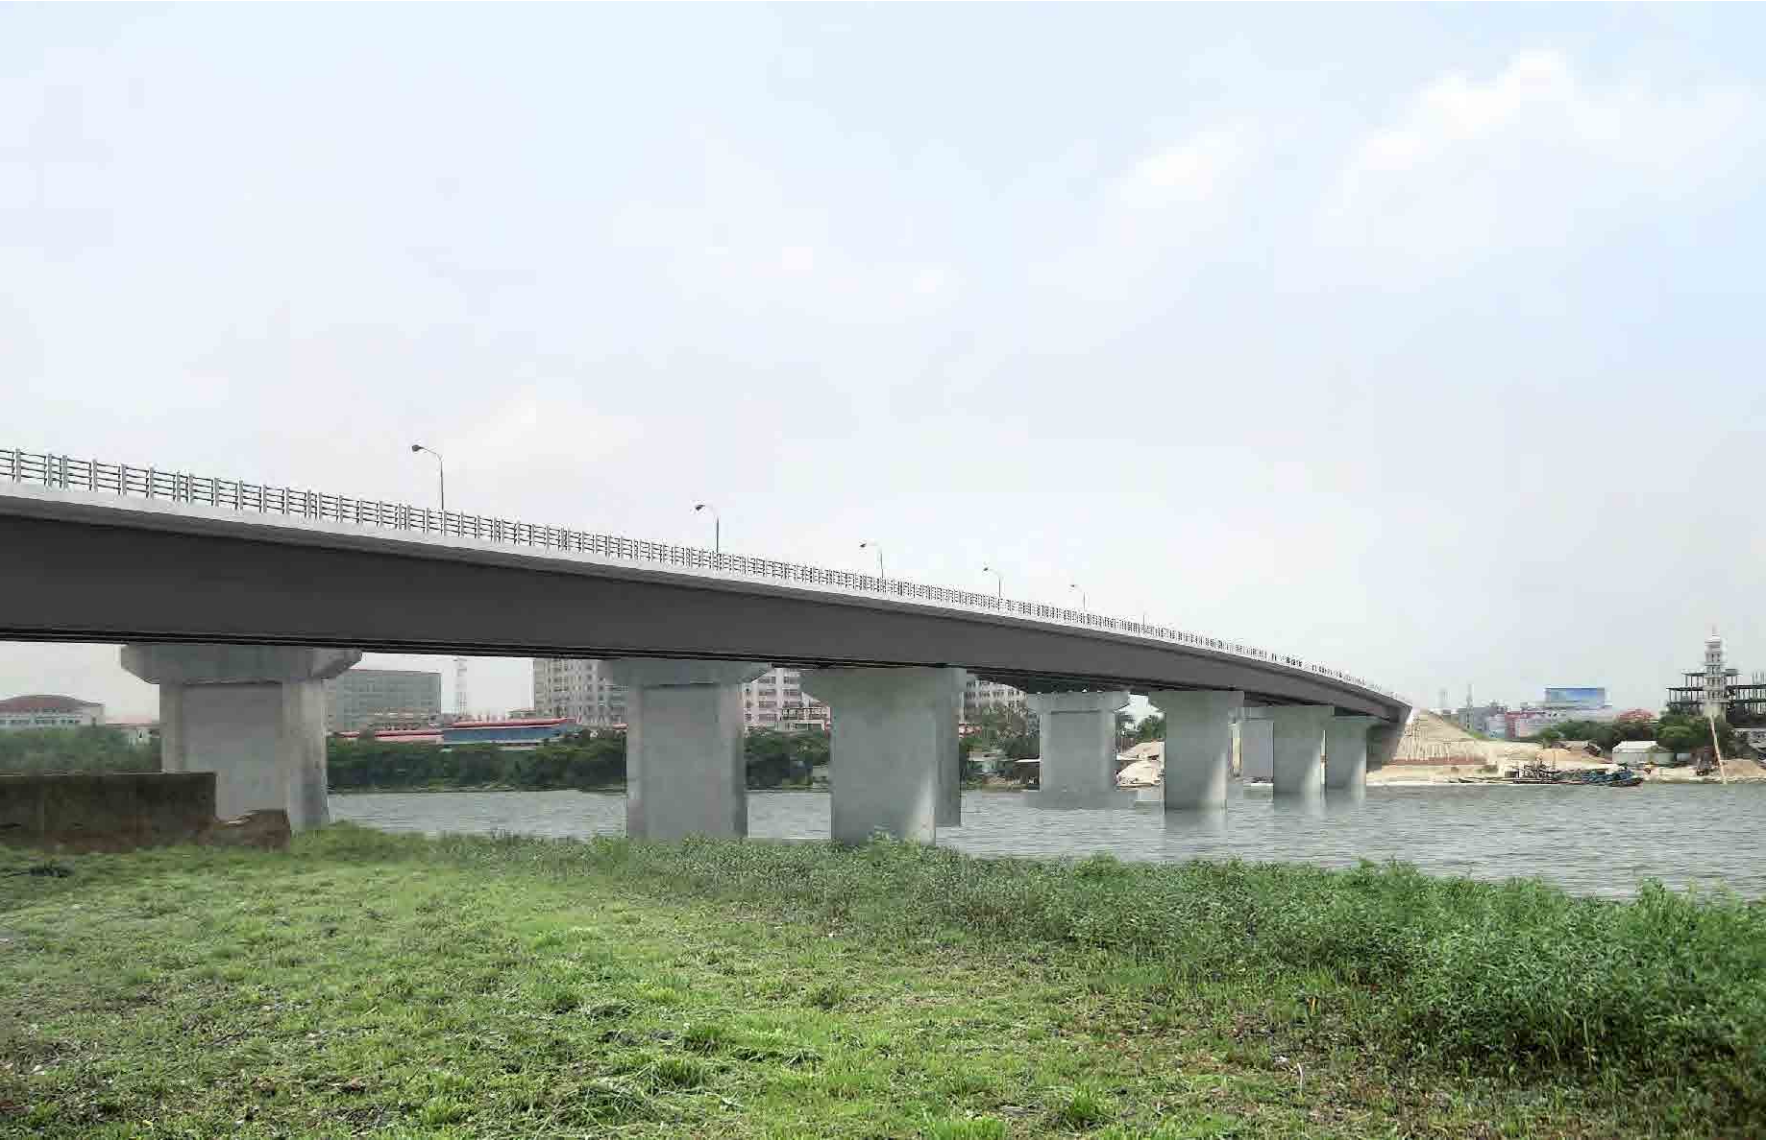
**Computer Graphics of completed 2<sup>nd</sup> Kanchpur Bridge (Dhaka side)**

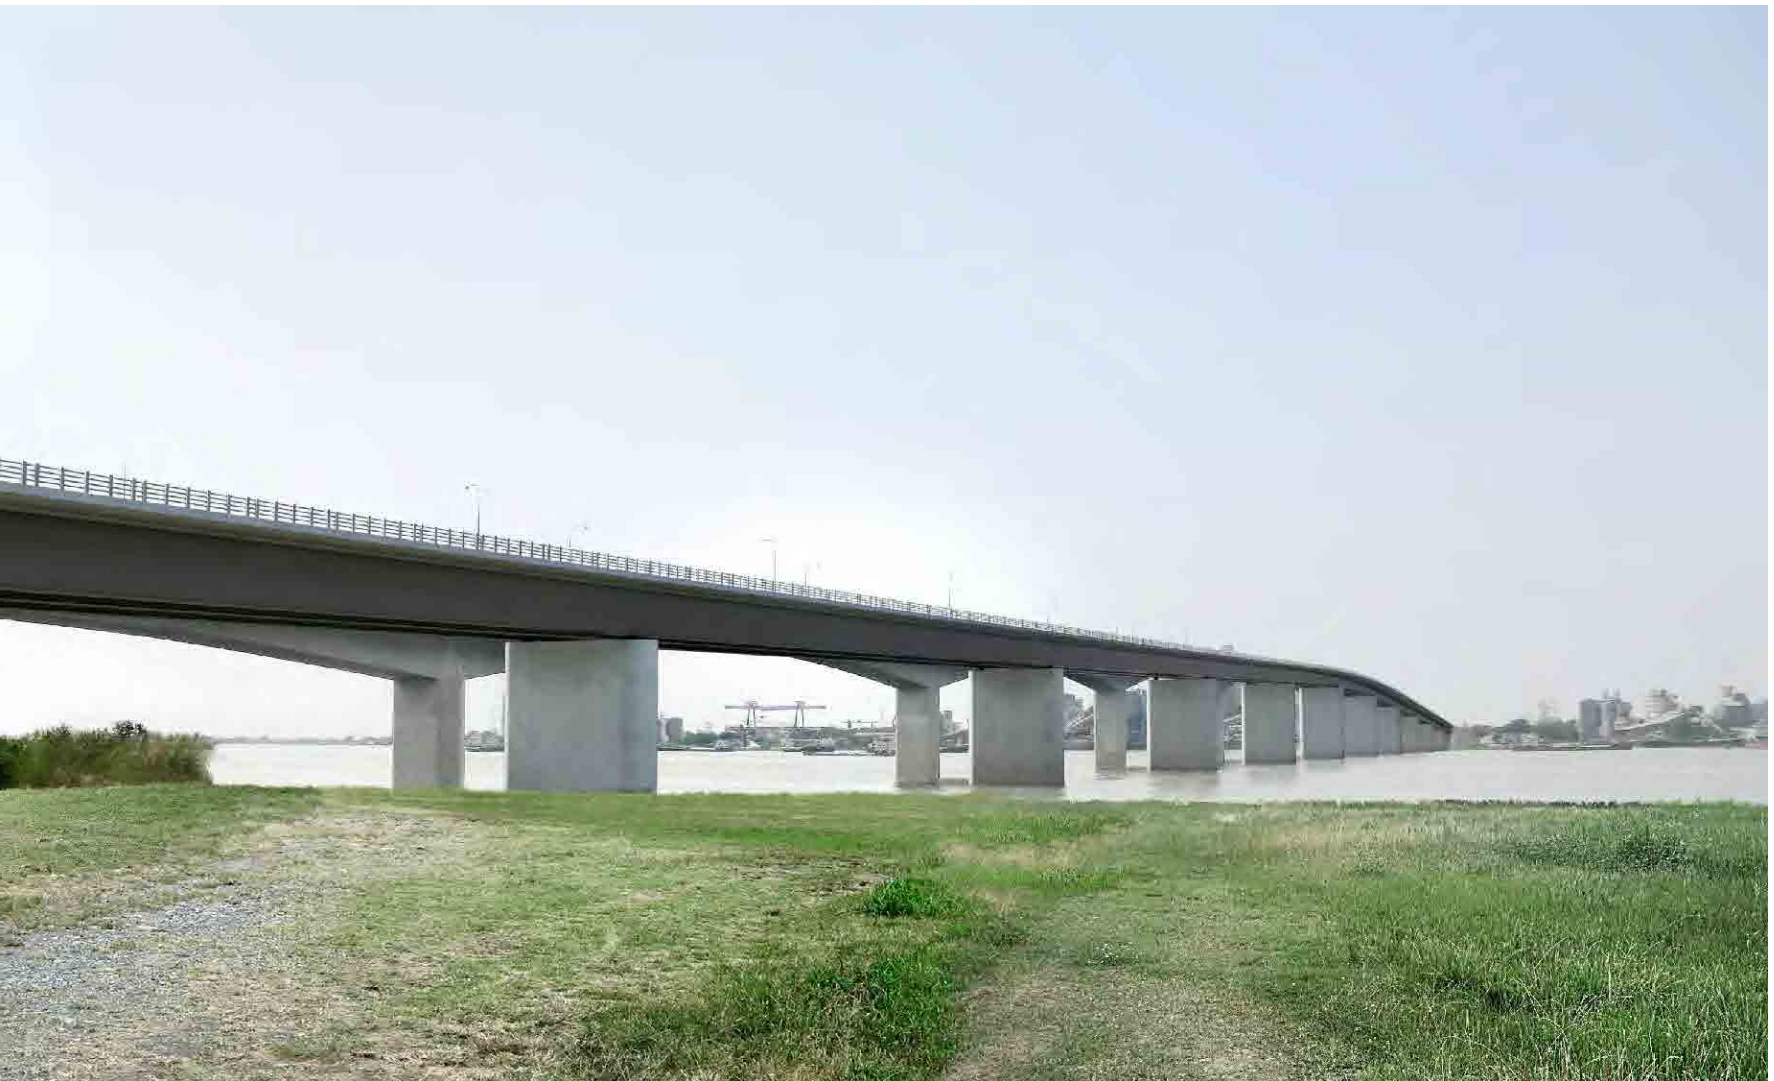
**Computer Graphics of completed 2<sup>nd</sup> Meghna Bridge (Chittagong side)**

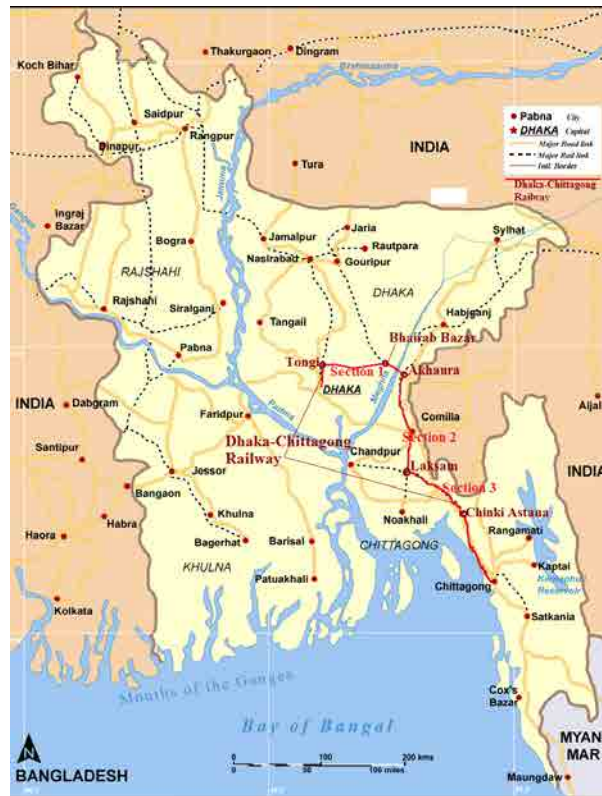
Figure 1.5.2 Dhaka-Chittagong Railway Network

About 200 km out of the 320 km railway line from Dhaka to Chittagong (Figure 1.5.2) is still only single track and therefore, a constraint to increase the number of trains in this corridor. Within those 200 km, of single track, the 3.7 km. single track section from Bhairab Bazar to Ashuganj has a rail-bridge named 'Bhairab Bridge' constructed on Meghna River, which is beyond the scope of double tracking. The Bangladesh Government's Sixth Five-Year Plan, 2011-2015 assigns high priority to increasing the capacity of the Dhaka-Chittagong corridor by completing double tracking on the entire corridor, which is important to increase the market share of the railway. Enhancing the capacity of the entire corridor will also allow operating additional trains for sub-regional trade through Chittagong Port with Bhutan, India and Nepal; a part of the Trans Asian Railway (TAR) network.

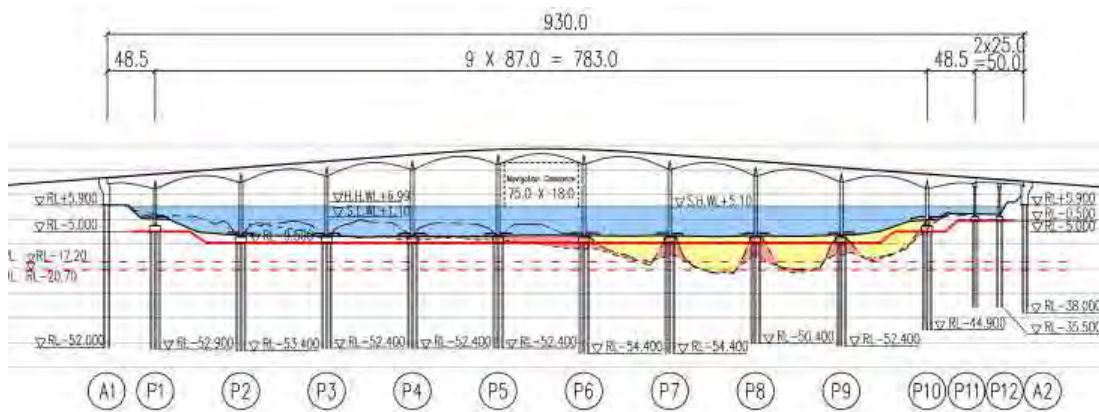
Figure 2.2.3 Longitudinal Profile of Existing Meghna Bridge (1995)

At the time of bridge construction, the elevation of Meghna riverbed at the lowest part was -7.0 m PWD. But after that, due to severe scouring effect, the riverbed elevation changed to -19.5 m PWD in 2010.

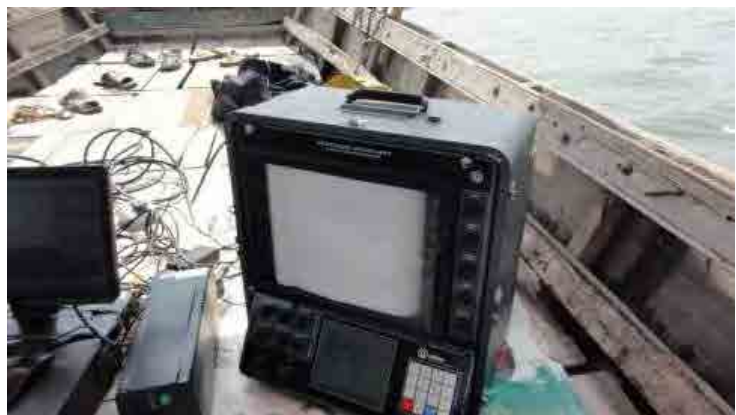
Echo-sounding device -Echo-trac DF3200 MKII

Odom Hydrographical Systems Inc.)

- ◆ River Bathymetric Survey (under the river flow)
- ◆ Using Echo- Sounding device (Figure 2.2.12)
- ◆ River Topographic Survey (on the land)

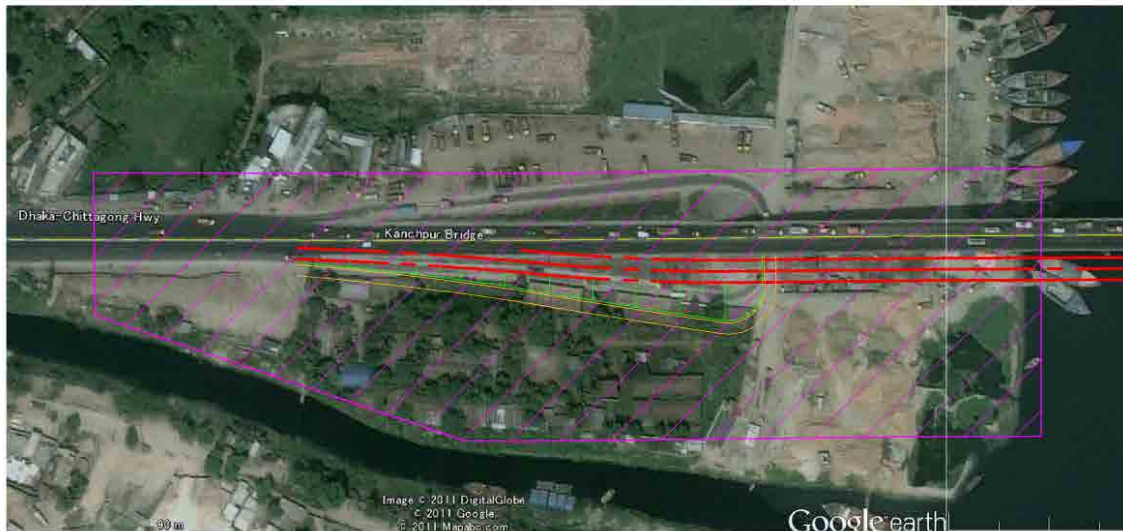
**Figure 2.2.14 Kanchpur Bridge (Dhaka side) Plane Table Survey Area**

**Kanchpur Bridge (Dhaka side)**  
**plane-table area 46,000m<sup>2</sup>**

Plane table survey areas are schematically shown in the following maps for Kanchpur Bridge, Meghna Bridge and Gumti Bridge.

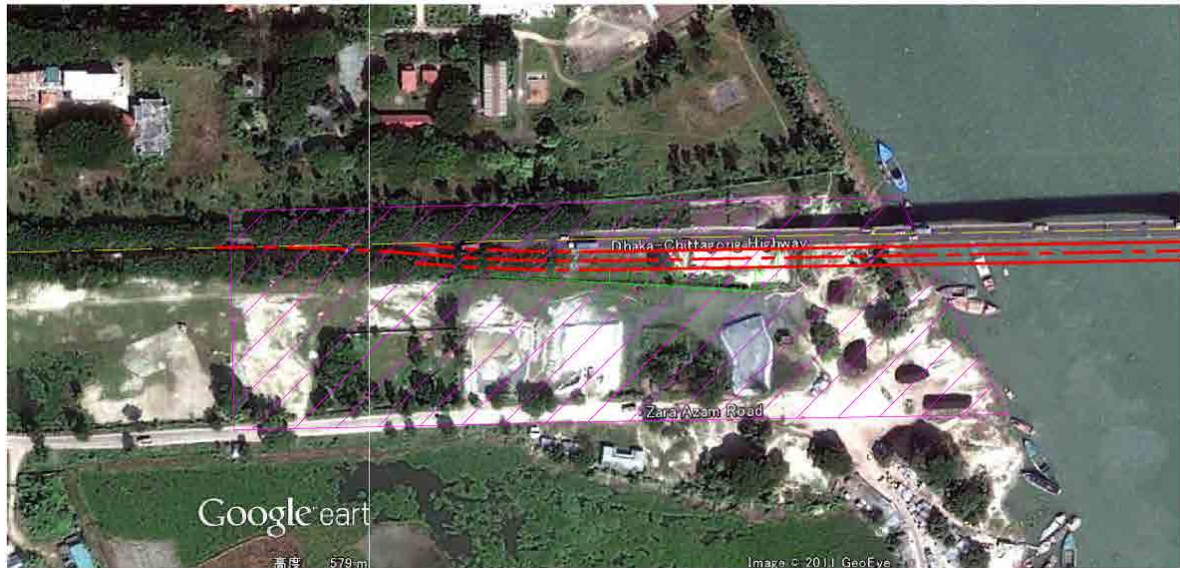
**Figure 2.2.17 Gumti Bridge (Dhaka side) Plane Table Survey Area**

**Gumti Bridge (Dhaka side)**

plane-table area 47,000m<sup>2</sup>

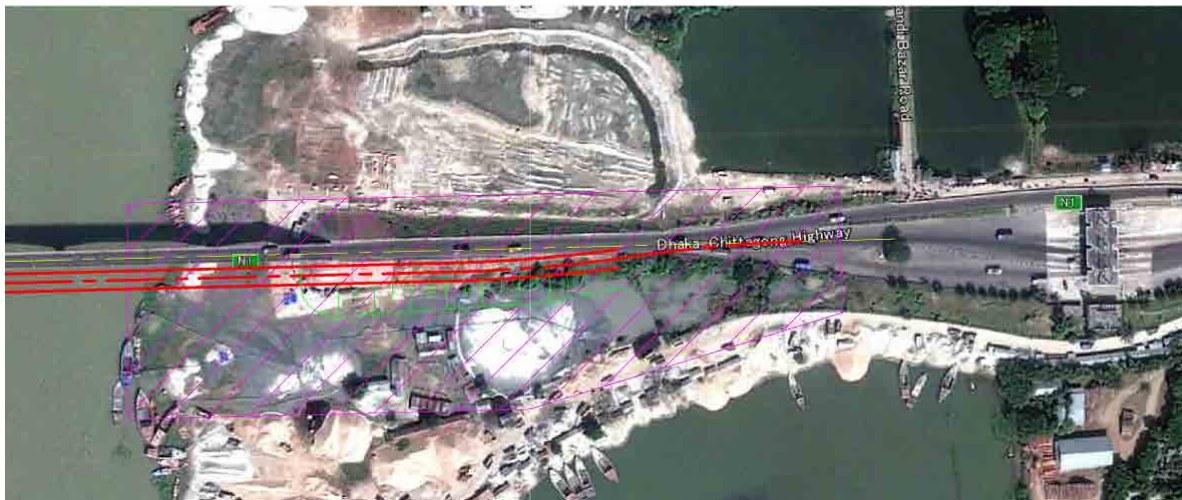
**Figure 2.2.18 Gumti Bridge (Chittagong side) Plane Table Survey Area**

**Gumti Bridge (Chittagong side)**

plane-table area 43,000m<sup>2</sup>

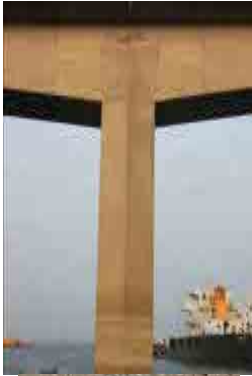
<p>A crack under 0.2 mm width in P1. Cracks over 0.2 mm width in P2, 3, 4, 5, 6, 7, 8, 9, 10, 13, 14, 15 and 16. Water leakage in P14 and 16. Small indents in P1, 2, 3, 4, 6, 7, 8, 8, 10, 12, 13, 14, 15 and 16. No rebar deterioration.</p> <p style="text-align: center;">Pier 14</p>

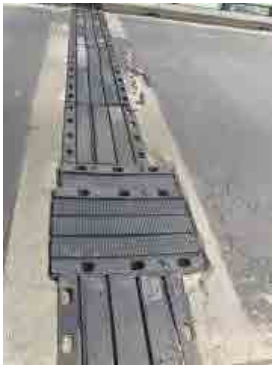
**Table 2.5.7 Observation of the Damages (Accessories)**

Kanchpur	Meghna	Gumti
Expansion joint

Damage	Exist	Exist	Exist
Hinge
