(3) Gumti Bridge

The hydraulic value of numerical analysis results at bridge center line in 100-year return period discharge is shown in Table 2.3.7, and cross section bed profile, water level, current velocity and water depth at same line is shown in Figure 2.3.11.

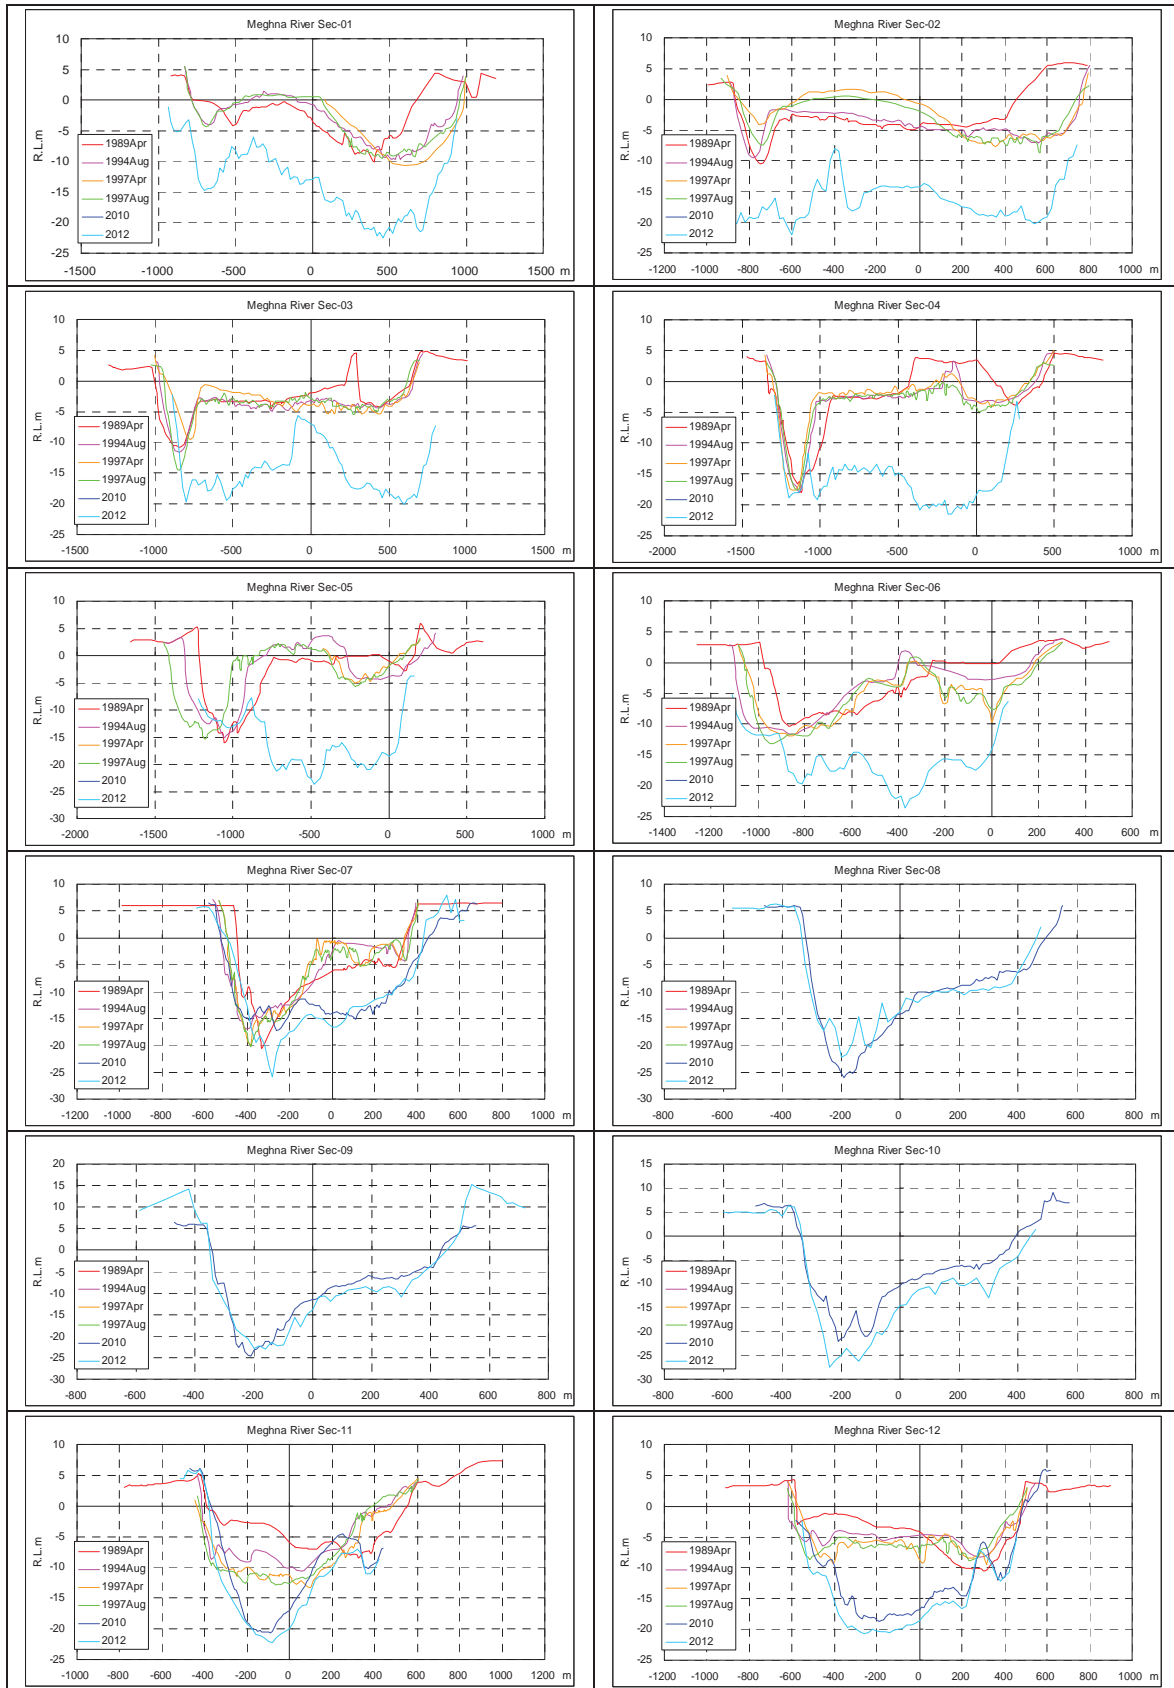
Figure 2.4.1 Historical Change of Cross Section Profile around Meghna Bridge

The historical change of cross section around Meghna Bridge is shown in Figure 2.4.1, which indicate that river bed height is widely declined between 1989 to 2012. It seems that river bed degradation is little for long range around Meghna Bridge by BWDB's regularly cross section survey shown in Figure 2.4.2, then it is supposed that reason of degradation is not change of natural circumstance like discharge, sediment transport.

It is difficult to define the reason of degradation, but it seems that illegal dredging is one of the affective impact, hence it supposed that it should be keeping bed height around bridge.

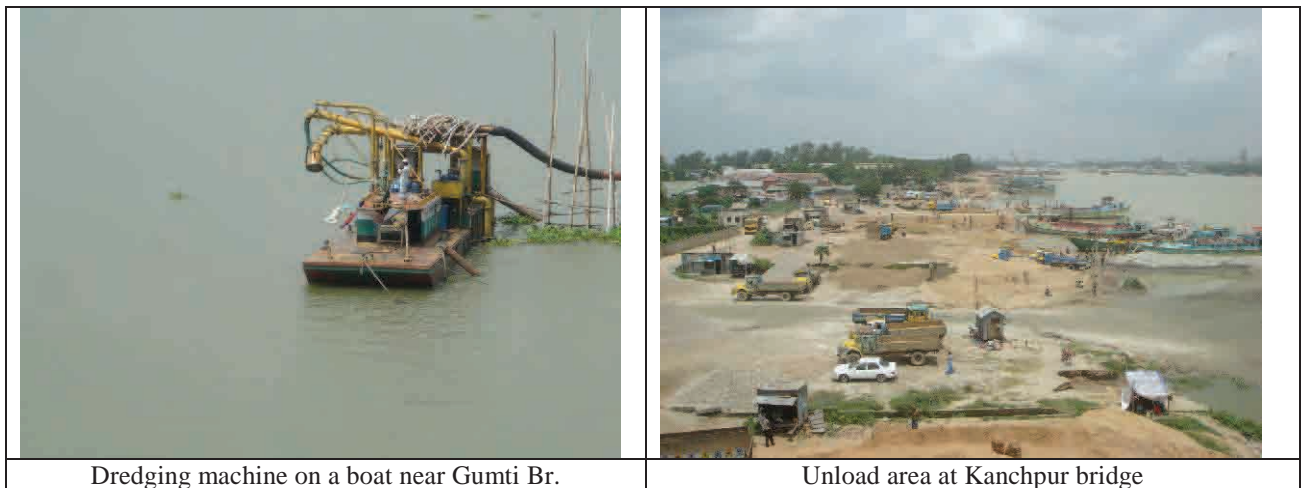
Figure 2.4.4 Dredging around the Bridge

Dredging machine on a boat near Gumti Br.

Unload area at Kanchpur bridge

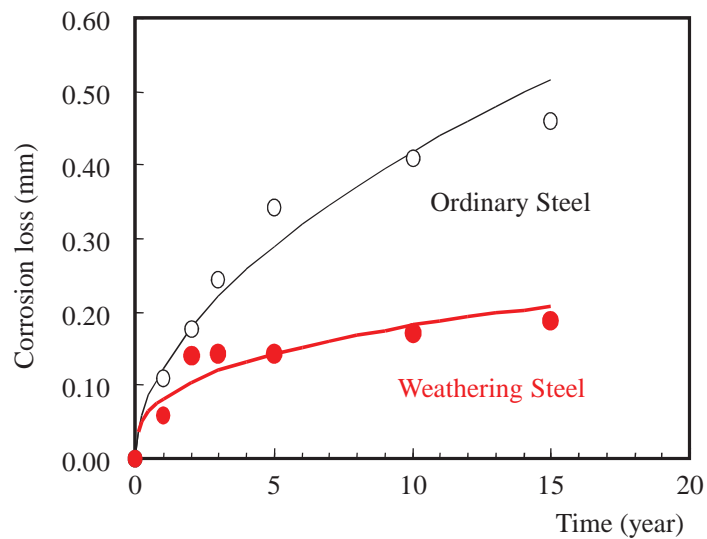
Figure A11.3.1 Corrosion resistance mechanism and corrosion loss in weathering steel

In order to explain the corrosion restraint mechanism, at first the chemical composition of weathering steel is examined and compared to that of ordinary steel. The mass distribution of the chemical constituents in weathering steel is shown in Table A11.3.1 in which copper (Cu), nickel (Ni) and chromium (Cr) are added to activate the corrosion resistance mechanism. This

(a) Mechanism of corrosion resistance

(b) Corrosion loss

Based on the observation results shown in Figure A11.3.1 and Figure A11.4.2 , a general trend of corrosion loss over time is formulated by an exponential relationship.

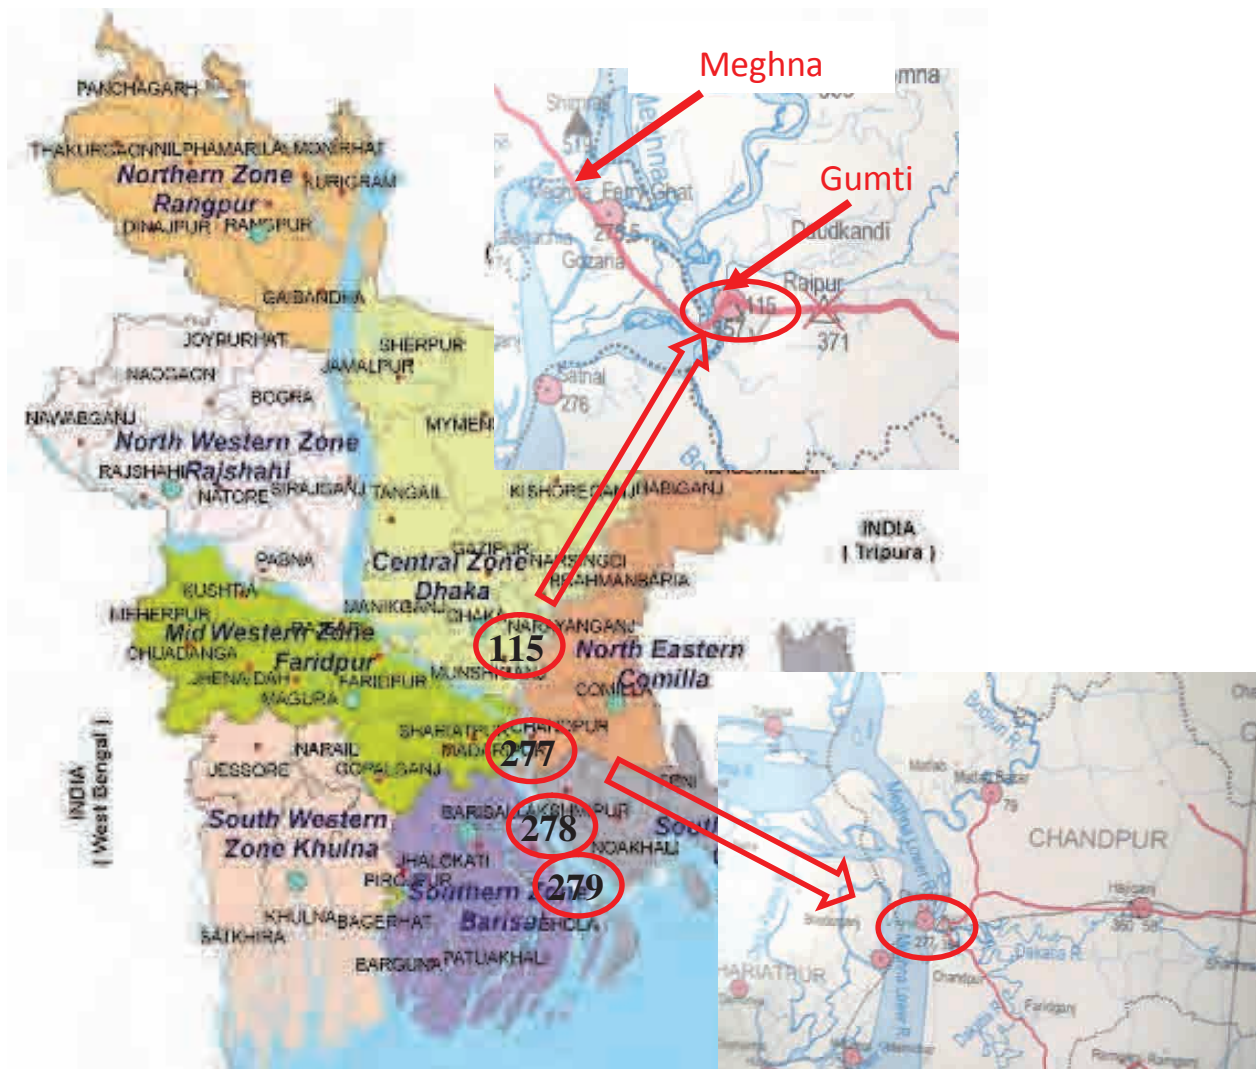
Figure A11.7.1 Locations of Salinity Stations (BWDB)

In order to verify the applicability of weathering steel in Bangladesh, the salinity data has been collected from Bangladesh Water Development Board (BWDB) for the respective bridge sites. The salinity data has been collected at four stations (ID 115, 277, 278, and 279) marked in Figure A11.7.1. Among the four stations, the station ID 115 is located at Gumti Bridge site, while the station ID 277 is near Meghna Bridge site. But, the salinity data at the station near Kanchpur Bridge site is not available. But, it is assumed that the salinity level at Kanchpur site will be lower than that at other two bridge sites. This is because the Kanchpur Bridge is located at upstream of Meghna and Gumti Bridges.

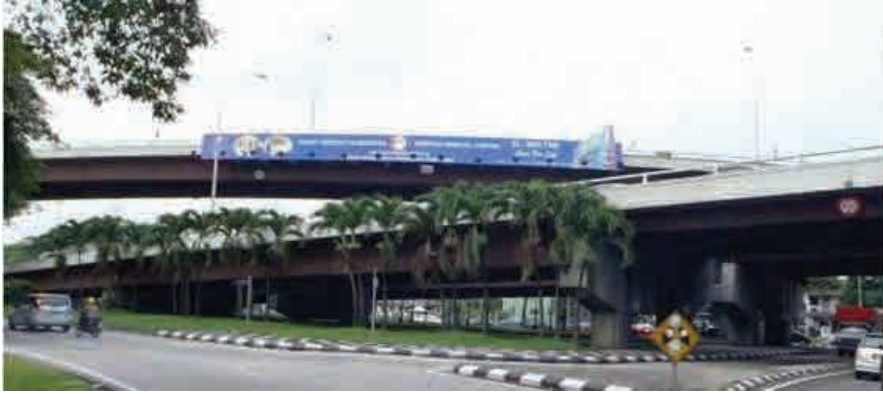
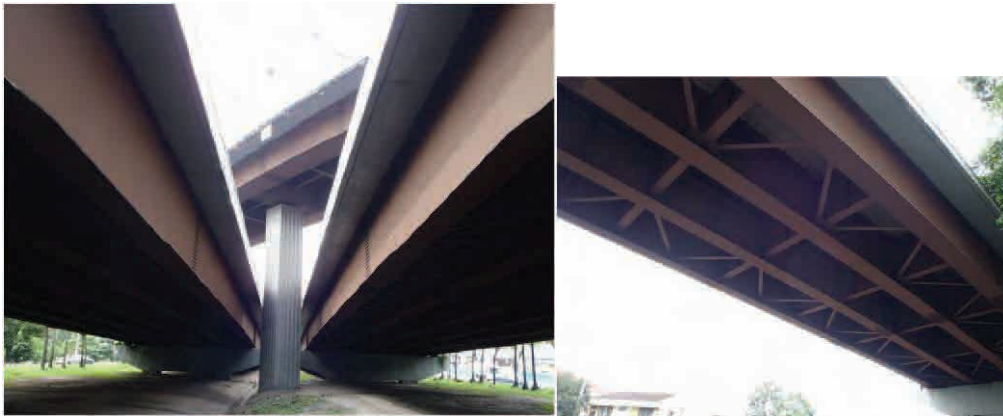
Bridge length: $(70.25+3 \times 80.0+70.25=380.5\text{m})$

Completion: 2007

(a) Kepong Interchange (Malaysia)

Figure A11.7.6 Example of weathering steel bridges in South-East Asia

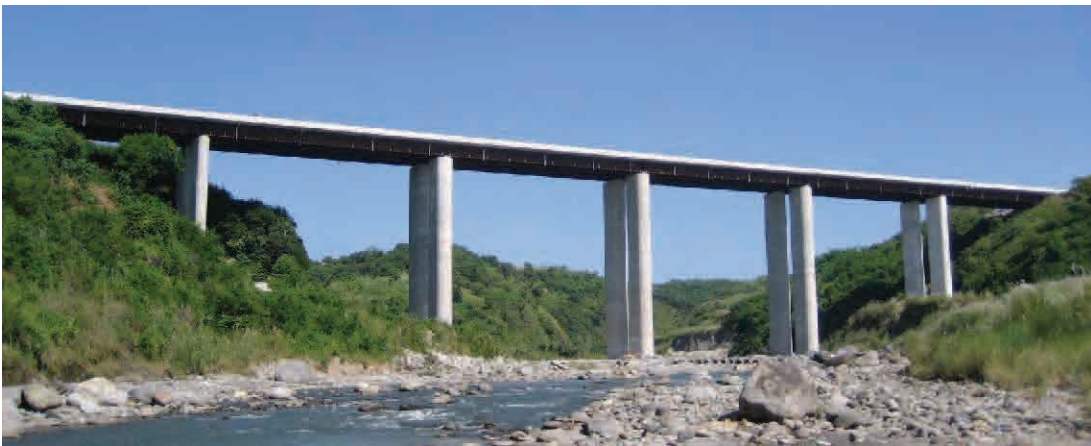
(b) Gumain Bridge (Philippine)

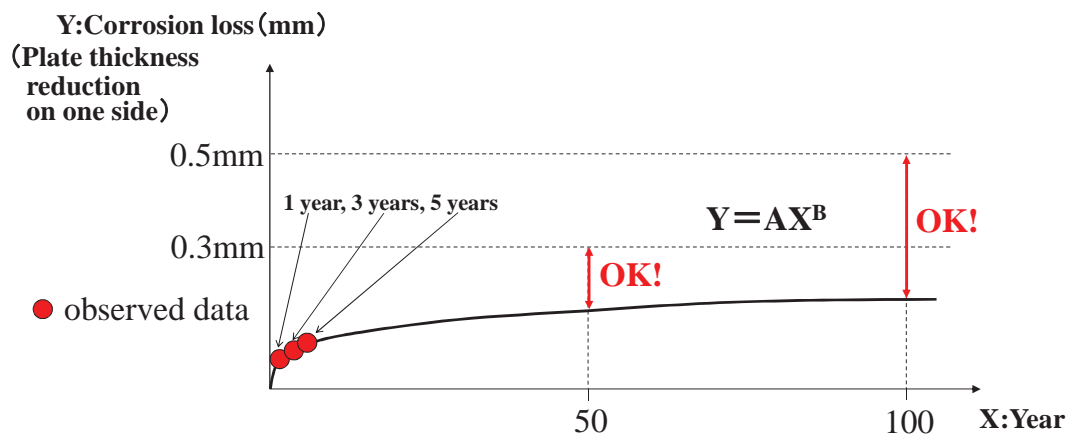
Figure A11.8.1 Evaluation the applicability of weathering steel

In order to evaluate the applicability of weathering steel, the corrosion loss due to reduction of plate thickness shall be examined in accordance with its tolerable limit over exposed time. In accordance with exposure test results conducted in Japan, the corrosion loss should be less than 0.03mm in first year. Moreover, some tolerable values recommended for corrosion loss over time to be elapsed are set at

$$\begin{aligned} \text{Corrosion loss} &\leq 0.03 \text{ mm (in 1 year)} \\ &\leq 0.30 \text{ mm (in 50 years)} \\ &\leq 0.50 \text{ mm (in 100 years)} \end{aligned}$$

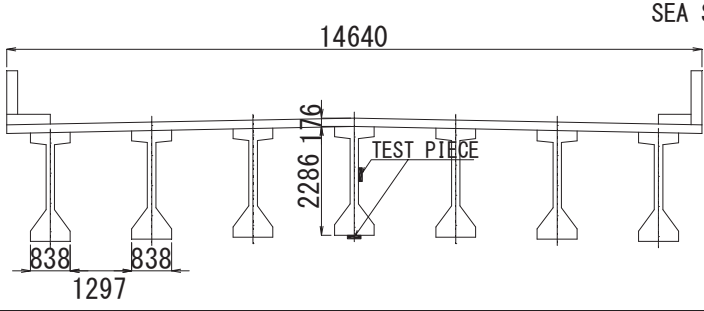
- (i) Middle of girder (humidity concentrated area) (Kanchpur Bridge)
- (ii) Side and lower side of girder (Meghna Bridge)
- (iii) Inner of the girder (Gumti Bridge)

| Bridge name | Girder end | Test piece |
|---|--|---|
| Kanchpur | <p>14640 SEA SIDE 2286 176 TEST PIECE 838 1297</p> | 12 |

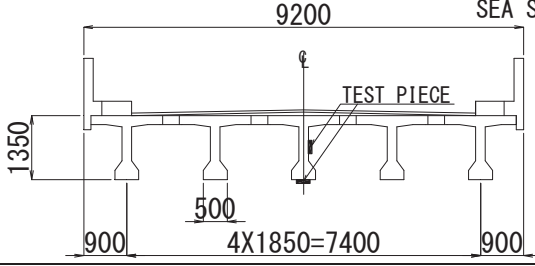
| Bridge name | Girder end | Test piece |
|---|--|---|
| Meghna | <p>9200 SEA SIDE 1350 500 4X1850=7400 900 TEST PIECE</p> | 12 |

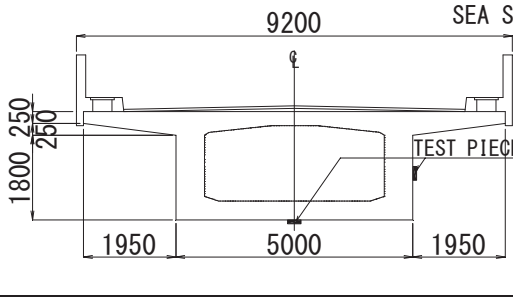
| Bridge name | Girder end | Test piece |
|---|--|---|
| Gumti | <p>9200 SEA SIDE 1800 250 1950 5000 1950 TEST PIECE</p> | 12 |

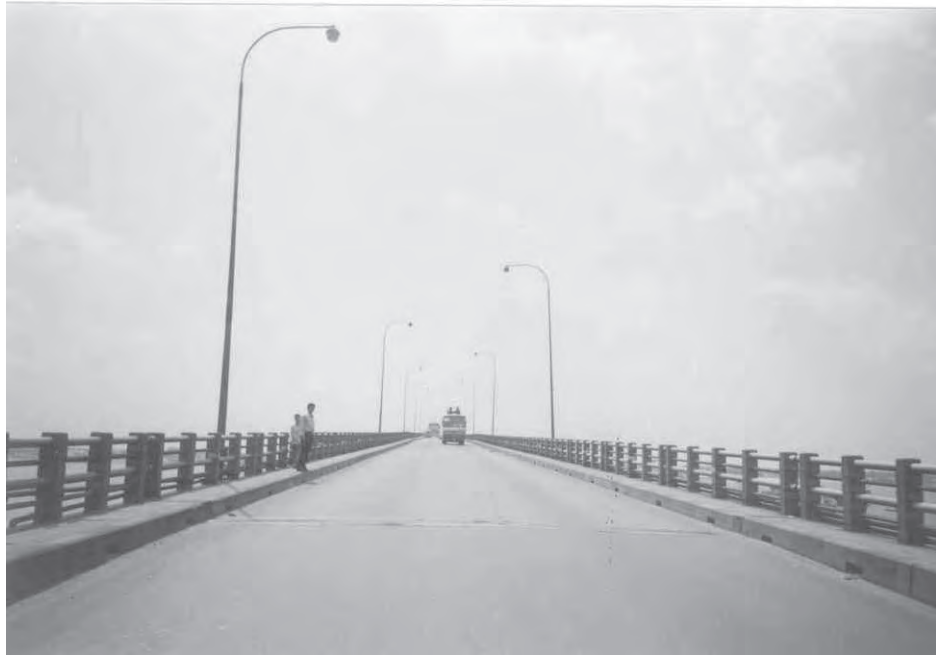
TOP VIEW OF BRIDGE

2sqm slope protection need repair, 8sqm side walk at right side need repair

6m. expansion joint, 2m. railing need repair and 4 m. railing need replacement.
