1.2.5 Land Sat Data

1.3 Topographic Survey (on river)

1.4 River Current Velocity Survey

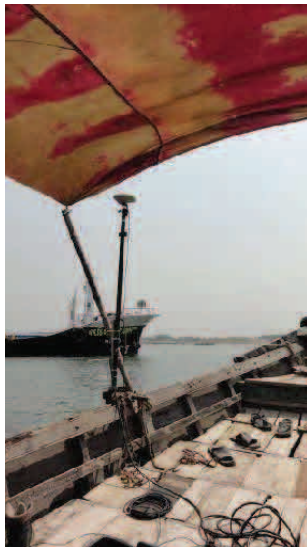
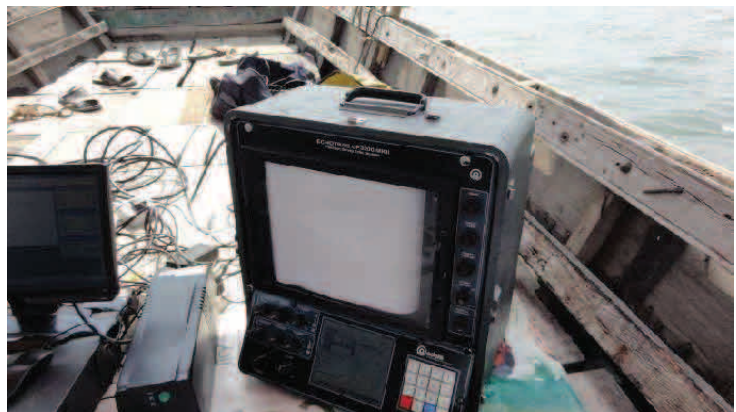
Figure 1.3.1 bathymetric survey device.

- River Bathymetric Survey (under the river flow, water)
- Using Echo- Sounding device (Figure 1.3.1)
- River Topographic Survey (on the land)

Echo-sounding device -Echotrac DF3200 MKII
Odom Hydrographical Systems Inc.)

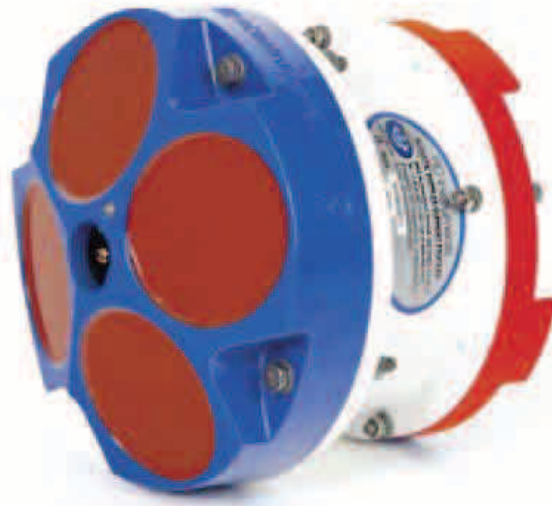
Figure 1.4.1 ADCP Device (Workhorse Rio Grande 600khz)

The R D Instruments state-of-the earth Workhorse Rio-grande ADCP (600 Khz) with bottom tracking option has been used for the survey. The instrument is capable of velocity profiling upto 45m depth. The measurement has been done following WinRiver User Guide supplied by the manufacturer of the instrument. The instrument is used for measuring velocity at a fixed time interval (known as ensemble) without anchoring at desired transects location (moving boat condition). It measures flow velocity at each ensemble (around 2.5 second intervals) at 50cm interval throughout the water column.
