2. HYDROLOGICAL AND HYDRAULIC ANALYSIS

2.1 Design Criteria

2.2 Hydrological Analysis

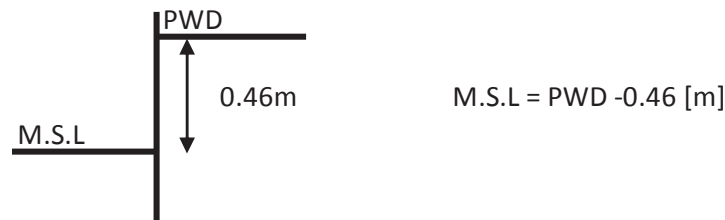
Figure 2.3.1 Relationship between BWDB's PWD.m and M.S.L.m

The boundary condition for numerical model simulation is summarized in Table 2.3.1. Water Level measured at BWDB's station is transformed from PWD.m to R.L.m by relationship shown in Figure 2.3.1.

- The water level data collected from BWDB is expressed in PWD units which are converted to MSL units by deducting 0.46m. The water level data along the bridge axis expressed in MSL units is used for the present project.
- In Table 2.3.8, four categories of water level data are shown using MSL units. Among them, Mean High Water Level (M.H.W.L) that corresponds to the mean of annual highest water level in an observation period shall be used as the base for water surface elevation which is termed Standard High Water Level (S.H.W.L).
- Design water level with a 100 year return period corresponds to the design discharge shown in the table.

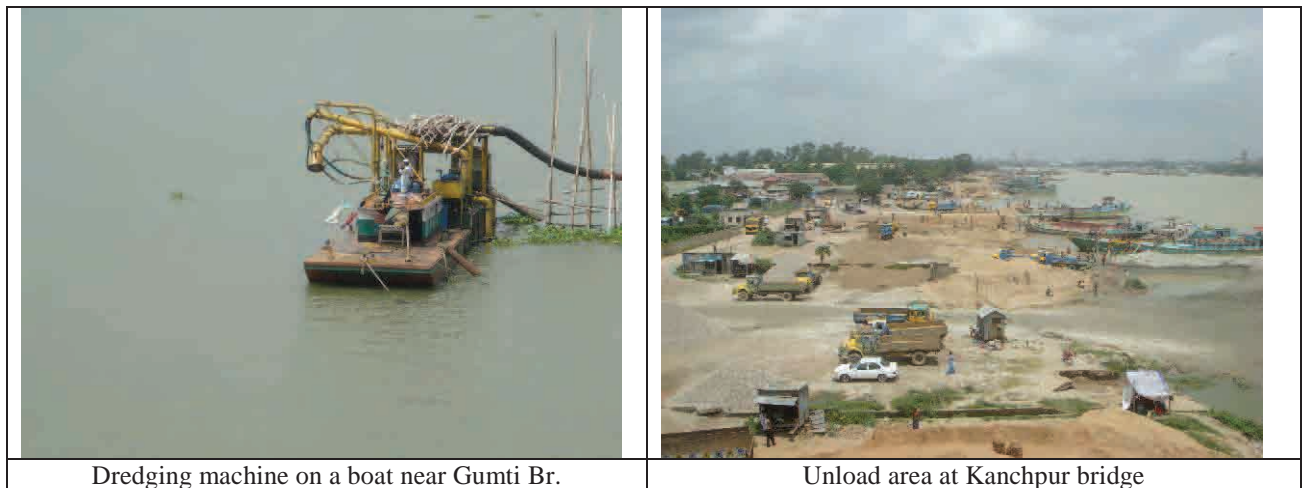
Dredging machine on a boat near Gumti Br.

Unload area at Kanchpur bridge

Figure 2.4.4 Dredging around the Bridge

It is reported that illegal dredging is carried out in Bangladesh and it causes social problems, and it is known that dredging was carried out around Meghna Bridge by interview at RHD.

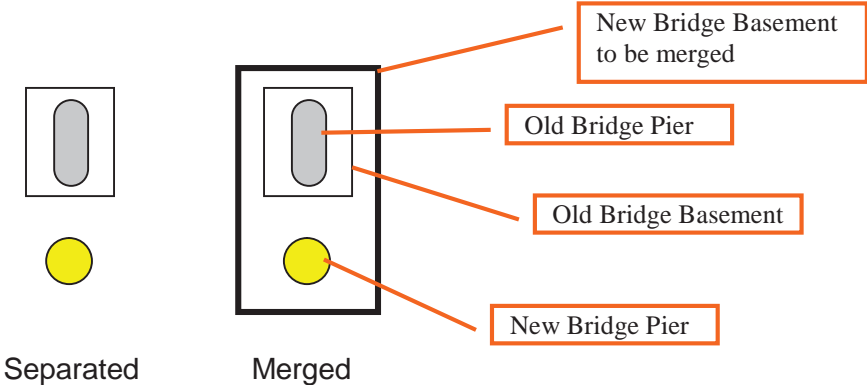
Figure 2.4.7 Bridge size for Local Scour estimation

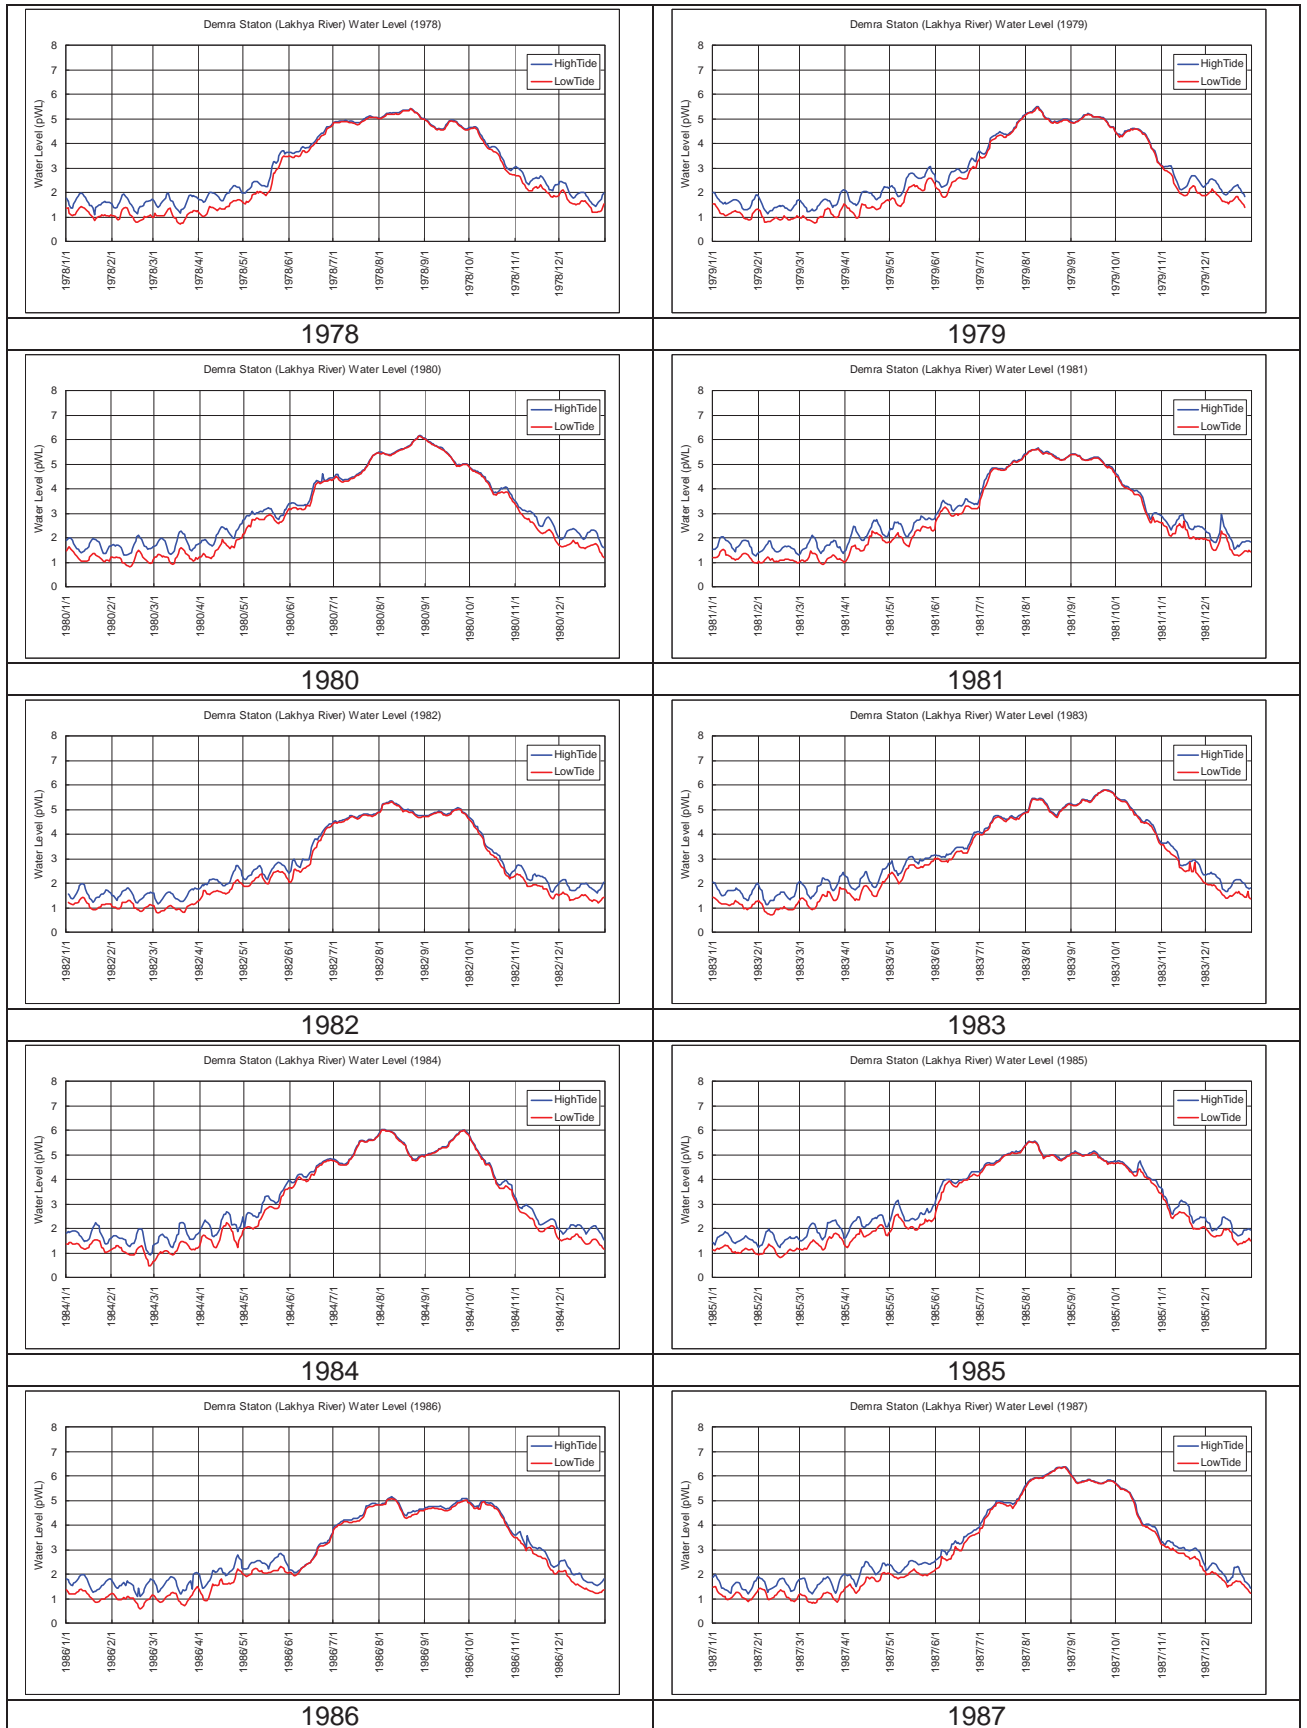
Figure 13(1) Daily Water Level at Demra(Lahkya) St (1/5)
