National Road No. 5 (from PK 001+000 to PK 50+000)

National Road No. 5 (from PK 110+000 to PK 160+000)

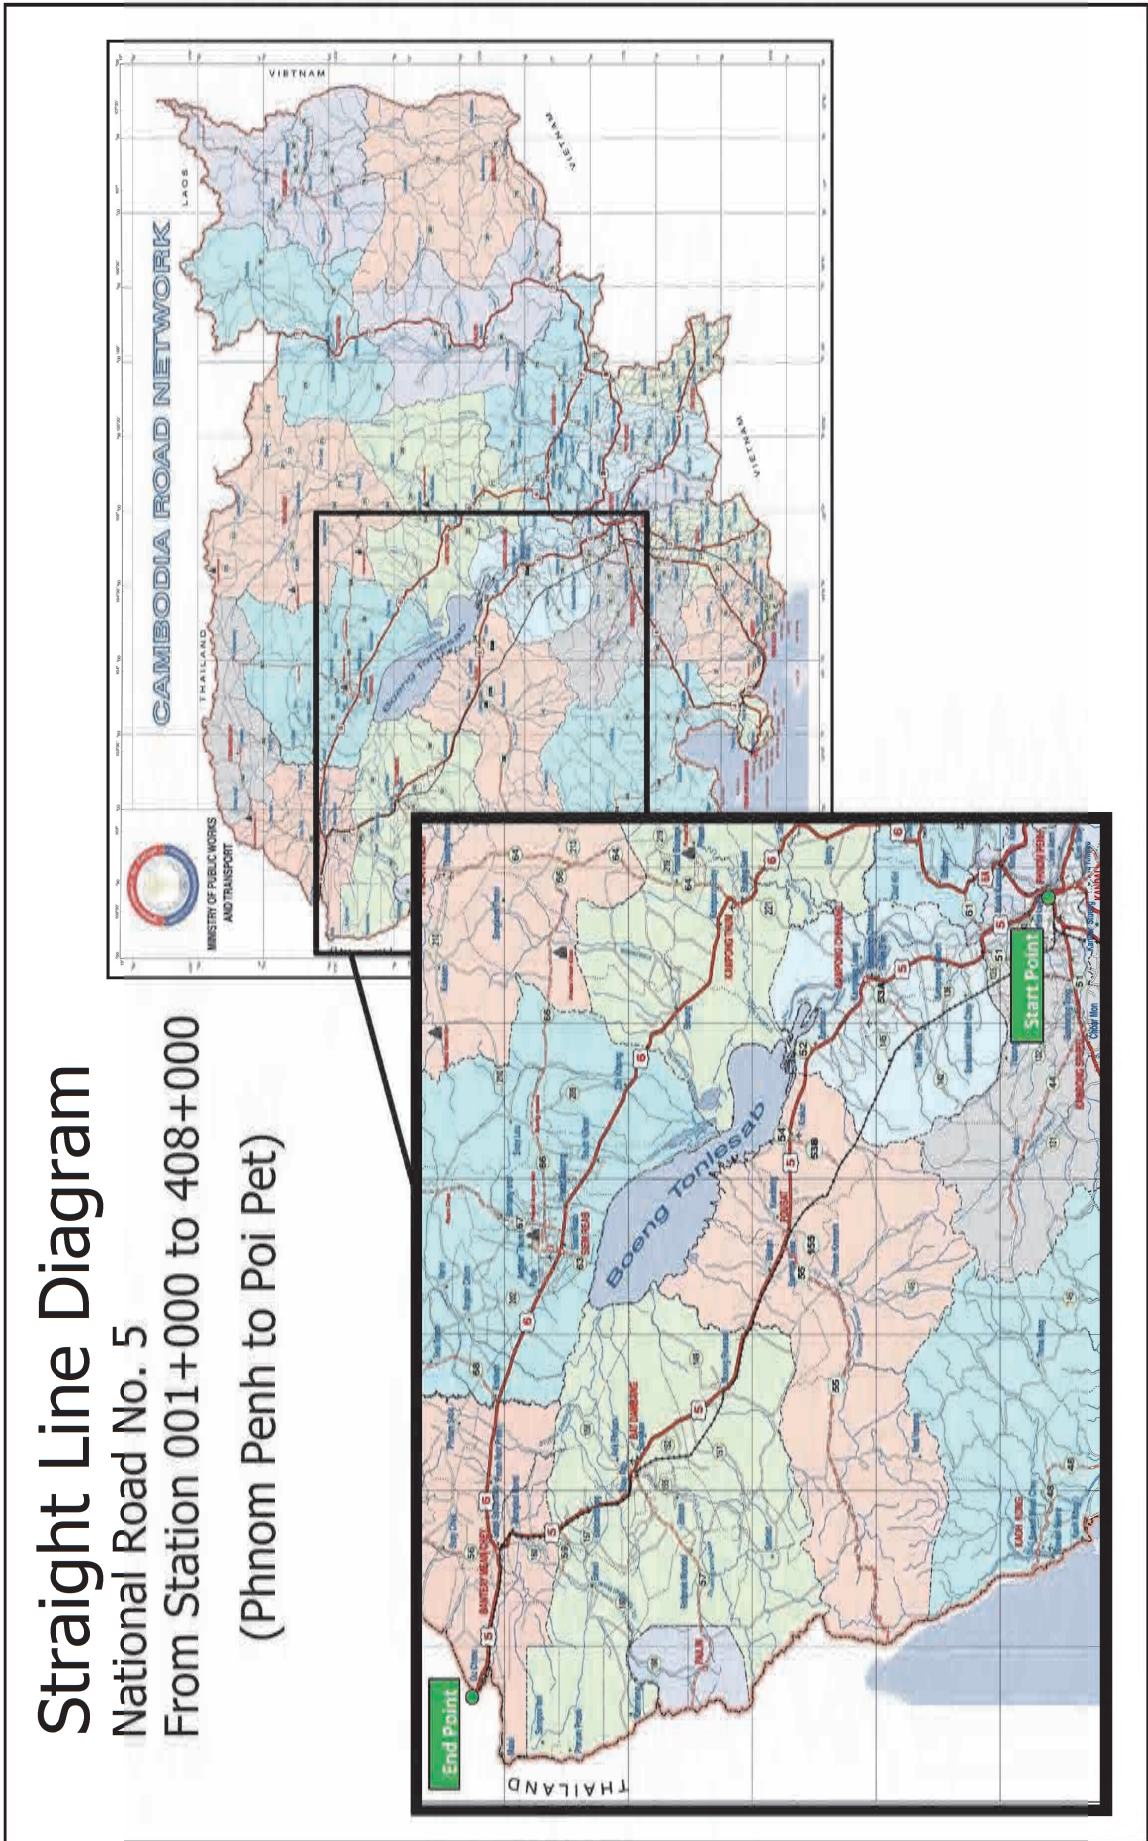
PK 01+000	PK 10+000	PK 20+000	PK 31+000	PK 35+000	PK 40+000	PK 50+000	
Right side	Photograph of road condition							
	Terrain	1	1	1	1	1	1	
	Affect house	2	2	1	2	2	1	
	Land Use Type	9	1	1	1	1	1	
	Shoulder Condition	-	3	2	2	3	3	
	Shoulder Width (m)	-	3.0	1.2	0.5	2.5	2.5	
	Shoulder Type	-	Laterite	Laterite	Laterite	Laterite	Laterite	
	Road Condition	1	1	1	1	1	1	
	Road Width (m)	5.3	5.0	3.4	4.9	5.2	5.1	
	Lane Number (no)	1	1	1	1	1	1	
	Road Pavement Type	AC	AC	DBST	DBST	DBST	DBST	
	Lane Number (no)	1	2	1	1	1	1	
	Road Width (m)	5.3	7.2	5.0	4.8	5.0	5.1	
	Road Condition	1	1	1	1	1	1	
	Left side	Shoulder Type	-	laterite	laterite	Laterite	Laterite	Laterite
Shoulder Width (m)		-	1.3	3.5	1.5	1.2	1.5	
Shoulder Condition		-	1	3	2	1	3	
Land Use Type		1	1	1	1	1	1	
Affect house		2	2	2	2	4	5	
Terrain		1	1	1	1	4	1	
Remark		No center line marking Central Divider (3.3m)						
Bridge Type			STEEL	STEEL	STEEL	STEEL	STEEL	STEEL
Span Number (no)			1	3	3	3	2	2

Photograph of Bridge condition								
			PK12+500	PK21+500	PK24+500	PK24+500	PK41+550	PK41+550

PK 55+000	PK 60+000	PK 65+000	PK 70+000	PK 75+000	PK 80+000	PK 85+000	PK 90+000	PK 95+000	PK 100+000	PK 105+000	
Photograph of road condition													
Right side	Terrain	1	1	1	1	1	1	1	1	1	1	1	
	Affect house	2	1	2	2	2	1	1	1	2	2	2	
	Land Use Type	1	9	9	5	1	1	1	9	1	1	1	
	Shoulder Condition	2	2	2	2	2	3	2	2	2	2	3	
	Shoulder Width (m)	2.5	2.0	1.0	2.0	1.5	1.0	1.5	1.5	-	1.5	2.0	1.5
	Shoulder Type	Laterite	Laterite	Laterite	Laterite	Laterite	Laterite	Laterite	Laterite	Laterite	Laterite	Laterite	Laterite
	Road Condition	2	3	1	2	2	2	2	1	1	1	1	1
	Road Width (m)	5.1	5.0	5.2	4.9	4.6	4.8	5.3	6.6	3.9	3.9	3.7	3.9
	Lane Number (no)	1	1	1	1	1	1	1	1	1	1	1	1
	Road Pavement Type	DBST	DBST	DBST	DBST	DBST	DBST	DBST	DBST	DBST	DBST	DBST	DBST
Left side	Lane Number (no)	1	1	1	1	1	1	1	1	1	1	1	
	Road Width (m)	5.1	5.0	5.2	4.9	4.6	4.8	5.3	6.6	3.9	3.7	3.9	
	Road Condition	3	2	1	2	2	1	1	1	1	1	2	
	Shoulder Type	Laterite	Laterite	Laterite	Laterite	Laterite	Laterite	Laterite	Laterite	Laterite	Laterite	Laterite

Shoulder Width (m)	3.0	2.5	1.5	1.5	1.5	1.5	1.5	2.0	1.5	2.0	1.5	
	Shoulder Condition	1	1	2	2	2	2	2	2	2	1	2	
	Land Use Type	1	1	5	9	1	1	1	2	1	1	5	9
	Affect house	2	2	2	2	2	1	2	1	2	2	2	2
	Terrain	1	1	1	1	1	1	1	1	1	1	1	1
	Remark	CRACK, POTHOLE, DEPRESS, FLUSH, RUTTING											
Bridge	Bridge Type	STEEL			STEEL			STEEL			STEEL		
	Photograph of Bridge condition
