**THE PROJECT FOR DEVELOPMENT
PLANNING FOR THE RAPID PROMOTION
OF RECONSTRUCTION AND
DEVELOPMENT IN JAFFNA DISTRICT
(PHASE 2)**

MONITORING REPORT

MARCH 2012

Monitoring Report

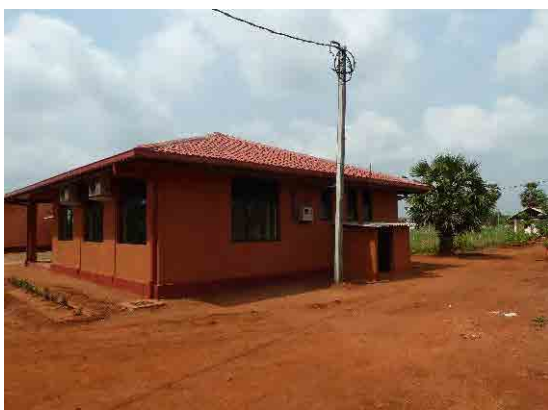
Picture 2c: Leading in Power Line

Due to the war in 1990s, high-voltage electrical power lines were destroyed in the area. Since then, power supply to the area including the coconut nursery had been cut off. The rehabilitation of Atchuhuvveli Coconut Nursery contributed to re-electrification of the area and benefited the neighbouring area, such as, a training school and residences.

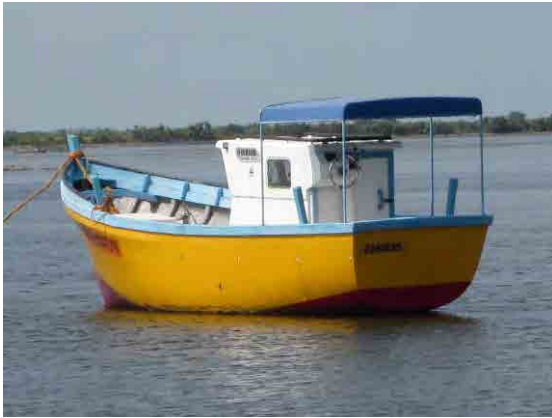
Picture 3c: Wheel Type One-day Boat

The objective of training is to learn about repair and maintenance for outboard motors, and consists of practical training at the workshop (66 hours), lectures at the lecture hall (66 hours) and on boat training using the supplied boats (6 hours). The training tends to be held twice a week (on Saturday and Sunday) every three months, considering providing an opportunity for the trainees from other districts. Due to reconstruction of the facility and the procurement of equipment under the Project, the training environment was improved significantly. In the past, the COF conducted lectures using pictures because they had no equipment for the purpose, and then, sent the trainees to the COF Tangalle to attend training on a wheel type one-day boat because it did not have the same type boat. After the Project, the trainees can learn about repair and maintenance works using the donated equipment at the workshop, and practice the training for the wheel type one-day boat which belong to the COF Jaffna. Now, the COF Jaffna can accommodate trainees from other districts including Trincomalee and Batticaloa for this training programme. The number of trainee increased to around 30 to 35, while it was around 5 to 10 in the past.

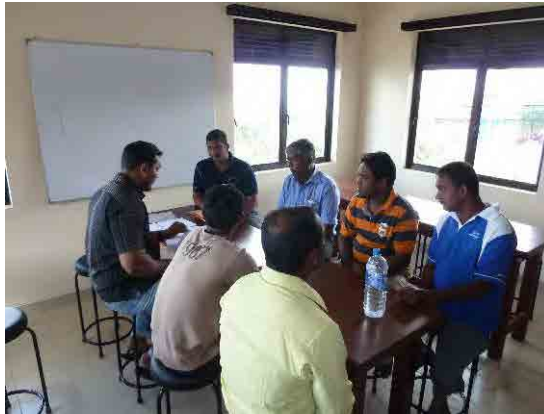
Picture 3e : Multipurpose Room

This room tends to be used for meeting purposes now, although no training using the room has been conducted so far.
