**DIRECTORATE GENERAL OF WATER RESOURCES  
MINISTRY OF PUBLIC WORKS  
THE GOVERNMENT OF THE REPUBLIC OF INDONESIA**

**THE PREPARATORY SURVEY  
ON  
BALI BEACH CONSERVATION  
PROJECT-PHASE II  
IN  
THE REPUBLIC OF INDONESIA**

**FINAL REPORT (SUMMARY)  
[SIMPLE VERSION]**

**March 2013**

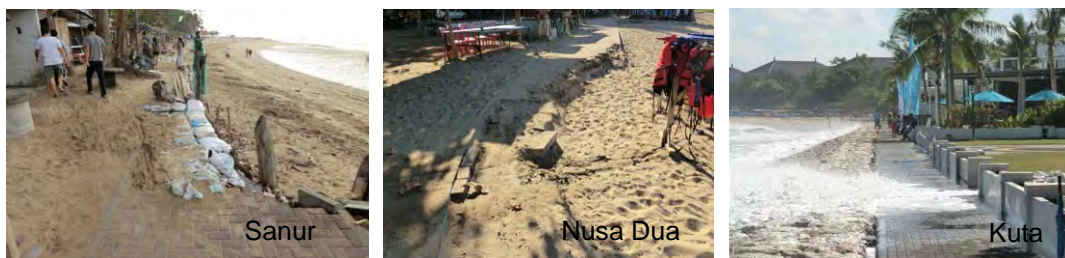
Some coastal and public facilities have been damaged after completion of the project due to progression of partial retreat of beach, wave overtopping, various human activities, etc. In order to reduce partial retreat of beach, some maintenance and construction works have been implemented by BWS-BP. However, these works have not reached the inclusive maintenance because only a small portion of countermeasures were done. Serious beach erosion has been occurring in the following areas; southern part of Sanur, northern part of Nusa Dua, and in front of Kartika Plaza Hotel in Kuta. Some parts of the revetment were damaged due to progressing beach erosion and scouring due to waves. Regarding public facilities, some pavement parts of the walkroad on the groin were damaged due to wave overtopping and some areas of the walkway were also damaged and washed out due to beach erosion.

**Photo 2.2.1 Partial Retreat of Beaches**

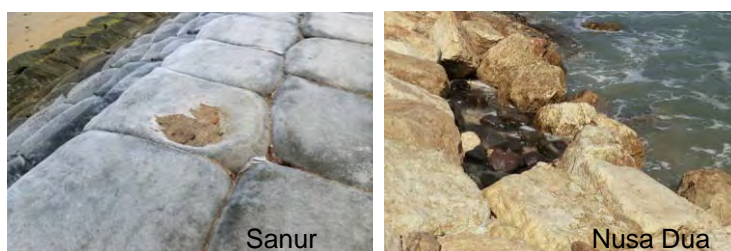
**Photo 2.2.2 Damages to Coastal Facilities**

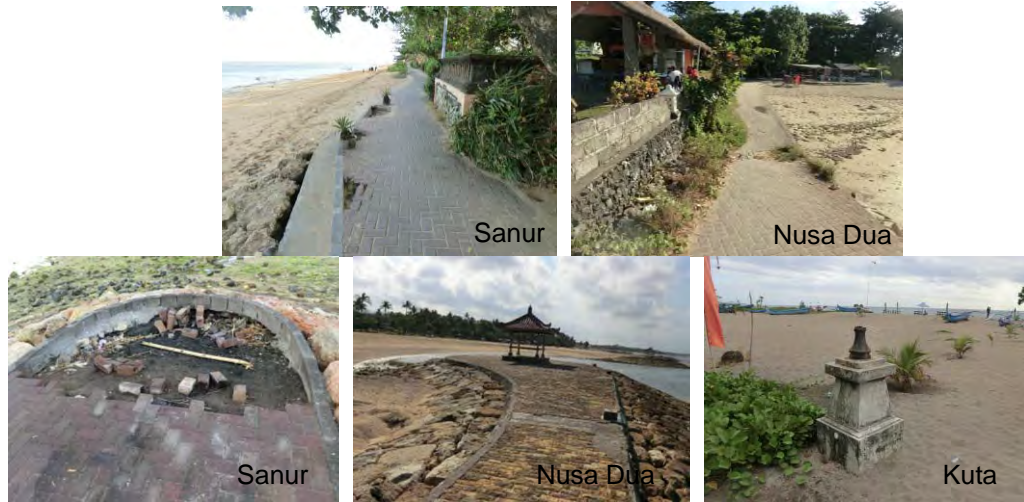
**Photo 2.2.3 Damages to Public Facilities**

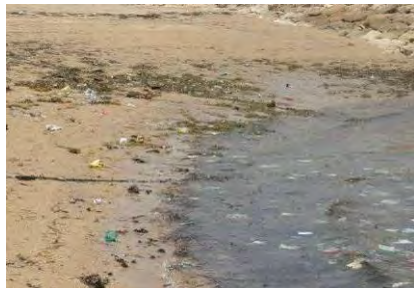
Improper disposal of trashes is one of the major problems faced by Phase-1 beaches. Continuous cleanup is necessary to keep the beach clean since trashes are not only coming from the land but also from the ocean continuously. In most cases, the beach surroundings in front of a hotel is properly kept clean by hotel employees; on the other hand, public areas and fisherman’s quarters located just next to the hotel are covered with trashes. The trashes degrade the area’s tourism value which also affects the hotel business. In addition, some parts of the walkway are covered with sand where stakeholders neglect to clean.

Plastic wastes are scattered along Nusa Dua Beach Coastline

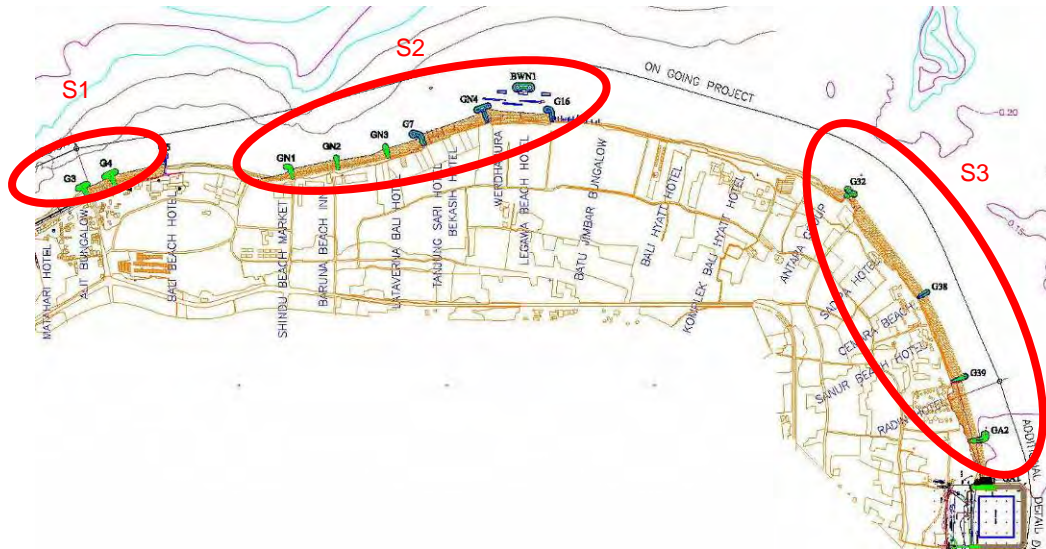
The project area at Sanur beach is shown in Figure 6.1.1. This area is divided into three sub-areas which are called S1, S2, and S3.

Figure 6.1.1 Layout of Sanur Beach

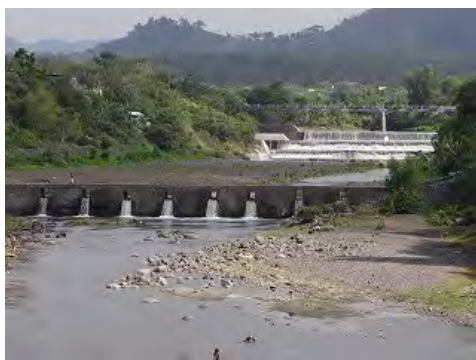
(1) Check (Sabo) Dam

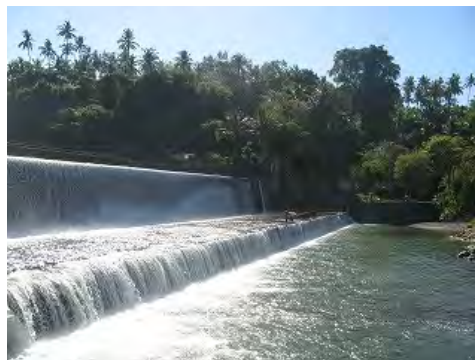
(2) Weir for Irrigation

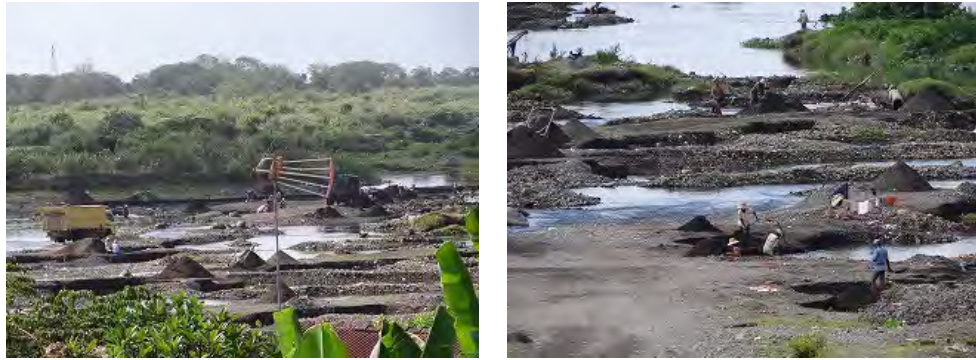
Significant sand and gravel mining were undertaken at the upstream and river mouth of the Unda River. According to the collected information, active sand mining at the river mouth of the Unda River was undertaken since 2000. Although this activity has been already prohibited since 2007, illegal mining still continues as shown in Photo 7.3.2. Several ten thousand cubic meters per year of sand seem to have been obtained from mining annually from the Unda River mouth before such activities were prohibited. This quantity is the same level of the quantity of littoral transport in the east coast area.

**Photo 7.3.2 Sand Mining at the River Mouth (Unda River)**

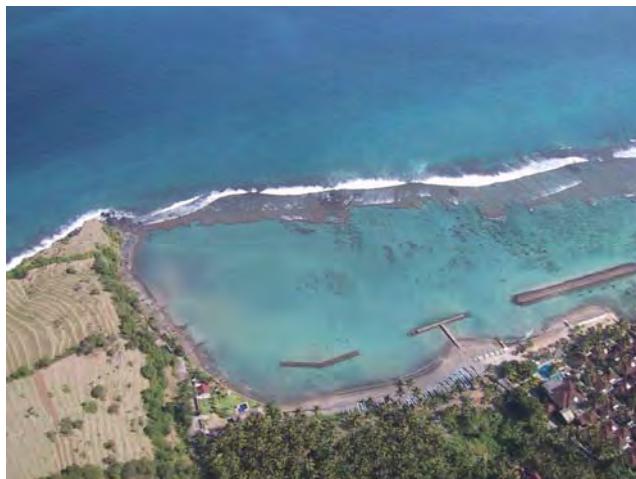
According to the information from the previous report (Syamsdin, 1993), the coral mining areas at Sanur were 75,000 m<sup>2</sup>, 200,000 m<sup>2</sup> and 600,000 m<sup>2</sup> in the north, middle and south areas, respectively. In Nusa Dua Beach, the total area of coral mining was estimated to be 200,000 m<sup>2</sup>. In Candidasa Beach, the mining area as shown in Photo 7.3.3 was estimated to be about 200,000 m<sup>2</sup>.

**Photo 7.3.3 Trace of Coral Mining (Candidasa)**

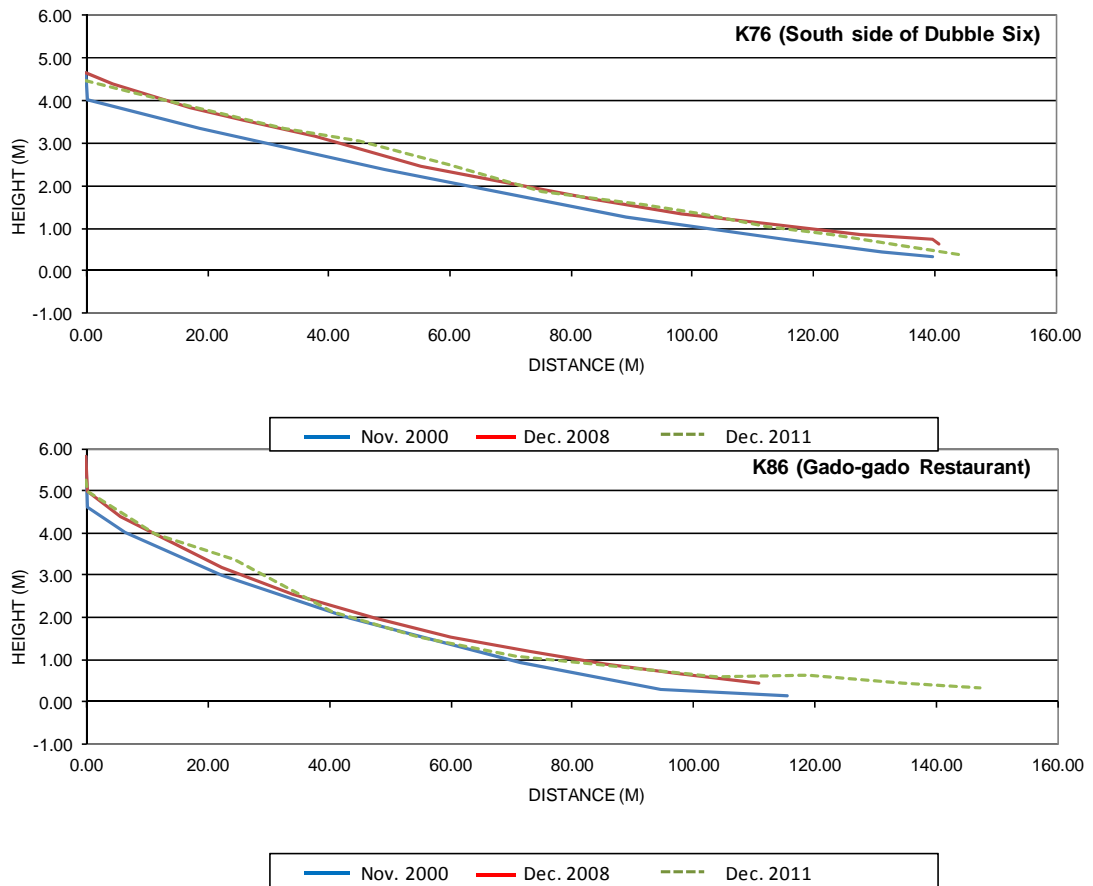
**Figure 10.3.4 Comparison on the Beach Profile Taken at Typical Survey Lines from North Kuta to Seminyak (Example)**

Beach profile survey and sand sampling on the beach were carried out at two candidate sites namely, Candidasa and from North Kuta to part of Canggu as shown in Figure 10.3.1 and Figure 10.3.2. Obtained beach profile was compared to the previous profile as shown in Figure 10.3.3 and 10.3.4.

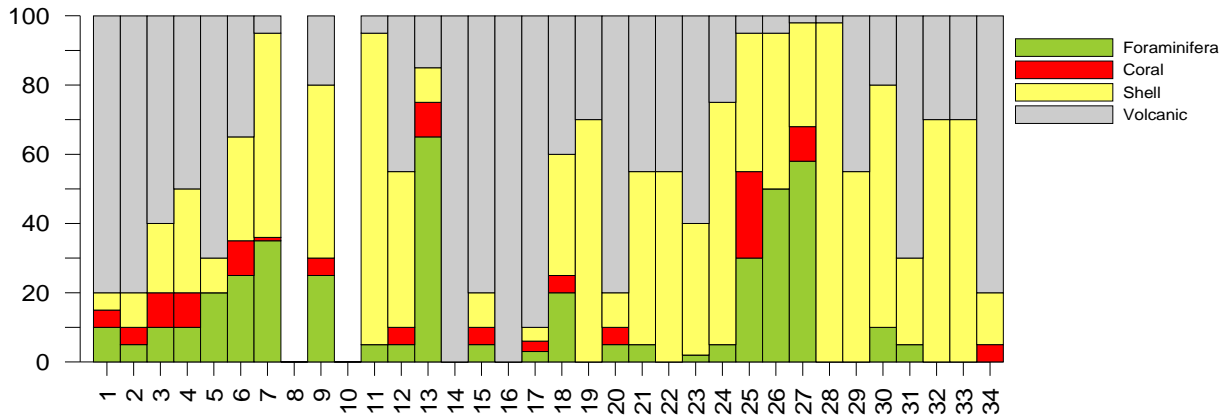
- They are composed of a high percentage of volcanic matter from land in the eastern and central parts of Candidasa. Other parts have a high percentage of biogenic matter such as shell and foraminifera.
- Seabed materials at the southwest coast are composed of a high percentage of biogenic matter in the eastern part, and appeared that the percentage of volcanic matter from land is increasing towards the north.

Figure 10.3.5 Seabed Material Composition in Candidasa

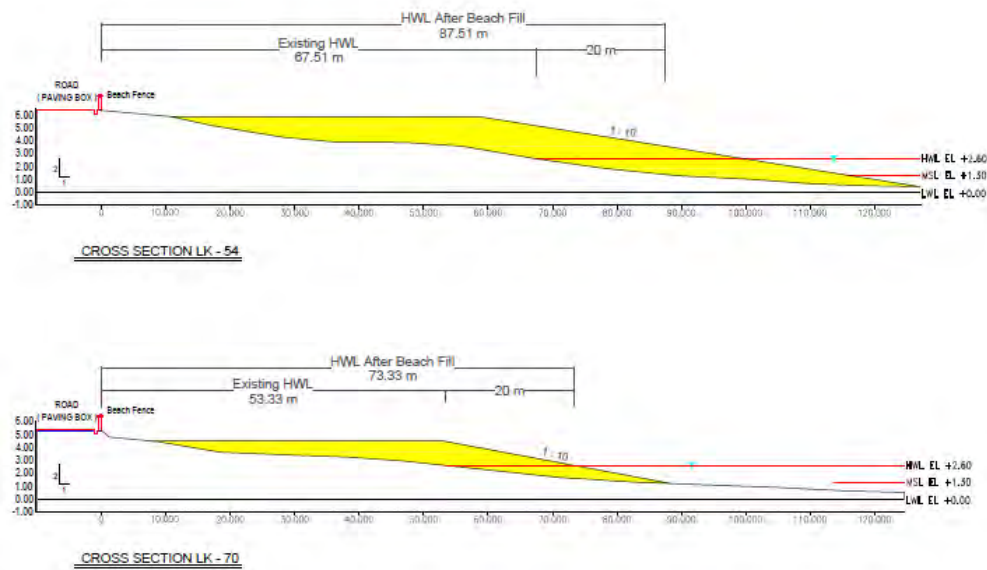
**Figure 11.5.3 Typical Cross Section for Beach Nourishment**
