**JAPAN INTERNATIONAL COOPERATION AGENCY**

**The Data Collection Survey on Road  
Protection against Natural Disaster  
(Landslide-Disaster)**

**FINAL REPORT (1/2)**

**December, 2012**

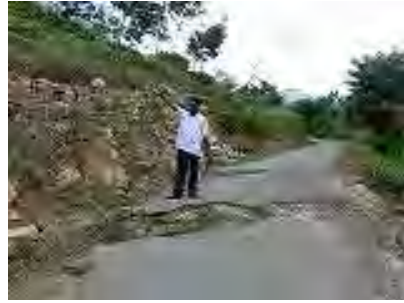
i) Soaring escarpment with fresh traces of collapse at National Road (NR) A005

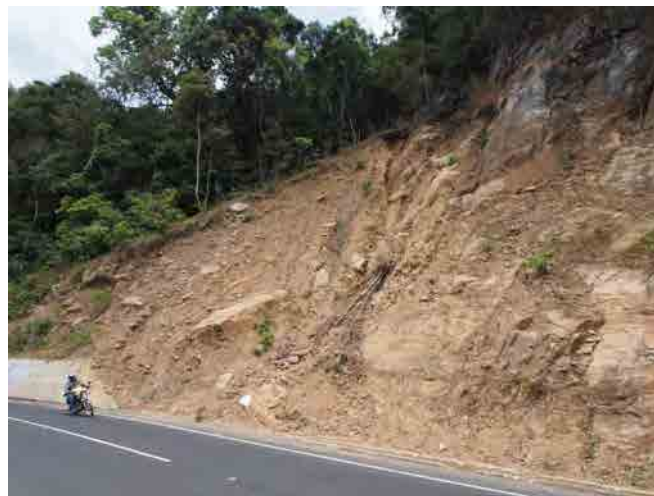
Figure 2-12: Example of Slope Failure

Not so often like that of landslide, slope failure has some recurrent tendency, often along with retrogressive failure at shoulder of slope which often entails open cracks and subsidence. It shall be noted that slope has nature of degradation, larger or lesser, the degree of degradation depend on various factors, such as rock type, landform condition, weathering condition and groundwater condition. If placed under the same conditions, older slope has higher possibility of slope failure than newer one. Similar to slide, rise in groundwater is one of main triggers of slope failure. Surface water also facilitates activity of slope failure by causing erosion on slope such as gully erosion.

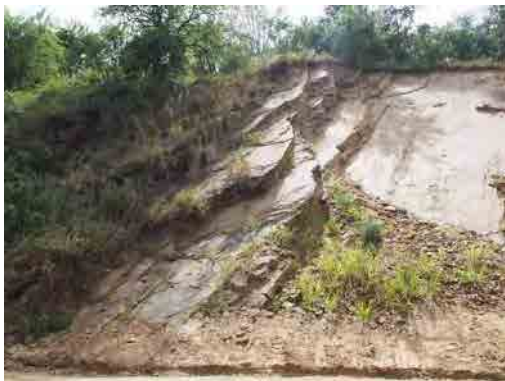
Figure 2-13: Example of Rock Slide

Rock slide occurs in rocky slope where foliation and cracks as well as joints compose

unfavorable condition for rock slide such as dip slope structure. When vertical cracks are dominant in a slope, we shall pay attention to topple.

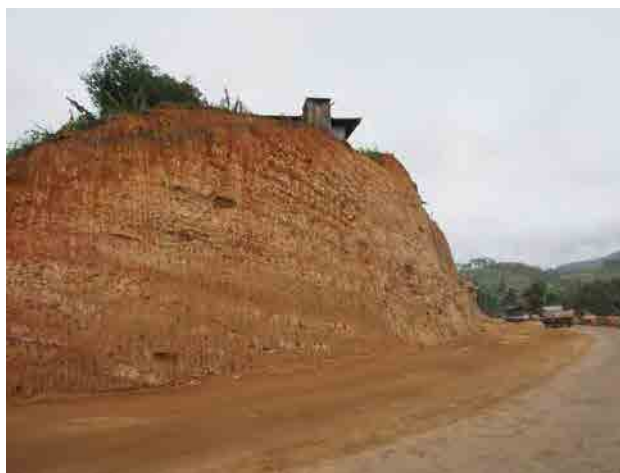
Figure 2-16: Typical Cutting Slope, Too Steep, No Drainage

- In general, steeper gradient of slope than stable is applied to the section where residual soil and weathered rock or colluvium appears. Especially for the upper sections of the slopes where overburden or residual soil appears, a gentler gradient of slope than currently applied shall be adopted.
- Furthermore, no drainage system along the shoulder of the slopes or vertical drainage system can be confirmed on site. Such drainage systems shall be duly installed on site to prevent erosion and infiltration of surface water into the ground.

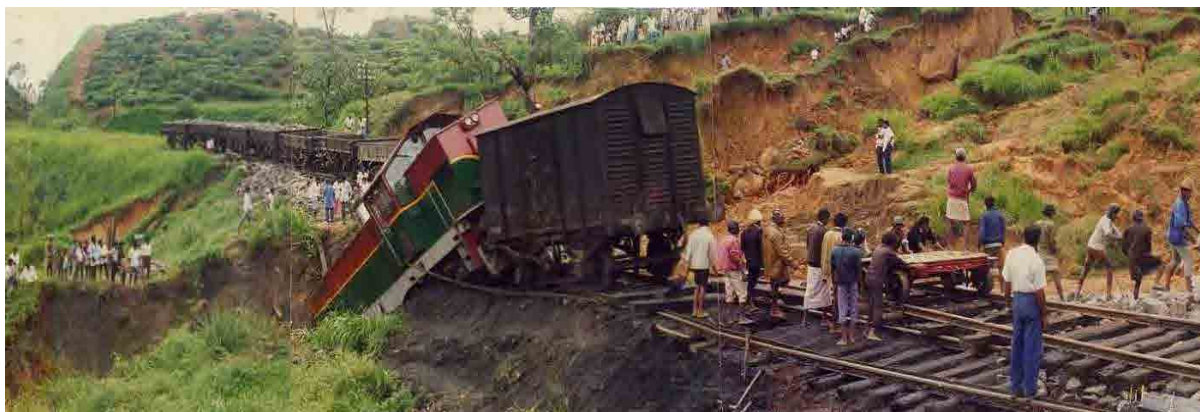
Figure 2-18: Watawala landslide and the damage of train (photo by NBRO)

The landslide occurred on the southern slope of the Watawala ridge in the Nuwara Eliya district, where the Colombo-Badulla railroad runs. The slope was creeping for about 50 years, and it finally failed on 3 June 1992. The total area of the moving mass was about 33,120m<sup>2</sup>. The Colombo-Badulla railroad was heavily damaged, and thousands of passengers who use the train daily as well as tourists were in the train. The landslide caused a severe impact on the people and economy of the country.

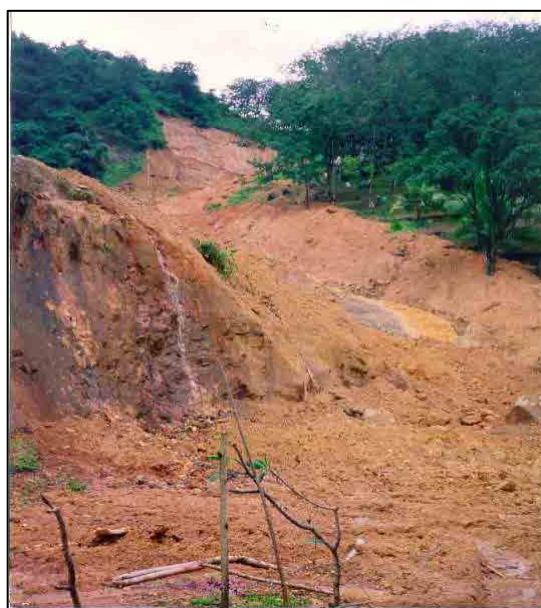
Figure 2-19: Earthflow at Helauda (photo by NBRO)

On 8 October 1993, an earth flow occurred on a slope approximately 3km north of the heart of Ratnapura city. The road and houses below the slope, which ran parallel with the road, were instantly swallowed, resulting in the death of 31 inhabitants. Because unstable earth and sand had previously accumulated in the middle of hillside of the collapsed part, following that, torrential rains, as mentioned below (17 May, 2003), caused a small-scale earth flow in the same place on 24 August 2006.

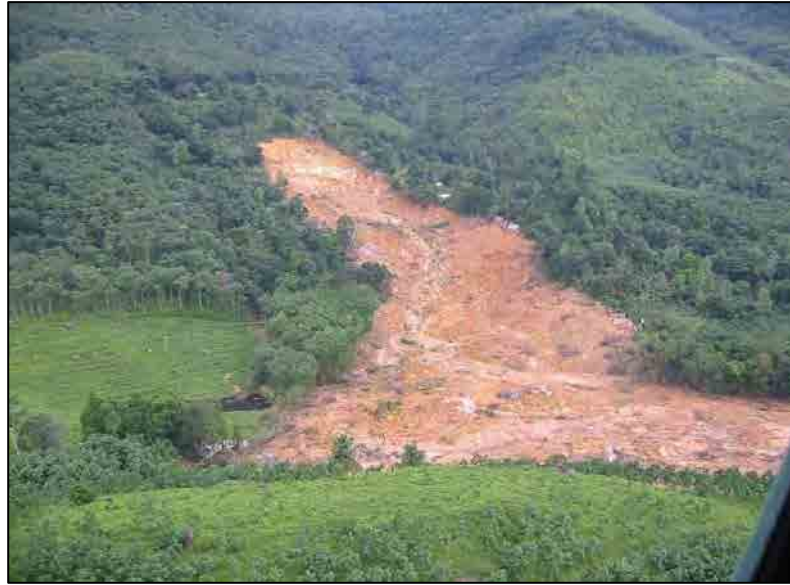
Figure 2-20: Earthflow at Palawela (2003, photo by NBRO)

There were also large-scale earth flows, such as in Palawale, Ratnapura District, where the gentle slope of a mountain base slid down, crossing the valley floor and ran up to the slope on the opposite side. The tail end of the earth flow combined in the small rivers and became a debris flow.

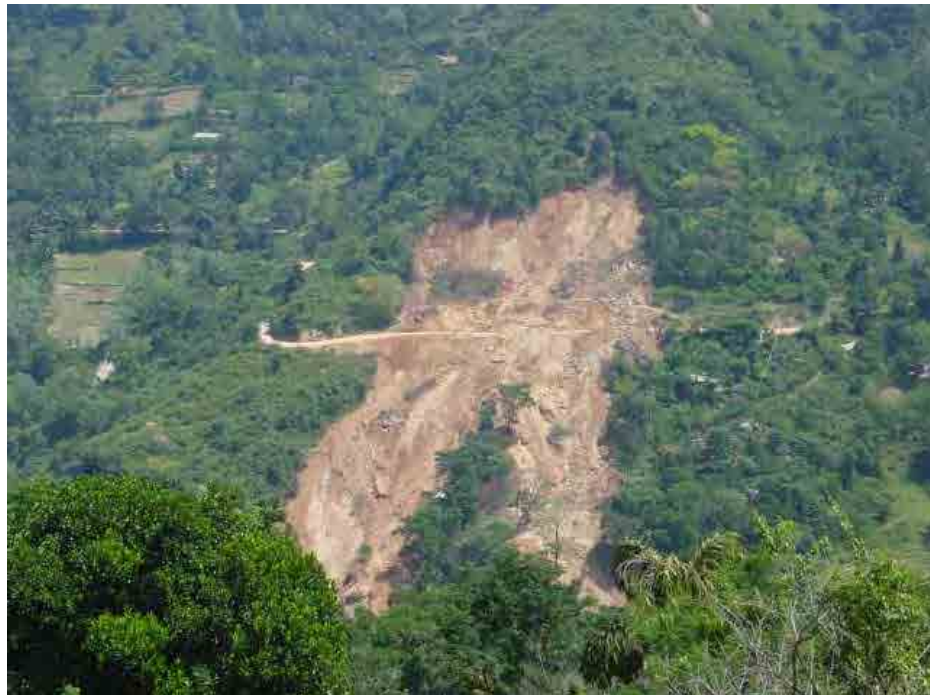
Figure 2-21: Landslide at Walapane(photo by Mr.Tsukamoto)

Walapane National Highway B413 saw multiple episodes of cutting failure, landslide and debris flow. Among places along the national highway where landslide disasters occur frequently, one occurrence reached 100m. In the tracks left behind a landslide which resulted in the deaths of 10 people.

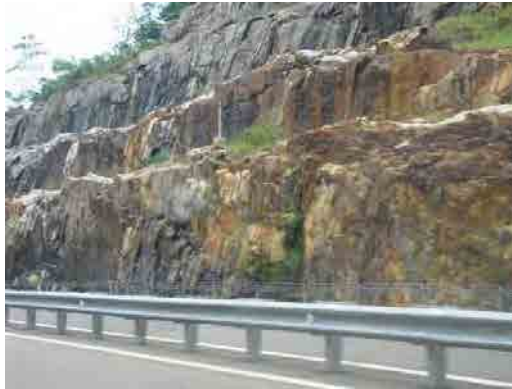
- Cutting overhang and loose rocks to avoid rock falls,
- Benching of rock slope cutting (Figure 3-4),
- Remove soil from the head of a slide to reduce the driving force,
- Embank at the toe of the slope to increase the stability,

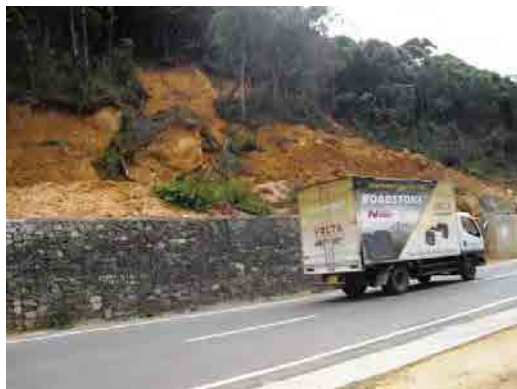
Gabion walls are simple and economical but the location shall be carefully selected because they are not so strong for strong backside landslide pressure. Gabion in the photo below has projected forward due to the strong earth pressure behind.

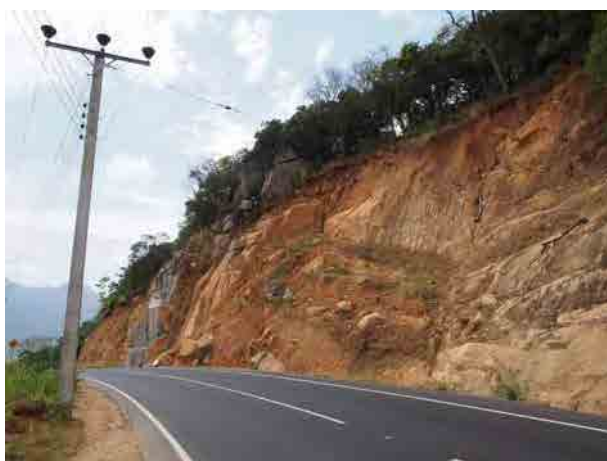
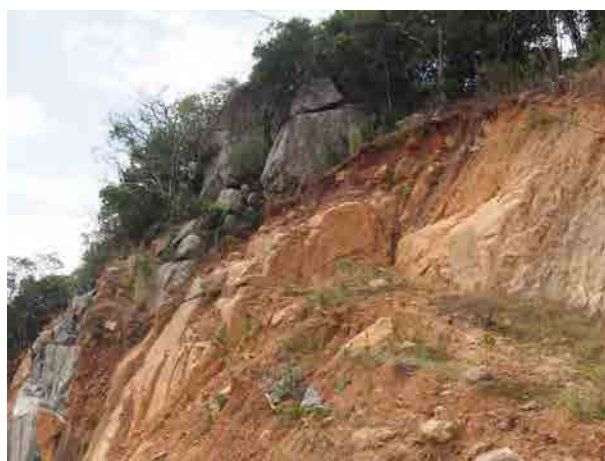
Between the rocky parts, weathered parts were confirmed on site. Thus this site requires countermeasures against rock fall, rock slide and slope failure of the weathered parts.

(Full view)

(Close up view of the above)

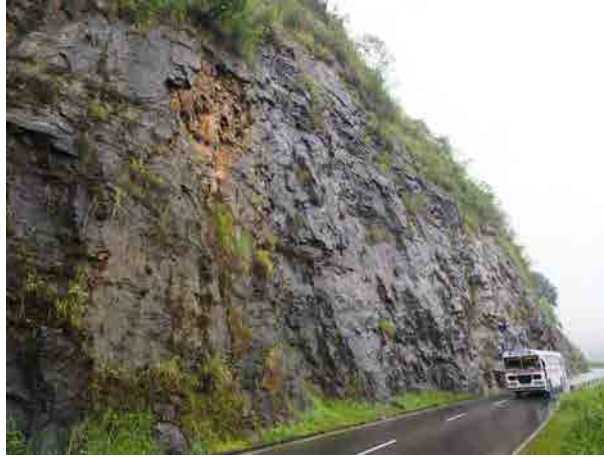
Figure 4-3: Great wall of A005-046

Other than the direct countermeasures, engineers may come up with a detour plan of the road by utilizing bridges which may jut from the existing road shoulder and enable the road to secure enough distance from the escarpment. The steep lower slope will force difficulties in construction of the bridges but supposed temporary works may not affect the road. In case bridges are not applicable to this site, rock shed may be a candidate for the countermeasures.

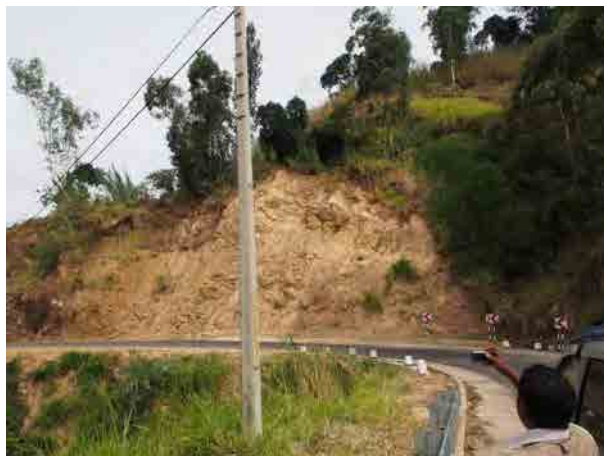
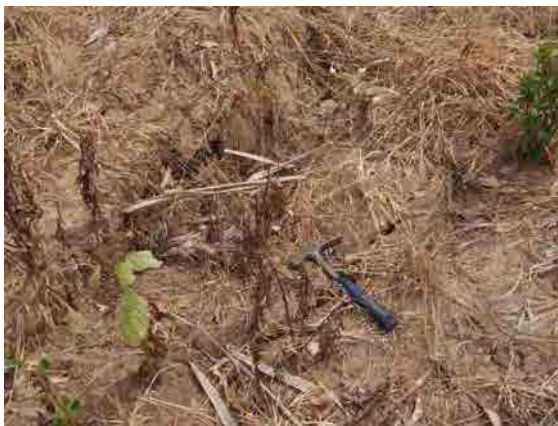
Figure 4-4: Slope failure of A005-091 (Full view)

(Tension cracks with subsidence and opening)

Figure 4-4 explains the condition of the slope failure of A005-091.

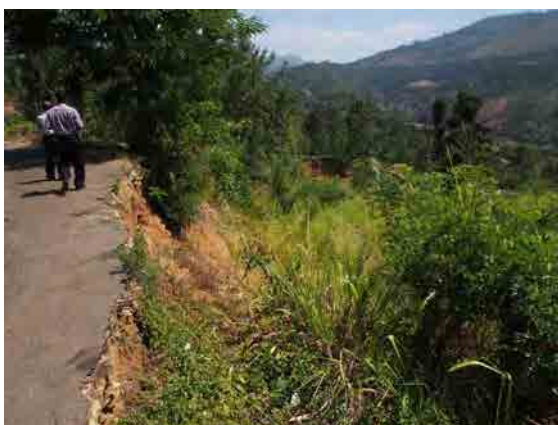
Figure 4-6: Condition of the landslide of A005-135

The landslide of A005-135 is categorized as a multiple landslide in which many divided landslides move separately or interdependently. The size of the whole landslide was estimated to reach 200-300 metres in length. The landslide occurred in a gentle slope of a tea plantation and has destructed many buildings inside its area, including a hospital, office buildings and schools for the plantation as well as houses for officials and labours. A005 runs along the toe of the landslides and has repeatedly suffered from blockades or disruption by debris flown out from the toe of the landslide.

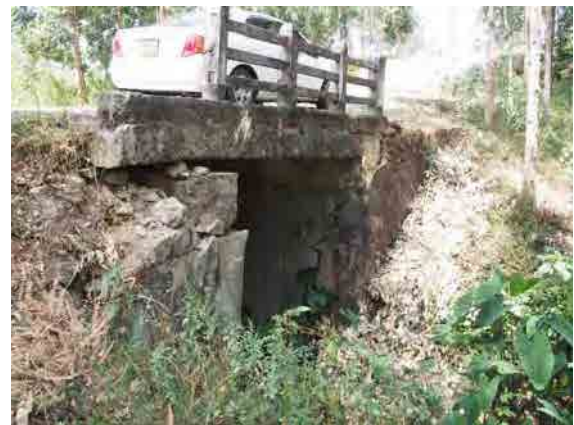
(Crack on the abutment of the small bridge at Km 70)

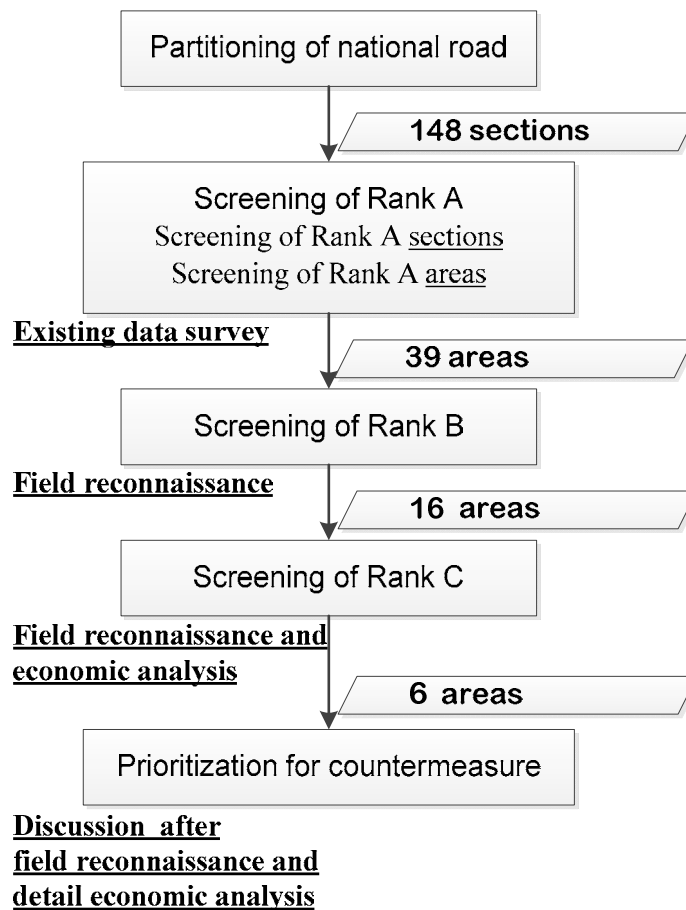
Figure 4-8: Flowchart of screening of Rank A, B and C

The screening of Rank A, Rank B and Rank C is conducted in the Survey, and a risk assessment is implemented in consideration of their hazards, traffic volume, local economic indices, etc in each stage of screening. Rank A and B are screened based on the existing data and knowledge owned by the RDA and NBRO. Rank C for which countermeasures are examined and their prioritization are determined by the discussion among RDA, NBRO and JET after conducting a field reconnaissance and a detail economic analysis. The flow of the screening is outlined as follows, and the flowchart and schematic image are shown in Figure 4-8 and Figure 4-9 respectively. The screening process for target areas is Table 4-1.

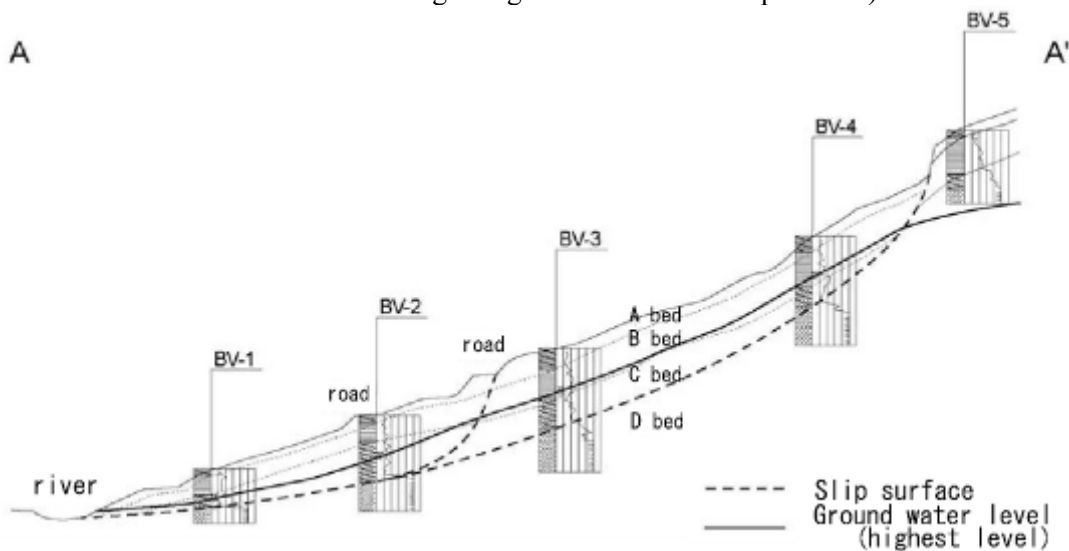
Figure 5-2: An example of landslide cross section

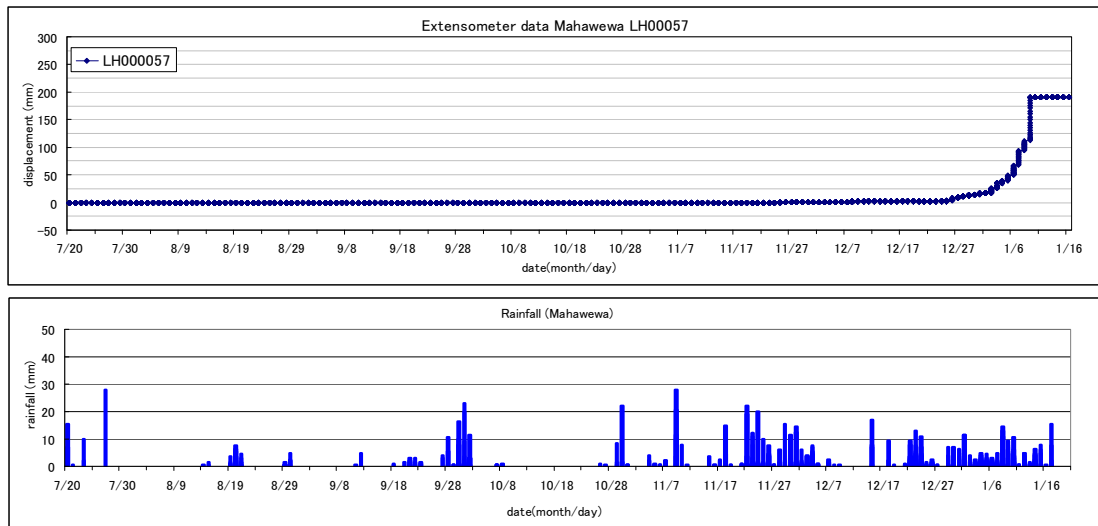
Figure 5-3: Sample fixed data-set of Extensometer (source: DiMCEP)

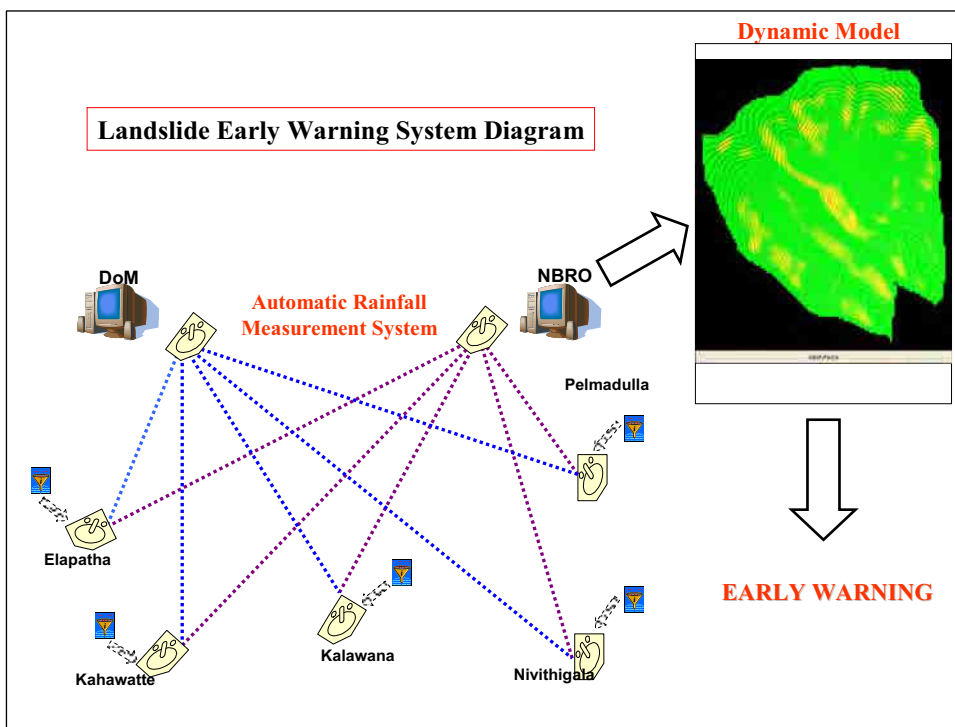
Figure 5-6: Current Landslide Early Warning System in Ratnapura District  
 (Source: NBRO's Presentation)

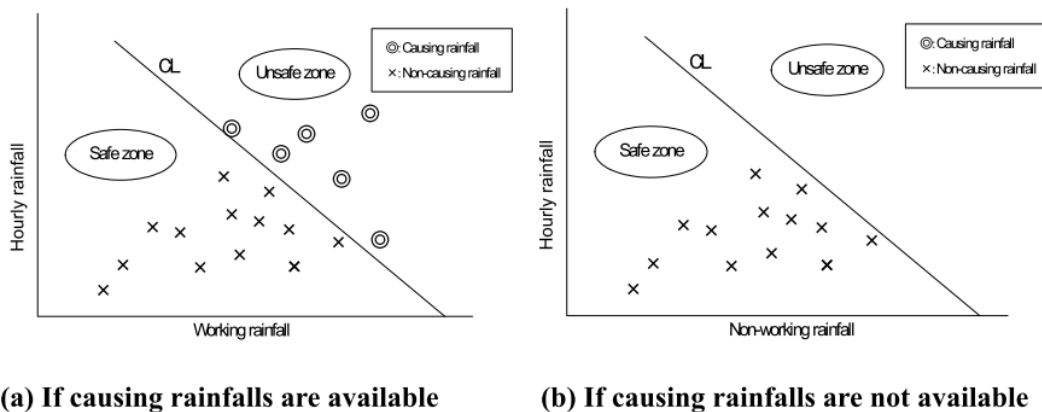
Figure 5-7: Boundary between landslide causing rainfalls and non-causing rainfalls
