**Follow-up Cooperation Study on the Project for Construction of the  
Suez Canal Bridge (Pavement on Steel Deck)**

**Executive Summary of Survey and Basic Policy for resolution of the damages**

### Study of Cement-based Pavement Method

TECHNICAL NOTE  
ON THE FOLLOW-UP COOPERATION STUDY  
ON THE PROJECT FOR CONSTRUCTION  
OF THE SUEZ CANAL BRIDGE (PAVEMENT on STEEL DECK)  
IN ARAB REPUBLIC OF EGYPT

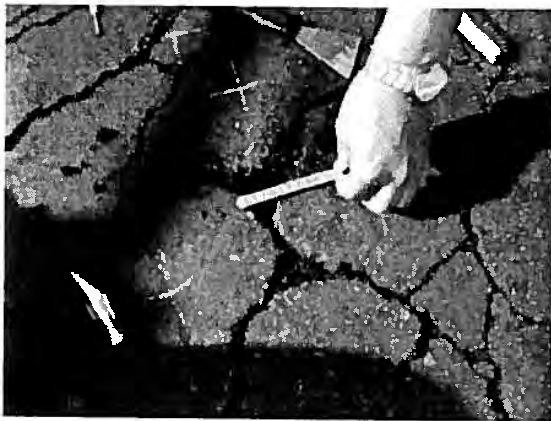
Photo-1 Crack Condition

- ✓ Cracks have occurred on more 95 percent of the whole surface area
- ✓ The area with crack widths of 10mm or more is about 70 percent of the whole surface
- ✓ It is expected that cracks with a width of 10mm or more reach into the Binder Layer

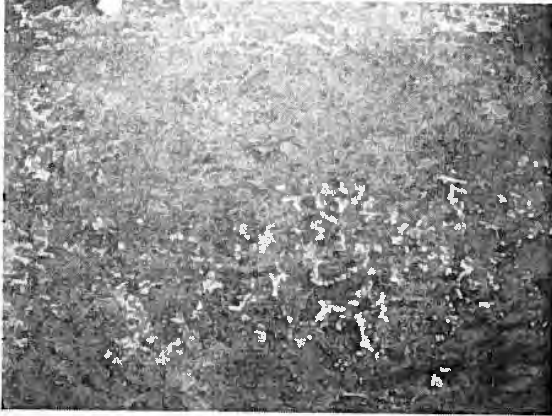
Photo-5 Corrosion roughness on steel deck plate

- ✓ Corrosion on the steel plate was found at all 5 excavation tests.
- ✓ Maximum thickness loss caused by corrosion is more than 0.5mm; thickness is less than 11.5mm compared with the design thickness of 12mm.

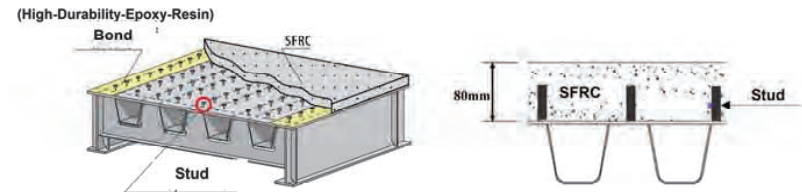
**Stud is welded on whole surface of steel deck plate, Bond painted partially (along construction joint, or negative fracture moment portion).**

On the case of Nagoya City Expressway in Japan

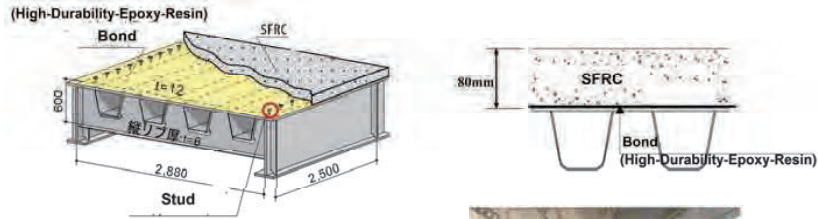
**Boning** is painted on whole surface of Steel deck plate, Stud installed partially ( along edge ).

On the case of Yokohama - Bay-Bridge in Japan

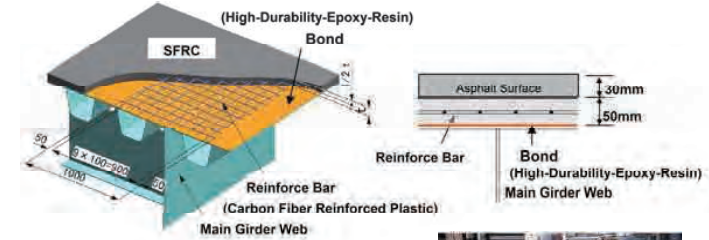
**Boning** is painted on whole surface of Steel deck plate. **Reinforced bar (CFRP)** is installed on negative fracture portion on the girder. Moreover, **Asphalt is surfaced** to prevent traffic noise along the route.

(On the case of Tokyo Metropolitan Expressway in Japan

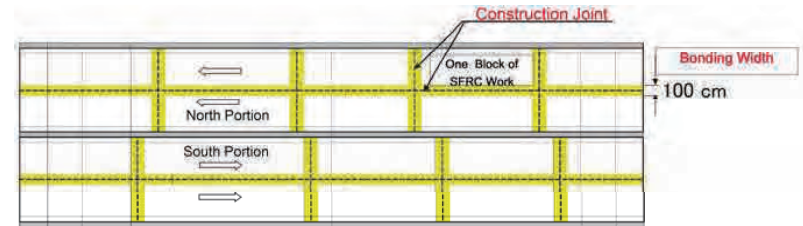
### 6.4 Notes on Construction Plan

- **Shot-blasting is essential** to remove completely existing rust
- **Stud** should be welded evenly and vertically
- **High-Durability-Epoxy-Resin** should be painted along **construction joint of SFRC.**

- **Stretchable Joint material is filled** along **Construction joint of SFRC**
- **Special concrete finisher** should be prepared for adequate compaction to SFRC.
- The repair work under **public traffic closure** during **winter season** due to;
  - **Avoid vibration by vehicles passing during Concrete strengthening.**
- Work including bonding (HDER) within **120minutes** under **lower than 30 degree temp.**

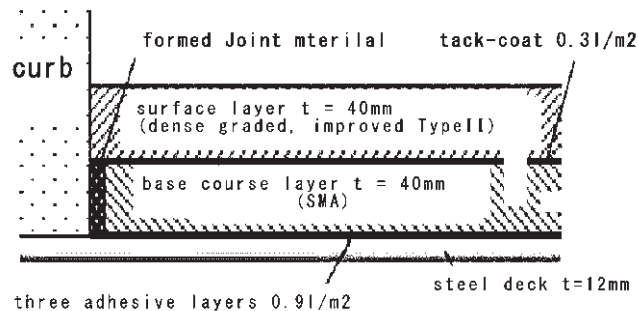
**Figure A.1 Existing Pavement Layers**

- The location of removal of exiting pavement shown as in below figure is whole area on main cable stayed bridge. Existing pavement layers of both Surface course and Binder Course shall be removed.

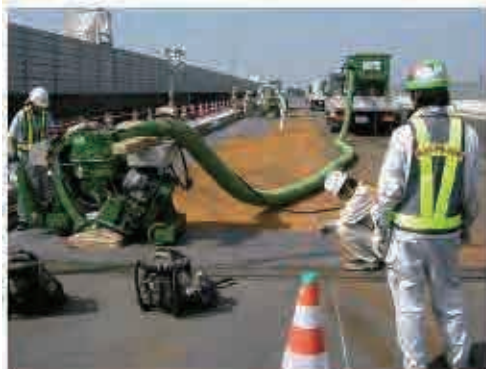
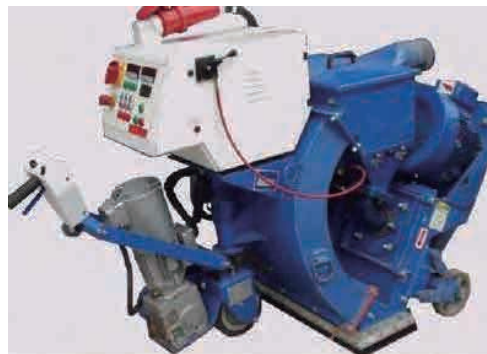
**Photo B.1 Sample Equipment of Shot-blast Projection**

- Preparation of the steel deck for the bonding layer shall be carried out by means of Shot-blasting to remove the existing bonding layer, along with any rust, oil, deteriorated paint, dust, etc. Prior to the Blasting work, the surface of the deck plate shall be made dry. If water or moisture remains on the surface, the wet area shall be dried by using air-blowers or heaters. The Shot-Blasting shall be carried out by projection of steel hemispheres sized from about 1.4 mm to 1.7 mm with a projection density 300kg/m2.
- After the Blasting, the remaining steel hemispheres shall be collected by using Magnets or Dust-collectors.

**Shot-blast Projection**

**Dust-Collector**

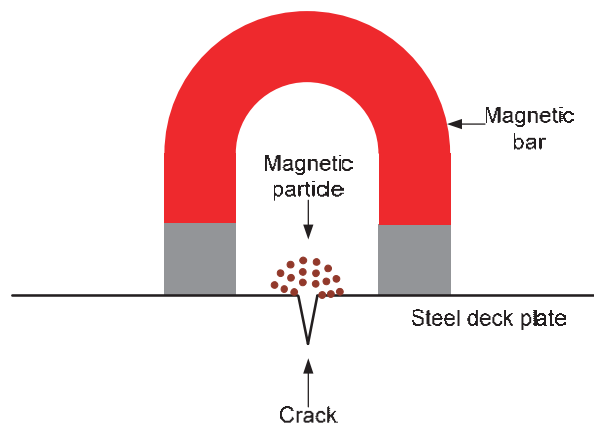
**Figure C.1 Magnetic Particle Inspection**

Magnetic particle inspection detects cracks and shows the detailed damage condition, based on information from the visual inspection.

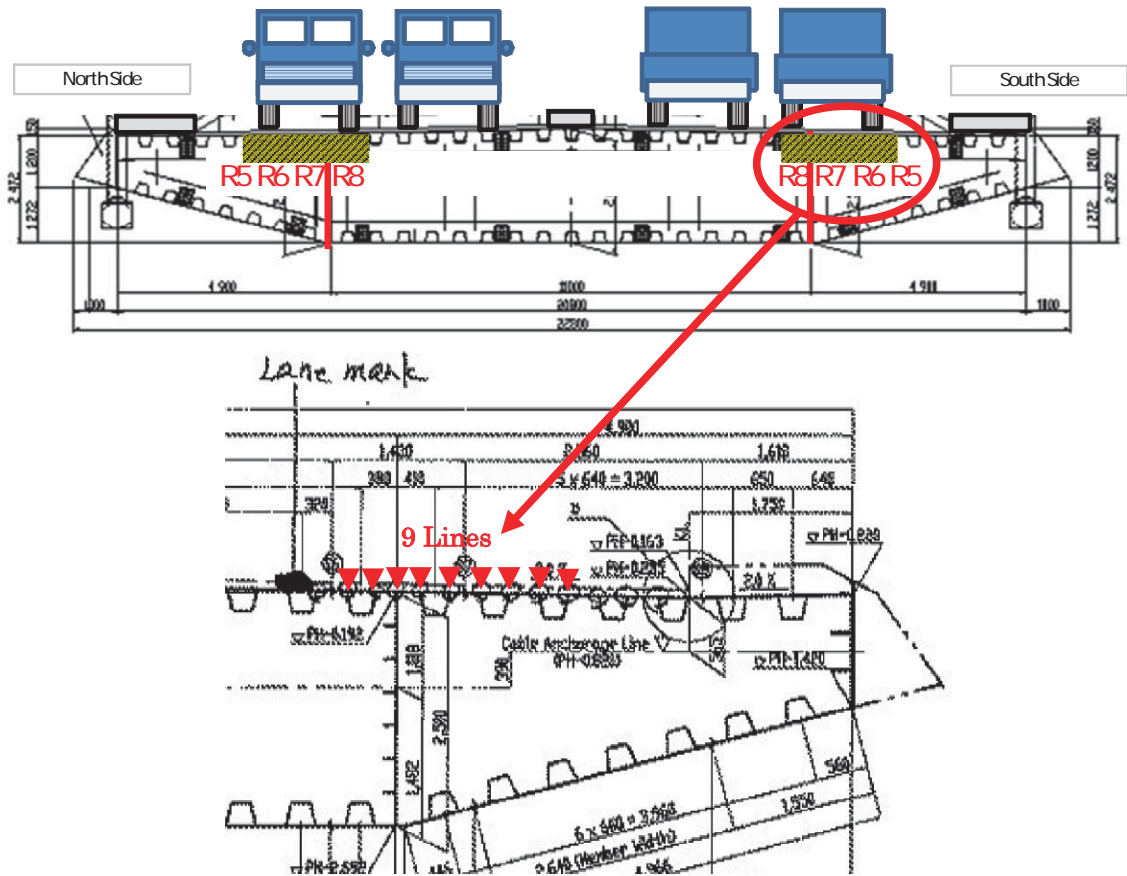
**Figure C.2 Location of Magnetic Particle Inspection**

- Inspection area: South side 9 lines (top of 4 U shaped ribs and 1 web) X 4 m long = 36 m

- Location of inspection lines shall be determined as the most corroded area by consultant's approval.
- Before magnetic particle inspection, surface of inspection lines on steel deck plate shall be grinded to remove corrosion completely.
- Inspection item: invisible cracks.
- As the corrosion is removed, magnetic particle testing is applied.
- Take pictures of all test steps.

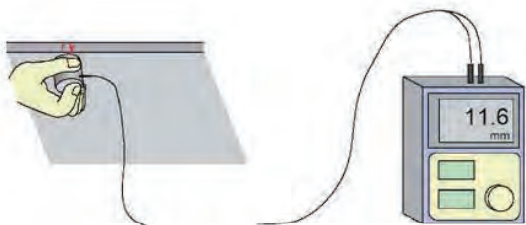
**Figure C.3 Plate Thickness Inspection by Ultrasonic Inspection**

The plate thickness shall be measured by Ultra Sonic Inspection.

- Inspection area: South side 9 lines (top of 4 U shaped ribs and 1 web) X 4 m long = 36 m.  
(Refer figure C.2)
- Number of inspection point: Every 10 cm pitch along 9 lines of 4 m = 369 points
- Location of inspection lines shall be determined as the most corroded area by consultant's approval.
- Before thickness inspection, surface of inspection lines on steel deck plate shall be grinded to remove corrosion completely.
- Inspection item: plate thickness.
- Inspection method: ultrasonic inspection.
- As the corrosion is removed, ultrasonic inspection is applied.
- The plate thickness is measured and verified by comparing with the original 12 mm.

If measured average thickness in one square meter of steel deck plate will be less than 11.0 mm, detailed inspection shall be done for other portion. After identification of the area where has average thickness less than 11.0 mm, the repair work of steel deck plate shall be executed by appropriate method which shown in Annex 1.

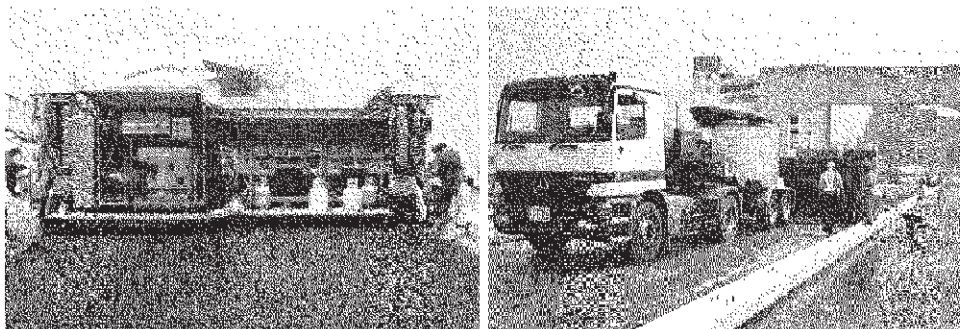
- If necessary, to confirm the final properties of the asphalt concrete mixture. The job mix process shall be executed.
- (6) Equipment for Guss Asphalt Binder Layer
- A mobile Special Asphalt Finisher and Cooker used for mixing shall be prepared for construction of Guss Asphalt Binder Layer since the mixture has to be heated to 240 °C.

Guss Finisher

Guss Mobile Cooker

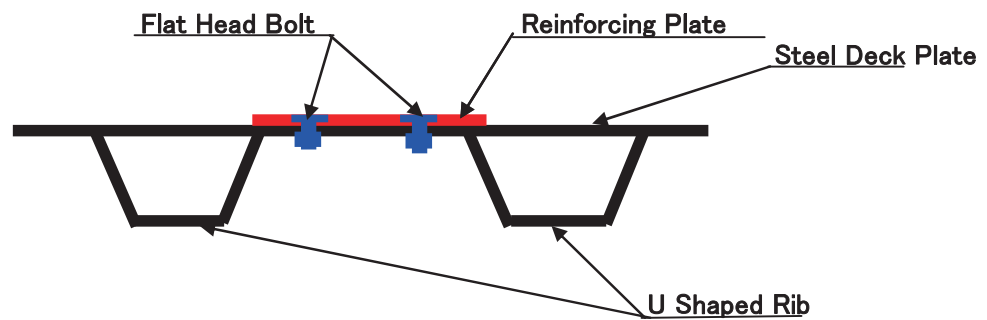
**Figure 1 Reinforcing Plate of the Steel Deck Plate**

- If fatigue cracks or thickness reduction of the steel deck plate will found by detailed inspection specified in C, appropriate reinforcement work of the steel deck plate shall be executed for damaged area.
- Method of reinforcement work is to apply a reinforcing additional plate as the following figure.

- High tension flat head bolt shall be utilized to secure a flatness of top surface of the reinforcing plate.
- Original steel deck plate and additional reinforcing plate shall be connected by epoxy bonding material.
- Area to be repaired, details of repair method and materials to be used shall be approved by consultant before commencement of repair work of the steel deck plate.
