**MINUTES OF DISCUSSIONS
ON THE FOLLOW-UP COOPERATION STUDY
ON
THE PROJECT FOR CONSTRUCTION OF THE SUEZ CANAL BRIDGE
(PAVEMENT FOR STEEL DECK PLATE)**

Executive Summary of Survey and Basic Policy for resolution of the damages

TECHNICAL NOTE
ON THE FOLLOW-UP COOPERATION STUDY
ON THE PROJECT FOR CONSTRUCTION
OF THE SUEZ CANAL BRIDGE (PAVEMENT on STEEL DECK)
IN ARAB REPUBLIC OF EGYPT

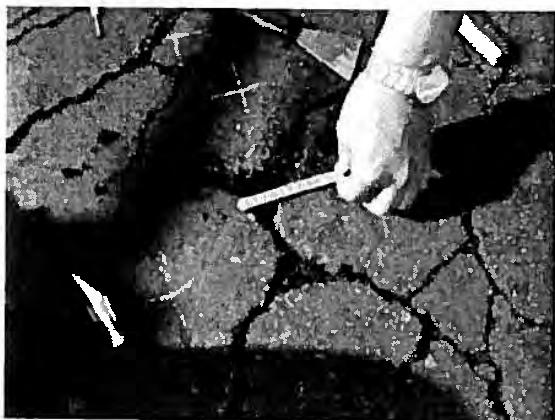
Photo-1 Crack Condition

- ✓ Cracks have occurred on more 95 percent of the whole surface area
- ✓ The area with crack widths of 10mm or more is about 70 percent of the whole surface
- ✓ It is expected that cracks with a width of 10mm or more reach into the Binder Layer

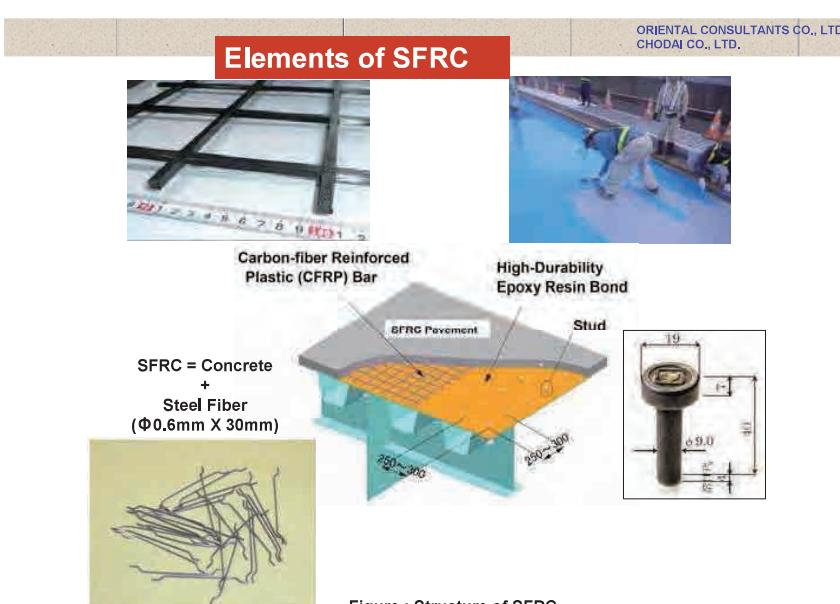
Figure : Structure of SFRC

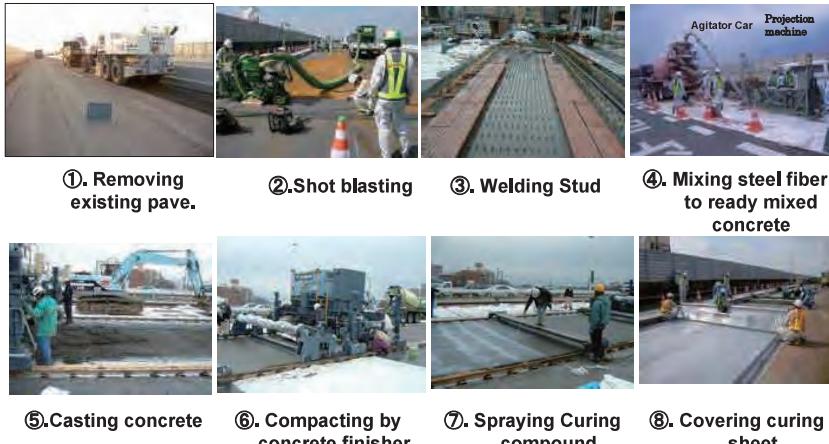
6.3 Construction Procedure

- Shot-blasting is essential to remove completely existing rust
- Stud should be welded evenly and vertically
- High-Durability-Epoxy-Resin should be painted along construction joint of SFRC.

- Stretchable Joint material is filled along Construction joint of SFRC
- Special concrete finisher should be prepared for adequate compaction to SFRC.
- The repair work under public traffic closure during winter season due to;
 - Avoid vibration by vehicles passing during Concrete strengthening.
- Work including bonding (HDER) within 120minutes under lower than 30 degree temp.

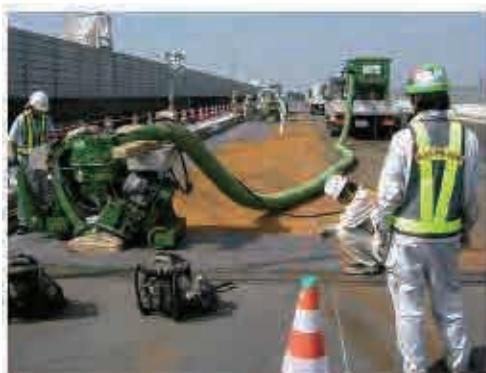
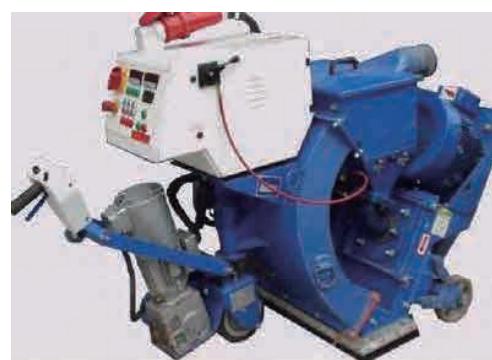
Photo B.1 Sample Equipment of Shot-blast Projection

- Preparation of the steel deck for the bonding layer shall be carried out by means of Shot-blasting to remove the existing bonding layer, along with any rust, oil, deteriorated paint, dust, etc. Prior to the Blasting work, the surface of the deck plate shall be made dry. If water or moisture remains on the surface, the wet area shall be dried by using air-blowers or heaters. The Shot-Blasting shall be carried out by projection of steel hemispheres sized from about 1.4 mm to 1.7 mm with a projection density 300kg/m².
- After the Blasting, the remaining steel hemispheres shall be collected by using Magnets or Dust-collectors.

Shot-blast Projection

Dust-Collector

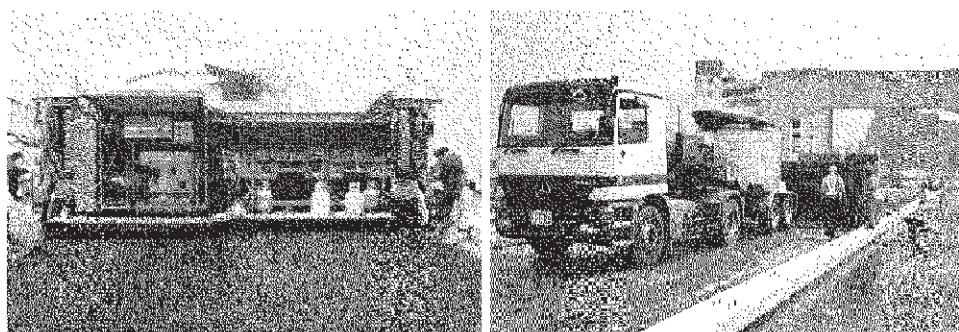
- A mobile Special Asphalt Finisher and Cooker used for mixing shall be prepared for construction of Guss Asphalt Binder Layer since the mixture has to be heated to 240 °C.

Guss Finisher

Guss Mobile Cooker
