**MALAWI POLYTECHNIC
CIVIL ENGINEERING DEPARTMENT**

**REPORT ON GEOTECHNICAL INVESTIGATIONS ON THE PROJECT FOR
CONSTRUCTION OF A TEACHER TRAINING COLLEGE FOR SECONDARY
SCHOOL TEACHERS IN LILONGWE**

**PREPARED BY: TUTULE MSUKWA, MPhil, BSc Civil Eng, Reng.
Geotechnical Engineer**

6-3 BOREHOLE INVESTGATION REPORT AT TTCL (Nalikure Site)

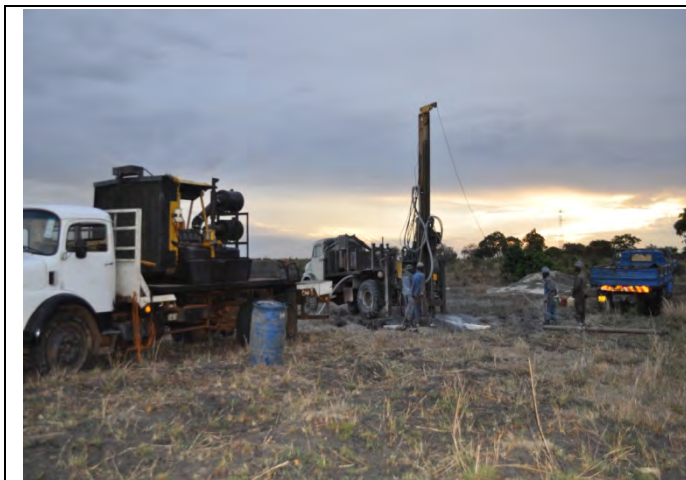
1. Drilling at TTC No. 1

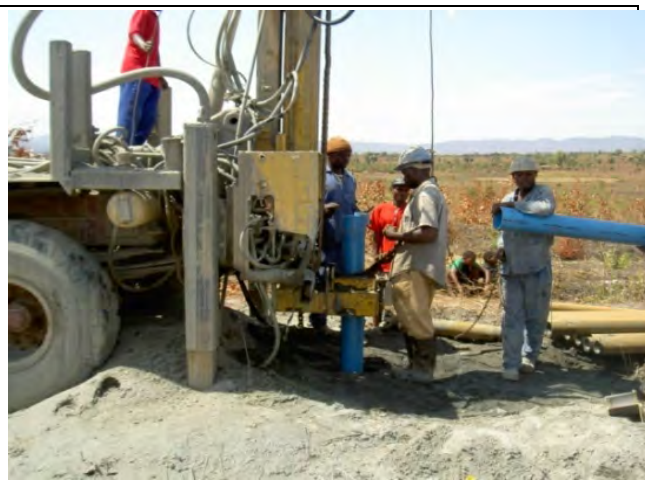
2. Setting of casing (D160mm) at TTC No. 3

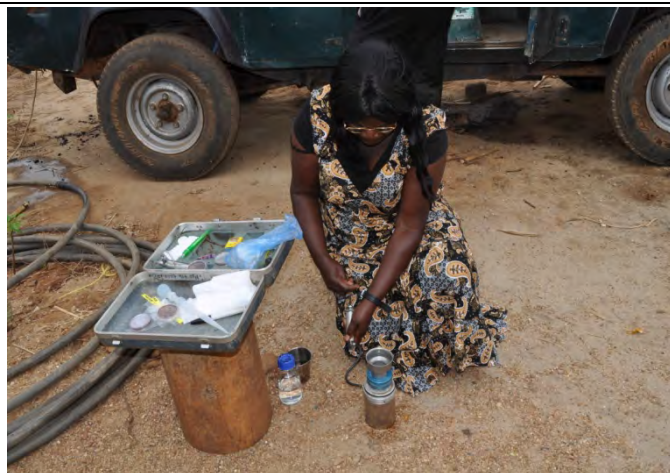
3. Sampling by the technical officer of MAIWD at TTC No. 3

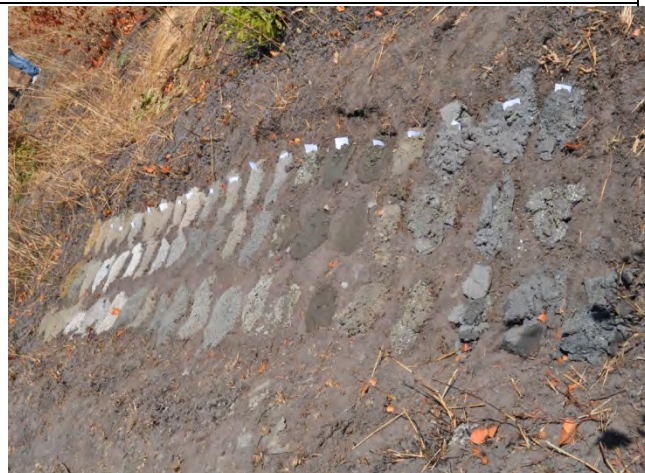
4. Soil sample (GL-3m~61m) at TTC No. 3

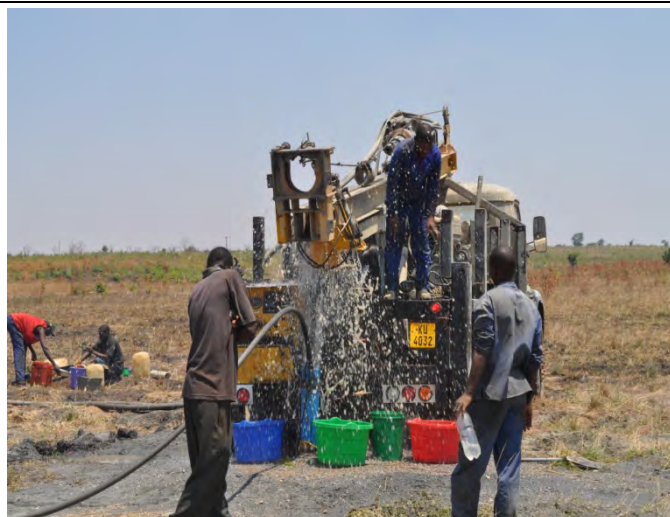
5. Clean development at TTC No. 4

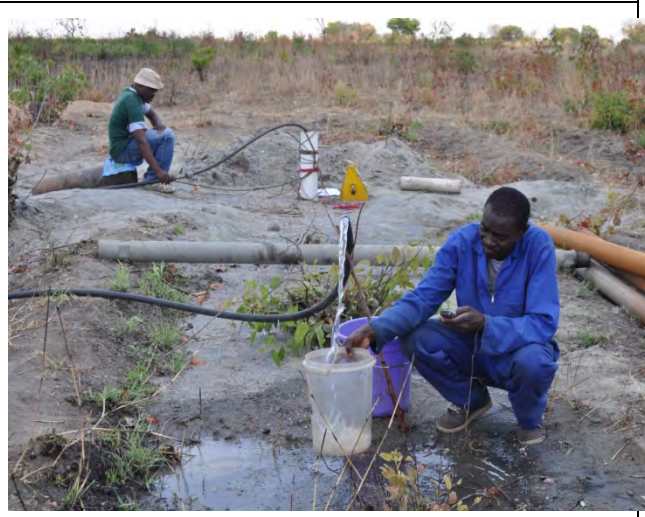
6. Constant discharge test at TTC No. 3
