**CHAPTER 3**  
**CONTENTS OF**  
**THE FOLLOW-UP COOPERATION**

### **3-1 Outline of the Follow-up Programme**

### **3-2 Outline Design of the Cooperation Project in Abuyog WD**

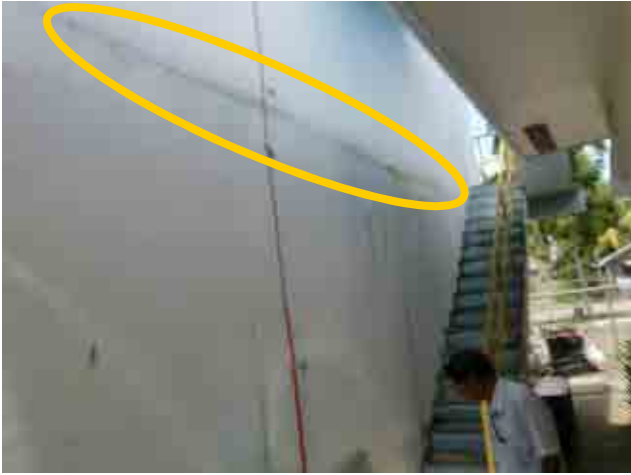
Before rehabilitation  
Aeration Tower: Leakage from the concrete joint.

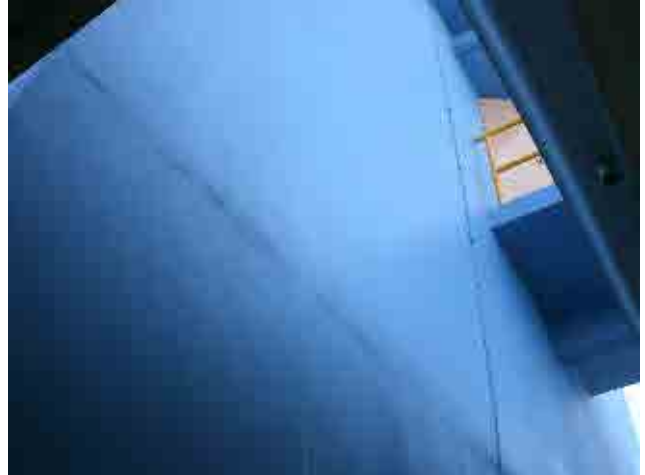
After rehabilitation:  
Aeration tower: Leakage part was repaired and each facilities were painted.

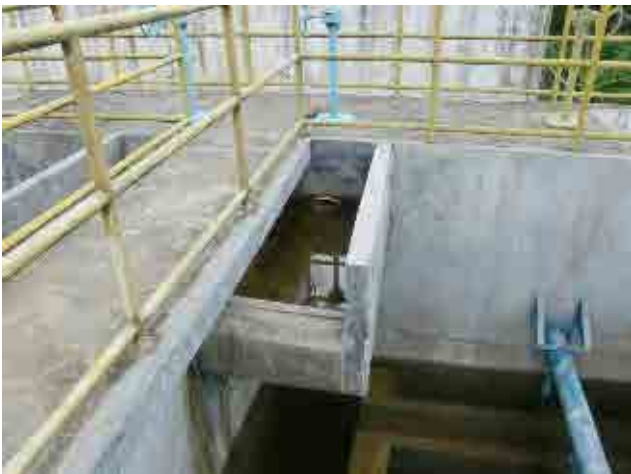
Before rehabilitation  
Rapid sand filter, inlet trough: Improvement is required to prevent flocs inflow to prevent the breakage.

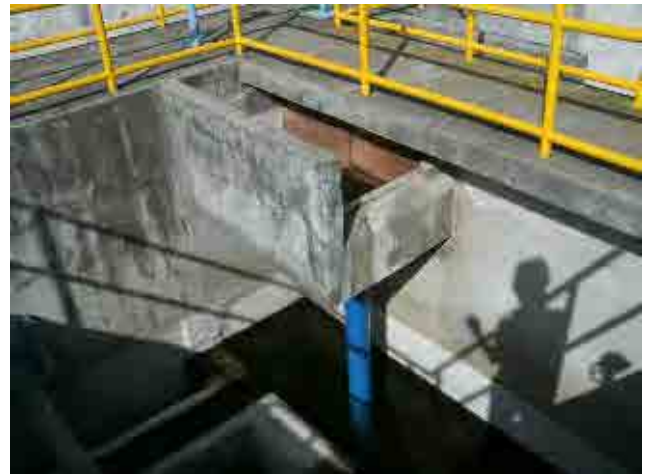
After rehabilitation  
Rapid sand filter: Inlet pipe was installed to prevent floc breakage

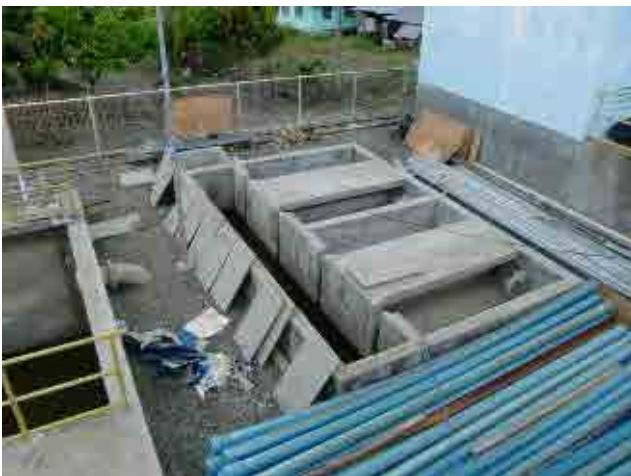
Before rehabilitation  
Sludge drying bed: Installation of bed sand is required due to accommodate the change in Philippines effluent standard.

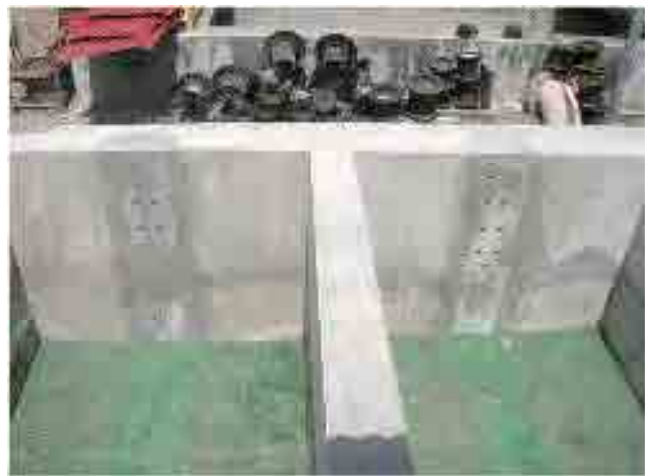
After rehabilitation  
Sludge Drying bed: Gravel and sand are filled and re-graded. Tank volume is appropriate for the drying purpose.

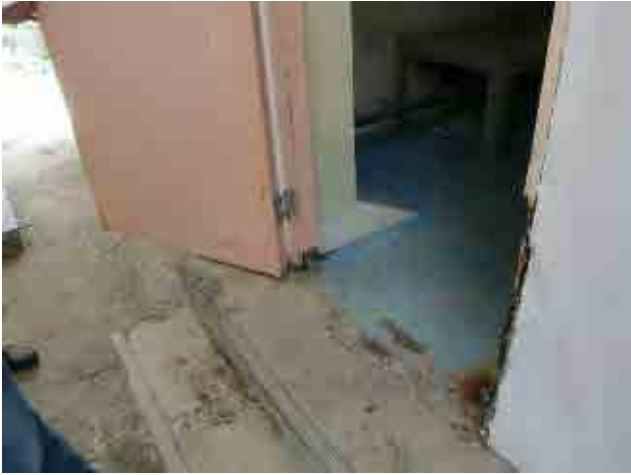
Before rehabilitation  
Chlorination room: The entrance door and its frame are corroded.

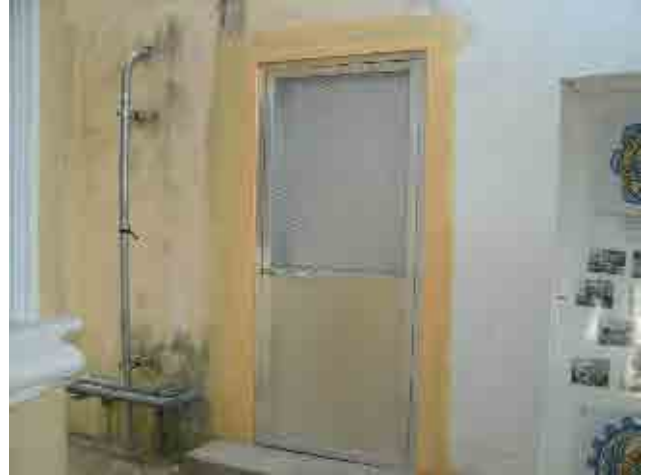
After rehabilitation:  
Door of chlorination facility: Replaced to aluminum double door and it will not be corroded.

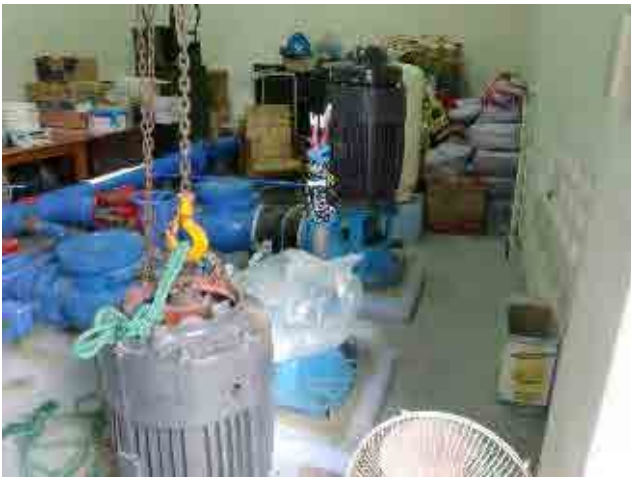
Before rehabilitation  
Distribution pumps: They are not in use due to a breakdown. Pump No.1 is not in use because of the broken shaft. Pump No.2 has a problem with over-current; the motor has no problem, thus the pump could be defective.

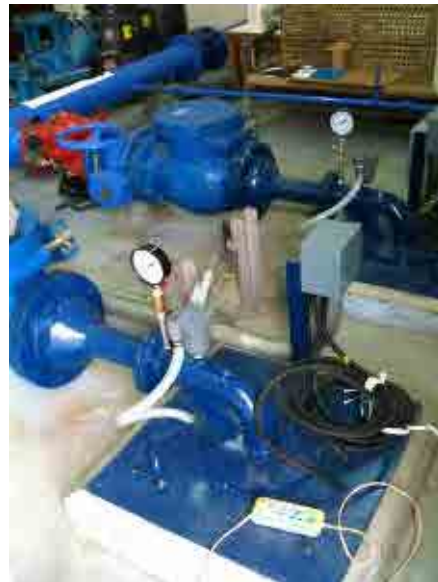
After rehabilitation:  
Distribution pumps: Replaced to submerged pump and water is distributed properly.

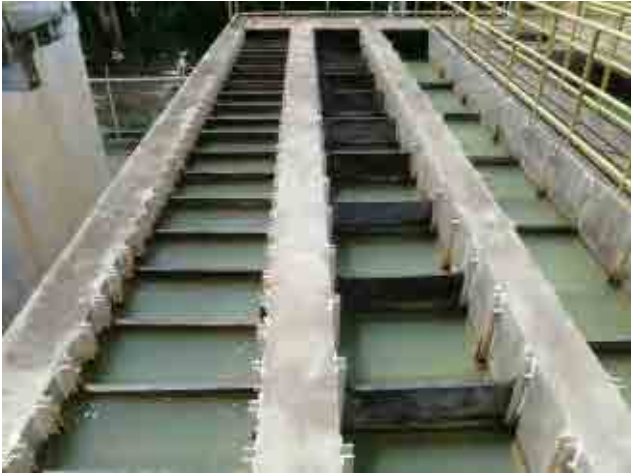
Before rehabilitation  
Hydraulic Flocculator: Adjustment of vertical baffles is required.

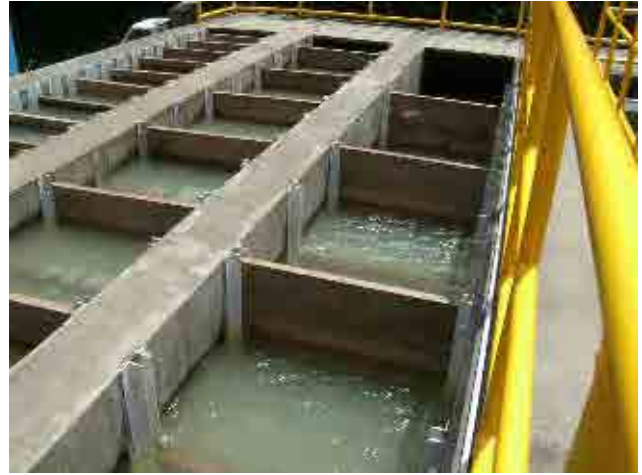
After Rehabilitation  
Flocculator: flow velocity is increased by adjusting the vertical baffles.

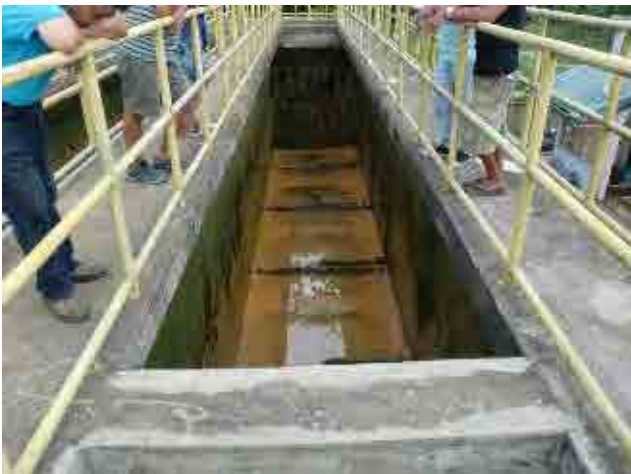
Before rehabilitation  
Sedimentation basin, sludge drain pipes: All pipes are corroded by high salinity of the raw water.

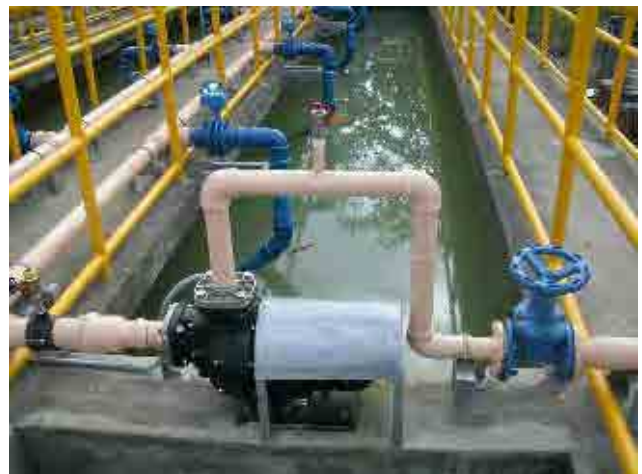
After rehabilitation  
Sedimentation basin, sludge drain pipes: Sludge pump and distribution pipes are installed, and operated properly

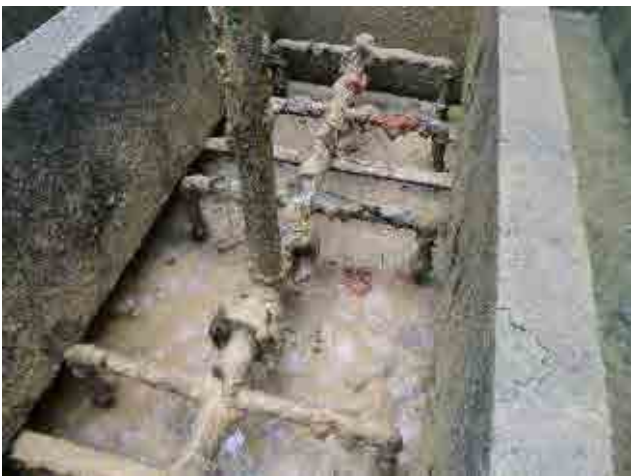
Before rehabilitation  
Rapid sand filter, surface-wash pipe: After drainage of water from the filter basin, settled flocs and sludge adhere to the surface-wash pipes.

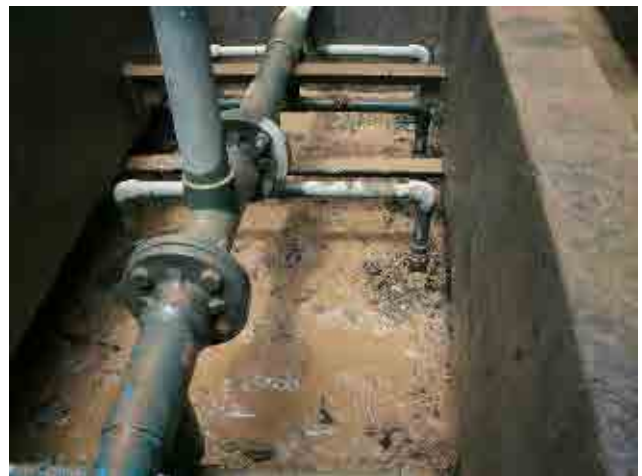
After rehabilitation  
Rapid sand filter  
Surface wash pipes were replaced to PVC and the surface became able to be washed properly.

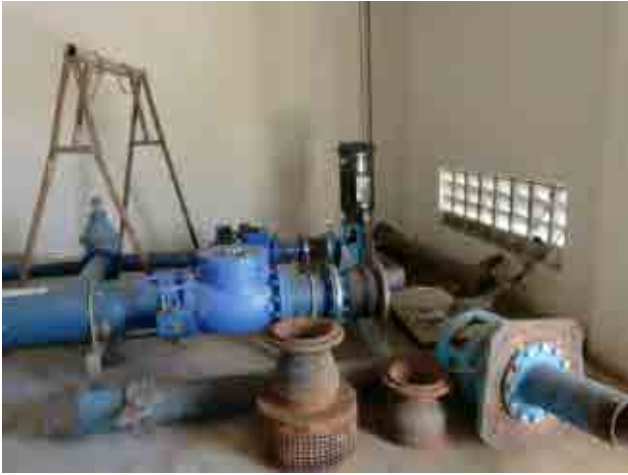
Before rehabilitation  
Backwash pump: It has been removed since Oct 2009 because of a breakdown.

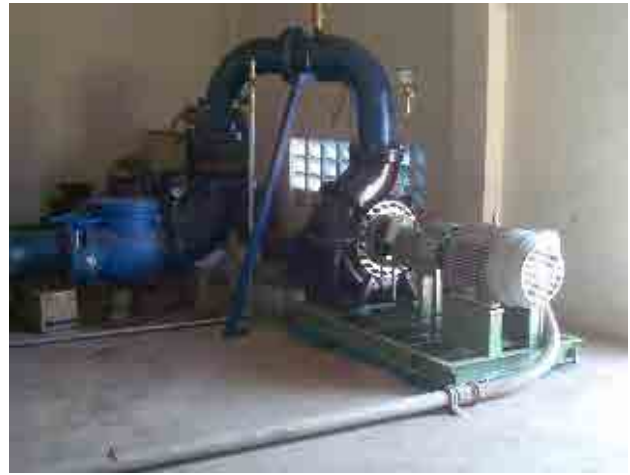
After rehabilitation  
Backwash pump  
Anti-corrosion pump is installed and backwash is done properly.

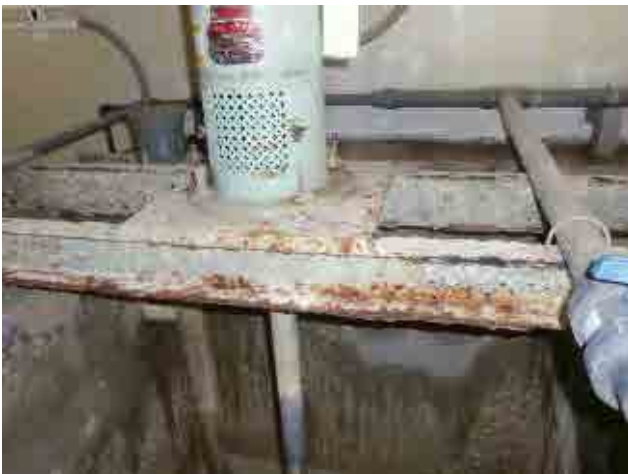
Before rehabilitation  
Chlorination agitator support: It was covered by rust of the corrosion.

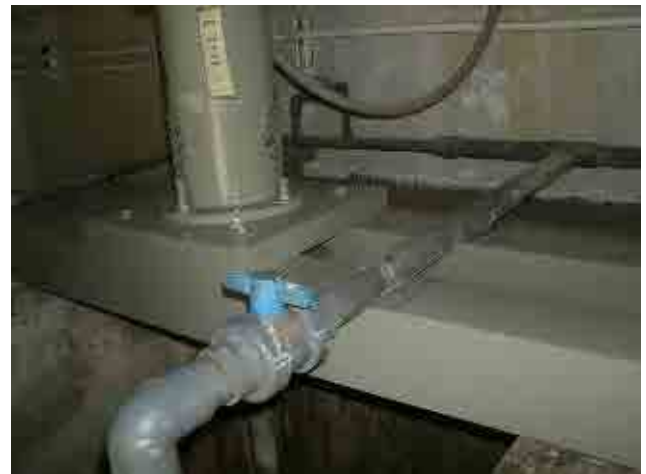
After rehabilitation  
Chlorination agitator support  
It was changed to wooden support, and durability is increased

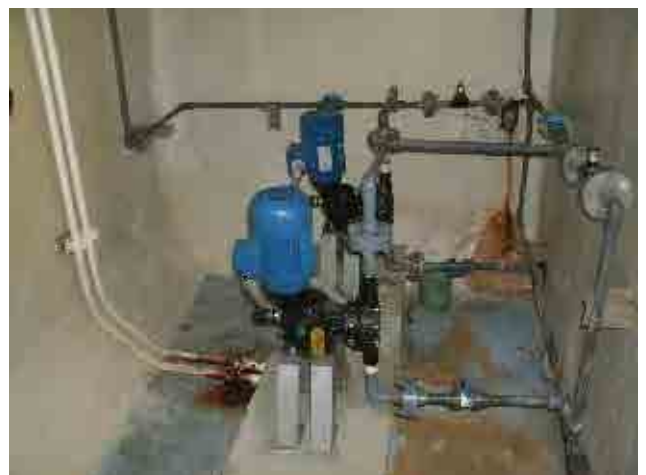
After rehabilitation  
Intermediate chlorination, injection pump: Pump is renewed and valve is installed to each injection pipe and it enabled equal injection to each pipe.

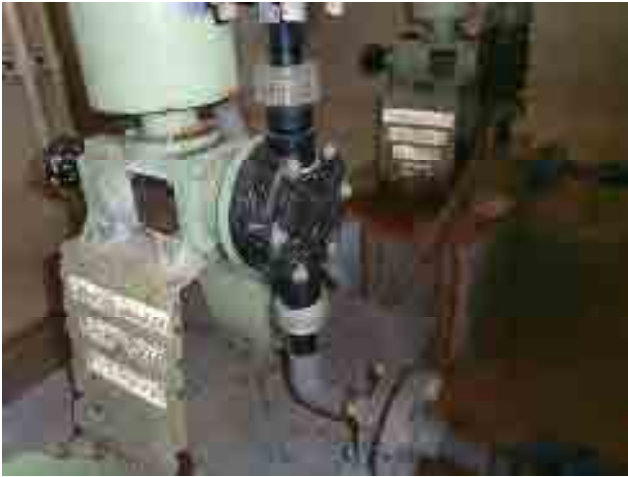
Before rehabilitation  
 Post chlorination, injection pump: Not in use due to a breakdown.

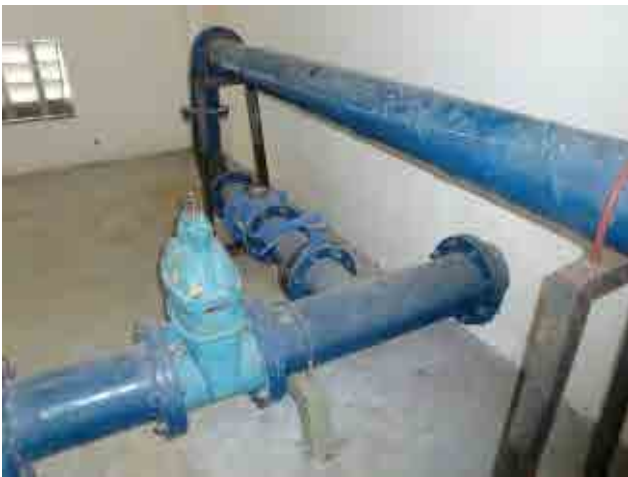
Before rehabilitation  
 Transmission pipe: A bypass line is connected from another water source to dilute the saline water in the reservoir.

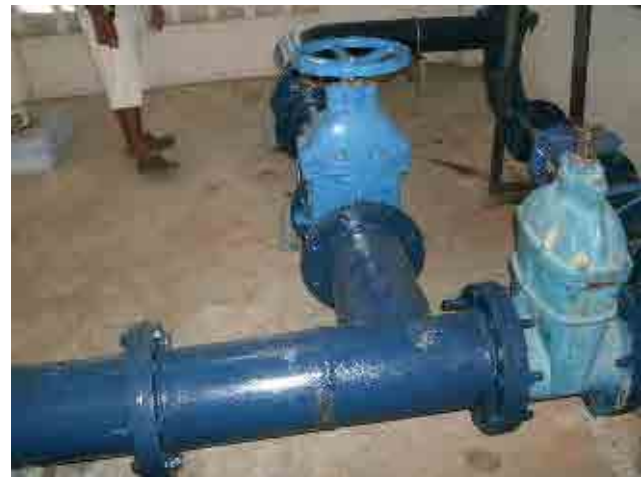
After rehabilitation  
 Transmission pipes were installed and flow meter was replaced, so maintenance became easier.

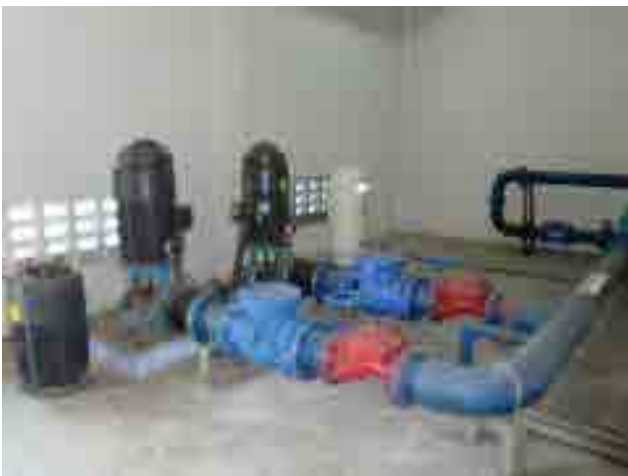
Before rehabilitation  
 Transmission and distribution pump  
 Pumps were wearing out with corrosion. There is the risk of sudden interruption.

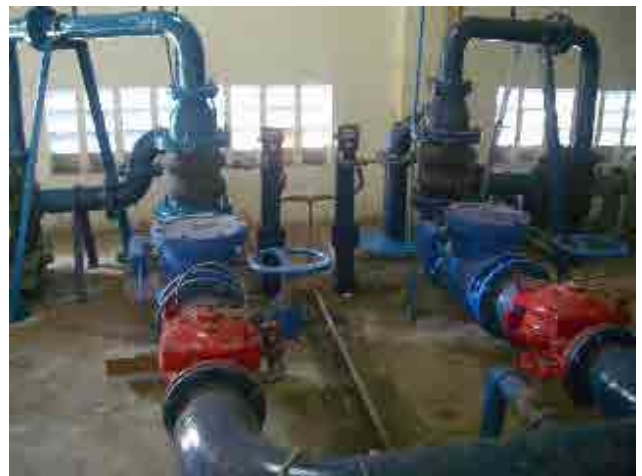
After rehabilitation  
 Transmission and distribution pump  
 The pumps were replaced to the anti-corrosion ones and the concern of rusting was resolved.

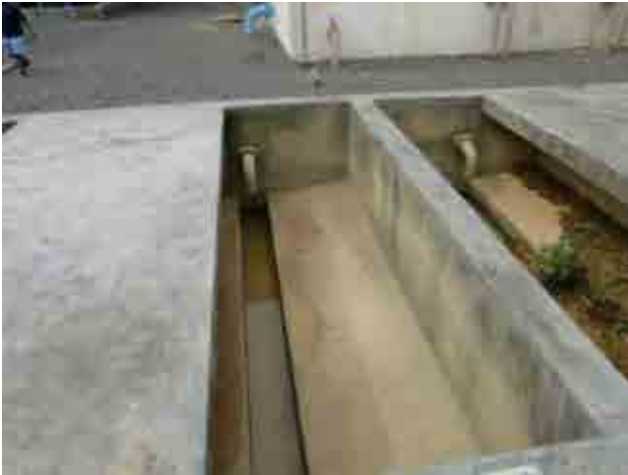
Before rehabilitation  
 Sludge drying bed: Installation of bed sand is required due to accommodate the change in Philippines effluent standard..

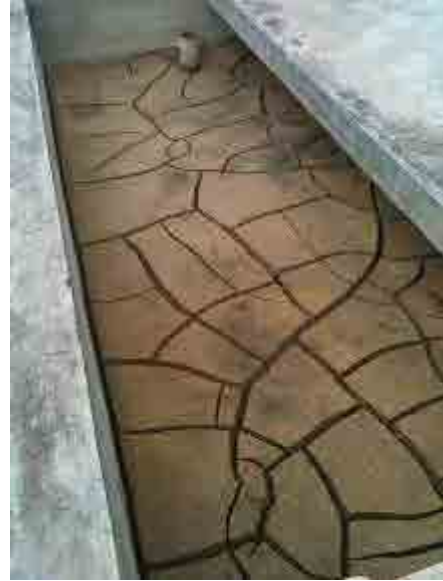
After rehabilitation  
 Sludge Drying Bed  
 Gravel and sand are filled, and sludge drying bed is functioning properly.

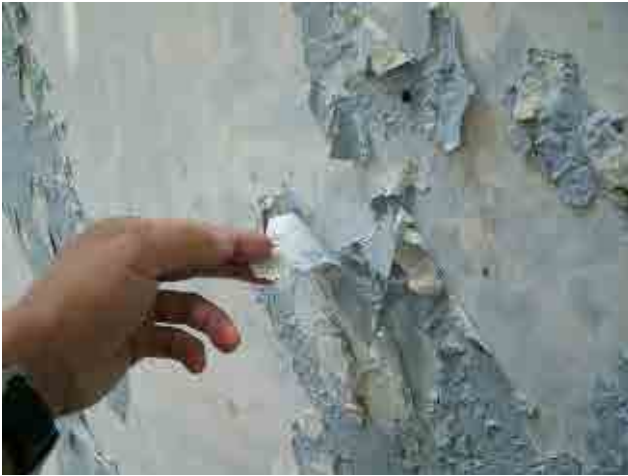
Before rehabilitation  
Aeration tower: Paint of exterior wall is peeled off. WD requested its removal.

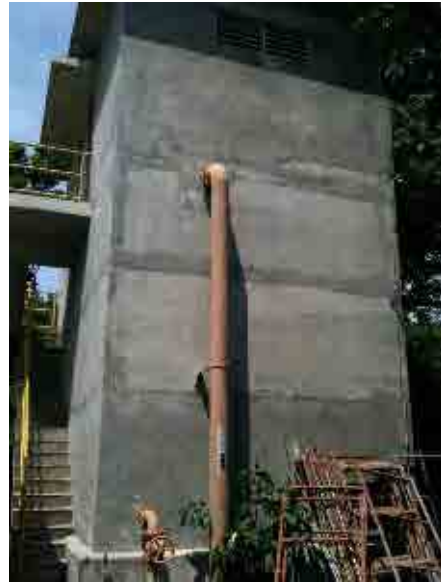
After rehabilitation  
Aeration tower:  
Removal of paint is completed and appearance became better.

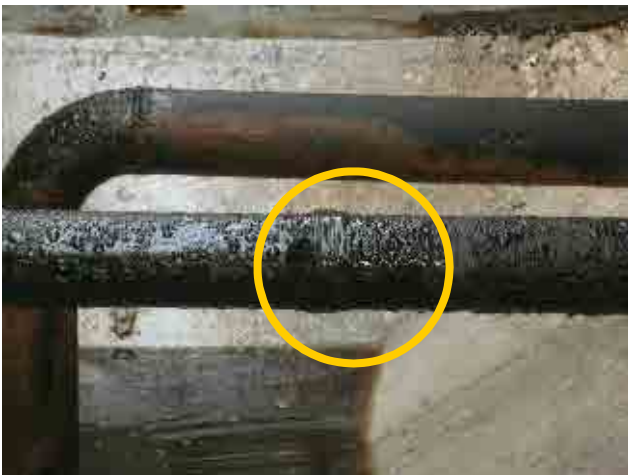
Before rehabilitation  
Sedimentation basin: Hole on the sludge drain pipe has been repaired with rubber sheet.

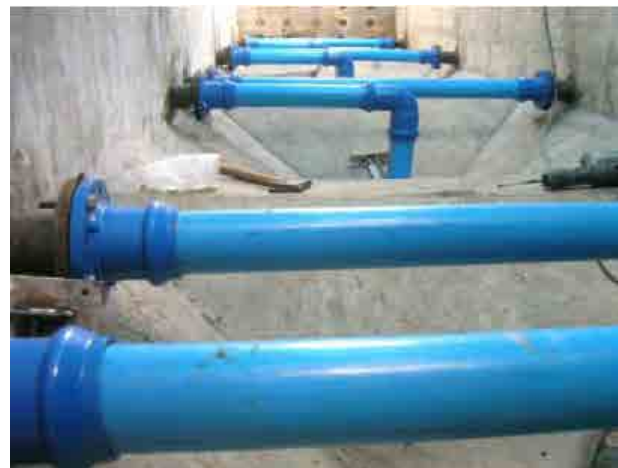
After rehabilitation  
Sedimentation basin: Corroded parts were replaced to PVC so as to drain properly and eliminate the risk of corrosion.

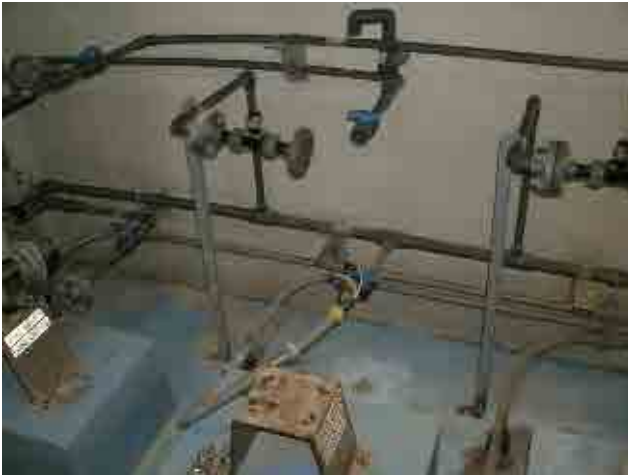
Before rehabilitation  
 Post chlorination pump: It has been removed due to breakdown.

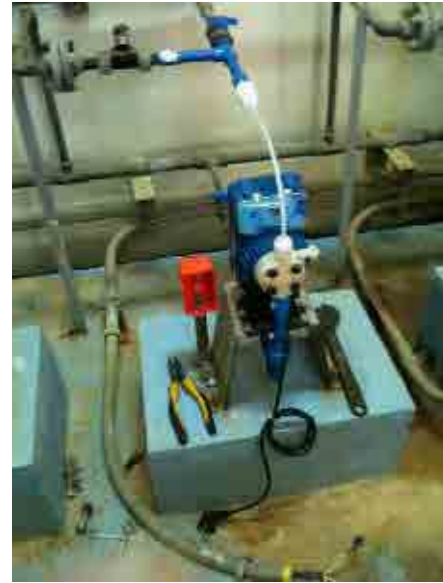
After rehabilitation  
 Post Chlorination injection pump  
 Pump is renewed so post chlorination can be done.

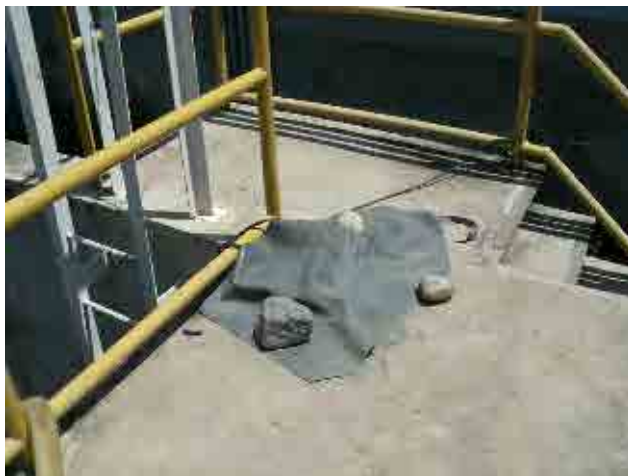
Before rehabilitation  
 Drainage basin: The single phase socket is covered by a sheet for insulation.

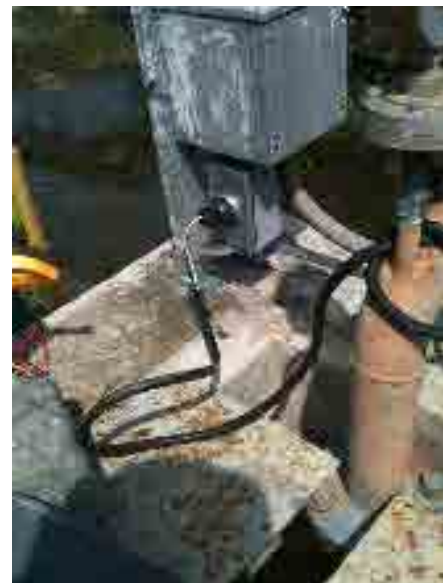
After rehabilitation  
 Drainage basin: Outside consent for the single phase supply is installed, and the maintenance became easier.

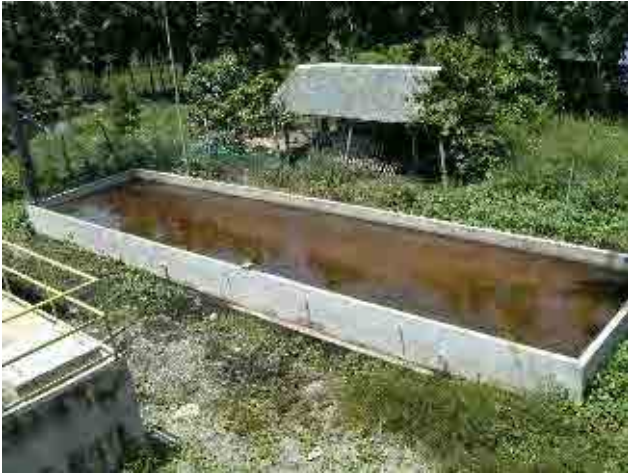
Before rehabilitation

Sludge Storage basin: A sludge storage basin was constructed by WD for receiving the excess sludge. The structure is for evaporation, and not for drying, therefore it takes 3 to 4 weeks.

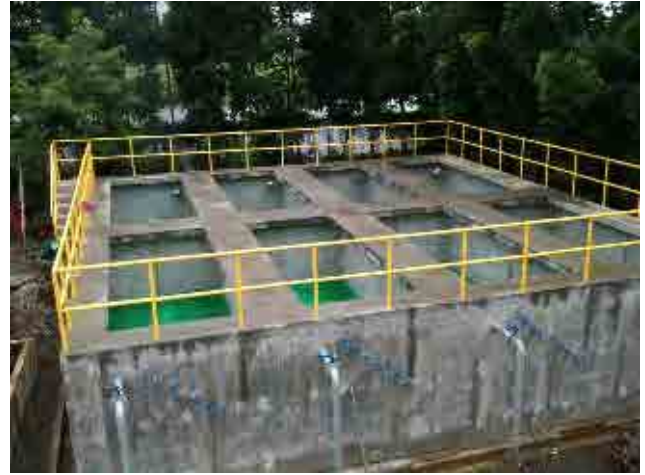
After rehabilitation

Sludge drying bed: Sludge is treated properly by the constructed sludge drying bed with the required volume.

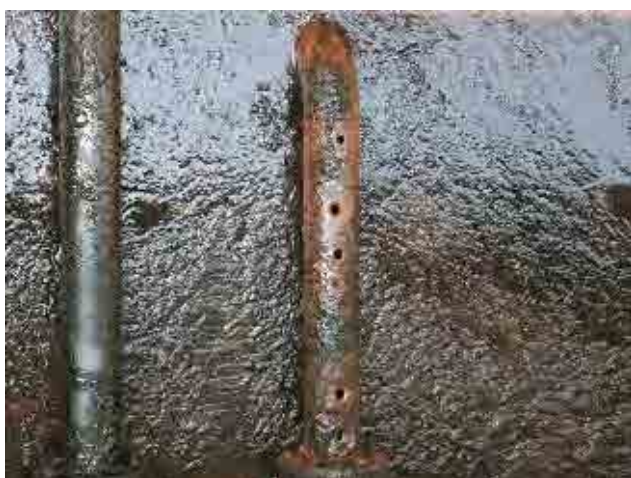
Before rehabilitation

Sedimentation basin: Sludge drain pipe has holes due to corrosion.

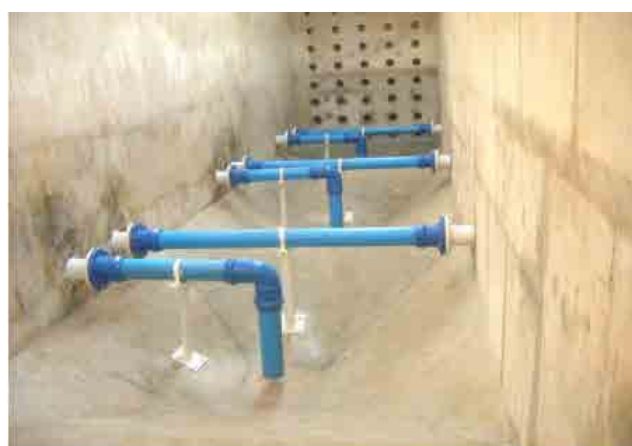
After rehabilitation

Sedimentation basin: Corrosion parts were replaced to PVC, therefore there is no risk of corrosion

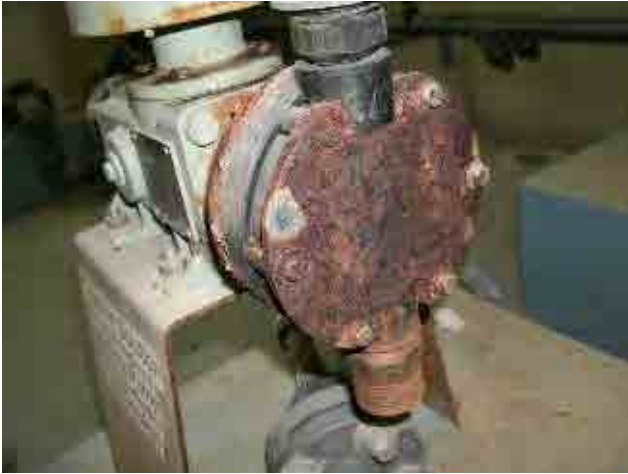
Before rehabilitation  
Post chlorination pump: Diaphragm part is malfunction due to corrosion. Post chlorination is missing.

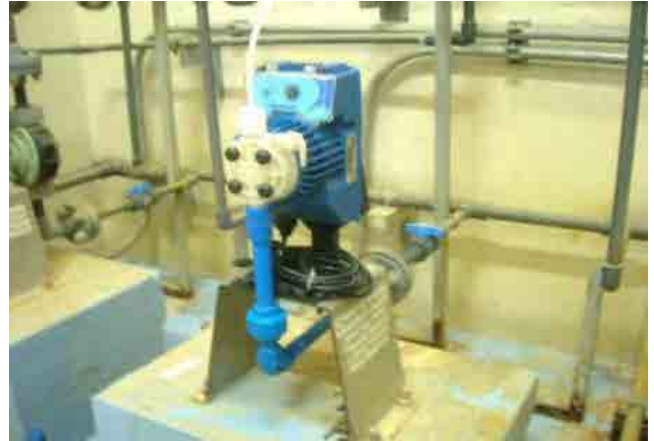
After rehabilitation:  
Post chlorination pump  
Pump is replaced and post chlorination can be done.

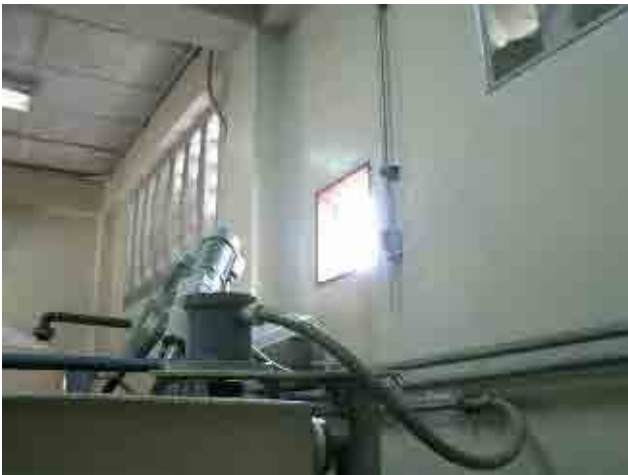
Before rehabilitation  
Chlorination room: Ventilation fan has been removed due to breakdown.

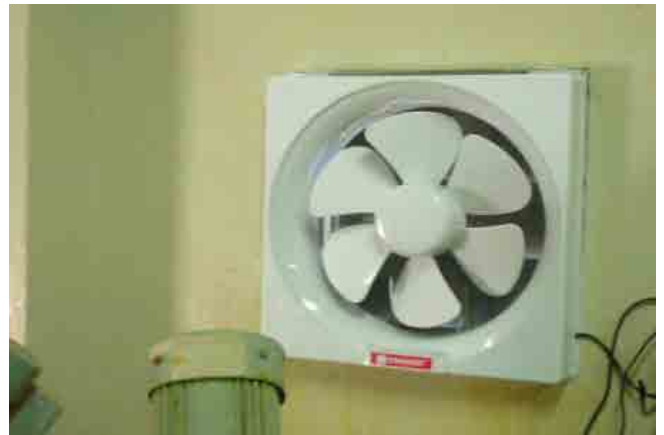
After rehabilitation:  
Chlorination room: Fan is replaced and the room is ventilated properly.

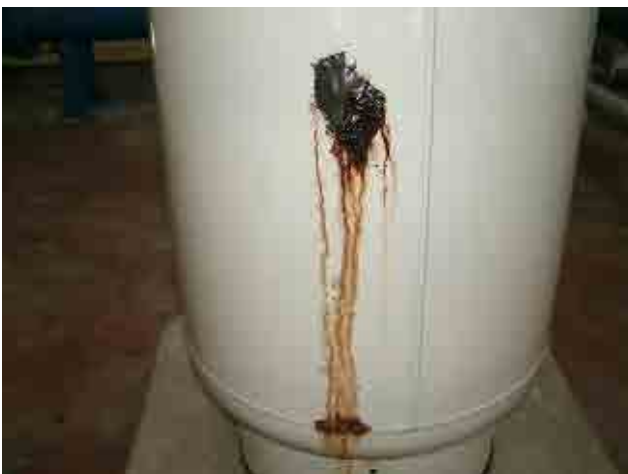
Before rehabilitation  
Pressure tank: The trace of leakage is found. It needs to be replaced.

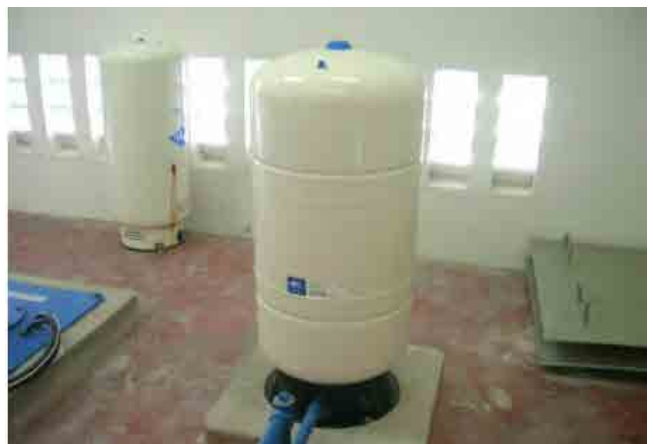
After rehabilitation  
Pressure tank: Pressure tank is replaced and used properly

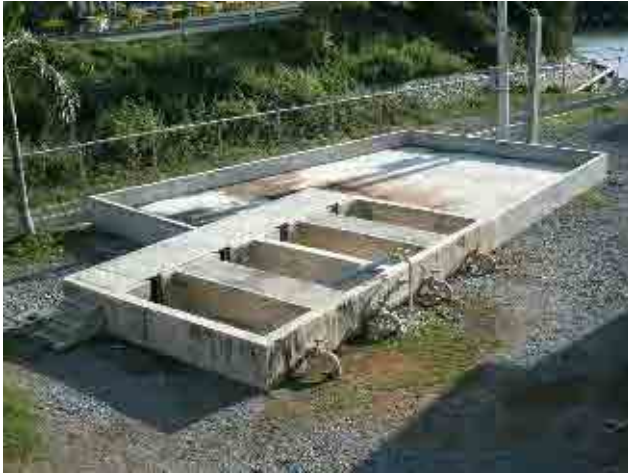
Before rehabilitation

Sludge Drying bed: An additional sludge storage basin was constructed by WD for receiving the excess sludge.

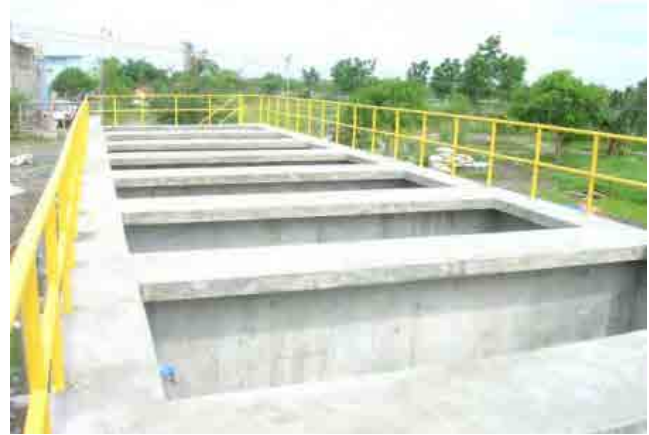
After rehabilitation

Sludge drying bed: Proper sludge treatment is practiced after the construction of required volume.

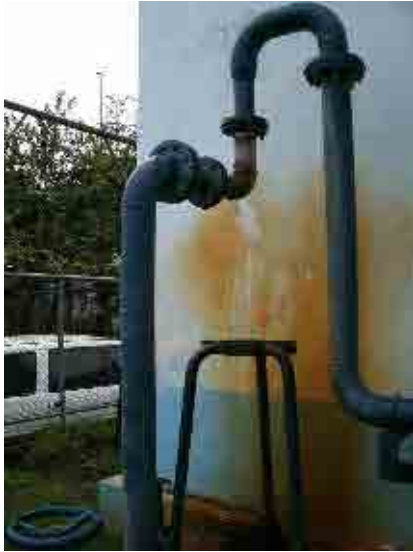
Before rehabilitation

Sand separator: It was changed two times and finally removed because of holes.

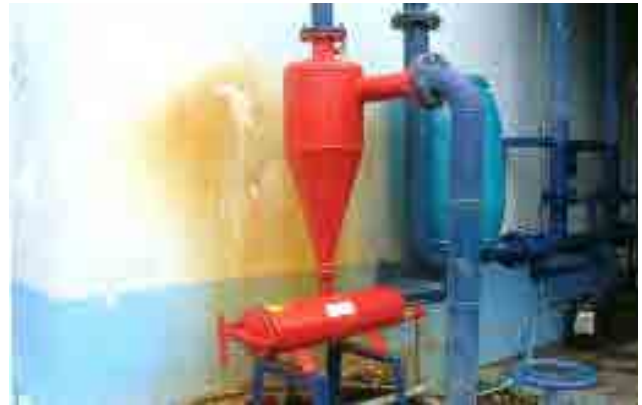
After rehabilitation

Sand separator: New sand separator is installed, therefore sand can be removed from the water.

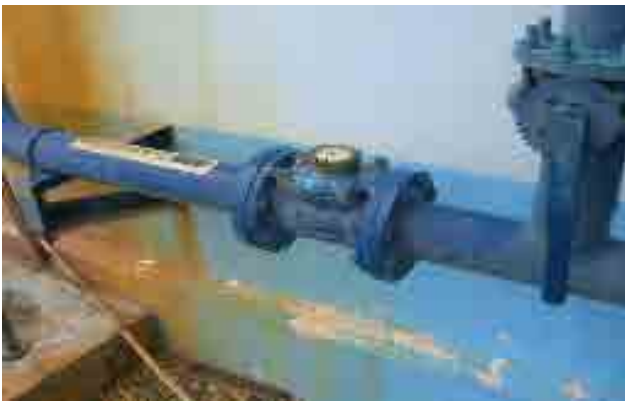
Before rehabilitation

Flow meter: Flow meter is broken and flow volume cannot be measured.

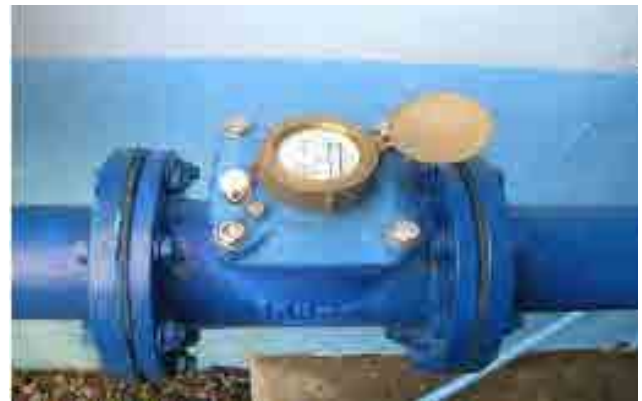
After rehabilitation

Flow meter: Flow meter is replaced and the flow volume can be measured.

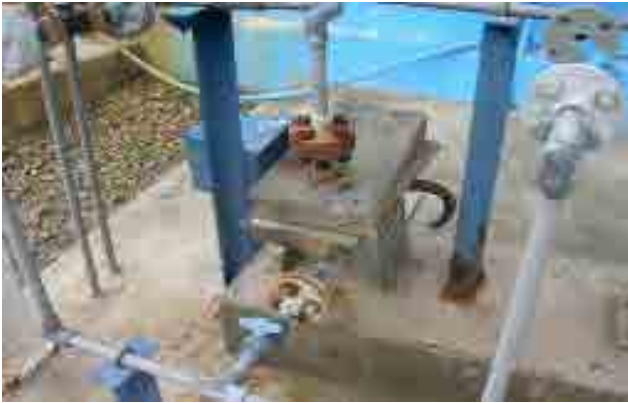
Before rehabilitation

Chlorination pump: It is removed due to a breakdown, and injection pump installed by WD is utilized temporarily. However there is a high risk of electrical leakage because single phase supply is connected from the distribution pump room.

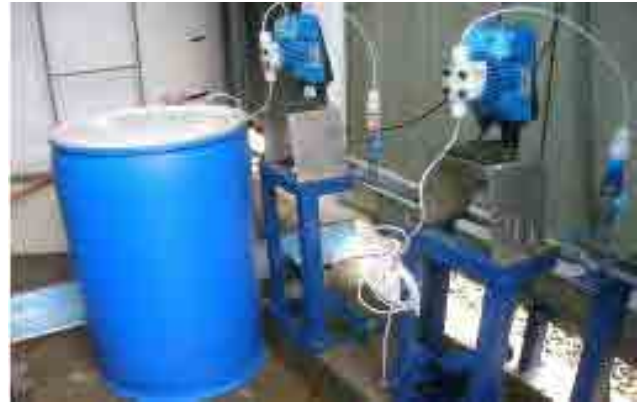
After rehabilitation

Chlorine injection pump: Pump is renewed and chlorination injection of each point is possible.

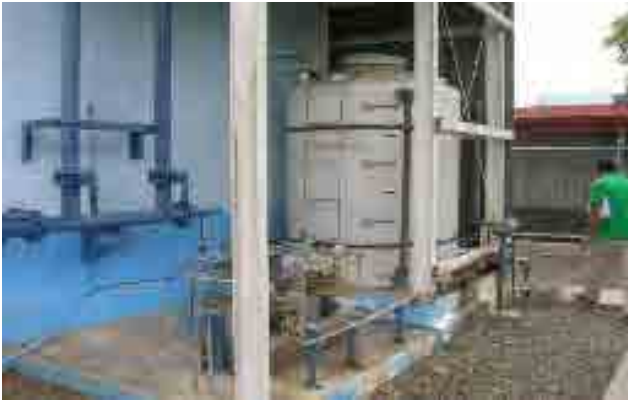
Before rehabilitation

Fence to prevent weather.

Chlorine injection pump was placed outside and exposed to the weather. The pump broke down due to corrosion in the end.

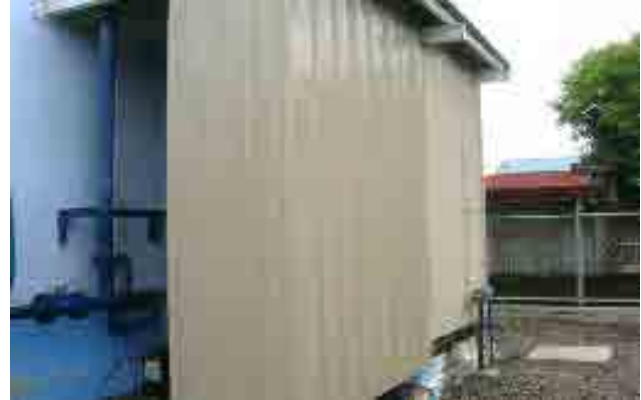
After rehabilitation

Fence to prevent the weather

The fence was installed around pump and direct effect of weather is avoided.

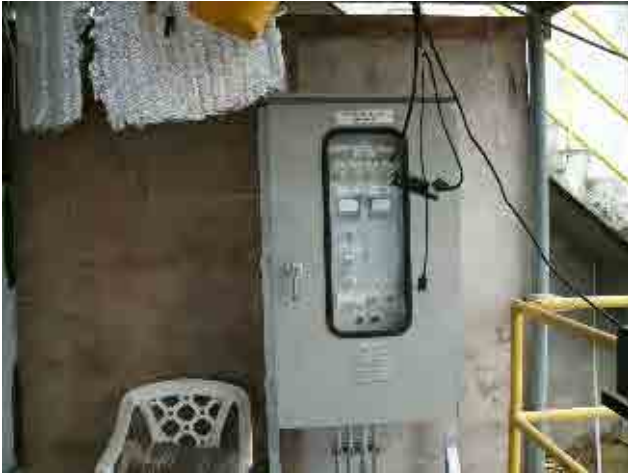
Before rehabilitation

Drain facility: Input of existing pump is for three phase, however pump which can be purchased at site is only for single phase supply, therefore it was difficult to obtain it in the case of breakdown.

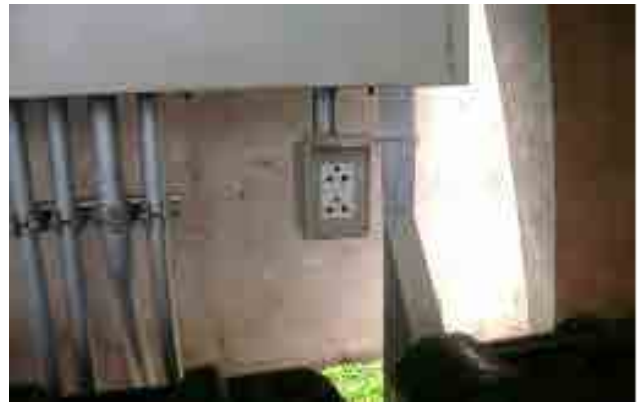
After rehabilitation

Drain facility: The installation of single phase consent made procurement of spare parts easier in case of a breakdown of the drain facility.

Drain facility	Installation of single phase supply	Drain facility: Input of existing pump is for three phase, however pump which can be purchased at site is only for single phase supply, therefore it was difficult to obtain it in the case of breakdown.	Electric point adaptable to the pumps for single phase supply is installed so the procurement of the spare parts became simpler.
