**Ministry of Agriculture  
Republic of Peru**

**THE PREPARATORY STUDY  
ON  
PROJECT OF THE PROTECTION OF  
FLOOD PLAIN AND VULNERABLE RURAL  
POPULATION AGAINST FLOOD IN THE  
REPUBLIC OF PERU**

**FINAL REPORT  
MAINREPORT  
I-1 PROGRAM REPORT  
(TEMPORARY VERSION)**

**March 2013**

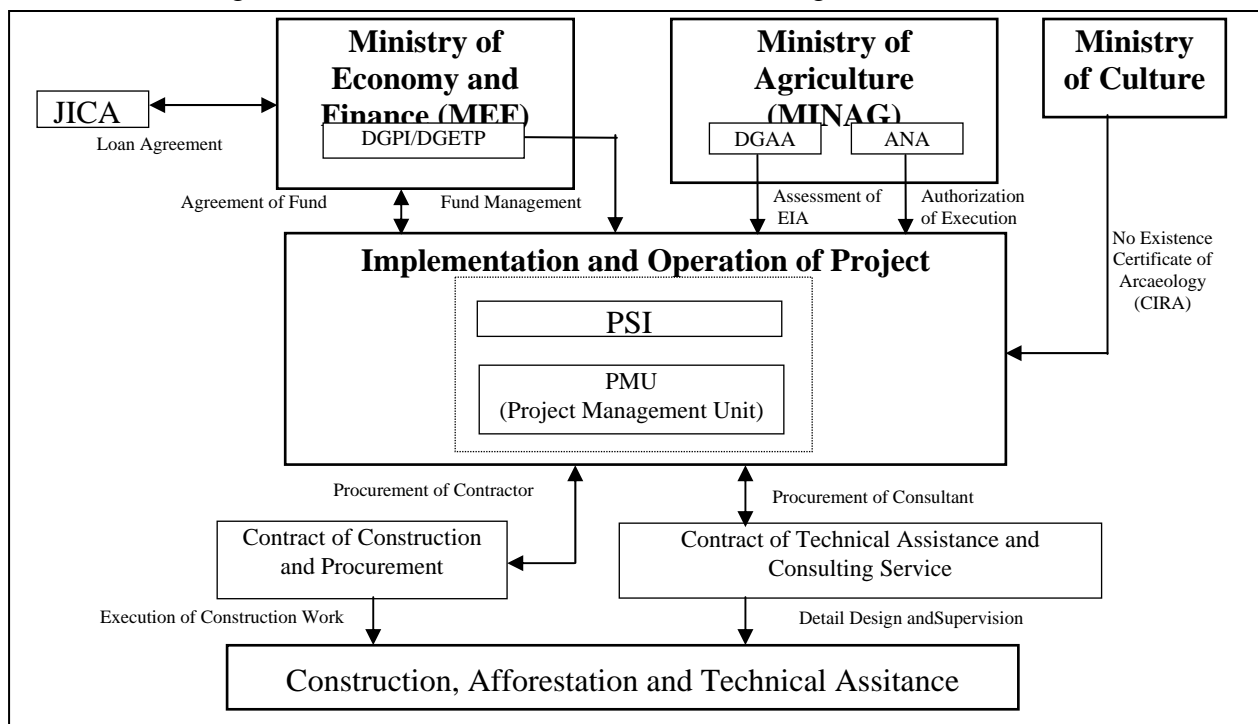
**Figure 1.9-1 Related Agencies in Implementation Stage of Project**

The institutions and its administration in the investment stage and in the operation and maintenance stage after the investment are as shown in the Figures 1.9-1 and 1.9-2.

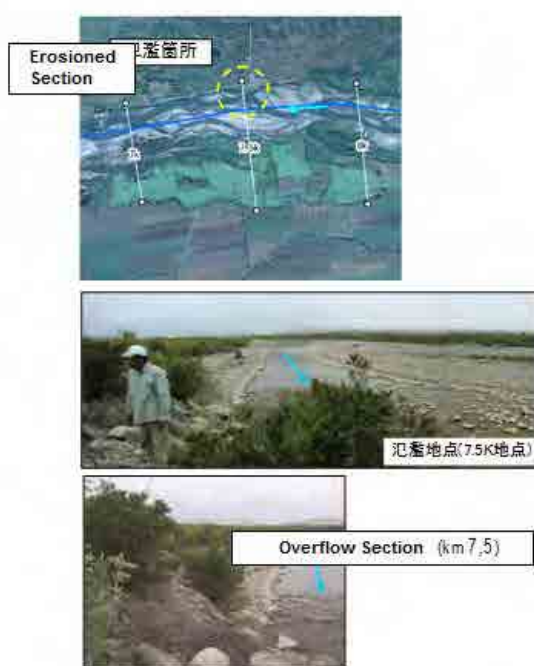
Current situation and challenges	<p>1998 floods destroyed the dike causing loss on agriculture field</p> <ul style="list-style-type: none"> <li>• In this area there are three destroyed sections of the dike (all of them on the right bank)</li> <li>• The water's greater impact area is on km 7.5, right bank. The fast and great flow causes scouring of the bed and consequently, the dike's destruction. Currently, the dike has been repaired, but there is still risk of destruction if great floods take place</li> </ul>
Main elements to be conserved	Crop land (main products: apple, grapes, cotton)
Basic measures	Dike and bank protection building for bank erosion control

**Figure 3.1.6-3 Local conditions related with Challenge 2 (Cañete river)**

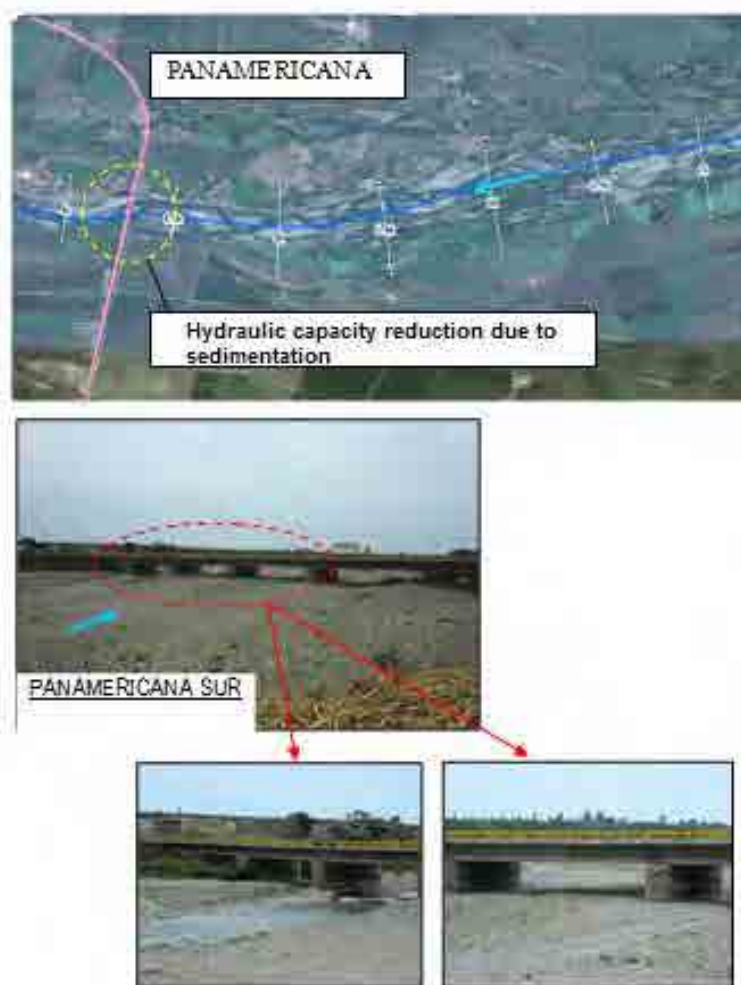
<p>Current situation and challenges</p>	<p>In 1998 floods, the river overflowed, flooding Panamericana Highway. The sediment accumulation did not allow transit temporarily</p> <ul style="list-style-type: none"> <li>▪ Panamericana Highway coincides with the narrow section of the river. In this section, the water level rises upstream accumulating sediments and causing overflowing</li> <li>▪ Only the critical section (dangerous for inundation) (approx. 200 m) has been protected with a dike(7.5km, right bank, refer to Fig. 3.1.6-3) , but not the other sections</li> </ul>
<p>Main elements to be conserved</p>	<ul style="list-style-type: none"> <li>▪ Panamericana Highway</li> <li>▪ Crop land (main products: apples, grapes and cotton)</li> </ul>
<p>Basic measures</p>	<ul style="list-style-type: none"> <li>▪ It is not possible to execute bridge repair works at the moment, due to which it is necessary to take other actions to ensure the necessary hydraulic capacity (bed drilling, etc)</li> </ul>

**Figure 3.1.6-4 Local conditions related with Challenge 3 (Cañete river)**

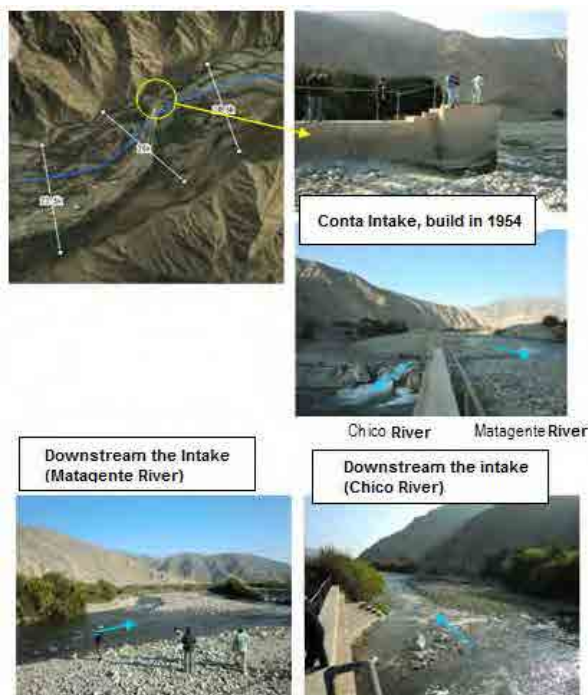
Current situation and challenges	<ul style="list-style-type: none"> <li>• The problem is from December to March. Approximately, 10 floods of 5 to 12 hours happen. Max flow in El Niño event reached 1.200m<sup>3</sup>/s.</li> <li>• According to design the river water must be derived within a relation 1:1, and this relation dose not happen when frequent overflows take place</li> </ul>
Main elements to be conserved	<ul style="list-style-type: none"> <li>• Lower watershed crop area</li> <li>• Urban Area of Chincha</li> </ul>
Basic measures	<ul style="list-style-type: none"> <li>• Rehabilitation of destroyed installations and existing dikes reinforcement</li> <li>• Extend longitudinal dike upstream of the intake</li> <li>• Channels rehabilitation upstream of the intake</li> <li>• The discharge control method with gate is difficult to be adopted from view point of operation and maintenance work and construction cost.</li> </ul>

**Figure 3.1.6-6 Local conditions related with Challenge 1 (Chincha river)**

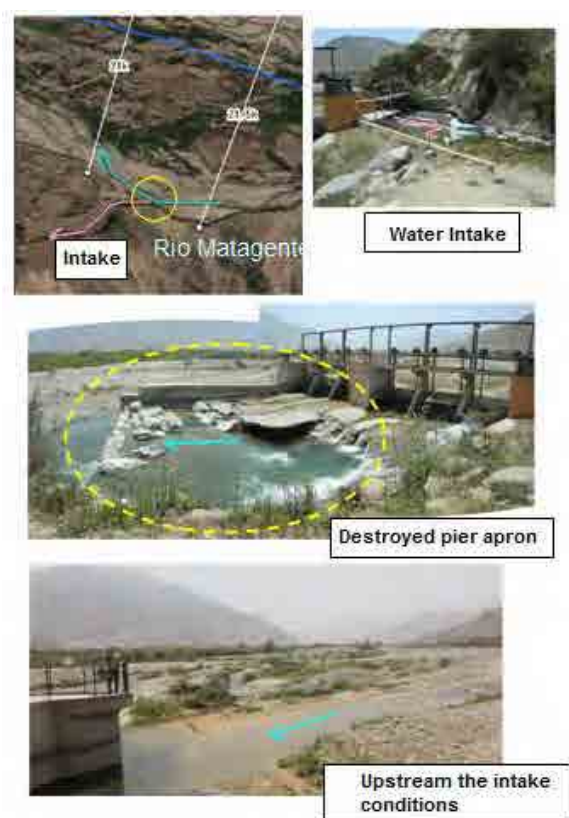
Current situation and challenges	<ul style="list-style-type: none"> <li>• Water intake is in January through March. This was built in 1936</li> <li>• It is one of the most important intakes in the area</li> </ul>
Main elements to be conserved	<ul style="list-style-type: none"> <li>• Lower basin crop land (main products: cotton and grapes)</li> </ul>
Basic measures	<ul style="list-style-type: none"> <li>• Compact the bed immediately Downstream the deteriorate intake, repair the longitudinal dike and reinforce the existing dike</li> </ul>

**Figure 3.1.6-7 Local conditions related with Challenge 2 (Chincha river)**

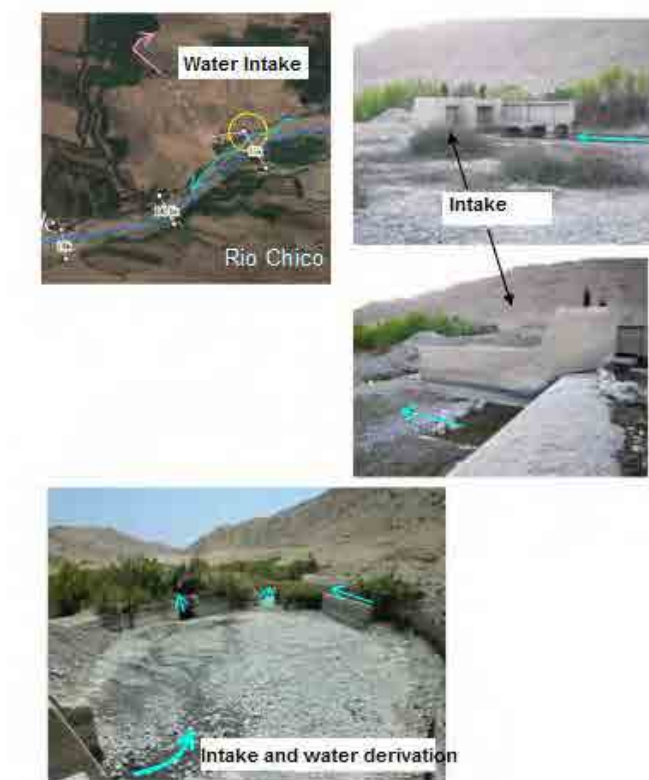
Current situation and challenges	<ul style="list-style-type: none"> <li>• Water intake is in January through March. This was built in 1936</li> <li>• In the past water has overflow on the left bank</li> <li>• Channel width is reduced near the intake, gathering overflows in this area</li> </ul>
Main elements to be conserved	<ul style="list-style-type: none"> <li>• Lower basin crop land (main products: cotton and grapes)</li> </ul>
Basic measures	<ul style="list-style-type: none"> <li>• Rehabilitate the existing dike (repair and reinforce deteriorate parts of the dam)</li> <li>• Stable scour of overflows through increase and rehabilitation of channels</li> </ul>

**Figure 3.1.6-8 Local conditions related with Challenge 3 (Chincha river)**

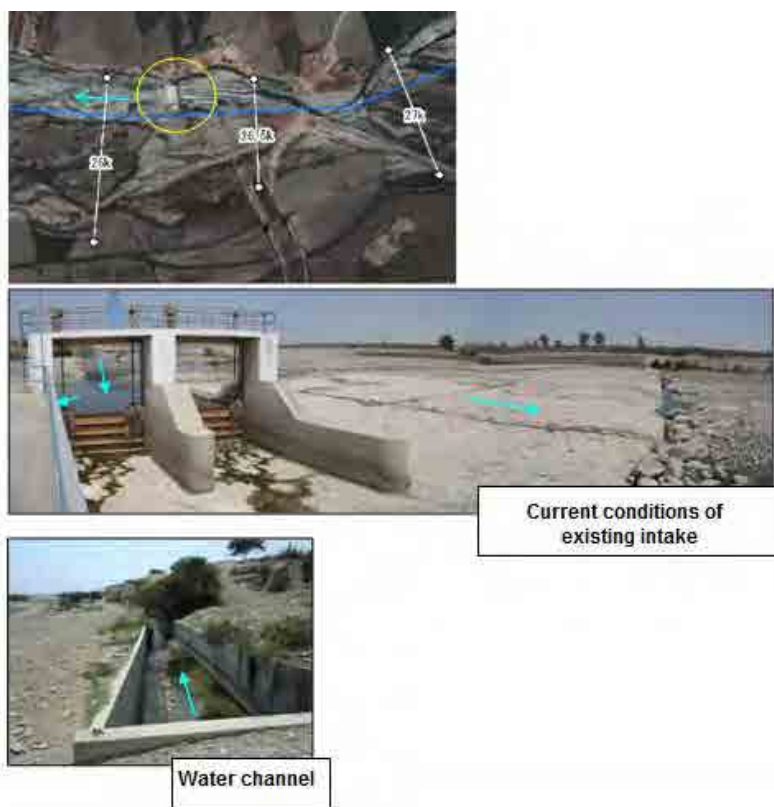
Current situation and challenges	<ul style="list-style-type: none"> <li>• During El Niño in 1998, the overflow waters gathered on the intake and destroyed it. Also, the channels were buried</li> <li>• Currently, the intake and the channel have been repaired</li> <li>• The river's width to the intake's height is 90meters and is narrower Downstream than upstream (between 250 and 500meters)</li> </ul>
Main elements to be conserved	<ul style="list-style-type: none"> <li>• Agricultural lands (main products are not known currently)</li> </ul>
Basic measures	<ul style="list-style-type: none"> <li>• Rehabilitate destroyed installations and reinforce the existing dike</li> <li>• Stable water flow throughout widening and rehabilitation of channels, buying the necessary lands</li> </ul>

**Figure 3.1.6-11 Local conditions related with Challenge 2 (Pisco river)**

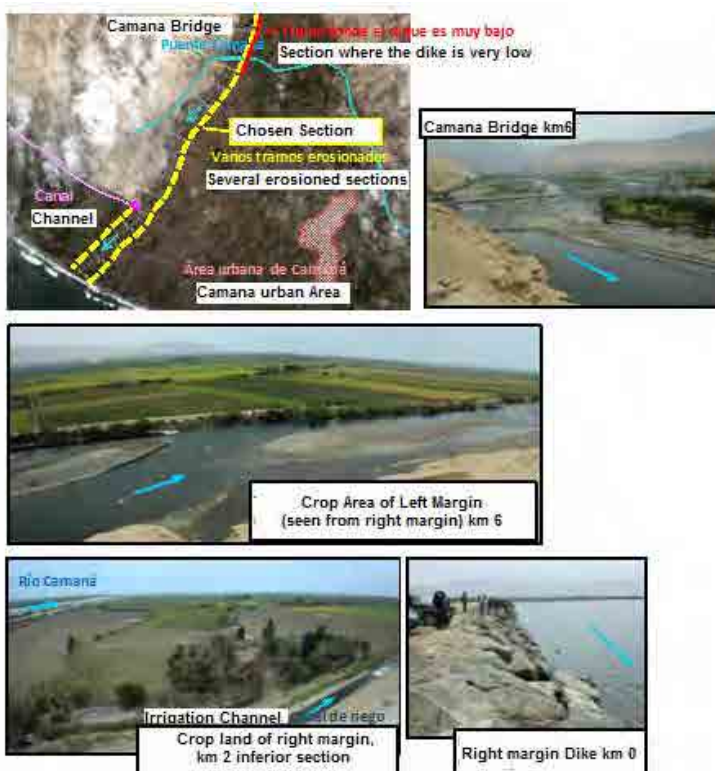
Current situation and challenges	<ul style="list-style-type: none"> <li>• The existing dike which control corresponds to the Irrigation Commission of Camana has been constructed about 30 years ago with their own resources. There are several eroded parts</li> <li>• The dike is low upstream and downstream of Camana Bridge at km 6, putting at flood risk arable lands and urban area</li> </ul>
Main elements to be conserved	<ul style="list-style-type: none"> <li>• Urban area of Camana</li> <li>• Arable lands (main crop: rice)</li> </ul>
Basic measures	<ul style="list-style-type: none"> <li>• Construction of dikes and riverbank protection</li> </ul>

**Figure 3.1.6-15 Local conditions related with Challenge 1 (Camana river)**

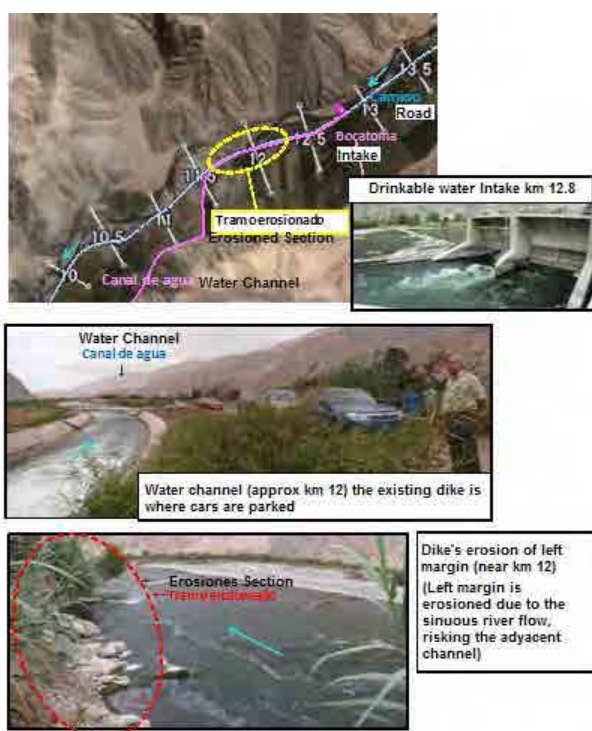
Current situation and challenges	<ul style="list-style-type: none"> <li>• There is an inlet for the drinking water service to Camana at km 13, as well as a channel along the river</li> <li>• Currently the left bank at km 12 is eroded and if not taking correct measures, this could affect the adjacent channel</li> </ul>
Main elements to be conserved	<ul style="list-style-type: none"> <li>• Channel for drinking water</li> </ul>
Basic measures	<ul style="list-style-type: none"> <li>• Reinforcement of the existing dike and riverbank protection</li> </ul>

Figure 3.1.6-16 Local conditions related with Challenge 2 (Camana river)

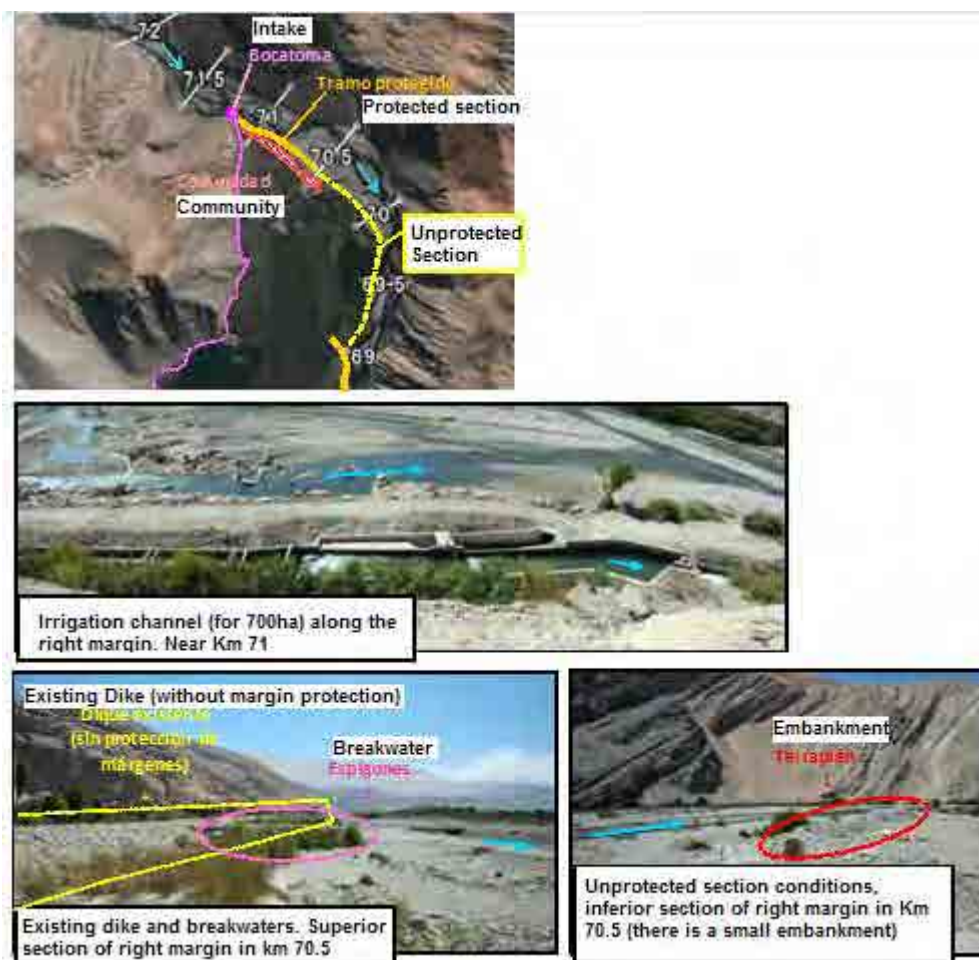
Current situation and challenges	<ul style="list-style-type: none"> <li>• There is a community, dike, along the riverside, in the narrow section, 30 houses in the low lands</li> <li>• Even though it is true that the higher section of this community is protected by a dike, there is a section downstream which is unprotected, with higher risk of overflowing</li> <li>• There is a water intake to supply irrigation water to 700ha of crop land, which is also exposed to flood risk</li> </ul>
Main elements to be conserved	<ul style="list-style-type: none"> <li>• Houses, water intake for irrigation</li> <li>• Croplands (main crop: rice)</li> </ul>
Basic measures	<ul style="list-style-type: none"> <li>• Construction of dikes and protection of banks (the extension of dike to the downstream non-dike section using existing small dike at river side of housing settlement is better compared with removal of 30 households in the cost and implementation of the project.)</li> </ul>

Figure 3.1.6-18 Local conditions related to Challenge 4 (Majes river)

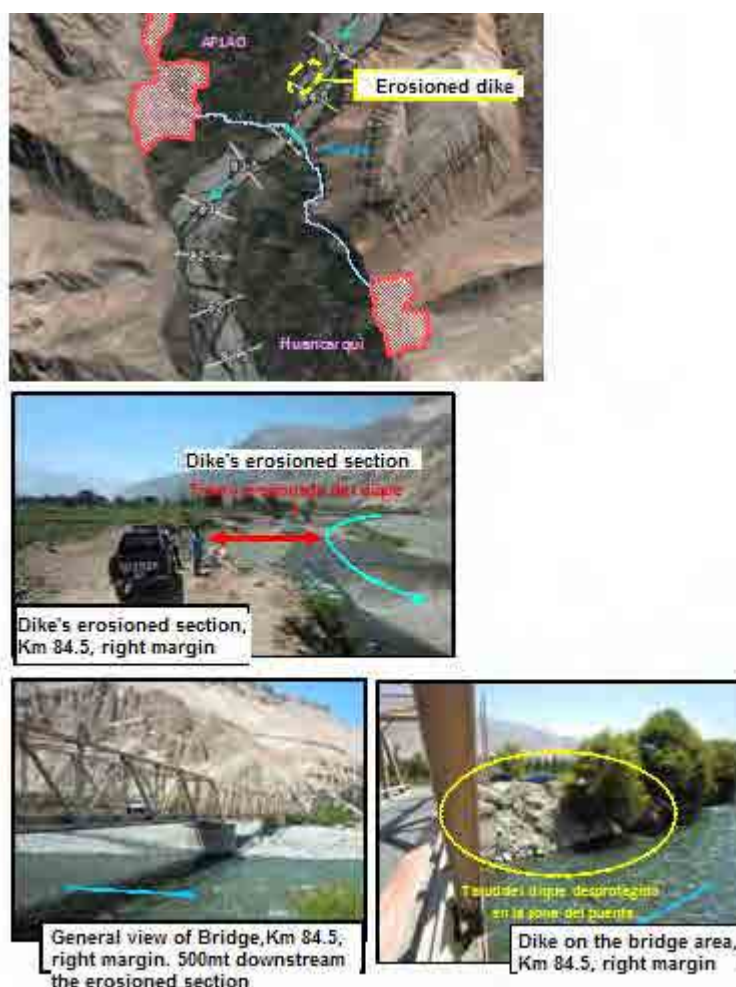
Current situation and challenges	<ul style="list-style-type: none"> <li>• The dike of the right bank is progressively eroded year by year, and if no measure is taken, it could affect the next bridge downstream (Huancariqui bridge)</li> <li>• This bridge is an important path which connects Aplao, the larger town of Majes (with a population of 18 thousand inhabitants), and Huancarqui (with a population of 5 thousand inhabitants)</li> </ul>
Main elements to be conserved	<ul style="list-style-type: none"> <li>• Bridge (Huancarqui)</li> <li>• Croplands (main crop: rice)</li> </ul>
Basic measures	<ul style="list-style-type: none"> <li>• Construction of dikes and protection to the banks</li> </ul>

Figure 3.1.6-19 Local Conditions related to Challenge 5 (Majes river)

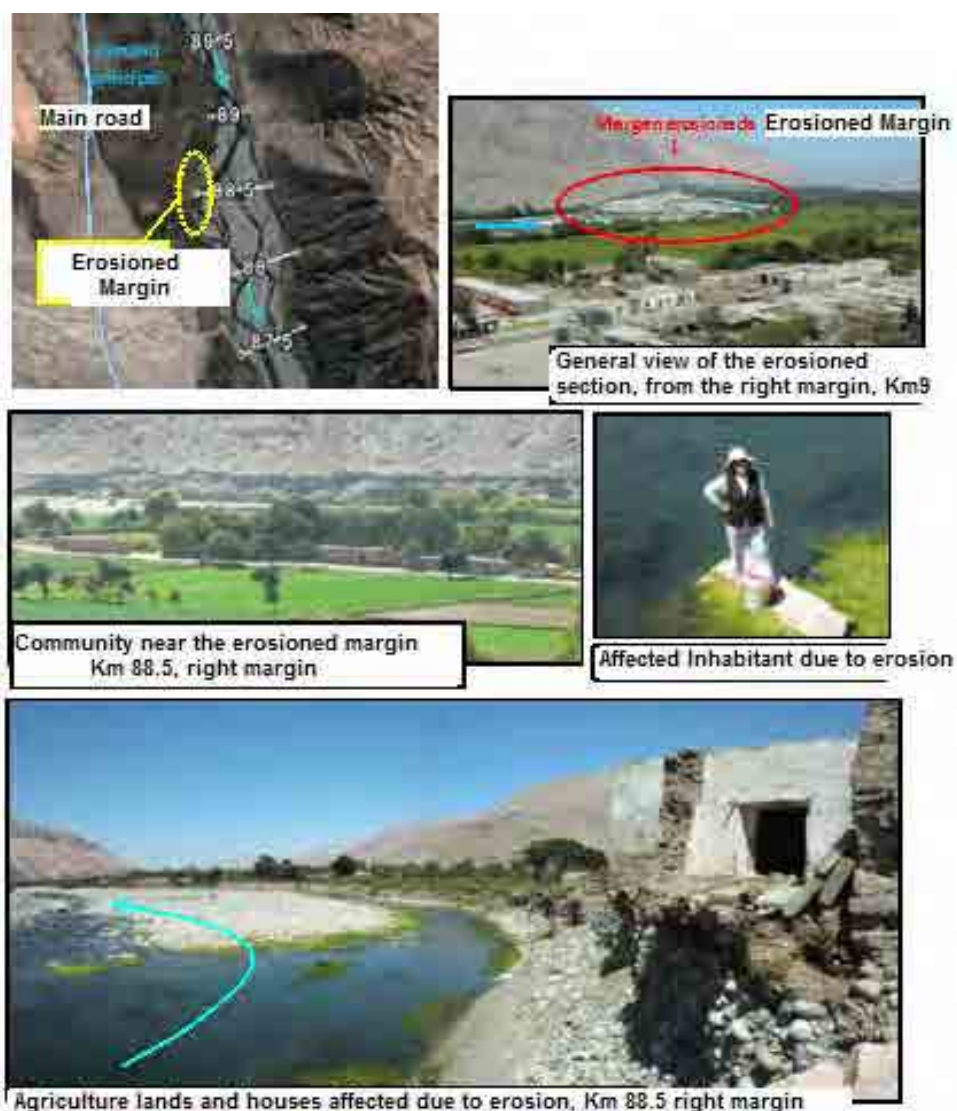
Current situation and challenges	<ul style="list-style-type: none"> <li>• The river banks are progressively eroded per year due to the risings and floods of February 2011, which dragged a house</li> <li>• Currently, the banks are unprotected and if the appropriate measures are not taken, it may worsen the damages, so taking measures is urgently needed</li> </ul>
Main elements to be conserved	<ul style="list-style-type: none"> <li>• Houses</li> <li>• Croplands (main crop: rice)</li> </ul>
Basic measures	<ul style="list-style-type: none"> <li>• Construction of dikes and protection to the banks</li> </ul>

Figure 3.1.6-20 Local conditions related to Challenge 6 (Majes river)
