**THE PREPARATORY STUDY
ON
PROJECT OF THE PROTECTION OF
FLOOD PLAIN AND VULNERABLE RURAL
POPULATION AGAINST FLOOD IN THE
REPUBLIC OF PERU**

**FINAL REPORT
PRE-FEASIBILITY STUDY REPORT
II-1 PROGRAM REPORT
(TEMPORARY VERSION)**

**JAPAN INTERNATIONAL COOPERATION AGENCY
(JICA)**

**YACHIYO ENGINEERING CO., LTD.
NIPPON KOEI CO., LTD.
NIPPON KOEI LATIN AMERICA –
CARIBBEAN Co., LTD.**

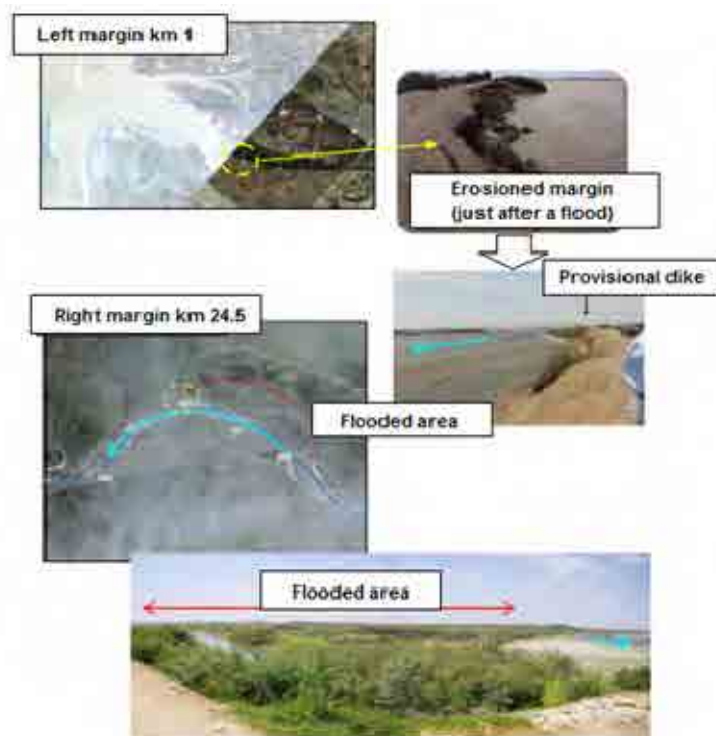
Figure 3.1.6-2 Local conditions related with Challenge 1 (Chira River)

Current situation and challenges	<ul style="list-style-type: none"> • Necessary measures were taken on the affected area due to 1983 El Niño. In 1998 event, also by El Niño, no floods occur but the dike was eroded • Currently, the flow design with modified design is being reviewed, but due to the lack of economic resources, the situation is being controlled by a provisional dike • There are only 8 sections of the affected dike that have been studied and their metering is a great challenge
Main elements to be conserved	<ul style="list-style-type: none"> • Agricultural lands (main product: cotton and banana) • Natural gas fields (12 currently exploited fields which resources are used to generate electricity in the area)
Basic measures	<ul style="list-style-type: none"> • Elevate the provisional dike's height and execute bank protection works • Protect the floor (measure against bed height reduction)

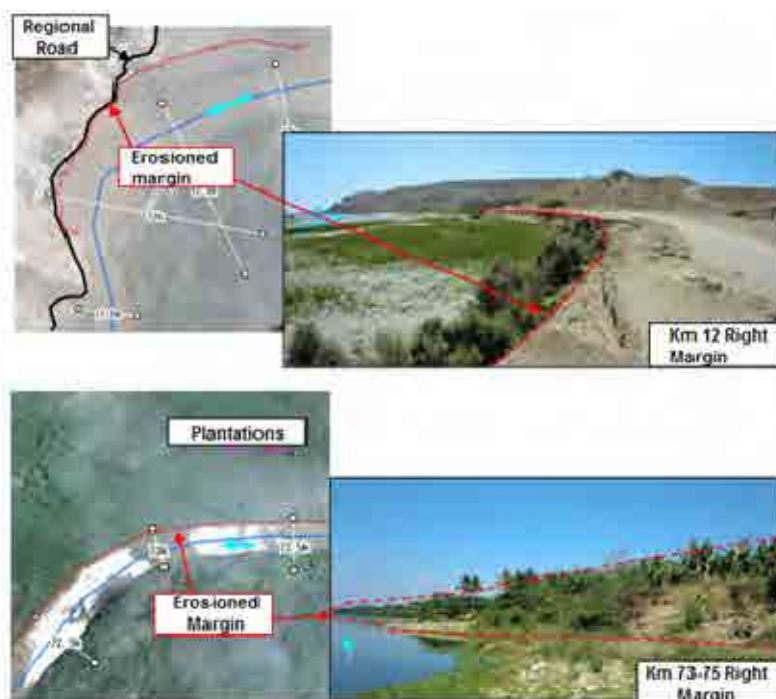
Figure 3.1.6-3 Local conditions related with Challenge 2 (Chira River)

Current situation and challenges	<ul style="list-style-type: none"> • Several bank erosion damages occurred in the floods of 1998 due to El Niño • There are several crops fields, roads and irrigation channels that are un-protected, and susceptible to be severely damaged if erosion continues
Main elements to be conserved	<ul style="list-style-type: none"> • Crop lands (main product: bananas) • Main regional road • Main irrigation channels
Basic measures	<ul style="list-style-type: none"> • Execute bank protection works to control erosion expansion

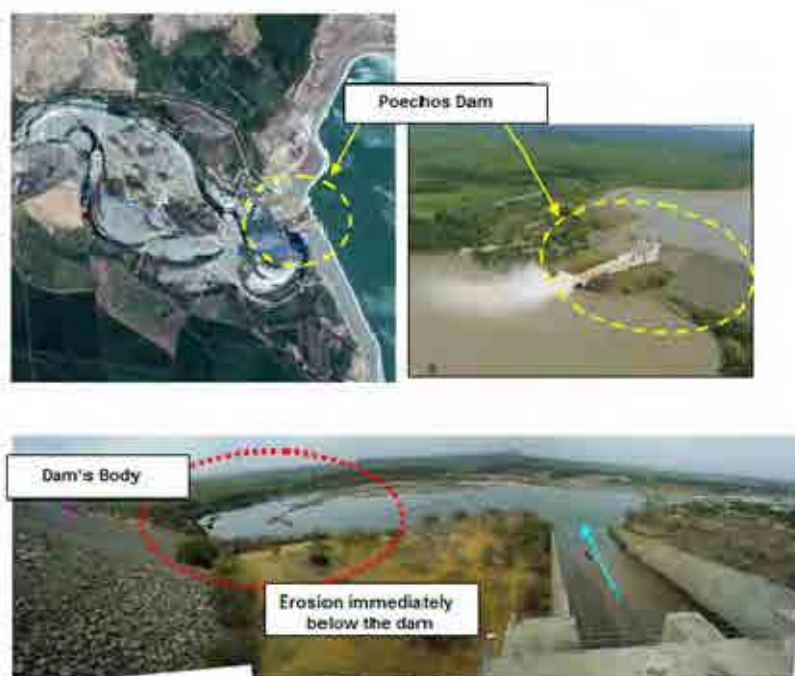
Figure 3.1.6-4 Local conditions related with Challenge 3 (Chira River)

Current situation and challenges	<ul style="list-style-type: none"> • The left margin immediately downwards the dam has been eroded during floods water discharges • It is probable that the dam is affected if floods of the same magnitude occur • Currently, the immediate eroded sector under the dam is being provisionally repaired (margin protection works)
Main elements to be conserved	<ul style="list-style-type: none"> • Dam's body
Basic measures	<ul style="list-style-type: none"> • Built retarding reservoirs (to reduce floods peak stream) • Built an intake (to integrate the existing small works)

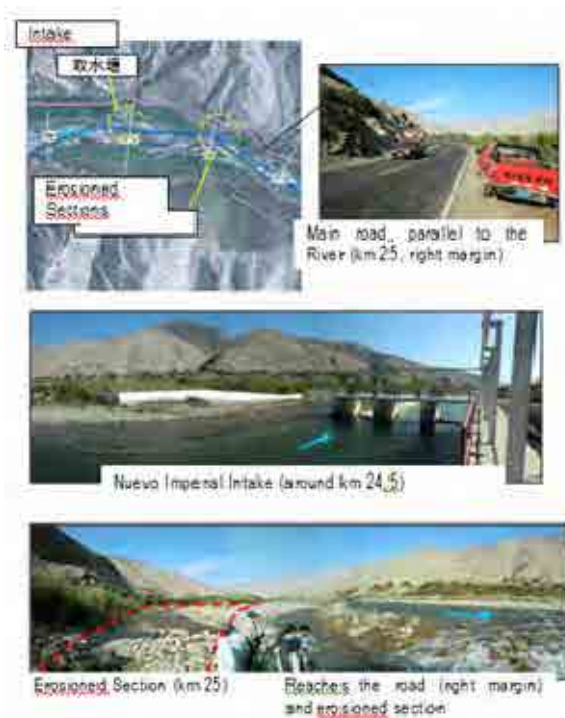
Figure 3.1.6-6 Local conditions related with Challenge 1 (Cañete River)

Current situation and challenges	<ul style="list-style-type: none"> • During 1998 floods, accumulated sediments in the intake stopped water taking for more than a month. It is probable that this repeats, so, the measures to control the Entrance of sediments must be controlled • Upstream the dam, banks have been eroded by the overflows that happened in the past, causing agricultural land loss. Because the eroded section is near the road, future overflows that may happen with the same magnitude are risk to destroy vial infrastructure
Main elements to be conserved	<ul style="list-style-type: none"> • Road • Intake
Basic measures	<ul style="list-style-type: none"> • Derivation Works building upstream the intake, aiming to control adequate flow distribution during overflowing • Measures execution against bank erosion (breakwater, etc.)

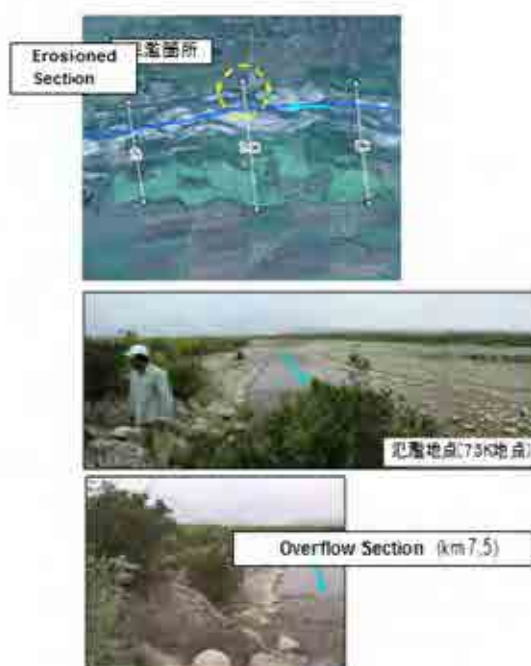
Figure 3.1.6-7 Local conditions related with Challenge 2 (Cañete River)

Current situation and challenges	<ul style="list-style-type: none"> • 1998 floods destroyed the dike causing loss on agriculture field • In this area there are three destroyed sections of the dike (all of them on the right bank) • The water's greater impact area is on km 7.5, right bank. The fast and great flow causes scouring of the bed and consequently, the dike's destruction. Currently, the dike has been repaired, but there is still risk of destruction if great floods take place
Main elements to be conserved	<ul style="list-style-type: none"> • Crop land (main products: apple, grapes, cotton)
Basic measures	<ul style="list-style-type: none"> • Dike and bank protection building for bank erosion control

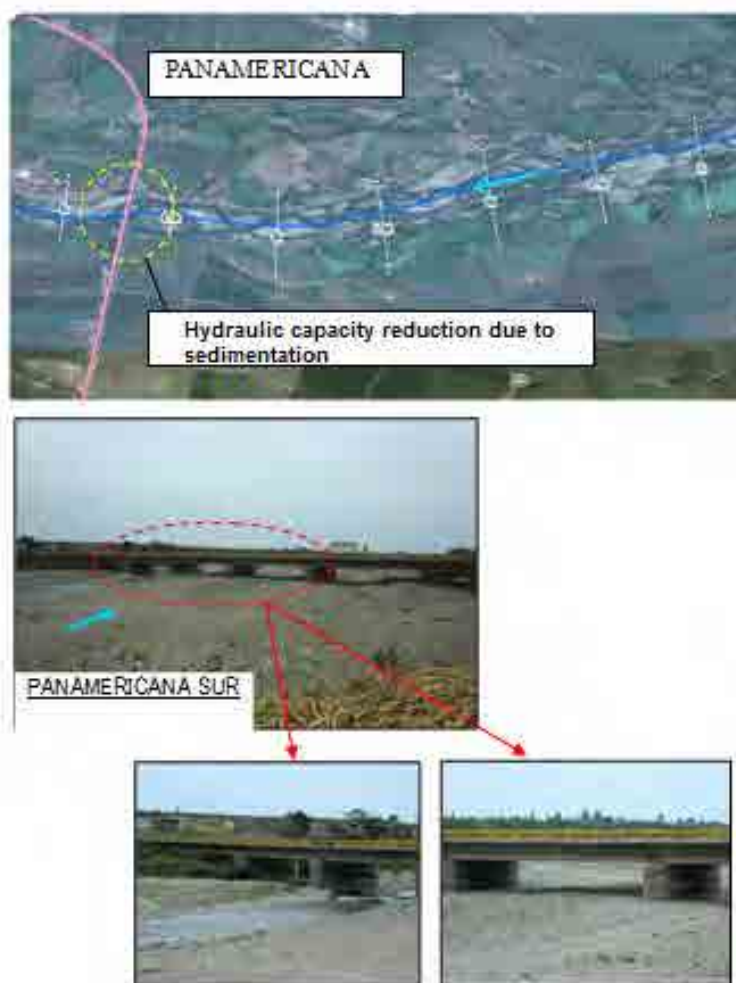
Figure 3.1.6-8 Local conditions related with Challenge 3 (Cañete River)

<p>Current situation and challenges</p>	<p>In 1998 floods, the river overflowed, flooding Panamericana Highway. The sediment accumulation did not allow transit temporarily</p> <ul style="list-style-type: none"> ▪ Panamericana Highway coincides with the narrow section of the river. In this section, the water level rises upstream accumulating sediments and causing overflowing ▪ Only the critical section (approx. 200 m) has been protected with a dike, but not the other sections
<p>Main elements to be conserved</p>	<ul style="list-style-type: none"> ▪ Panamericana Highway ▪ Crop land (main products: apples, grapes and cotton)
<p>Basic measures</p>	<ul style="list-style-type: none"> ▪ It is not possible to execute bridge repair works at the moment, due to which it is necessary to take other actions to ensure the necessary hydraulic capacity (bed drilling, etc)

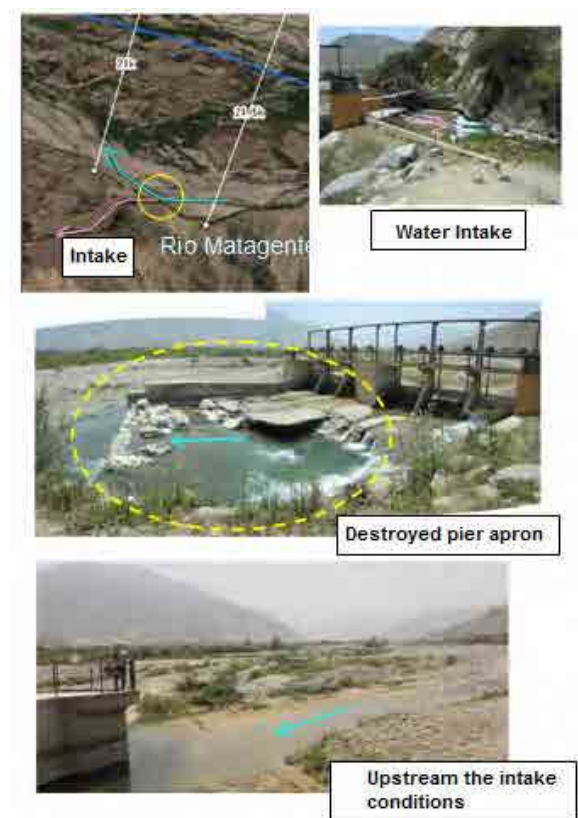
Figure 3.1.6-11 Local conditions related with Challenge 2 (Chincha River)

Current situation and challenges	<ul style="list-style-type: none"> • Water intake is in January through March. This was built in 1936 • It is one of the most important intakes in the area
Main elements to be conserved	<ul style="list-style-type: none"> • Lower basin crop land (main products: cotton and grapes)
Basic measures	<ul style="list-style-type: none"> • Compact the bed immediately Downstream the deteriorate intake, repair the longitudinal dike and reinforce the existing dike

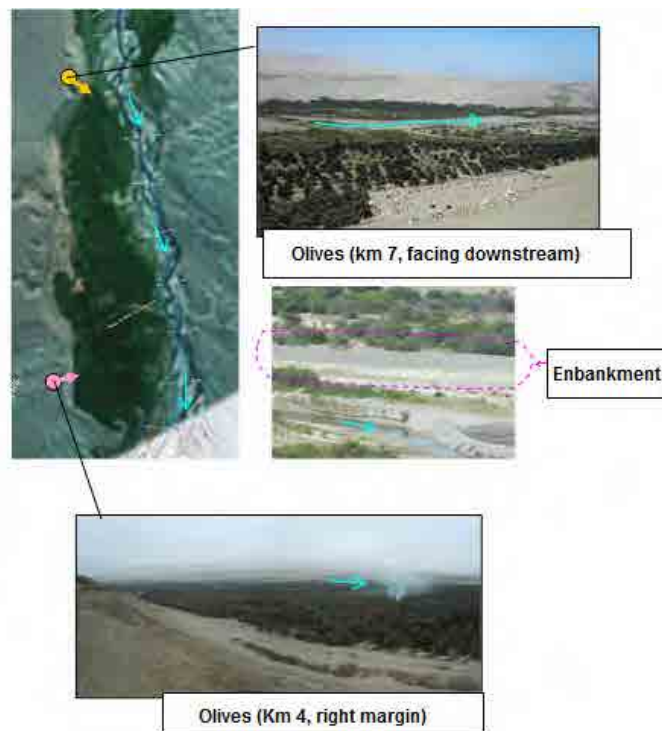
Figure 3.1.6-18 Local conditions related with Challenge 1 (Yauca River)

Current situation and challenges	<ul style="list-style-type: none"> • Main product is olive • Urban area is relatively in a high elevation so direct risk of floods and overflowing is reduced. The elements to be protected are the trees and hydraulic installations • A dike is built empirically and partially, but banks are eroded and flood may affect the olives
Main elements to be conserved	<ul style="list-style-type: none"> • Agricultural lands (main product: olive)
Basic measures	<ul style="list-style-type: none"> • Repair existing dike • Execute bank protection Works (banks erosion control) • Build retarding reservoirs

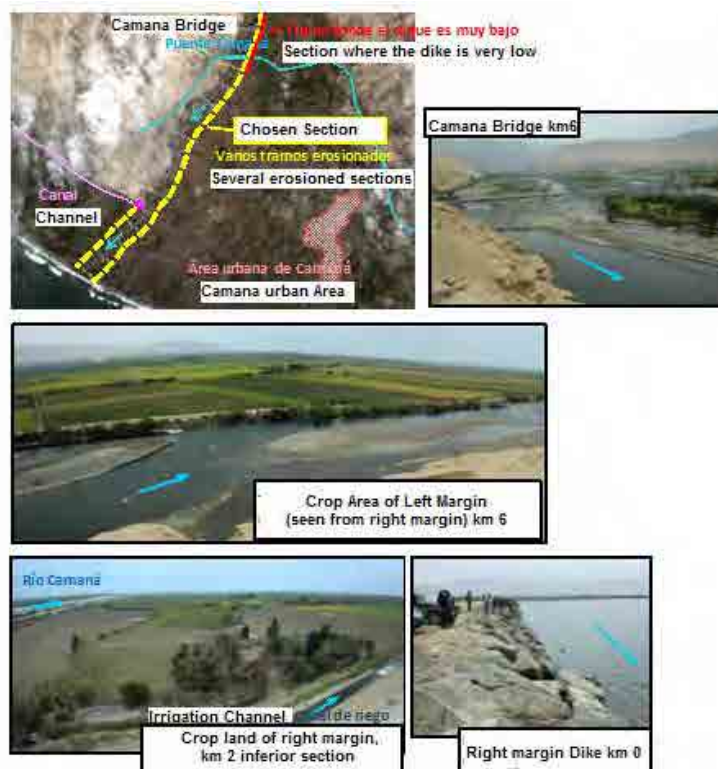
Figure 3.1.6-23 Local conditions related with Challenge 1 (Camana River)

Current situation and challenges	<ul style="list-style-type: none"> • The existing dike which control corresponds to the Irrigation Commission of Camana has been constructed about 30 years ago with their own resources. There are several eroded parts • The dike is low upstream and downstream of Camana Bridge at km 6, putting at flood risk arable lands and urban area
Main elements to be conserved	<ul style="list-style-type: none"> • Urban area of Camana • Arable lands (main crop: rice)
Basic measures	<ul style="list-style-type: none"> • Construction of dikes and riverbank protection

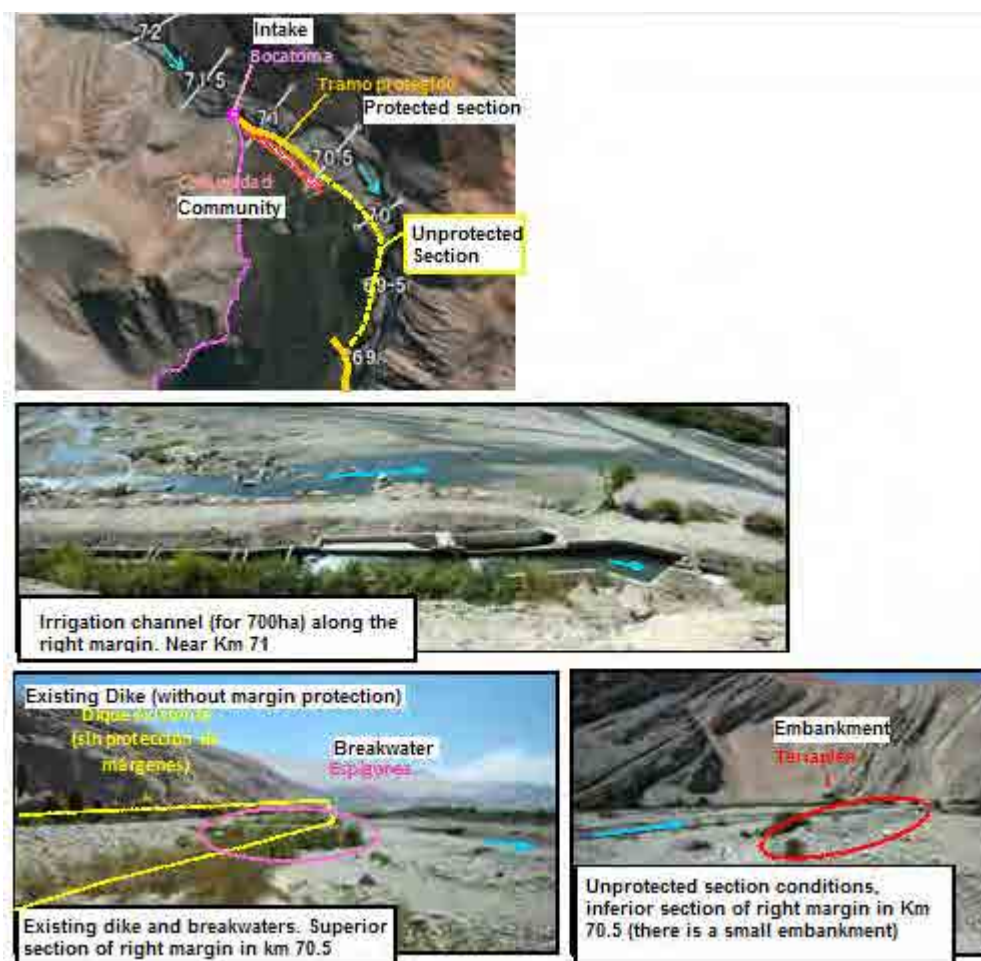
Figure 3.1.6-26 Local conditions related to Challenge 4 (Majes River)

Current situation and challenges	<ul style="list-style-type: none"> • There is a community, Deque, along the riverside, in the narrow section, 30 houses in the low lands • Even though it is true that the higher section of this community is protected by a dike, there is a section downstream which is unprotected, with higher risk of overflowing • There is a water intake to supply irrigation water to 700ha of crop land, which is also exposed to flood risk
Main elements to be conserved	<ul style="list-style-type: none"> • Houses, water intake for irrigation • Croplands (main crop: rice)
Basic measures	<ul style="list-style-type: none"> • Construction of dikes and protection of banks

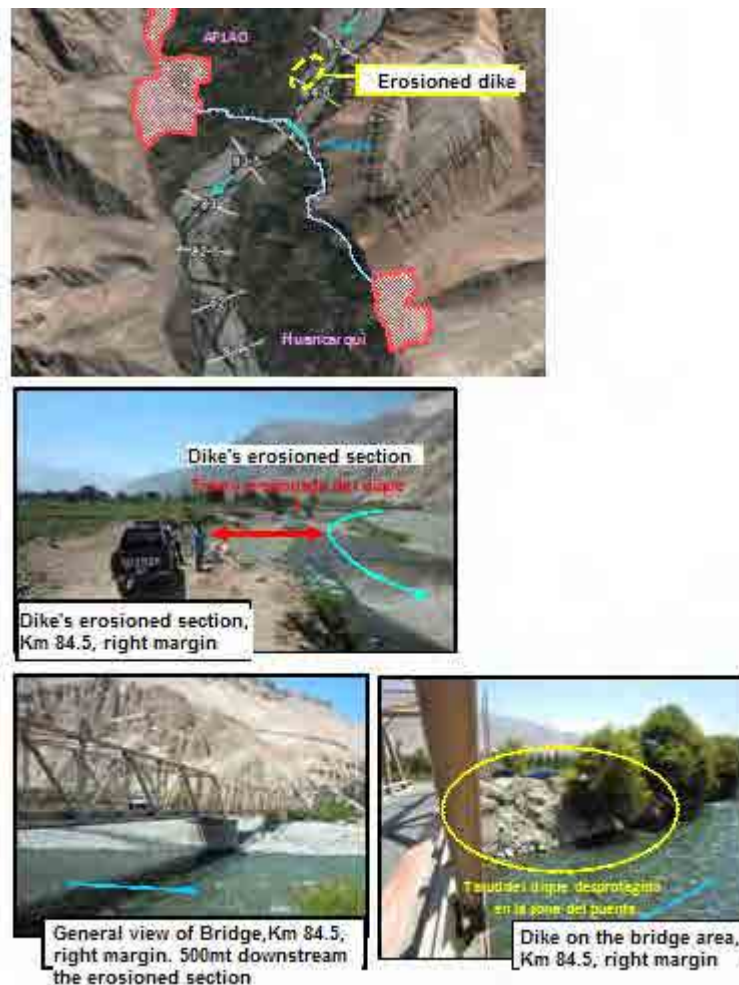
Figure 3.1.6-27 Local Conditions related to Challenge 5 (Majes River)

Current situation and challenges	<ul style="list-style-type: none"> • The dike of the right bank is progressively eroded year by year, and if no measure is taken, it could affect the next bridge downstream (Huancariqui bridge) • This bridge is an important path which connects Aplao, the larger town of Majes (with a population of 18 thousand inhabitants), and Huancariqui (with a population of 5 thousand inhabitants)
Main elements to be conserved	<ul style="list-style-type: none"> • Bridge (Huancariqui) • Croplands (main crop: rice)
Basic measures	<ul style="list-style-type: none"> • Construction of dikes and protection to the banks

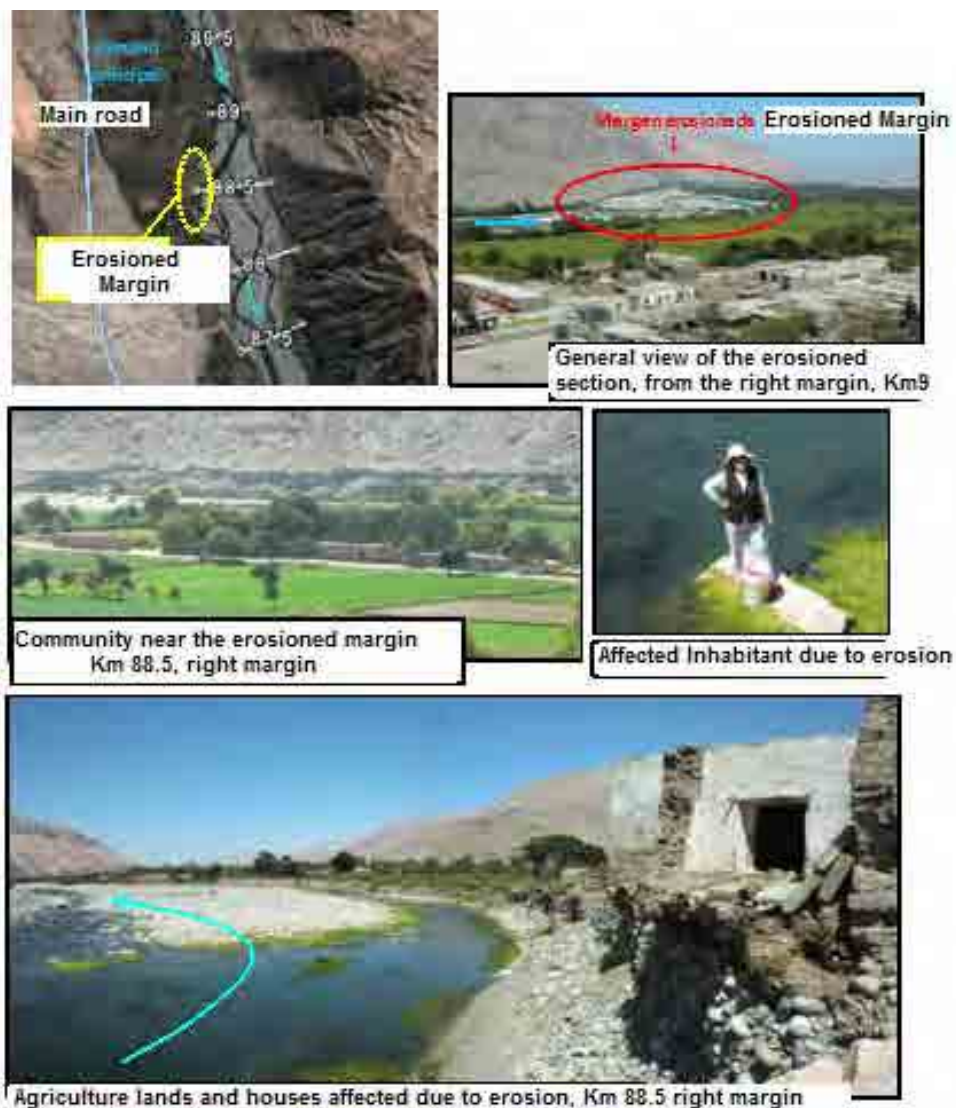
Figure 3.1.6-28 Local conditions related to Challenge 6 (Majes River)

Current situation and challenges	<ul style="list-style-type: none"> • The river banks are progressively eroded per year due to the risings and floods of February 2011, which dragged a house • Currently, the banks are unprotected and if the appropriate measures are not taken, it may worsen the damages, so taking measures is urgently needed
Main elements to be conserved	<ul style="list-style-type: none"> • Houses • Croplands (main crop: rice)
Basic measures	<ul style="list-style-type: none"> • Construction of dikes and protection to the banks

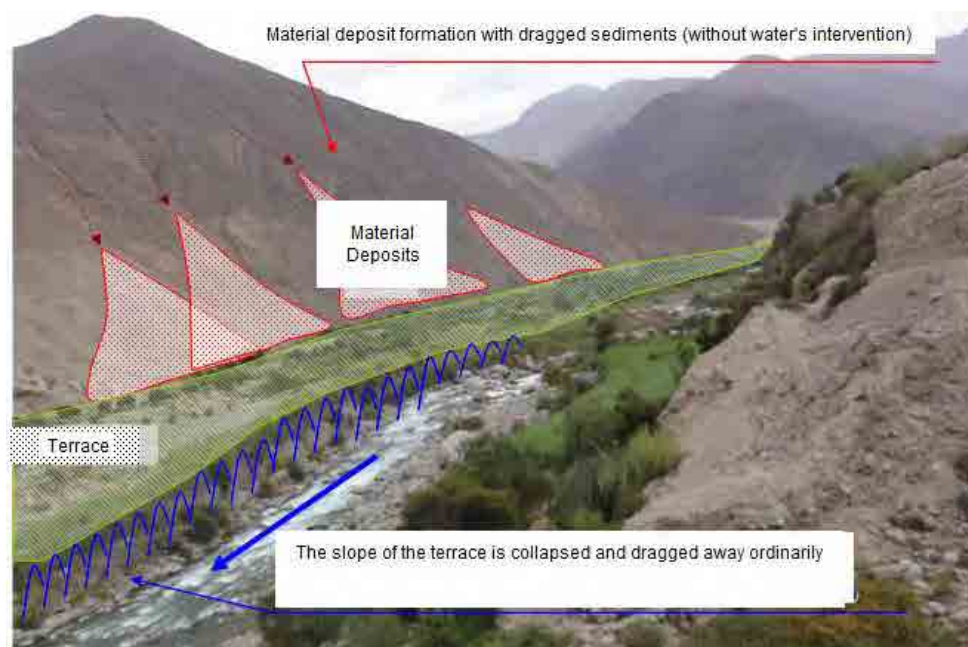
Figure 3.1.8-17 Stream sediment movement

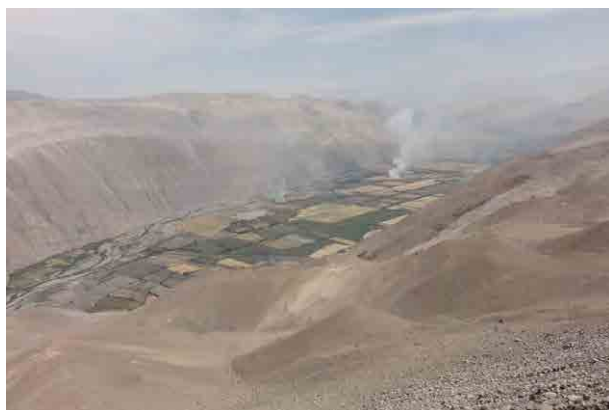
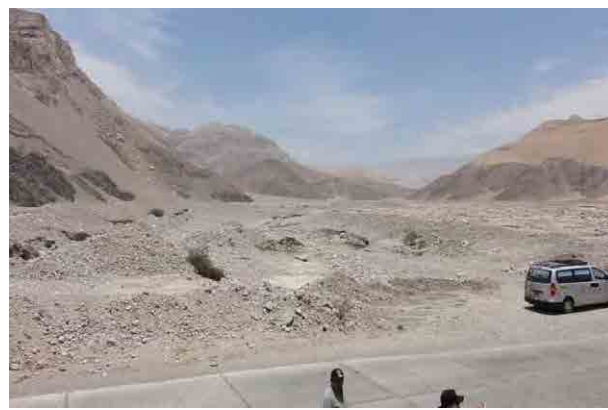
**Figure 3.1.8-10 Situation around Km 60
 (formation of the valley approximately 5km width)**

Figure 3.1.8-11 Situation of the sediment silting in Cosos river (Approx. 900m width)

No	River name	Distance	Situation
1	Cosos Figure 3.1.8-11 Figure 3.1.8-12	88km approx.	In rainy season, once per month, alluvium are generated which, due to the sediment entrainment, obstruct rural (=local) highways. The situation may be restored in a day. Sometimes it affects the water pipelines.
2	Ongoro Figure 3.1.8-13	103km approx.	In 1998, an alluvium was generated, 2 persons died due to the sediment entrainment. It took one month to recover the damages in the irrigation channels. 30 minutes before, approximately 8 families listened from the mountain a sound anticipating the alluvium, which helped them to evacuate. These 8 families currently live in the same place of the disaster. The main river of the Majes river is very large and the bed has not been silted. An NGO supported the restoration of the irrigation channels.
3	San Francisco Figure 3.1.8-14	106km approx.	In 1998, an alluvium was generated, producing damages in the irrigation channels. It took one month to temporary restore it and 4 years for restoration. The amount of the alluvium with sand sediment has been 10m. high approximately.

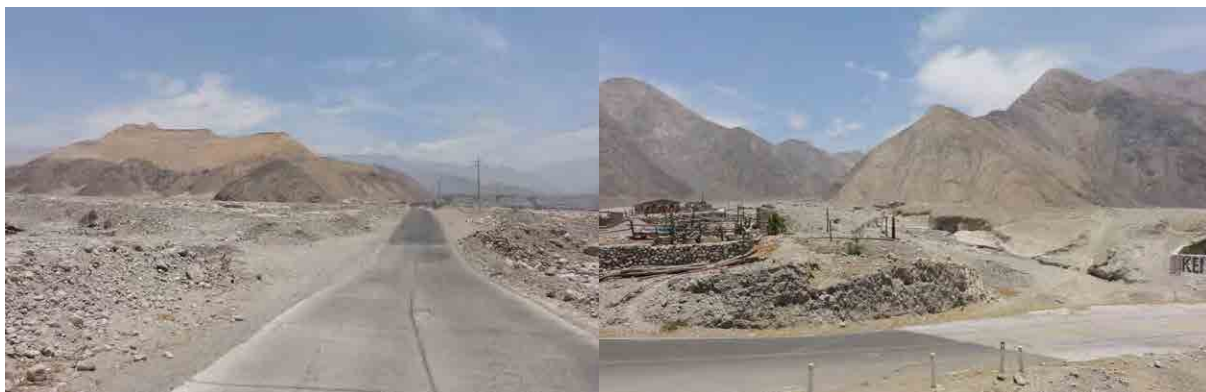
Figure 3.1.8-12 Rural (=local) highway crossing the Cosos river (in rainy season the sediments cover the rural highway, however, it is restored in a day)

Figure 3.1.8-13 Situation of Ongoro (in 1998, 2 persons died due to the alluvium)

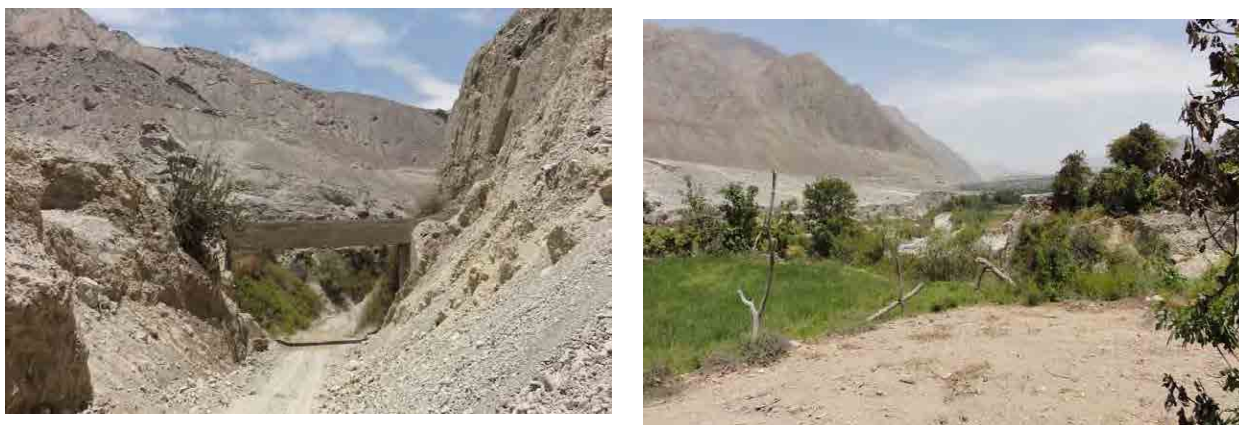
Figure 3.1.8-14 Situation of the sediment deposition in the San Francisco river (obstruction of irrigation channels due to the disaster. The walls of the highway are the soil and sand sediments at that time)

Figure 3.1.8-15 Situation of Jorón river (alluvium sediments arrived up to the main river in 1998)

4	Jorón Figure 3.1.8-15	106km approx.	The alluvium was generated and the sediments were entrained to the main river. The sand sediment alluvium was 10m high. It is thought it entrained 100.000 to 1.000.000 m ³ of sediments.
