**THE PREPARATORY STUDY
ON
PROJECT OF THE PROTECTION OF
FLOOD PLAIN AND VULNERABLE RURAL
POPULATION AGAINST FLOOD IN THE
REPUBLIC OF PERU**

**FINAL REPORT
MAINREPORT
I-1 PROGRAM REPORT**

**JAPAN INTERNATIONAL COOPERATION AGENCY
(JICA)**

**YACHIYO ENGINEERING CO., LTD.
NIPPON KOEI CO., LTD.
NIPPON KOEI LATIN AMERICA –
CARIBBEAN Co., LTD.**

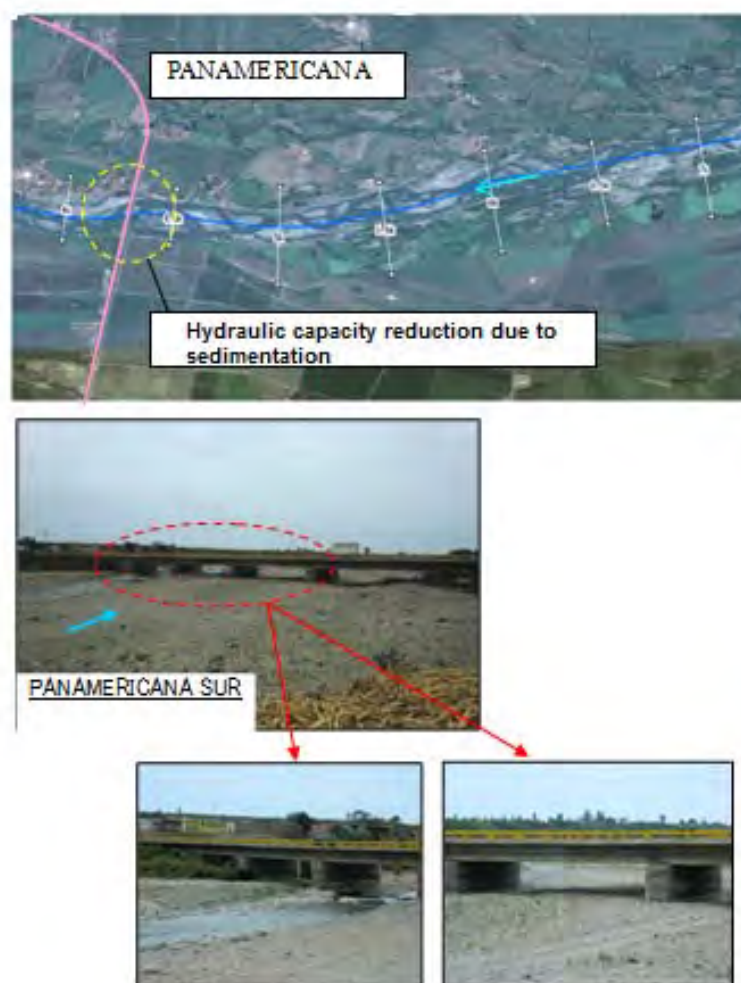
<p>Current situation and challenges</p>	<p>In 1998 floods, the river overflowed, flooding Panamericana Highway. The sediment accumulation did not allow transit temporarily</p> <ul style="list-style-type: none"> ▪ Panamericana Highway coincides with the narrow section of the river. In this section, the water level rises upstream accumulating sediments and causing overflowing ▪ Only the critical section (dangerous for inundation) (approx. 200 m) has been protected with a dike(7.5km, right bank, refer to Fig. 3.1.6-3) , but not the other sections
<p>Main elements to be conserved</p>	<ul style="list-style-type: none"> ▪ Panamericana Highway ▪ Crop land (main products: apples, grapes and cotton)
<p>Basic measures</p>	<ul style="list-style-type: none"> ▪ It is not possible to execute bridge repair works at the moment, due to which it is necessary to take other actions to ensure the necessary hydraulic capacity (bed drilling, etc)

Figure 3.1.6-4 Local conditions related with Challenge 3 (Cañete river)

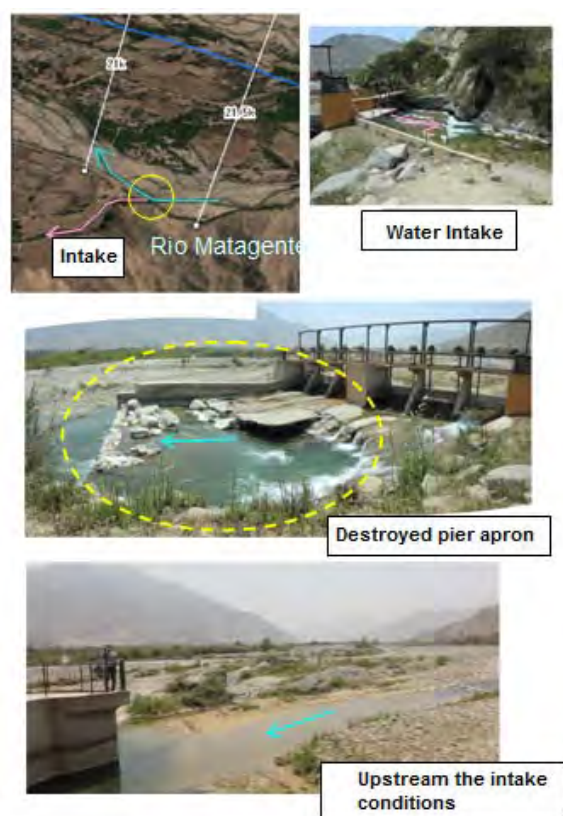
Current situation and challenges	<ul style="list-style-type: none"> • Water intake is in January through March. This was built in 1936 • It is one of the most important intakes in the area
Main elements to be conserved	<ul style="list-style-type: none"> • Lower basin crop land (main products: cotton and grapes)
Basic measures	<ul style="list-style-type: none"> • Compact the bed immediately Downstream the deteriorate intake, repair the longitudinal dike and reinforce the existing dike

Figure 3.1.6-7 Local conditions related with Challenge 2 (Chincha river)

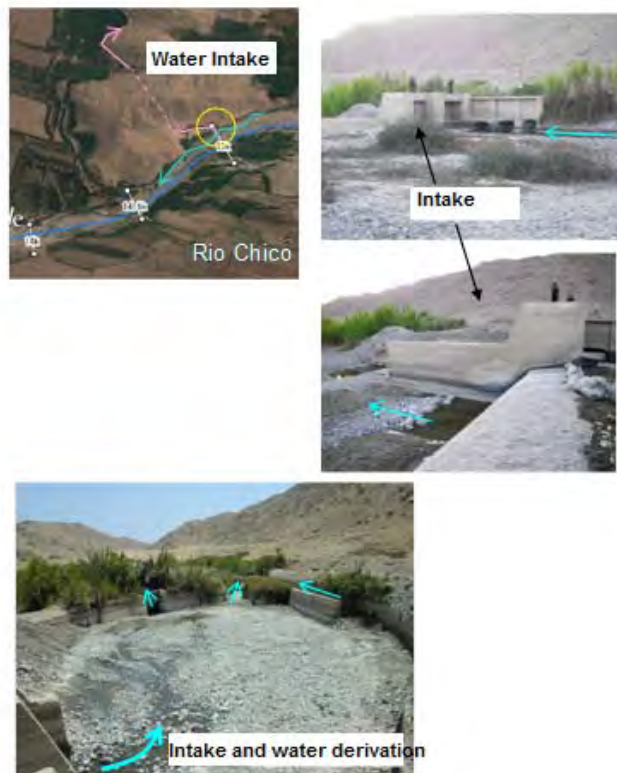
Current situation and challenges	<ul style="list-style-type: none"> • Water intake is in January through March. This was built in 1936 • In the past water has overflow on the left bank • Channel width is reduced near the intake, gathering overflows in this area
Main elements to be conserved	<ul style="list-style-type: none"> • Lower basin crop land (main products: cotton and grapes)
Basic measures	<ul style="list-style-type: none"> • Rehabilitate the existing dike (repair and reinforce deteriorate parts of the dam) • Stable scour of overflows through increase and rehabilitation of channels

Figure 3.1.6-8 Local conditions related with Challenge 3 (Chincha river)

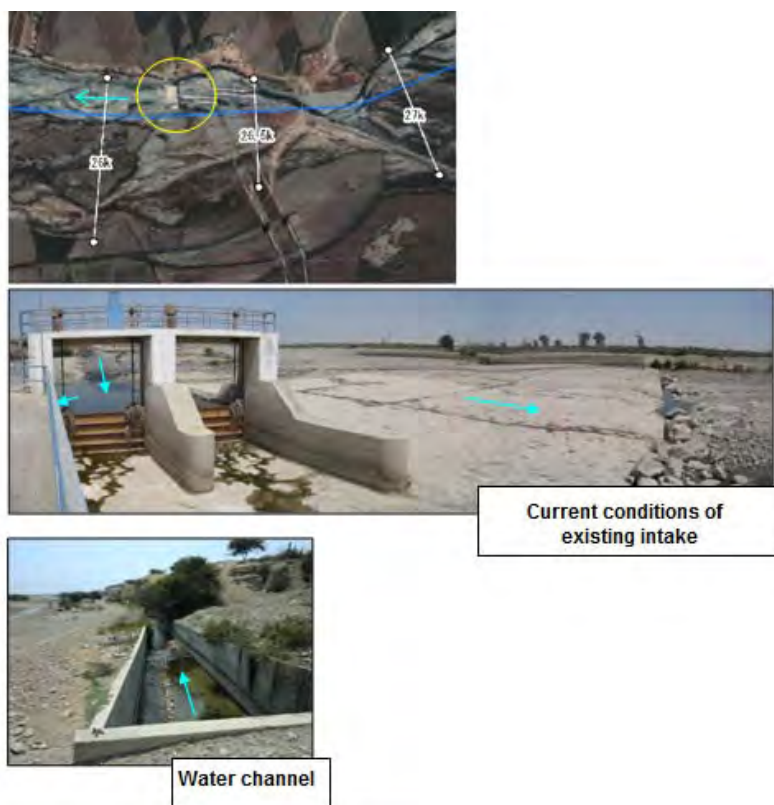
Current situation and challenges	<ul style="list-style-type: none"> • During El Niño in 1998, the overflow waters gathered on the intake and destroyed it. Also, the channels were buried • Currently, the intake and the channel have been repaired • The river's width to the intake's height is 90meters and is narrower Downstream than upstream (between 250 and 500meters)
Main elements to be conserved	<ul style="list-style-type: none"> • Agricultural lands (main products are not known currently)
Basic measures	<ul style="list-style-type: none"> • Rehabilitate destroyed installations and reinforce the existing dike • Stable water flow throughout widening and rehabilitation of channels, buying the necessary lands

Figure 3.1.6-11 Local conditions related with Challenge 2 (Pisco river)

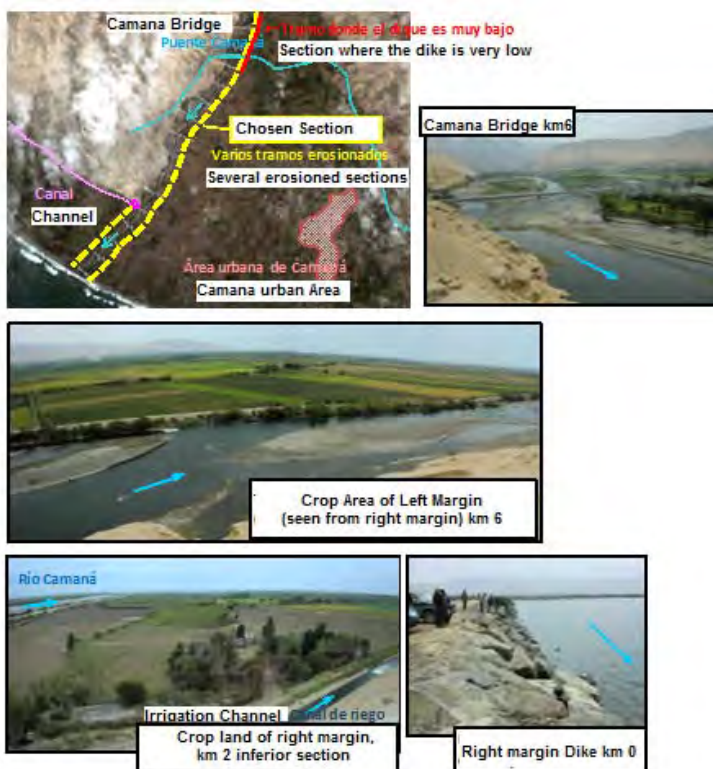
Current situation and challenges	<ul style="list-style-type: none"> • The existing dike which control corresponds to the Irrigation Commission of Camana has been constructed about 30 years ago with their own resources. There are several eroded parts • The dike is low upstream and downstream of Camana Bridge at km 6, putting at flood risk arable lands and urban area
Main elements to be conserved	<ul style="list-style-type: none"> • Urban area of Camana • Arable lands (main crop: rice)
Basic measures	<ul style="list-style-type: none"> • Construction of dikes and riverbank protection

Figure 3.1.6-15 Local conditions related with Challenge 1 (Camana river)

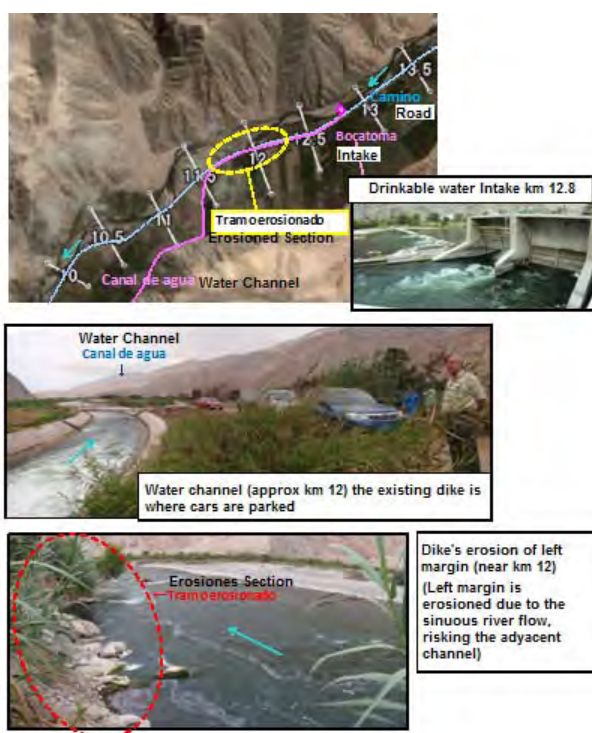
Current situation and challenges	<ul style="list-style-type: none"> • There is an inlet for the drinking water service to Camana at km 13, as well as a channel along the river • Currently the left bank at km 12 is eroded and if not taking correct measures, this could affect the adjacent channel
Main elements to be conserved	<ul style="list-style-type: none"> • Channel for drinking water
Basic measures	<ul style="list-style-type: none"> • Reinforcement of the existing dike and riverbank protection

Figure 3.1.6-16 Local conditions related with Challenge 2 (Camana river)

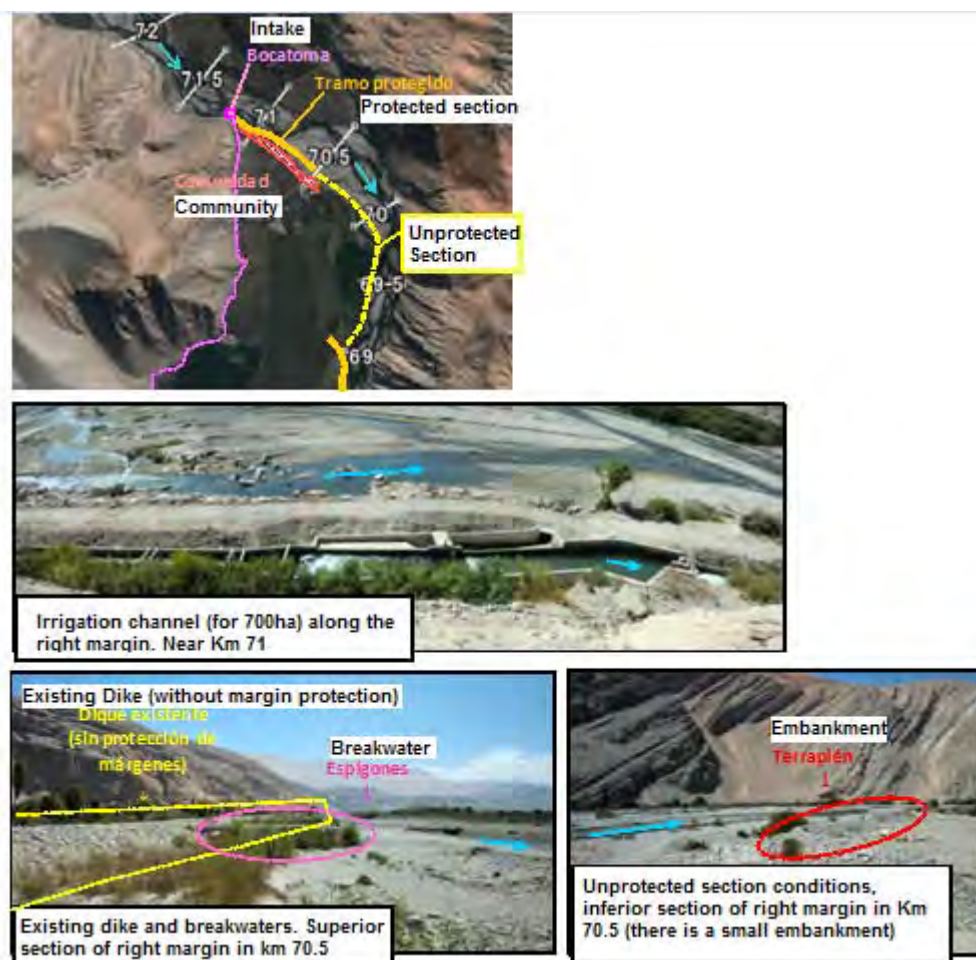
Current situation and challenges	<ul style="list-style-type: none"> • There is a community, dike, along the riverside, in the narrow section, 30 houses in the low lands • Even though it is true that the higher section of this community is protected by a dike, there is a section downstream which is unprotected, with higher risk of overflowing • There is a water intake to supply irrigation water to 700ha of crop land, which is also exposed to flood risk
Main elements to be conserved	<ul style="list-style-type: none"> • Houses, water intake for irrigation • Croplands (main crop: rice)
Basic measures	<ul style="list-style-type: none"> • Construction of dikes and protection of banks (the extension of dike to the downstream non-dike section using existing small dike at river side of housing settlement is better compared with removal of 30 households in the cost and implementation of the project.)

Figure 3.1.6-18 Local conditions related to Challenge 4 (Majes river)

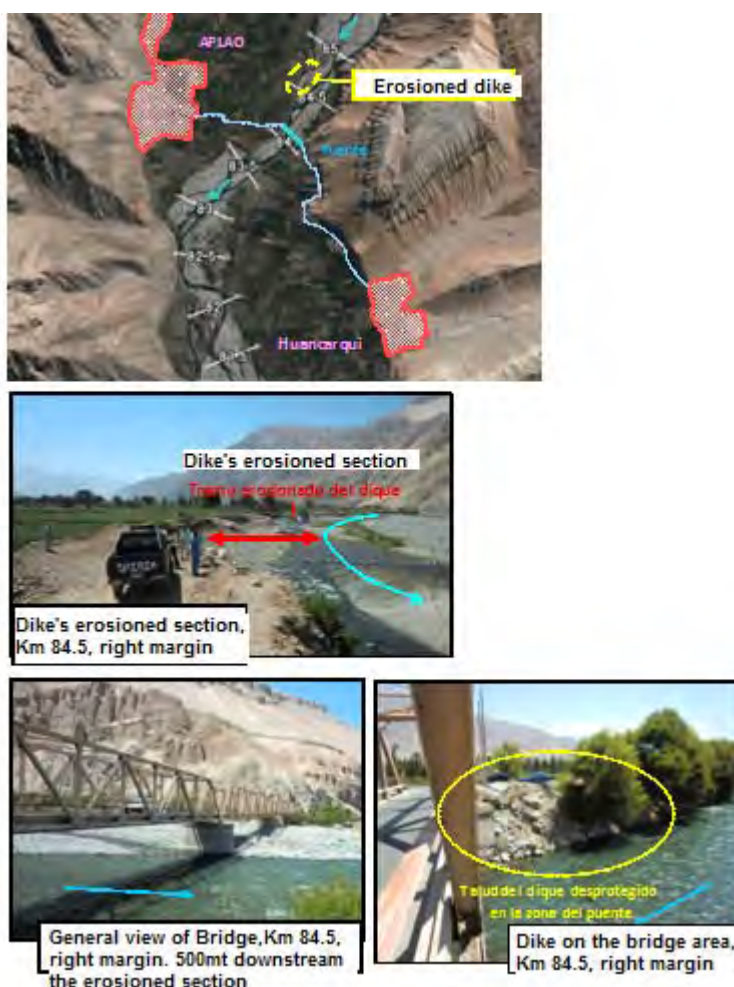
Current situation and challenges	<ul style="list-style-type: none"> • The dike of the right bank is progressively eroded year by year, and if no measure is taken, it could affect the next bridge downstream (Huancarqui bridge) • This bridge is an important path which connects Aplao, the larger town of Majes (with a population of 18 thousand inhabitants), and Huancarqui (with a population of 5 thousand inhabitants)
Main elements to be conserved	<ul style="list-style-type: none"> • Bridge (Huancarqui) • Croplands (main crop: rice)
Basic measures	<ul style="list-style-type: none"> • Construction of dikes and protection to the banks

Figure 3.1.6-19 Local Conditions related to Challenge 5 (Majes river)

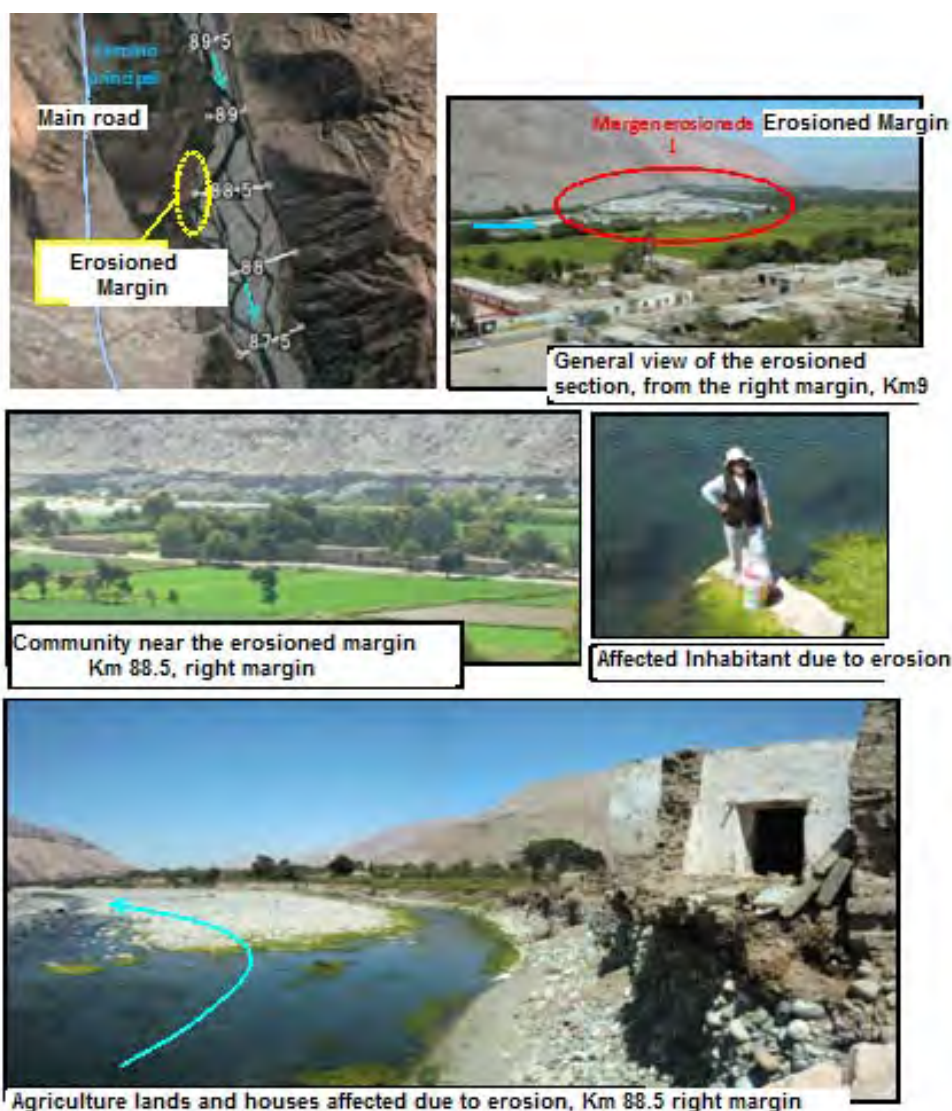
Current situation and challenges	<ul style="list-style-type: none"> • The river banks are progressively eroded per year due to the risings and floods of February 2011, which dragged a house • Currently, the banks are unprotected and if the appropriate measures are not taken, it may worsen the damages, so taking measures is urgently needed
Main elements to be conserved	<ul style="list-style-type: none"> • Houses • Croplands (main crop: rice)
Basic measures	<ul style="list-style-type: none"> • Construction of dikes and protection to the banks

Figure 3.1.6-20 Local conditions related to Challenge 6 (Majes river)

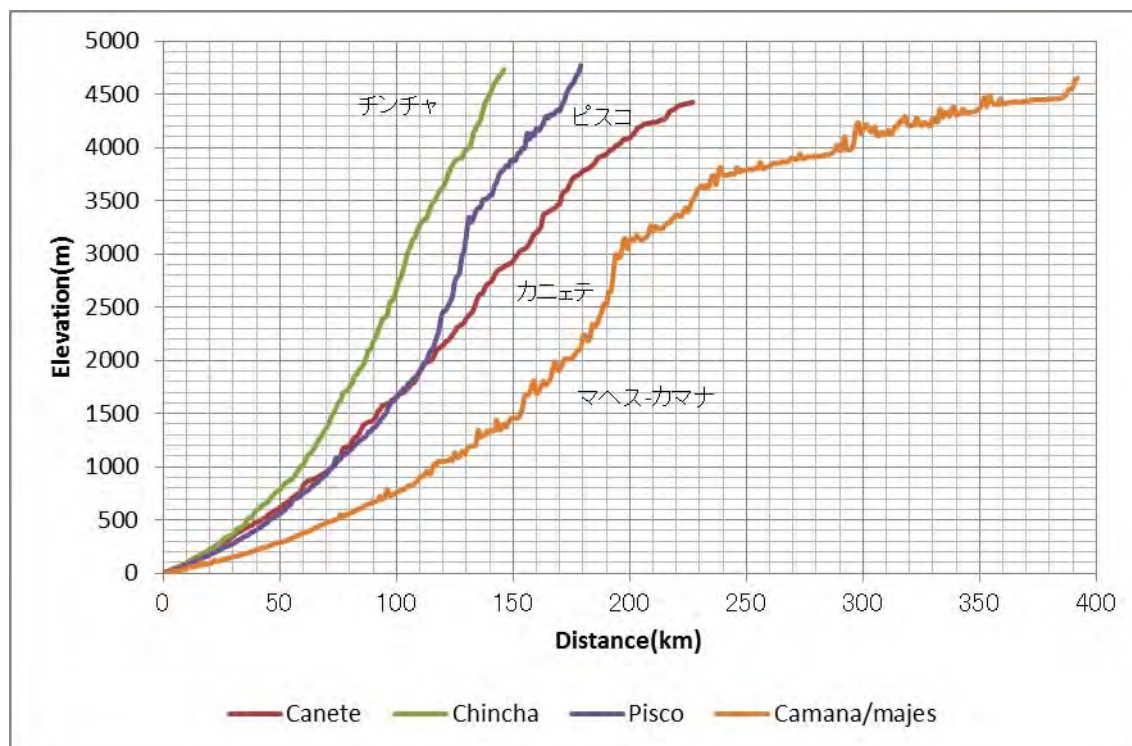
Figure 3.1.8-3 shows the longitudinal profile of the rivers. Cañete, Chíncha and Pisco have a similar profile. In case of Majes-Camana, the slope is steep from the mouth to km200, but from this point until km400, the slope is gentle.

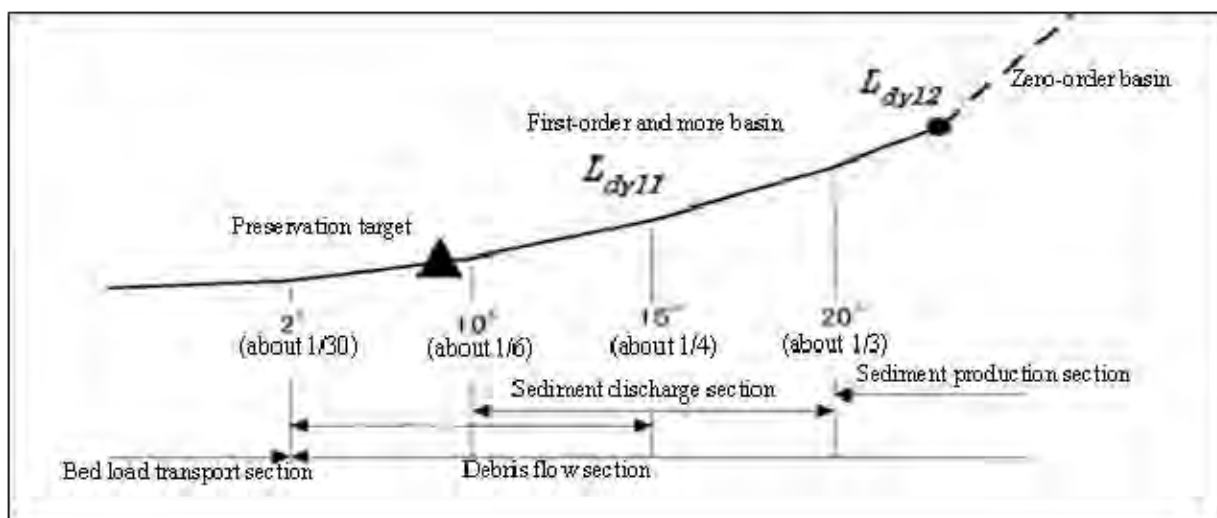
Figure 3.1.8-5 River-bed slope and sediment movement pattern
