**THE PREPARATORY STUDY
ON
PROJECT OF THE PROTECTION OF
FLOOD PLAIN AND VULNERABLE RURAL
POPULATION AGAINST FLOOD IN THE
REPUBLIC OF PERU**

**FINAL REPORT
PRE-FEASIBILITY STUDY REPORT
II-1 PROGRAM REPORT**

March 2013

**JAPAN INTERNATIONAL COOPERATION AGENCY
(JICA)**

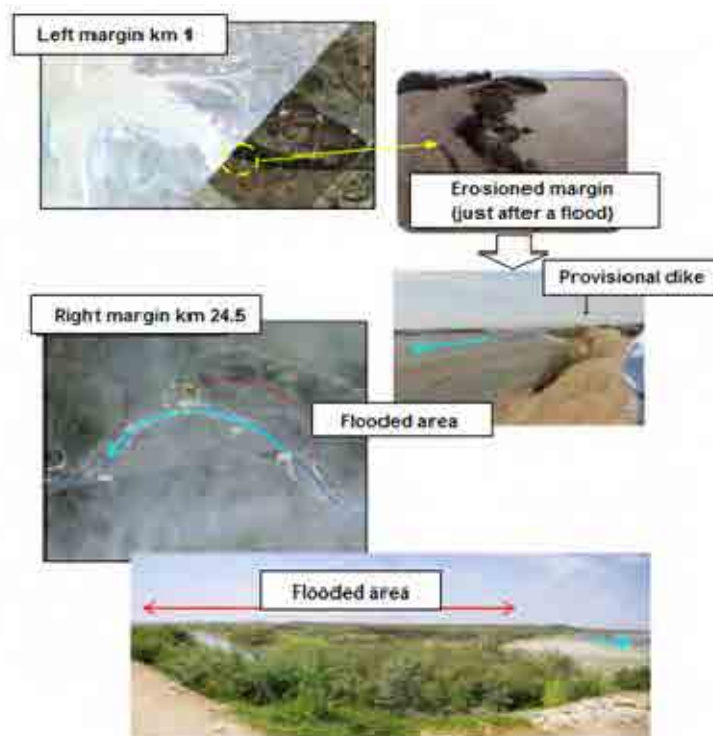
Figure 3.1.6-2 Local conditions related with Challenge 1 (Chira River)

Current situation and challenges	<ul style="list-style-type: none"> • Necessary measures were taken on the affected area due to 1983 El Niño. In 1998 event, also by El Niño, no floods occur but the dike was eroded • Currently, the flow design with modified design is being reviewed, but due to the lack of economic resources, the situation is being controlled by a provisional dike • There are only 8 sections of the affected dike that have been studied and their metering is a great challenge
Main elements to be conserved	<ul style="list-style-type: none"> • Agricultural lands (main product: cotton and banana) • Natural gas fields (12 currently exploited fields which resources are used to generate electricity in the area)
Basic measures	<ul style="list-style-type: none"> • Elevate the provisional dike's height and execute bank protection works • Protect the floor (measure against bed height reduction)

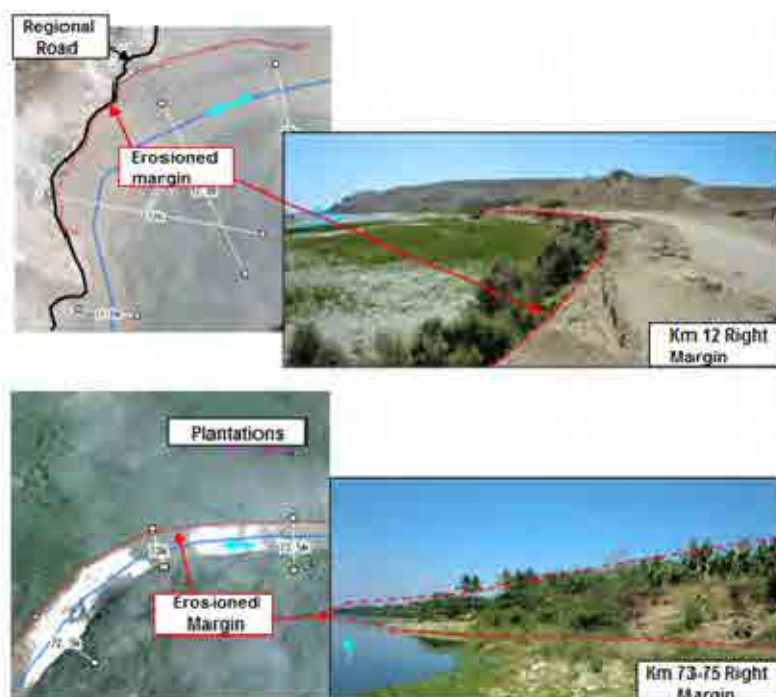
Figure 3.1.6-3 Local conditions related with Challenge 2 (Chira River)

Current situation and challenges	<ul style="list-style-type: none"> • Several bank erosion damages occurred in the floods of 1998 due to El Niño • There are several crops fields, roads and irrigation channels that are un-protected, and susceptible to be severely damaged if erosion continues
Main elements to be conserved	<ul style="list-style-type: none"> • Crop lands (main product: bananas) • Main regional road • Main irrigation channels
Basic measures	<ul style="list-style-type: none"> • Execute bank protection works to control erosion expansion

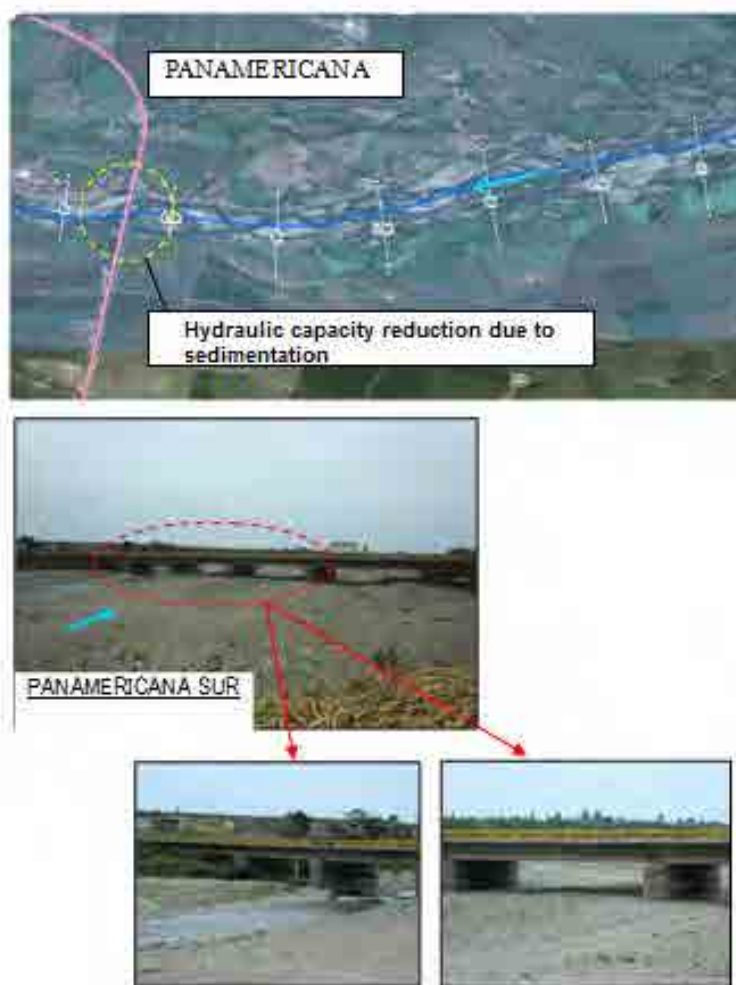
Figure 3.1.6-8 Local conditions related with Challenge 3 (Cañete River)

<p>Current situation and challenges</p>	<p>In 1998 floods, the river overflowed, flooding Panamericana Highway. The sediment accumulation did not allow transit temporarily</p> <ul style="list-style-type: none"> ▪ Panamericana Highway coincides with the narrow section of the river. In this section, the water level rises upstream accumulating sediments and causing overflowing ▪ Only the critical section (approx. 200 m) has been protected with a dike, but not the other sections
<p>Main elements to be conserved</p>	<ul style="list-style-type: none"> ▪ Panamericana Highway ▪ Crop land (main products: apples, grapes and cotton)
<p>Basic measures</p>	<ul style="list-style-type: none"> ▪ It is not possible to execute bridge repair works at the moment, due to which it is necessary to take other actions to ensure the necessary hydraulic capacity (bed drilling, etc)

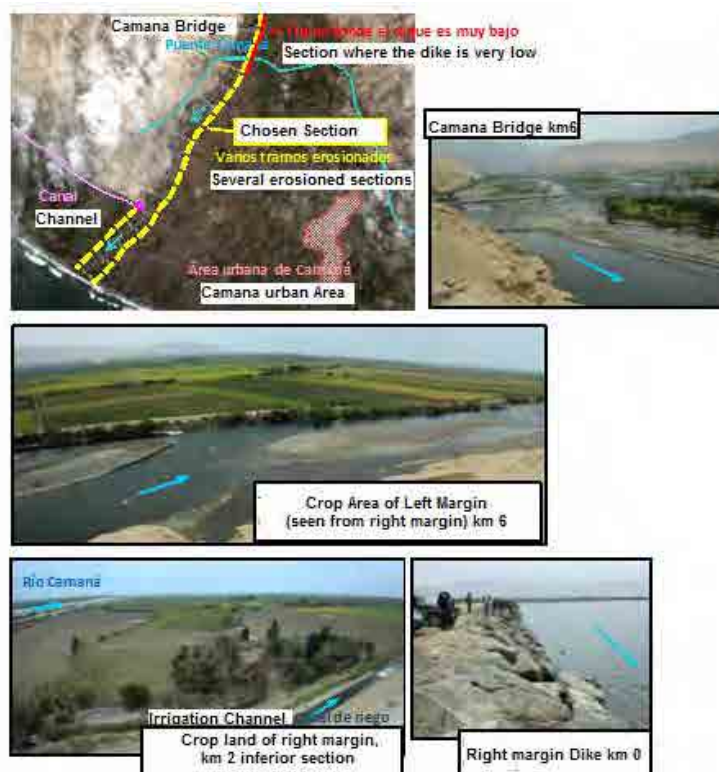
Figure 3.1.6-23 Local conditions related with Challenge 1 (Camana River)

Current situation and challenges	<ul style="list-style-type: none"> • The existing dike which control corresponds to the Irrigation Commission of Camana has been constructed about 30 years ago with their own resources. There are several eroded parts • The dike is low upstream and downstream of Camana Bridge at km 6, putting at flood risk arable lands and urban area
Main elements to be conserved	<ul style="list-style-type: none"> • Urban area of Camana • Arable lands (main crop: rice)
Basic measures	<ul style="list-style-type: none"> • Construction of dikes and riverbank protection

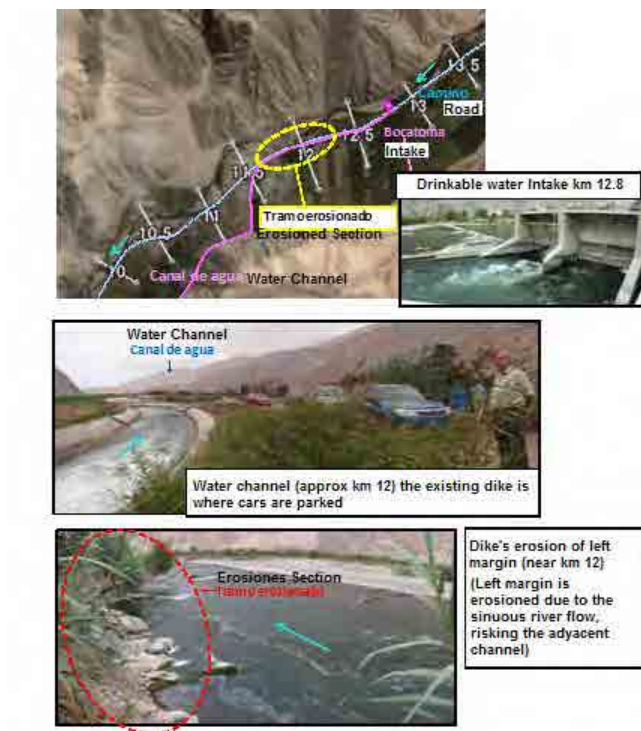
Figure 3.1.6-24 Local conditions related with Challenge 2 (Camana River)

Current situation and challenges	<ul style="list-style-type: none"> • There is an inlet for the drinking water service to Camana at km 13, as well as a channel along the river • Currently the left bank at km 12 is eroded and if not taking correct measures, this could affect the adjacent channel
Main elements to be conserved	<ul style="list-style-type: none"> • Channel for drinking water
Basic measures	<ul style="list-style-type: none"> • Reinforcement of the existing dike and riverbank protection

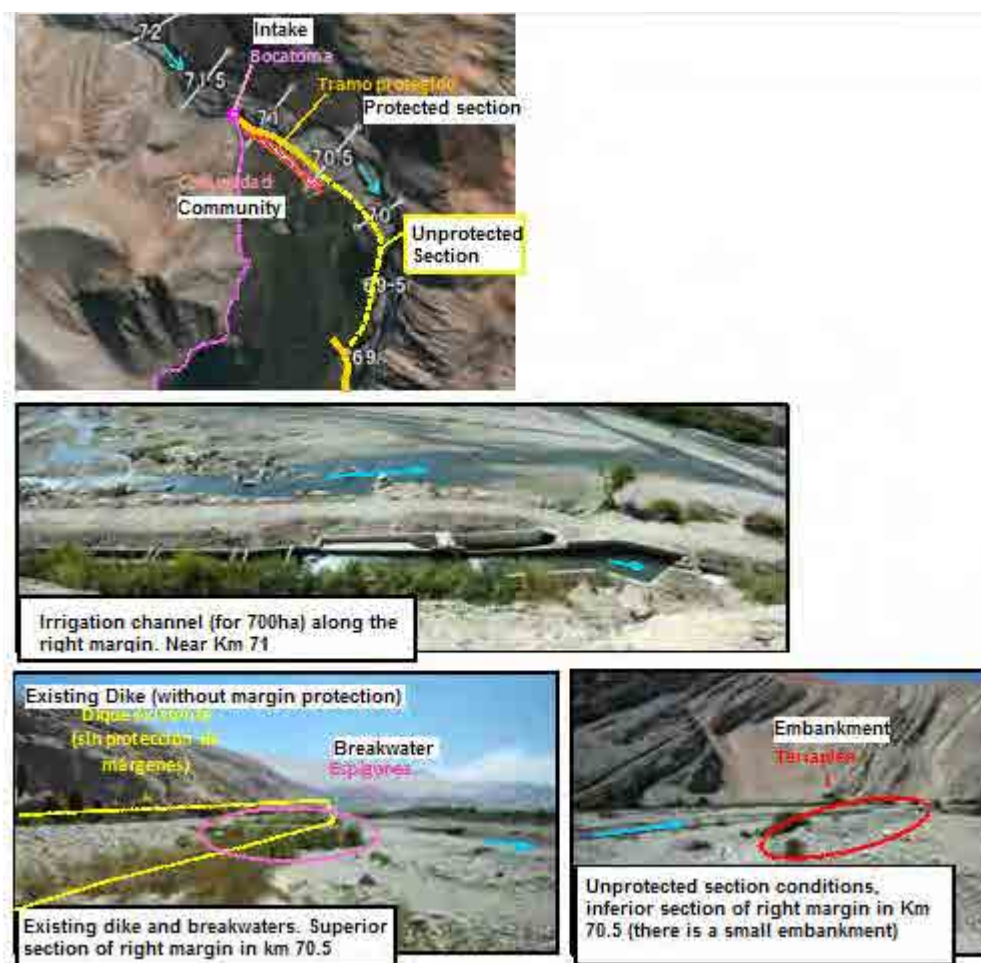
Figure 3.1.6-26 Local conditions related to Challenge 4 (Majes River)

Current situation and challenges	<ul style="list-style-type: none"> • There is a community, Deque, along the riverside, in the narrow section, 30 houses in the low lands • Even though it is true that the higher section of this community is protected by a dike, there is a section downstream which is unprotected, with higher risk of overflowing • There is a water intake to supply irrigation water to 700ha of crop land, which is also exposed to flood risk
Main elements to be conserved	<ul style="list-style-type: none"> • Houses, water intake for irrigation • Croplands (main crop: rice)
Basic measures	<ul style="list-style-type: none"> • Construction of dikes and protection of banks

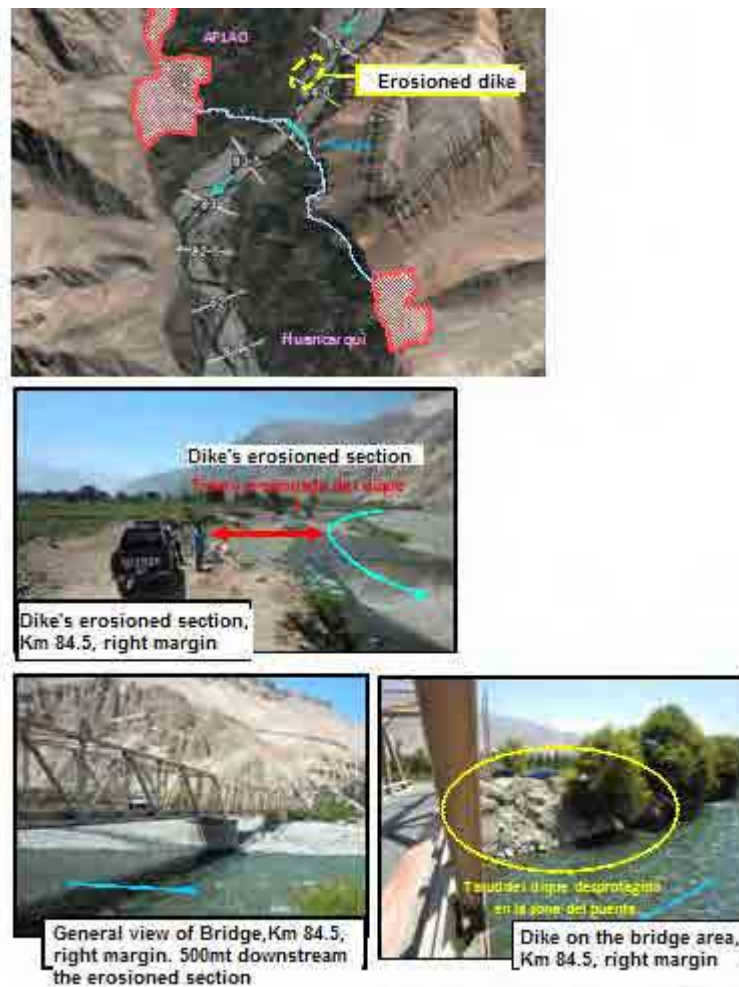
Figure 3.1.6-27 Local Conditions related to Challenge 5 (Majes River)

Current situation and challenges	<ul style="list-style-type: none"> • The dike of the right bank is progressively eroded year by year, and if no measure is taken, it could affect the next bridge downstream (Huancariqui bridge) • This bridge is an important path which connects Aplao, the larger town of Majes (with a population of 18 thousand inhabitants), and Huancariqui (with a population of 5 thousand inhabitants)
Main elements to be conserved	<ul style="list-style-type: none"> • Bridge (Huancariqui) • Croplands (main crop: rice)
Basic measures	<ul style="list-style-type: none"> • Construction of dikes and protection to the banks

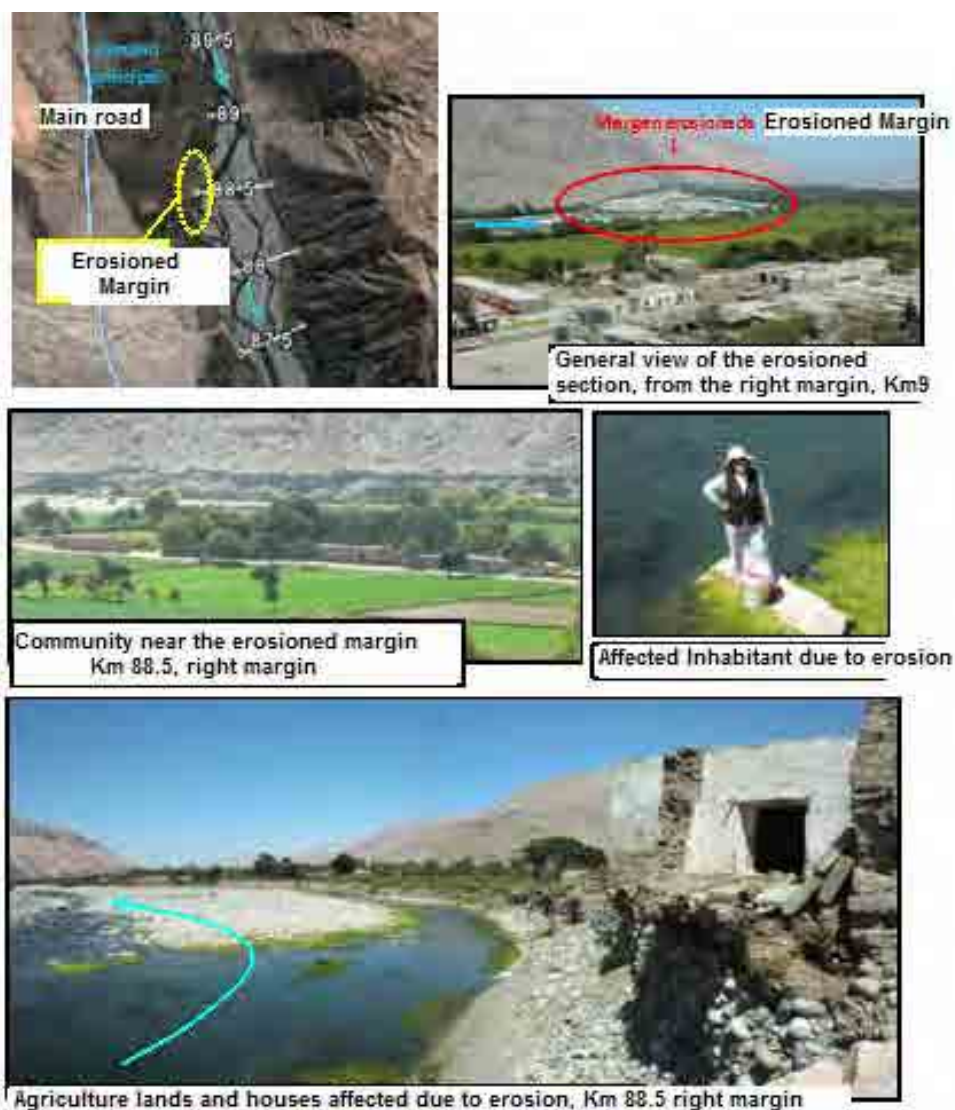
Figure 3.1.6-28 Local conditions related to Challenge 6 (Majes River)

Current situation and challenges	<ul style="list-style-type: none"> • The river banks are progressively eroded per year due to the risings and floods of February 2011, which dragged a house • Currently, the banks are unprotected and if the appropriate measures are not taken, it may worsen the damages, so taking measures is urgently needed
Main elements to be conserved	<ul style="list-style-type: none"> • Houses • Croplands (main crop: rice)
Basic measures	<ul style="list-style-type: none"> • Construction of dikes and protection to the banks
