**THE PROJECT
FOR THE IMPROVEMENT
OF**

**WATER SUPPLY, SEWAGE AND SOLID WASTE MANAGEMENT
IN CHITUNGWIZA**

FINAL REPORT

Summary

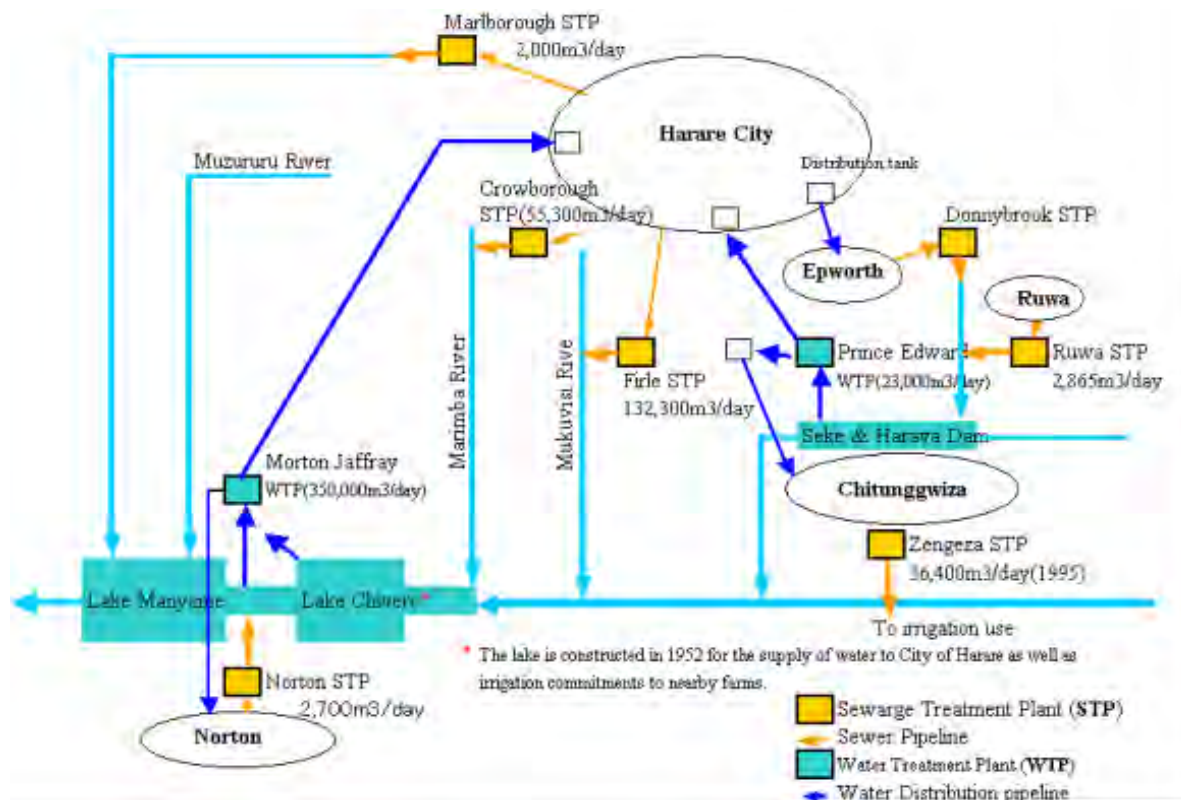
Figure 5.1 Manyame Catchment and WTP/STP Facilities

However, the two major STPs are partly broken and overloaded and often discharge partially treated effluent into the main tributaries of Lake Chivero. As a result, water quality of Marimba River and Mukuvisi River has been badly deteriorated in recent years, resulting in serious water quality problems in Lake Chivero. Since both STPs almost discontinued the use of the BNR facility because of budget problems, the direct discharge has polluted Lake Chivero more.

Zengeza STP in Chitungwiza Municipality was treating about 36,000 m³/day by TF and BNR processes. However, after 2004, both treatments were discontinued because of serious budget problem affecting proper maintenance. At the same time, effluent transmission pump broke down resulting in the direct discharge of the raw sewage into Nyatsime River polluting its tributaries.

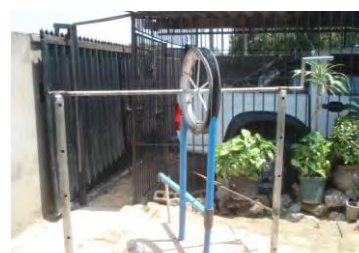
Photo 7.1 Elephant Pump

the housing units surrounding the area are using the well. An “Elephant Pump” is selected as the hand pump because it is prevailing in the municipality and is locally fabricated using common materials. Before and after installation, some questionnaires and public awareness on water quality problems and basic manner of utilizing pump were carried out. Survey results were analyzed numerically and are summarized below including features of families utilizing target wells:

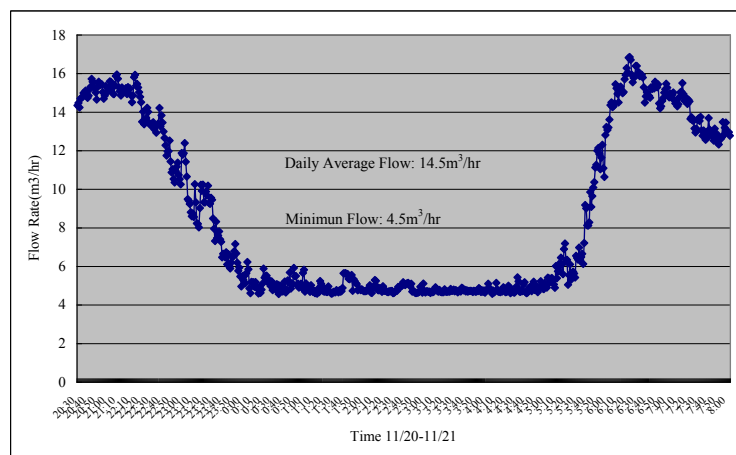
Figure 7.3 Measurement Results of Area “e”

Because this area was the first priority area for the municipality to provide a sustainable water supply, Valve ⑤ never fully closes. Measurement results for water leakage survey of area “e” were shown in Figure 7.3. As shown in the figures, in the midnight the water flow apparently decreases, and the average flow was decided by two hour intervals of measurement.

Based on the figures, if water consumption in midnight is assumed to be the water leakage, water leakage ratio of each area is calculated as shown below:

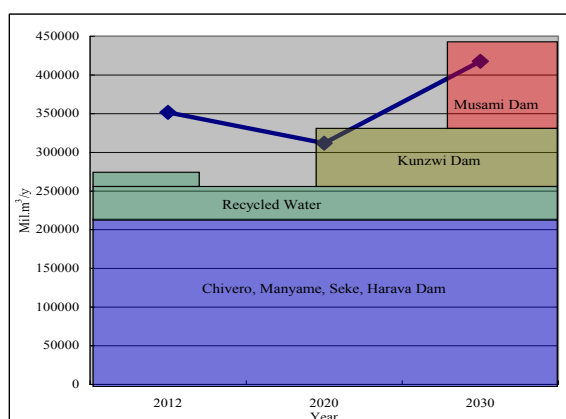
Figure 8.1 Comparisons between Water Demand and Source

In Harare Area, the available dams for water supply are Chivero, Manyame, Seke and Harava Dams, and their yield capacity is not enough to meet the demand including NRW and then the Kunzwi and Musami projects are planned for the water resources of Great Harare Area. The balance between water demand (including NRW) and water source considering these planned dams is shown in Figure 8.1.

As shown in the figure, currently the water source is outstandingly short, and although after the development of Kunzwi and Musami Dam the source capacity is set to meet the demand, the production capacity cannot meet the demand soon due to rapid increase of demand.

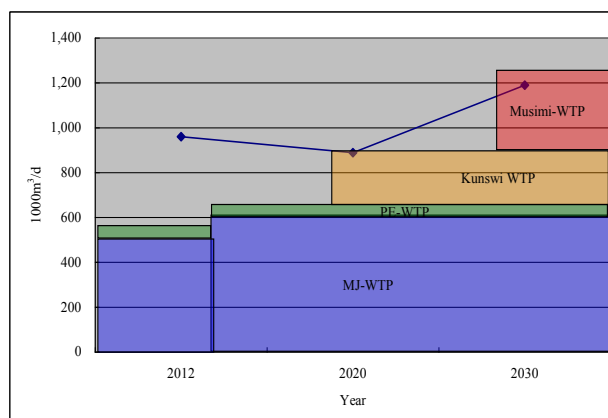
Figure 8.2 Comparisons between Water Demand and Production Capacity

The balance between water production capacity and demand is shown in Figure 8.2 and the tendency is almost similar to that of the water source. Because of insufficient water supply from Harare Water Works, groundwater resources were surveyed. However it was found that a total yield capacity of 5,000 m³/d is the limit surrounding the municipality. From the results of a test well survey, two (2) hopeful wells with capacity of over 300 m³/d can be installed, but since these wells cannot be installed nearby each other, the number of wells will be limited.
