**THE PROJECT  
FOR THE IMPROVEMENT  
OF**

**WATER SUPPLY, SEWAGE AND SOLID WASTE MANAGEMENT  
IN CHITUNGWIZA**

**FINAL REPORT**

**NJS CONSULTANTS CO., LTD**

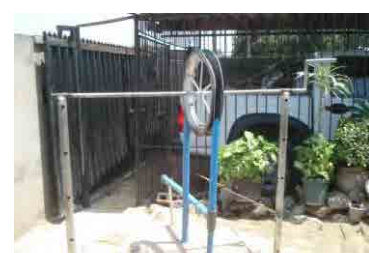
Photo 7.1 Elephant Pump

In the target area, 10 wells were selected for installation based on these conditions; the yield capacity is relatively large and people in

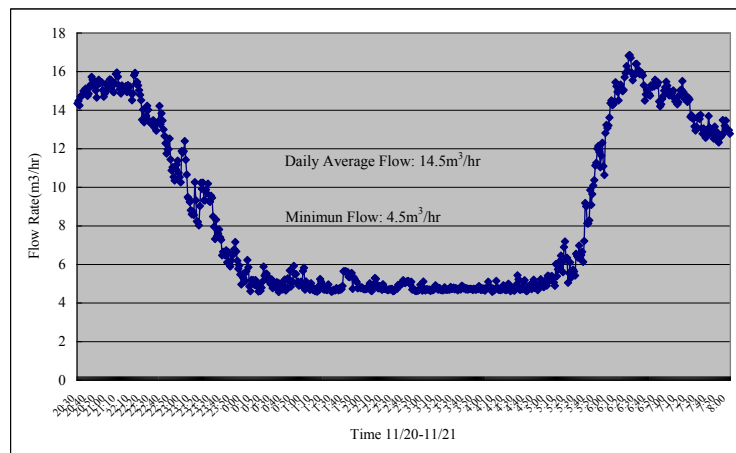
Figure 7.3 Measurement Results of Area “e”

Because this area was the first priority area for the municipality to provide a sustainable water supply, Valve ⑤ never fully closes. Measurement results for water leakage survey of area “e” were shown in Figure 7.3. As shown in the figures, in the midnight the water flow apparently decreases, and the average flow was decided by two hour intervals of measurement.

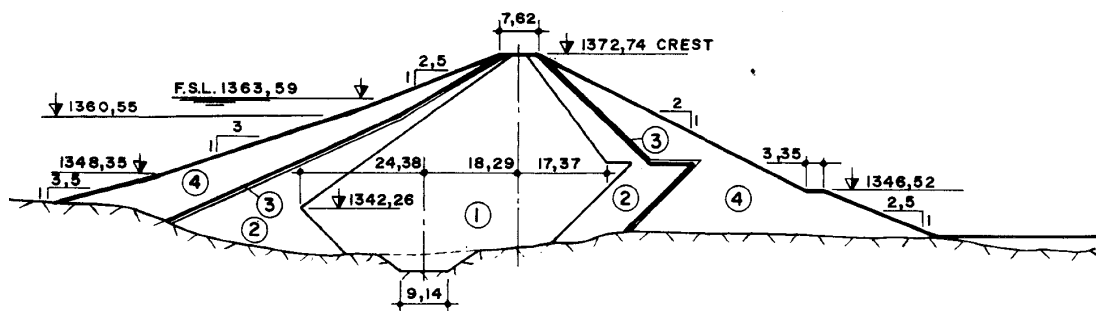
Figure 2.4.8 Cross Section of Manyame Poort Dam (Chivero Dam)

The original outlets were in a conduit below the embankment on the left flank, but a new outlet system was constructed in 1974. This comprises a control tower that was built from pontoons in the reservoir and gradually sunk until it penetrated the bed material, connected to a tunnel that passes under the lake and the range of hills on the shoreline, leading directly to the purification works.

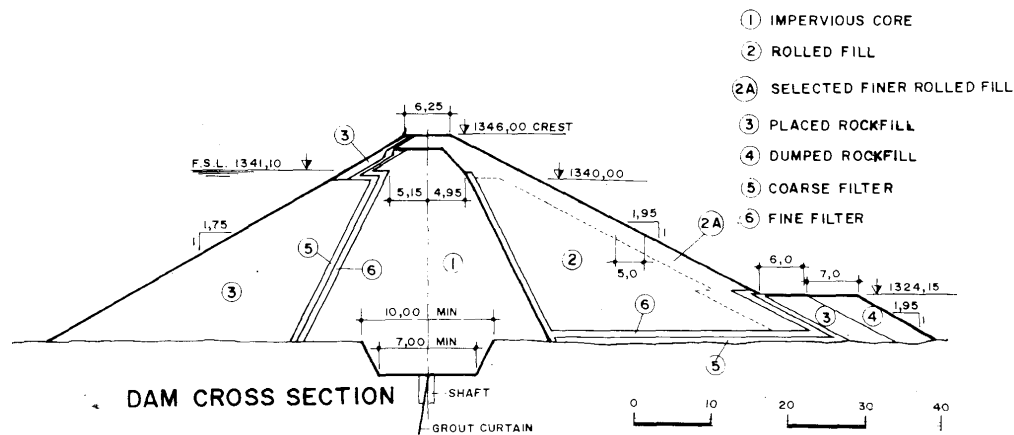
Figure 2.4.10 Cross Section of Manyame (Darwendale) Dam

The spillway is a gated structure with the water discharging down the glacis into a concrete-lined stilling basin. Gate operation is activated by electrode sensors at successive levels, and opening is electric powered with diesel engine and manual standby. The dam outlets comprise twin 1,200 mm pipes in a trench in the foundation rock, but drawoff for Harare water supply is via a tower in the reservoir and the Darwendale Tunnel which conveys the water to an underground pump station at the Morton Jaffray Water Treatment Works.

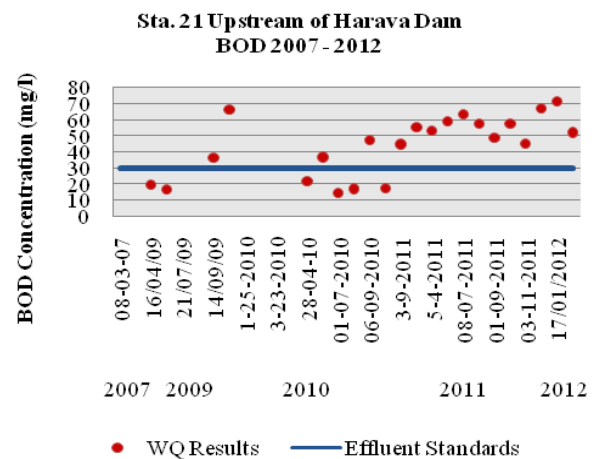
Figure 2.5.2 Water Quality (BOD), Upstream of Harava Dam 2007-2012 Source: EMA

BOD levels in all 5 sampling points monitored from 2009 to 2012 exceeded standards set for effluent discharge (Blue classification). Highest BOD levels were recorded in Nyatsime River (after discharge of STW) at 81.2 mg/l in 2009 and in Morton Bridge (after Lake Chivero) at 80.2 mg/l in 2011. Following figures showed the BOD levels above the blue line exhibited exceedances. Fluctuations were observed in all stations with significant drops in BOD levels in Nyatsime River (Figures 2.5.2 to 2.5.6).

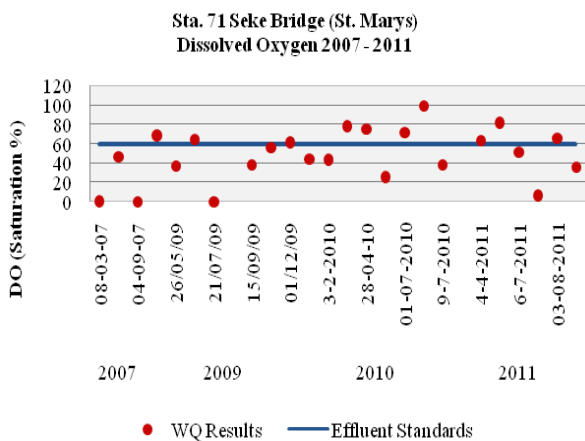
Figure 2.5.7 Water Quality (DO), Seke Bridge 2007-2011 Source: EMA

DO concentrations for the two sampling points, Seke Bridge and Nyatsime River consistently failed to meet the minimum concentration of 60% saturation from 2007 to 2012. Lowest concentrations were recorded in Nyatsime River at 0% saturation for years 2007 and 2009 (Figures 2.5.7 to 2.5.8). At this concentration, river water is considered “biologically dead”. Low DO levels may be found in areas where organic material (dead plant and animal matter) is decaying, as bacteria require oxygen to decompose organic waste, thus, depleting the water of oxygen. Areas near sewage discharges sometimes have low DO levels due to this effect.

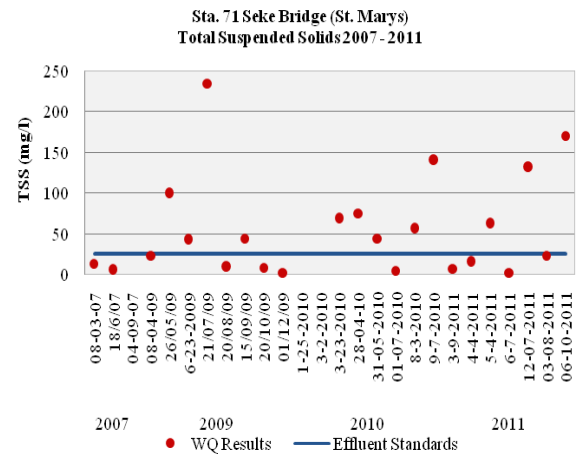
Figure 2.5.9 Water Quality (TSS), Seke Bridge 2007-2011 Source: EMA

recorded level was at 450 mg/l in Nyatsime River (October 2009) way above the minimum standard of equal or less 25 mg/l (Figures 2.5.9 to 2.5.10). The 3 other points had fair water quality. TSS measures the amount of un-dissolved solid particles in water such as level of siltation, domestic and industrial wastes, and decaying plant and animal matter. Figure 2.5.10 showed an outlier value of 836 mg/l TSS in Nyatsime River (April 2011) and therefore not considered in the assessment.

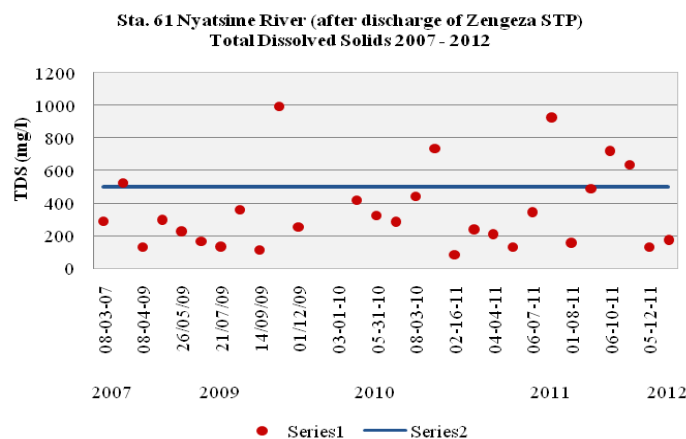
Figure 2.5.11 Water Quality (TDS), Nyatsime River 2007-2012 Source: EMA

Of the 5 monitored sampling points, exceedances were observed only in Nyatsime River in sampling years 2009 – 2011. Highest recorded concentration was at 990 mg/l in 2009 beyond the standard set of equal or less than 500 mg/litre (Figure 2.5.11). TDS is generally used as an aggregate indicator of the presence of a broad array of chemical contaminants. The primary sources of TDS in receiving waters are from agricultural runoff, leaching of soil contamination, and point source water pollution from domestic sewage or industrial waste.

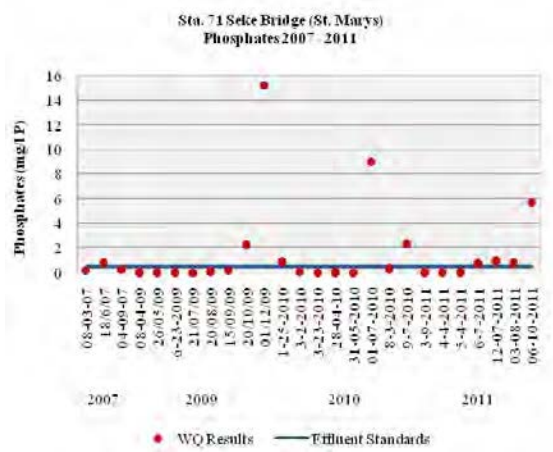
Figure 2.5.12 Water Quality (PO<sub>4</sub>), Seke Bridge 2007-2011 Source: EMA

Seke Bridge and Nyatsime River had phosphate concentration ranging from 0.56 to 17.73 mg/l exceeding the set limit of equal or less 0.5 mg/l (Figures 2.5.12 to 2.5.13). Surface run-offs of phosphates from excessively fertilized farmland (pasture and croplands) can be a cause of phosphate pollution in surface waters, leading to eutrophication (algal bloom) and consequent oxygen deficit, leading to (anoxia) for fish and other aquatic life in the same manner as phosphate-based detergents. Other sources include seepage from individual sewage treatment systems, partially treated sewage from STW and urban runoffs. Figure 2.5.13 showed another outlier value of 64 mg/l PO<sub>4</sub> in Nyatsime River (December 2009) and therefore not considered in the assessment
