**THE PROJECT
FOR
THE IMPROVEMENT OF WATER SUPPLY, SEWAGE AND SOLID WASTE
MANAGEMENT
IN
CHITUNGWIZA IN
THE REPUBLIC OF ZIMBABWE**

FINAL REPORT

APPENDIX 1**Status of the Existing Sewerage Facilities and Evaluation for the Future Operation****1.1 Administration Building**

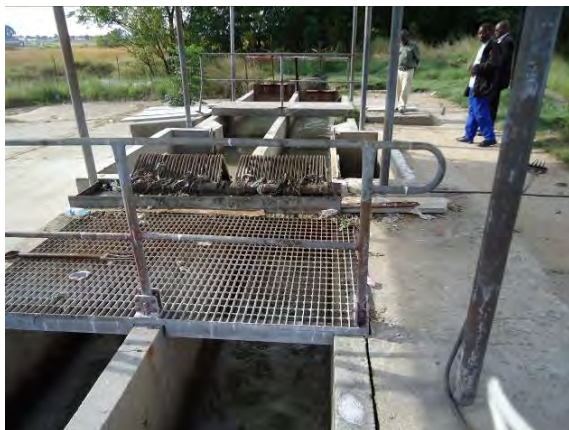
Picture 1: 1975 Head Works

Structural Safety	Equipment Soundness	Pipelines/Plumbing
Construction	1975		
Unit or number	One structure	1 lump sum	1 lump sum
Details/Specification	RC	Screen, Grit Chamber	1 lump sum
Current Status	Used, decrepit, cracks and rebar exposures	Rehabilitation, Maintenance needed	Rehabilitation, Maintenance needed
Current Practical Performance/Function	Usable	Rehabilitation, Maintenance needed	Rehabilitation, Maintenance needed
Possibility of Future Use	Usable	Rehabilitation, Maintenance needed	Rehabilitation, Maintenance needed
Expected Life Remaining	About 10-20yrs after rehabilitation		
Evaluation for Future Use	Possible	Possible	Possible
Required Measure for Future Use	Inspection and repair	Inspection and repair/change	Inspection and repair/change
Judgement	Usable, maintenance and rehabilitation needed after inspection. Subject to rehabilitation by AWF project under AfDB

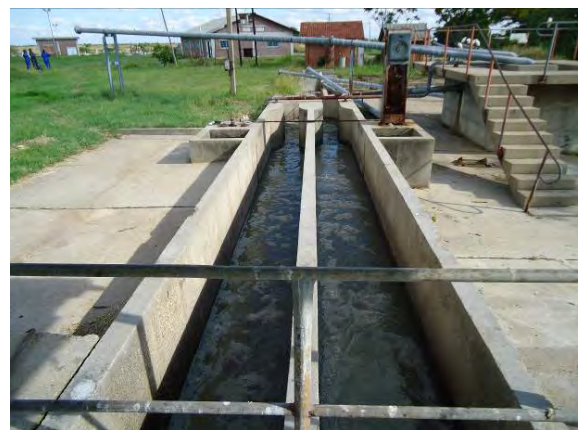
Picture 2: 1975 Head Works

Structural Safety	Equipment Soundness	Pipelines/Plumbing
Construction	1975-2000		
Unit or number	Three structures	1 lump sum	1 lump sum
Details/Specification	RC, and Earth	Screen	1 lump sum
Current Status	Used but not cleaned, structure sound	Maintenance needed	Need maintenance
Current Practical Performance/Function	Usable	Partly broken	Maintenance needed
Possibility of Future Use	Usable	Maintenance or rehabilitation needed	Maintenance needed
Expected Life Remaining	About 40 yrs		
Evaluation for Future Use	Possible	Possible	Possible
Required Measure for Future Use	Inspection and repair	Inspection and repair/change	Inspection and repair/change
Judgement	Usable, maintenance and rehabilitation needed after inspection. Subject to rehabilitation by AWF project under AfDB

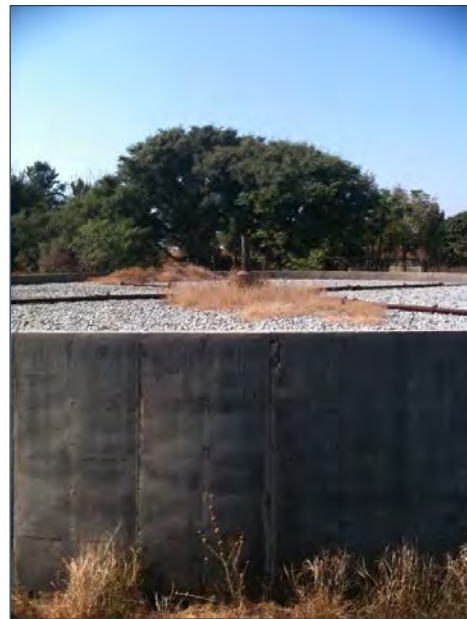
Picture 7: 1975 Trickling Filter

- (3) Old Trickling Filters are decrepit with a lot of cracks with wide openings. Re-bars are exposed and corroded in some parts. However, rehabilitation of the structure will be possible and it will be available for the treatment work, since water tightness of the side wall is not perfectly required as the water flow direction is downwards from the top of the structure. Further water flow is not a pressured flow against the wall.

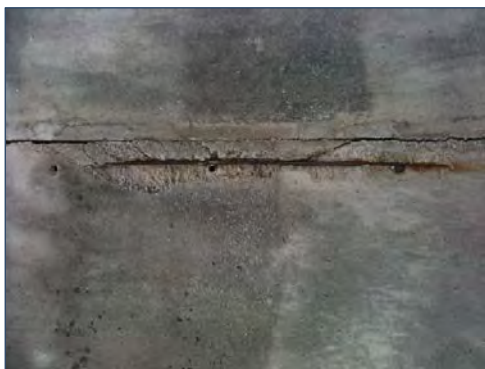
Picture 6: Cracks on the 1975 Trickling Filter Wall

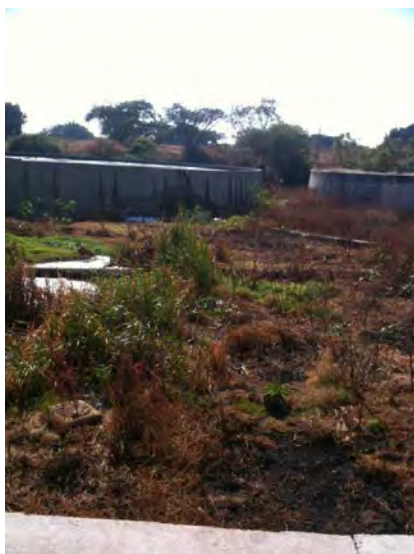
Picture 8: 1975 Tricking Filters

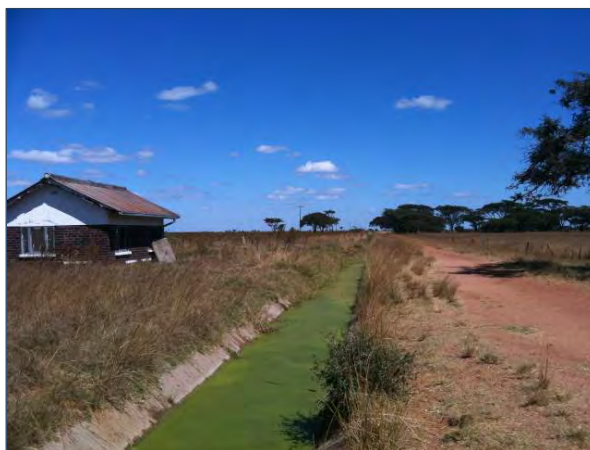
Picture 9: Channel from STP to Imbwa Farm

Structural Safety	Equipment Soundness	Pipelines/Plumbing
Construction	1995		
Unit or number	1 lump sum	-	1 lump sum
Details/Specification	RC	-	1 lump sum
Current Status	Not used	-	Need maintenance
Current Practical Performance/Function	Usable	-	Maintenance needed
Possibility of Future Use	Usable	-	Maintenance needed
Expected Life Remaining	Uncertain	-	Uncertain
Evaluation for Future Use	Possible	-	Possible
Required Measure for Future Use	Inspection and repair	-	Inspection and repair/change
Judgement	Usable, maintenance and rehabilitation needed after inspection.

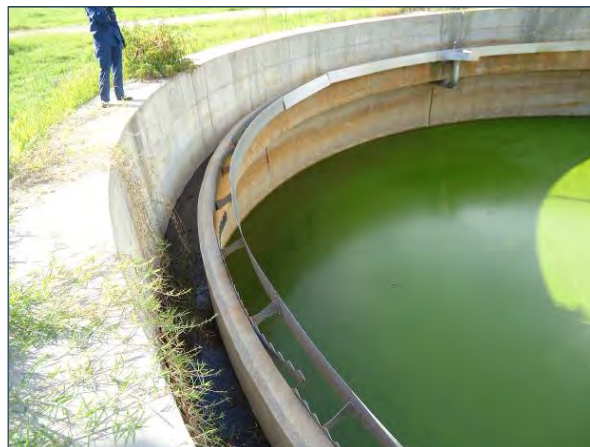
Picture 10: Primary Sedimentation Tank

Structural Safety	Equipment Soundness	Pipelines/Plumbing
Construction	1998-2000, commissioned in 2000		
Unit or number	Two structures	1 lump sum	1 lump sum
Details/Specification	RC	Sludge Scraper, Motor	1 lump sum
Current Status	Not used, sound in structure	Rehabilitation, Maintenance needed	Rehabilitation, Maintenance needed
Current Practical Performance/Function	Usable	Partly broken	Rehabilitation, Maintenance needed
Possibility of Future Use	Usable	Maintenance or rehabilitation needed	Rehabilitation, Maintenance needed
Expected Life Remaining	About 40 yrs		
Evaluation for Future Use	Possible	Possible	Possible
Required Measure for Future Use	Inspection and repair	Inspection and repair/change	Inspection and repair/change
Judgement	Usable, maintenance and rehabilitation needed after inspection.

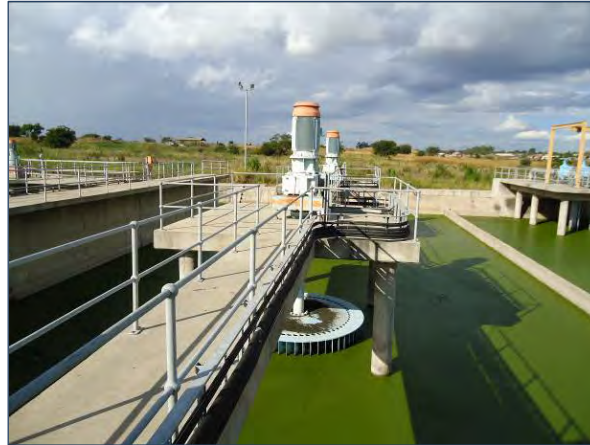
Picture 12 Biological Reactor

Structural Safety	Equipment Soundness	Pipelines/Plumbing
Construction	1998-2000, commissioned in 2000		
Unit or number	One structure	1 lump sum	1 lump sum
Details/Specification	RC	Mixers, Motor,	1 lump sum
Current Status	Not used, sound in structure	Maintenance or rehabilitation needed	Need maintenance
Current Practical Performance/Function	Usable	Partly broken	Maintenance needed
Possibility of Future Use	Usable	Maintenance or rehabilitation needed	Maintenance needed
Expected Life Remaining	About 40 yrs		
Evaluation for Future Use	Possible	Possible	Possible
Required Measure for Future Use	Inspection and repair	Inspection and repair/change	Inspection and repair/change
Judgement	Usable, maintenance and rehabilitation needed after inspection.

- (1) All the mechanical/Electrical equipment will be needed to be rehabilitated for future reuse.
- (2) Structures of the BNR facility are almost sound without visible wide cracks. Concrete surface is smooth and hard.

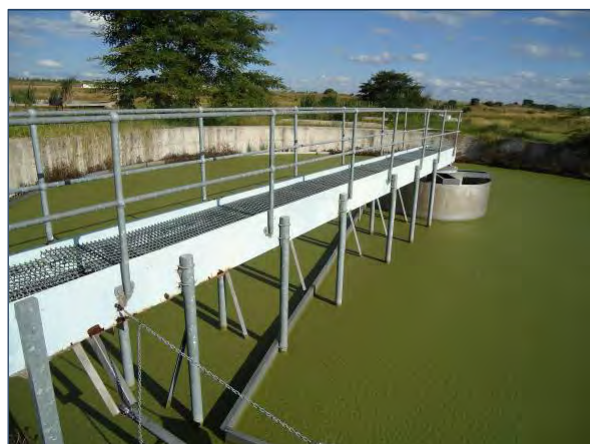
Picture 13 Final Sedimentation Tank

Structural Safety	Equipment Soundness	Pipelines/Plumbing
Construction	1998-2000, commissioned in 2000		
Unit or number	Four structures	1 lump sum	1 lump sum
Details/Specification	RC	Sludge Scraper, Motor	1 lump sum
Current Status	Not used, sound in structure	Rehabilitation, Maintenance needed	Rehabilitation, Maintenance needed
Current Practical Performance/Function	Usable	Partly broken	Rehabilitation, Maintenance needed
Possibility of Future Use	Usable	Maintenance or rehabilitation needed	Rehabilitation, Maintenance needed
Expected Life Remaining	About 40 yrs		
Evaluation for Future Use	Possible	Possible	Possible
Required Measure for Future Use	Inspection and repair	Inspection and repair/change	Inspection and repair/change
Judgement	Usable, maintenance and rehabilitation needed after inspection.

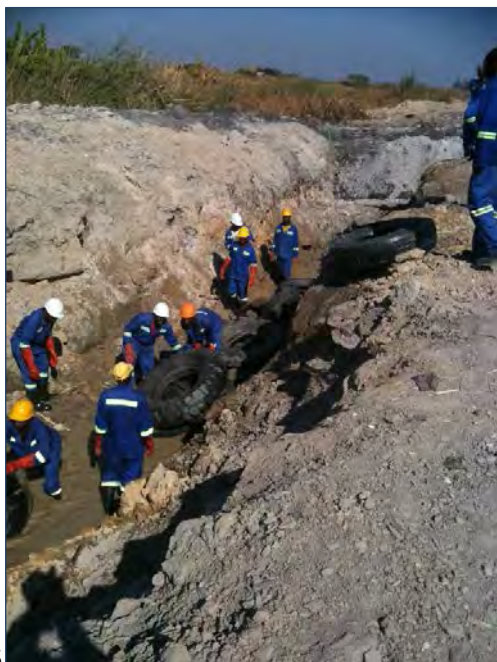
No. of pipes	Size	Type of pipe	No. of manholes
56	375mm	Asbestos Cement (AC)	
47	400mm	P V C	Total No. 7

Picture 14: New Sewer Pipes Installed by AWA Funds

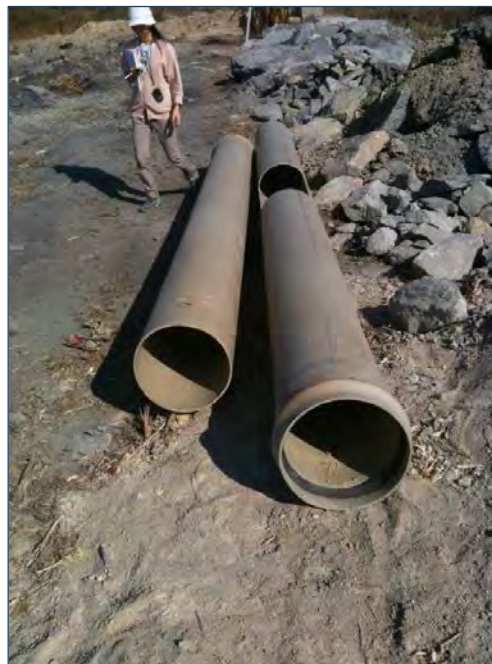
Picture 15: New ACP Sewer Pipes by AWA Funds

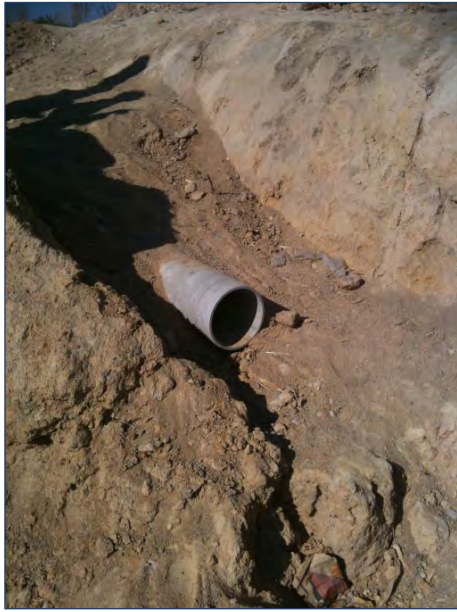
No. of pipes procured	Diameter	Pipe Material	No. of manholes
78	250 mm	Asbestos Cement (AC)	4

Picture 16: New Sewer Pipes Installed by AWA Funds

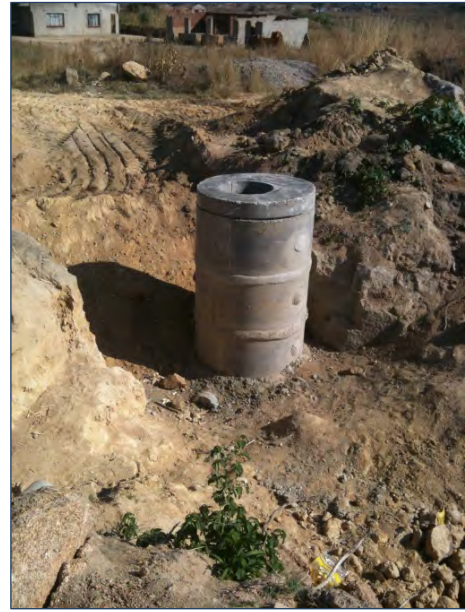
Picture 17: New Sewer MH Installed by AWA Funds

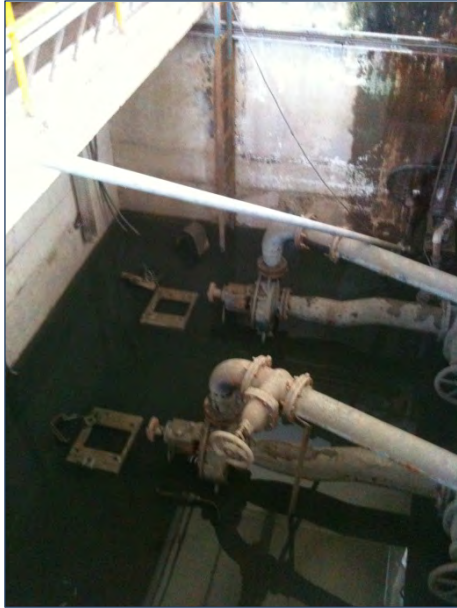
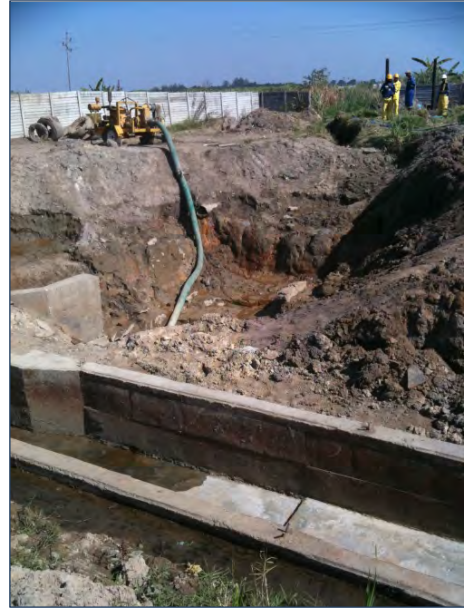
The pump was built in 70s. Pumps from the sump are corroded and they are now leaking. The contractor is currently working on building a tank to collect sand. They are going to construct a new vertical flow chamber on this pump station and a new mortar, new pump and new control panel is going to be installed. The ground has high water table and this has slowed down the progress since water constantly need to be pumped out of the trenches and ZESA load shading has also contributed the delay due to lack of electricity.

Picture 18: Inside Pump Station I

Picture 19: Outside Pump Station I

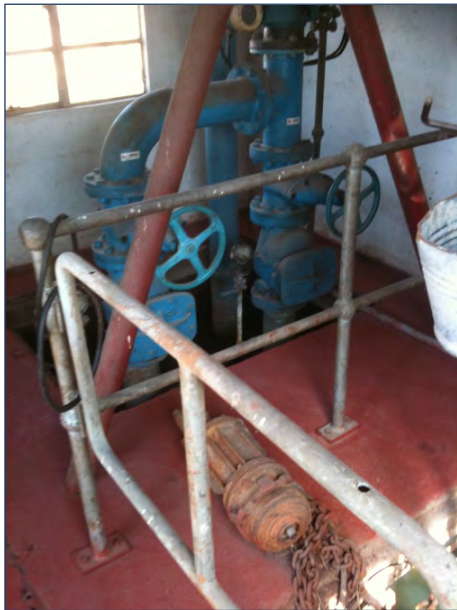
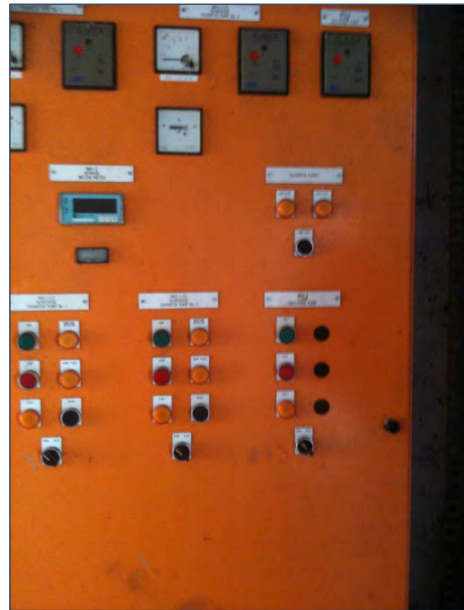
The station has not been working . On this station new pumps are needed.

Picture 20: Inside Pump Station II

Picture 21: Electrical Panel in Pump Station II

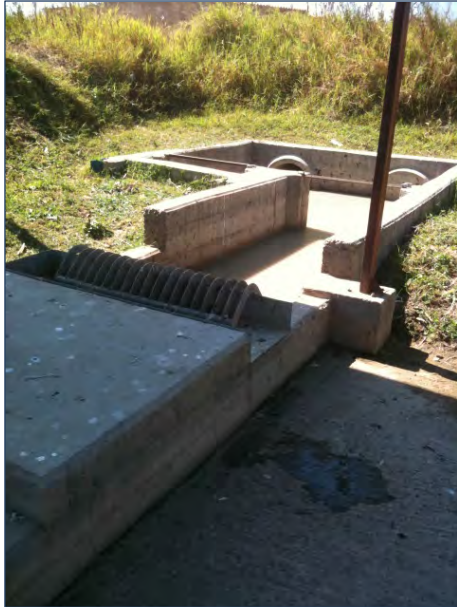
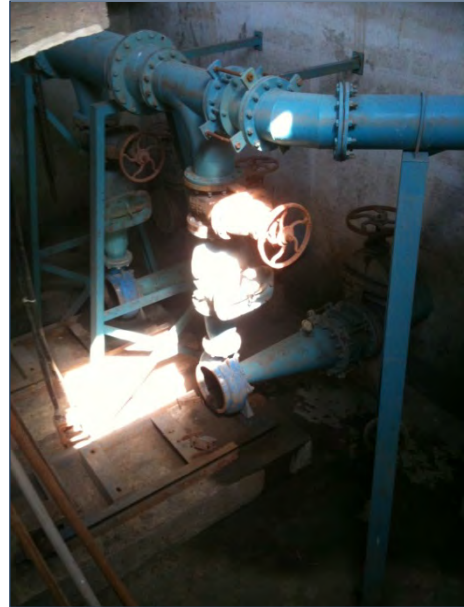
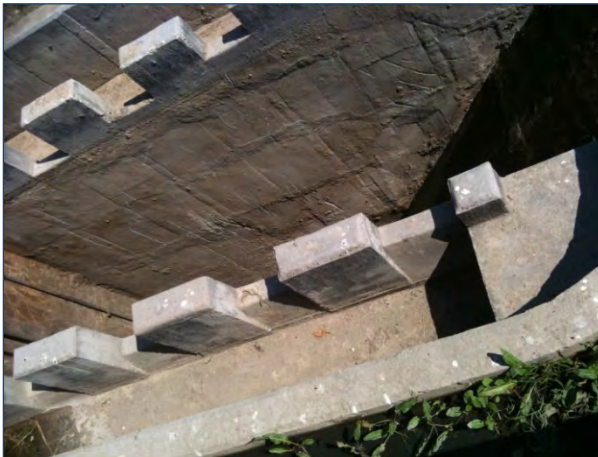
The pump station was built in 2003 and it only lasted for 2 years and up to now it is not working. The contractor is going to re habilitate the station. They are going to install a new vertical flow chamber. The pump station has 3 mortars and already the contractor collected 2 for servicing and one new one is going to be installed. Currently no work has started on this station

Picture 22: Vertical Chamber in Pump Station III

Picture 23: Pump in Pump Station III

Picture 24: Vertical Chamber in Pump Station III

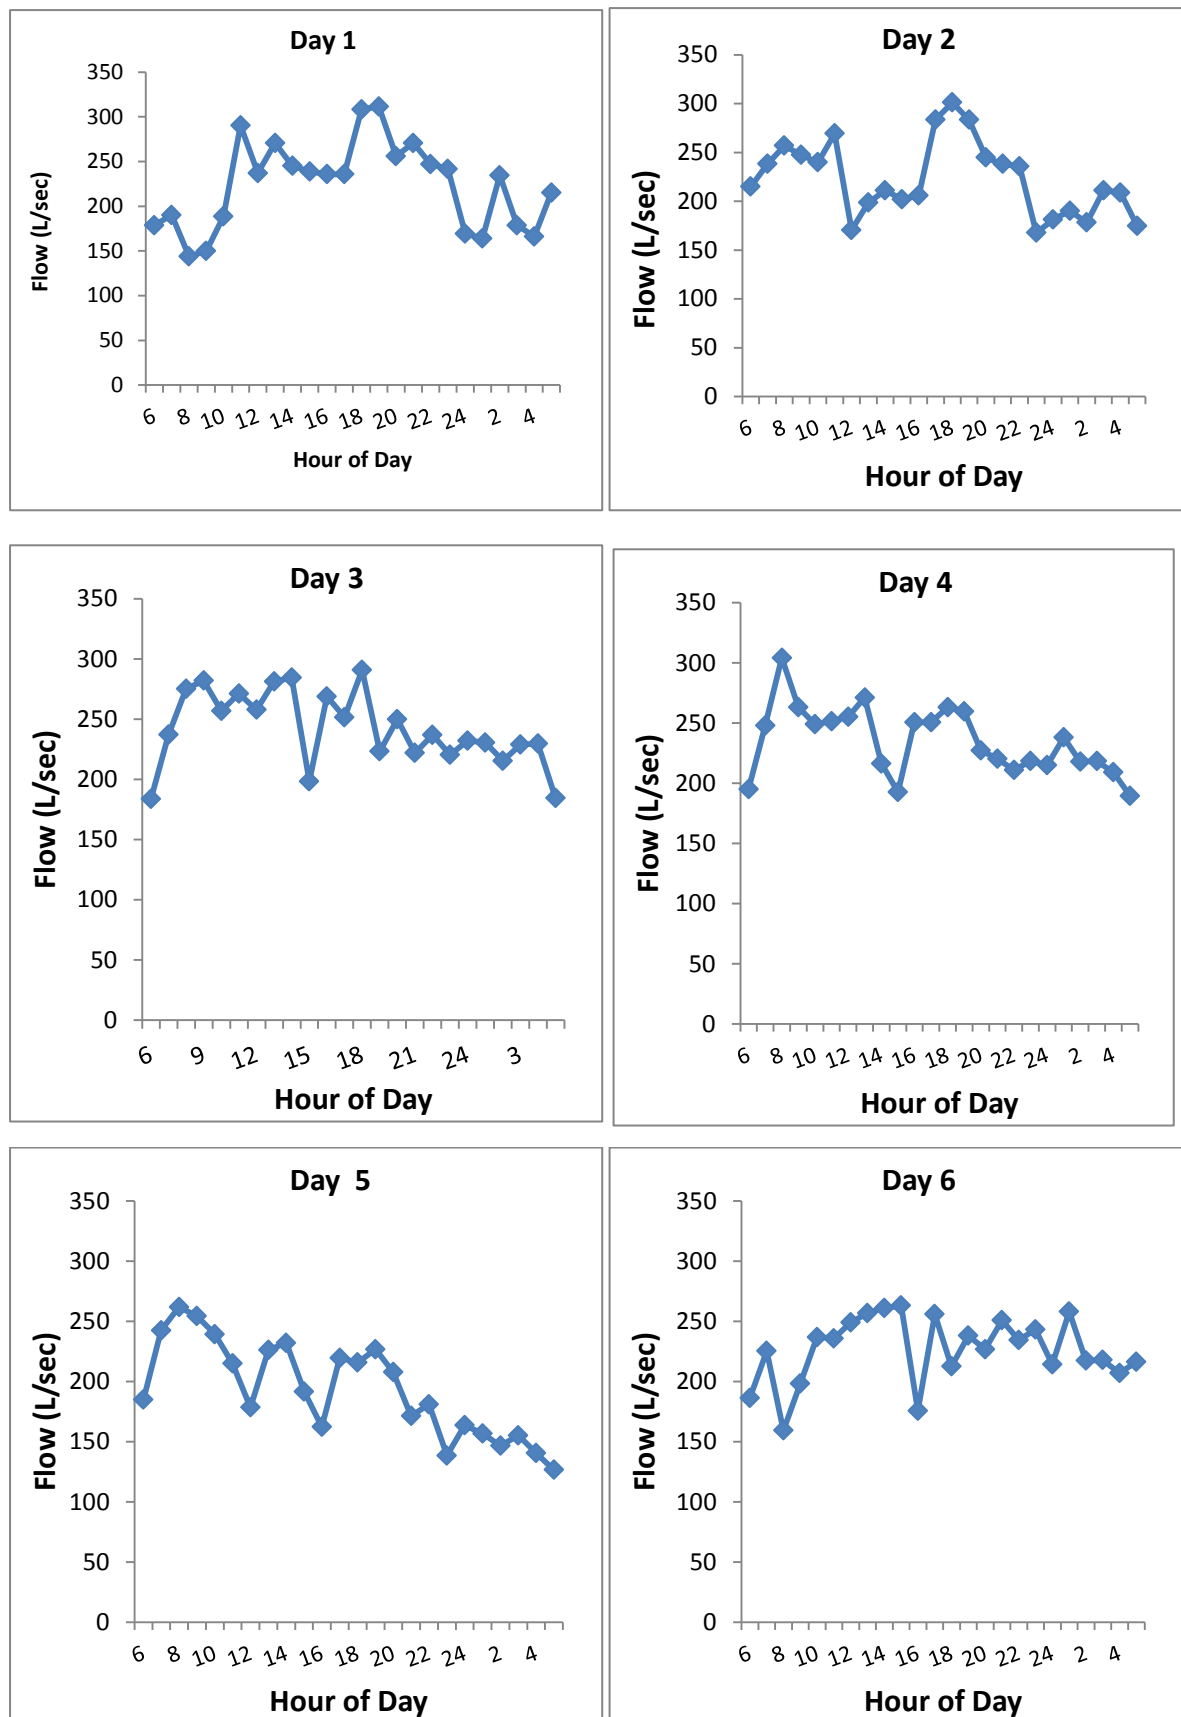
Sampling each day started at 06.00 hours every day. Daily inflow of sewage had two typical peaks one at between 10.00 hours and 11.00 hours and the other between 18.00 and 20.00 hours (Fig A2.3). This pattern was not clear on Day 3, Day 6 and Day 7. These daily peaks had attenuated at the outlet. The average daily inflow was between 193.7 and 244.8 l/s (16 735 and 21 151 m^3/day) with the highest recorded on 20 December (Fig A2.4). This high inflow coincided with the highest recorded daily rainfall of 22 mm (Table A2.2). Over the recording period, the average inflow was 224.6 l/s or 19 408 m^3/day . The average outflow was 255.7 l/sec/day or 22 090 m^3/day . The difference between the influent and the effluent is larger than expected and the source discrepancy may be due to infiltration of water into the system.

Figure A2.3. Pattern of sewage inflows throughout the day from Day 1
(18 Dec 2010 to Day 6 (24 Dec 2010)).

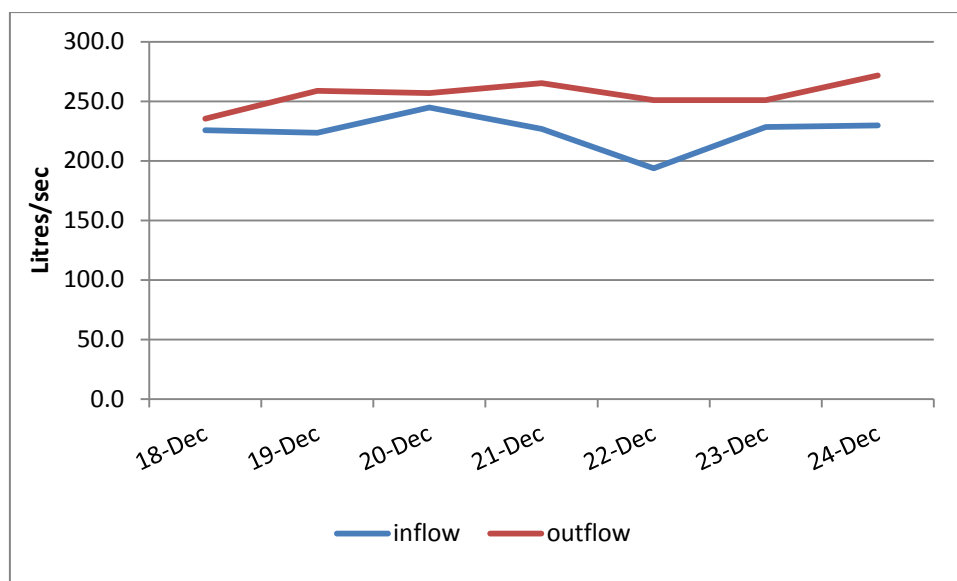
Figure A2.4. Average daily sewage flow rate through the ZSTP between 18 December and 24 December 2010.

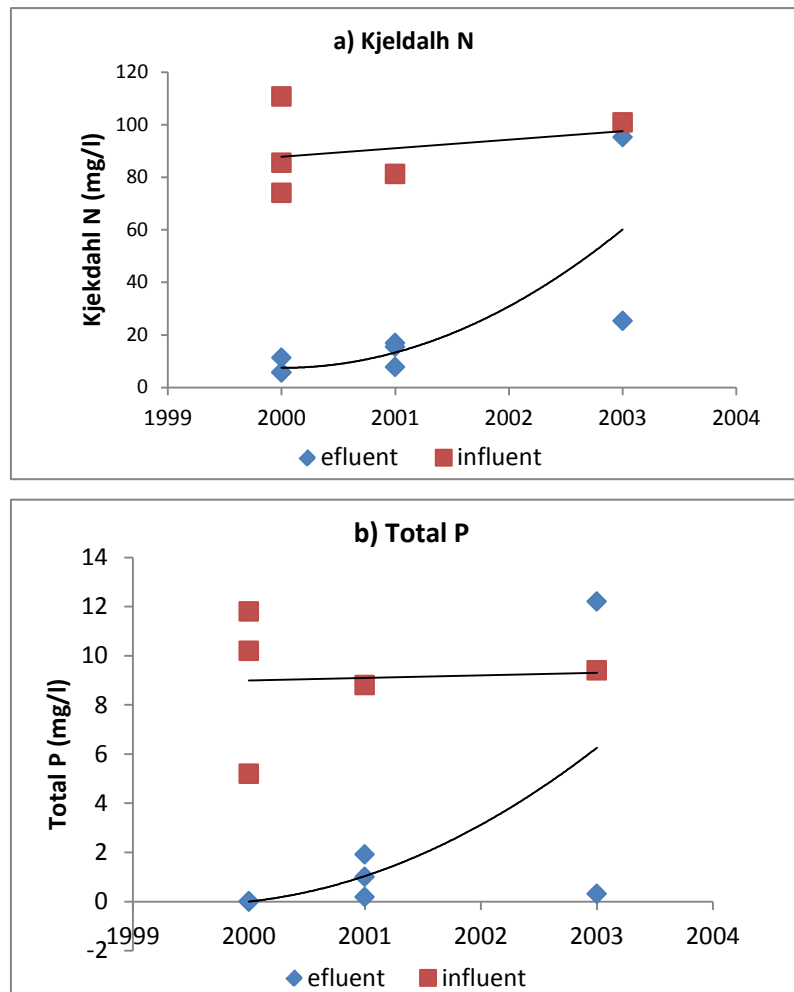
Figure A2.5. Changes in the concentration of Kjeldahl N and Total P in the influent and effluent from the ZSTP BNR from 2000 to 2003.

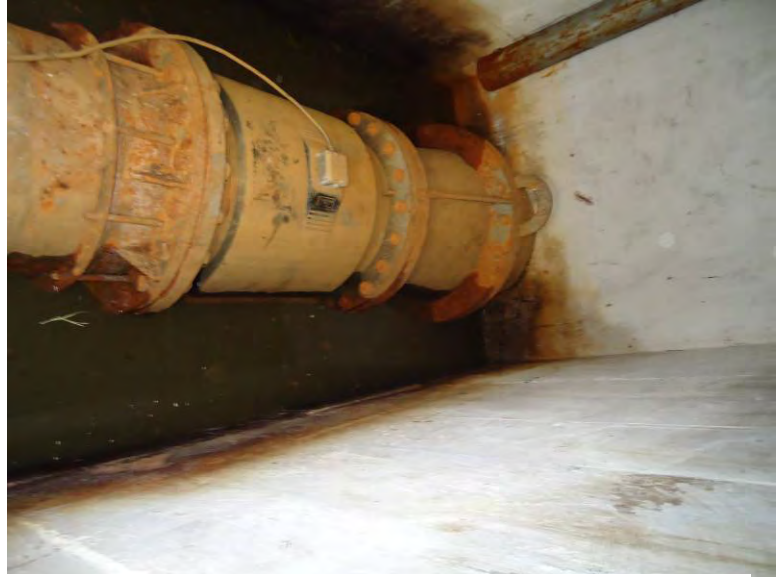
Photo A5.1.1 Inside of Meter Pit
There is almost no strait pipe

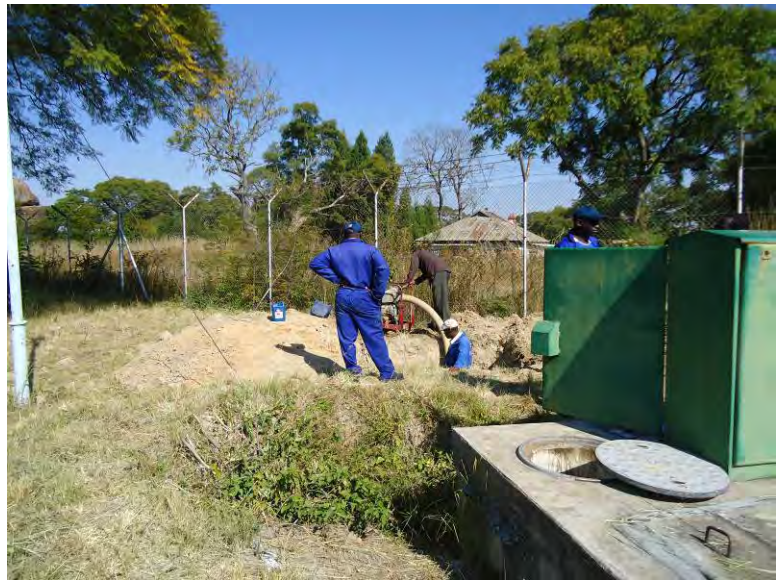
The coating was removed and the sensors were attached exposed steel pipe directly.

Photo A5.1.2 Excavated Place, 5m down stream from the pit

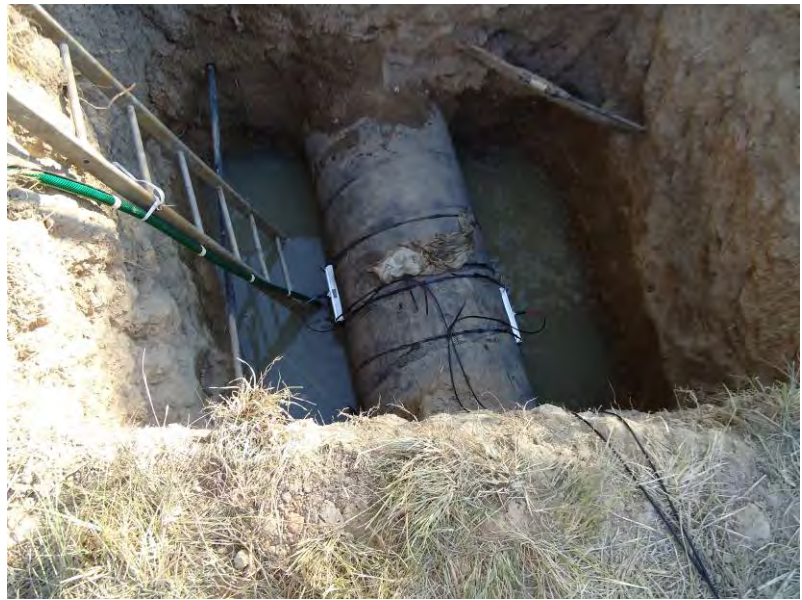
Photo A5.1.3 Attached Flow Meter

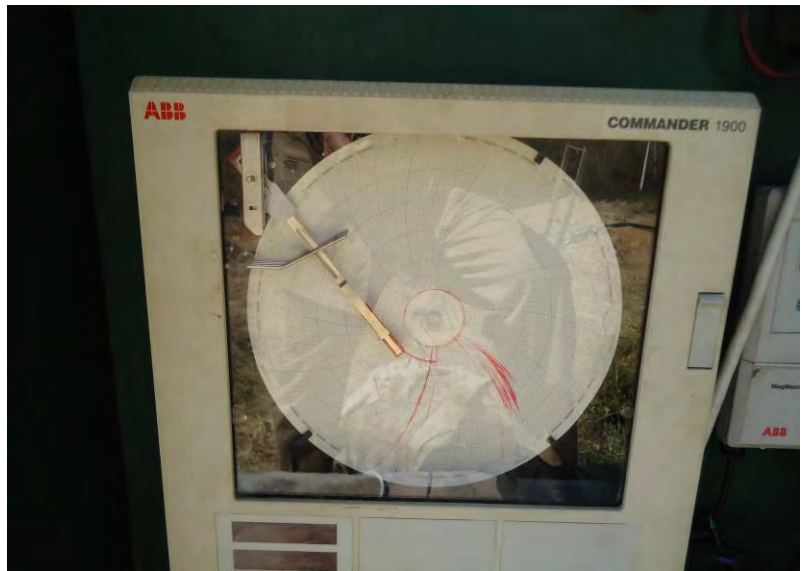
Photo A5.1.4 Utilizing Existing Flow Chart

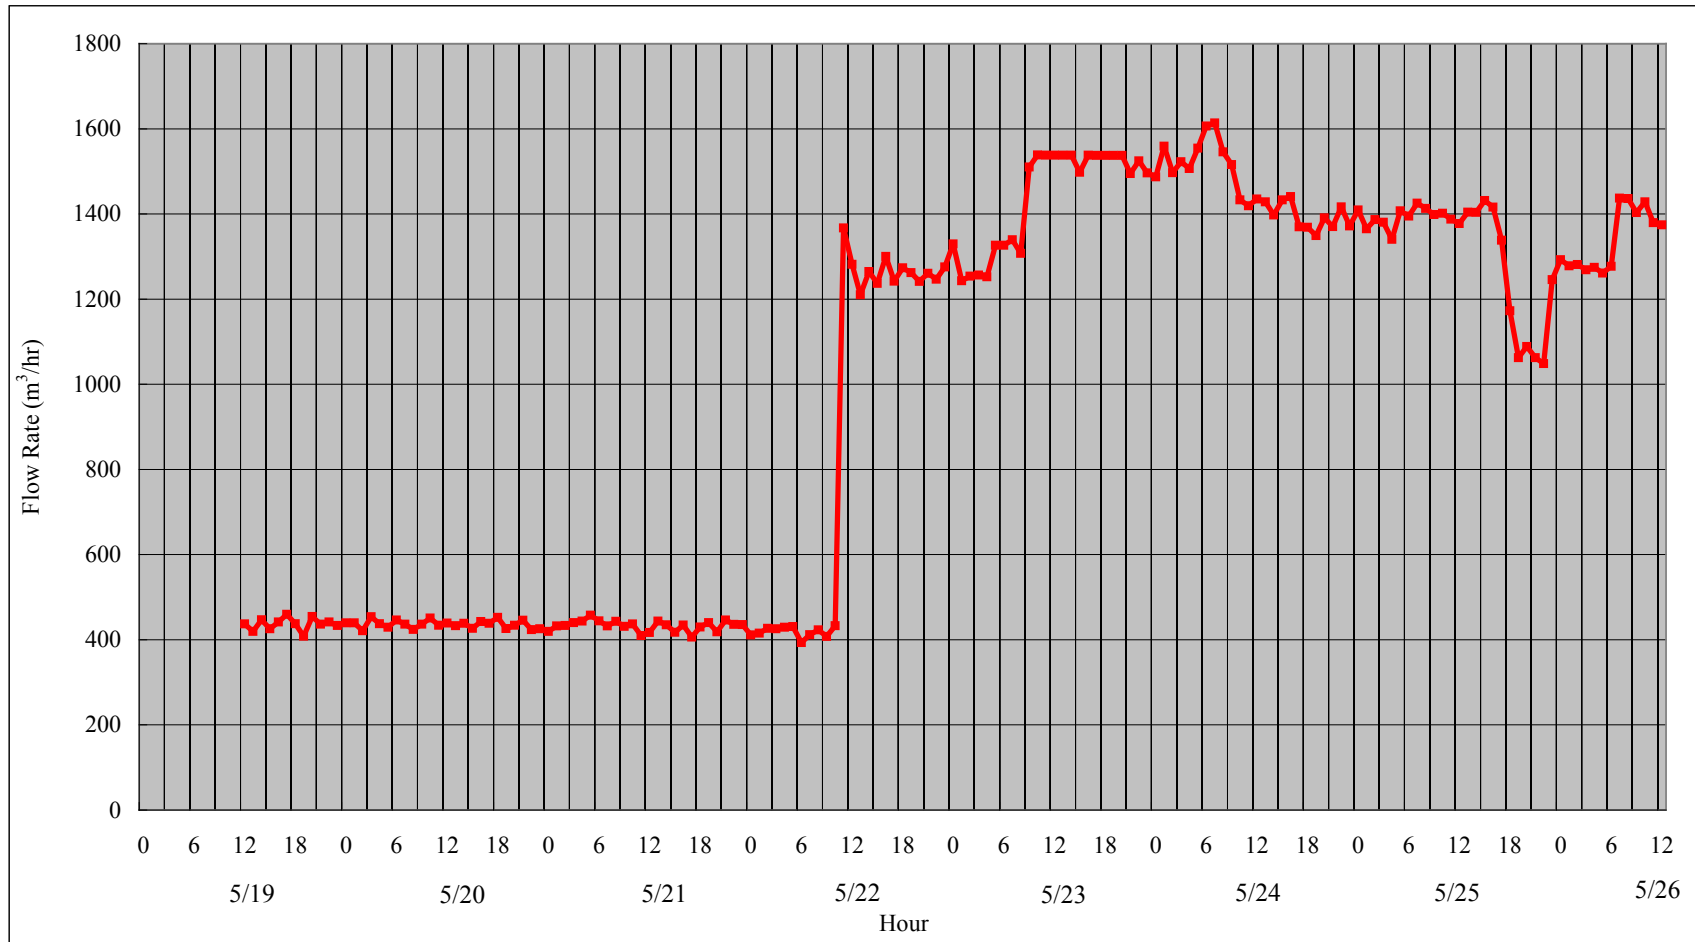
Figure A5.1.2 Flow Record

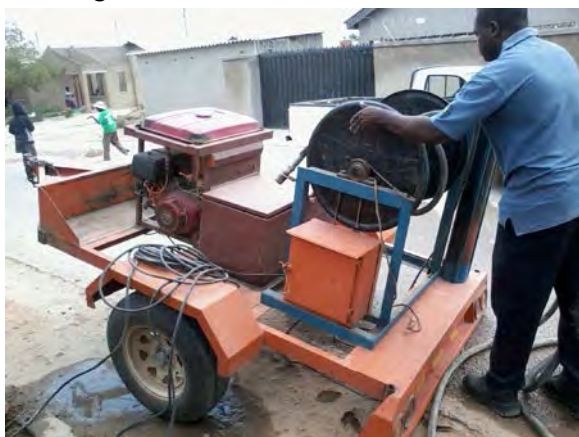
The tests are executed on 28th and 29th August. The test was carried out by submerged pump with the capacity of 1 around litter/s, water flow was measured by bucket. The photo of packaged facilities and testing condition is shown in Photo A5.3.1 and 2, respectively.

Photo A5.3.1 Packaged Facilities

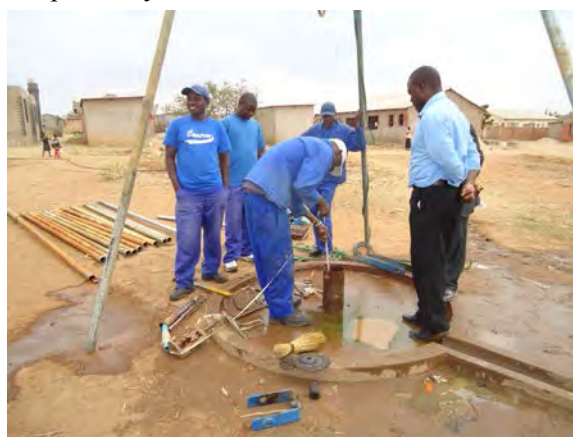
Photo A5.3.2 Testing Condition

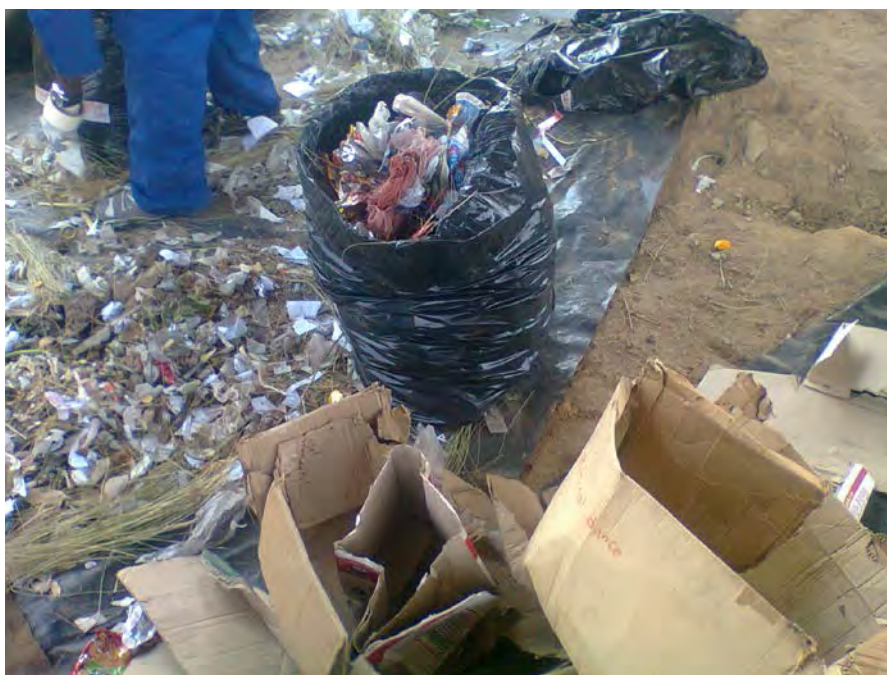
The samples collected were taken to the workshop (sorting area) of the municipality, weighed and then sorted into constituent waste components. The samples were collected between 8 am – 1 pm on each day of sampling. The team would collect the households' samples first then move on to establishments. During collection, the sampled households and establishments were provided with the black polythene plastics beforehand so that they put the waste being generated, making it easy for the team as they would just pick up the waste. However, for some of the establishment that arrangement was not possible hence the team would go and collect from establishment waste points. It is important to note that for this survey the team was forced to start collection of school samples earlier than the agreed work plan because the schools were closing earlier than expected. Their schedule had been changed by the ministry in order to prepare for the national census which was going to be conducted in the month of August 2012. Photo A5.4.1 below shows typical waste from schools.

Photo A5.4.1 Typical waste from schools

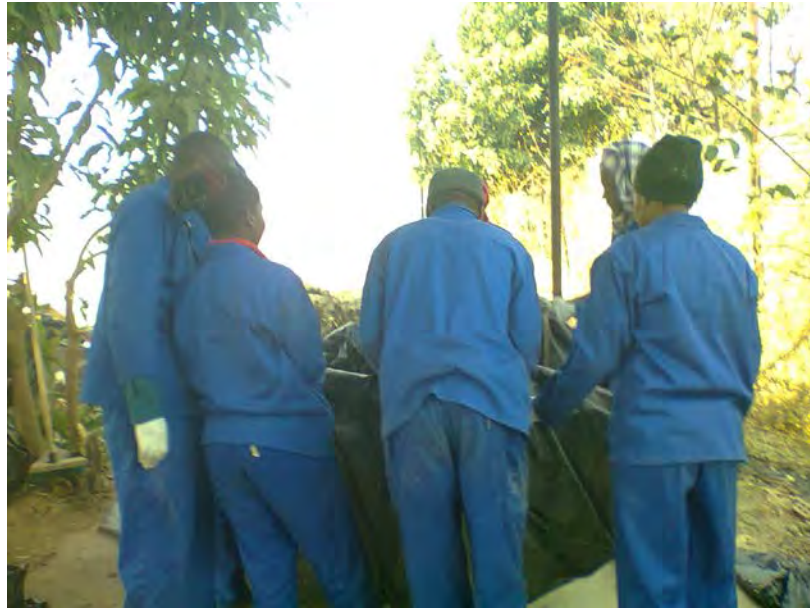
After completion of the waste amount and composition survey all the sorted waste categories for each waste stream would be mixed well using a shovel. The team also introduced a more effective method of mixing, where 4-5 members would hold polythene sheet corners high. They would then take turns to approach each other's side and through this the waste material would be turning and turning inside the sheet. Thus the composite sample would be well mixed. Photo A5.4.2 shows team members mixing the waste. The waste was then placed in a 75 L container. The container weight was determined and recorded. On filling the container the waste was not compacted but the team would just shake the container lightly several times to ensure that every space had been filled up with waste. The waste had to be level with the container. The filled waste was measured to obtain the net volume and weight of the solid waste. The bulk density was obtained by measuring weight of waste in a container with a volume of 75 L through dropping the samples three times from the height of 30 cm above ground level and followed by dividing its average weight by the volume of the container. The bulk density of the waste was obtained by computation in kg/m^3 as follows:

Photo A5.4.2 Mixing Waste for Bulk Density and Moisture Analysis

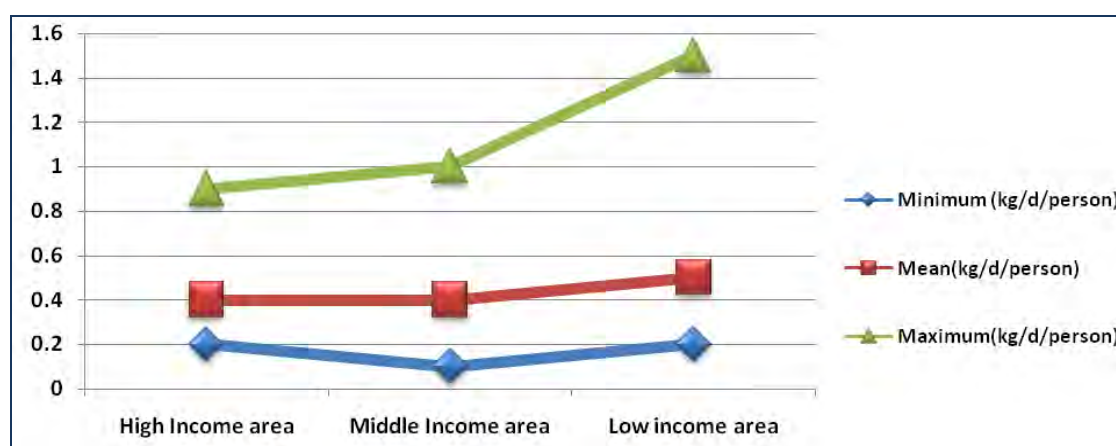
Fig A5.4.3 shows the mean waste generation per capita per day, yard waste included and excluded for the residential areas. From Fig A5.4.3, it can be seen that without the influence of yard waste the high income area has the highest waste generation per capita per day per person (0.31 kg/d/person), middle income followed with 0.29 kg/d/person while the low income was the least with 0.19kg/d/person. The high income area is a new residential area which has little trees planted compared to the low income areas. The low income areas, on one hand, were built in older times compared to the high income areas. Therefore, it is estimated that the large amount of yard waste generation is identified in low income areas.

Fig. A5.4.3 Waste Generation Per Capita Per Day

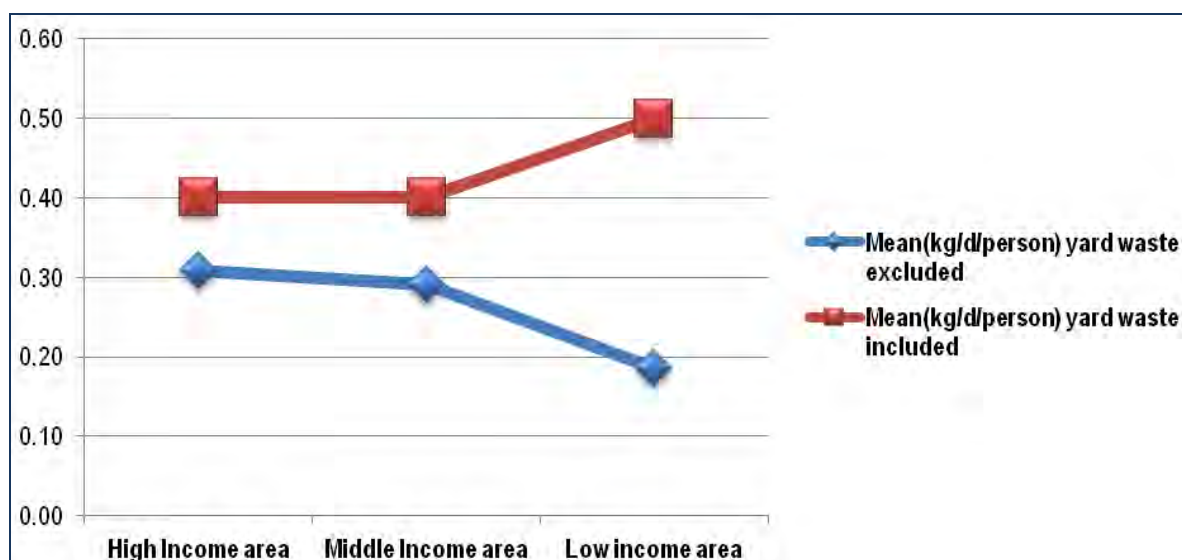
**Fig. A5.4.4 Per Capita Waste Generation including / excluding Yard Waste**

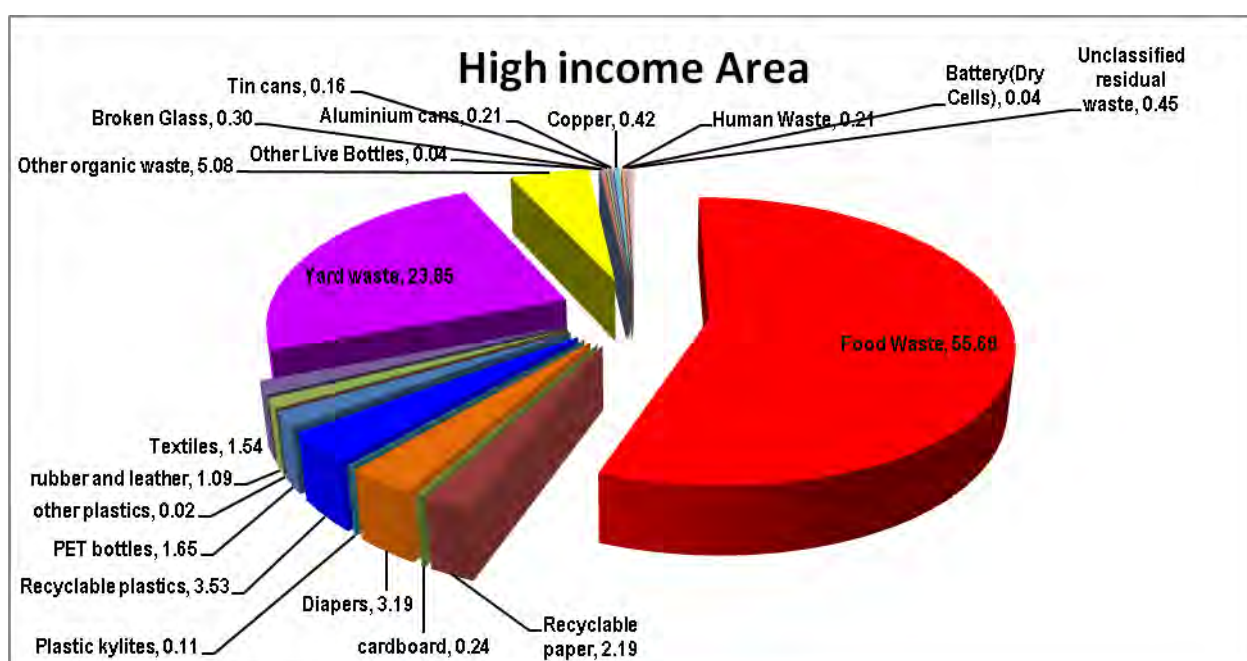
The results for each residential waste composition are illustrated in Fig A5.4.5 to Fig A5.4.7. Based on the values shown, food waste and yard waste occupies most of the waste produced by the residential communities. The results show that high and middle income areas produced higher food waste quantities as compared to low income areas. On the other hand the low income areas generated more yard waste as compared to the other income areas. This can probably be explained by that, the low income area sampled had smaller yards and no refuse pits were observed therefore all waste generated from sweeping their yards was thrown into the refuse bin.

Fig. A5.4.5 Waste Composition for High Income Area

Fig. A5.4.6 Waste Composition for Middle Income Area

Fig. A5.4.7 Waste Composition for Low Income Area

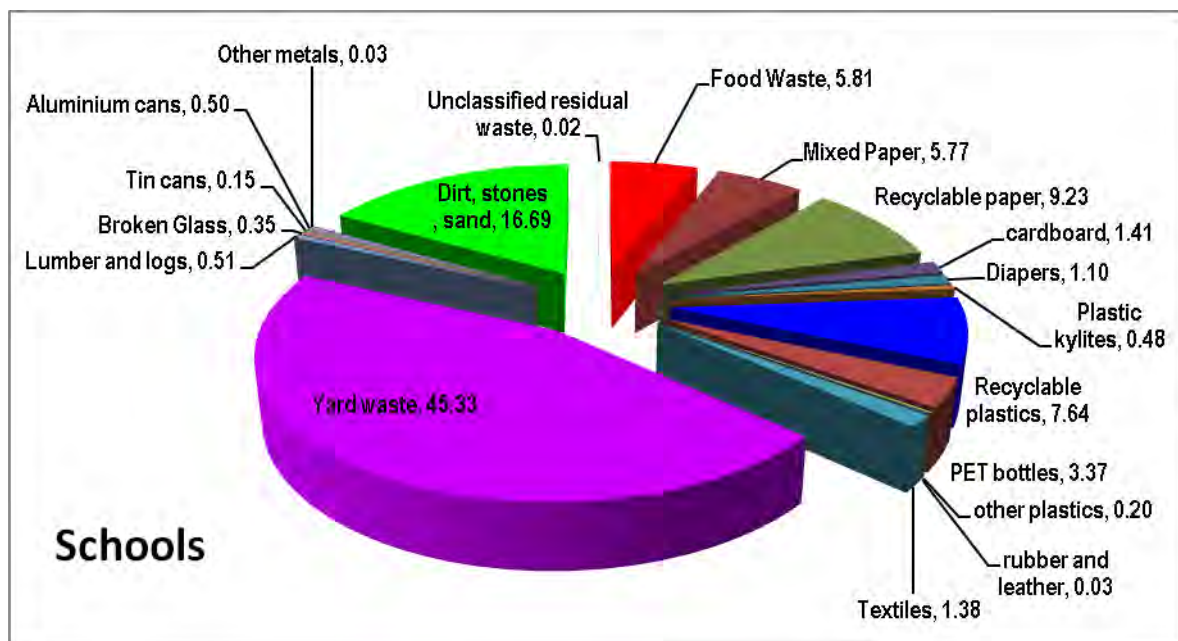
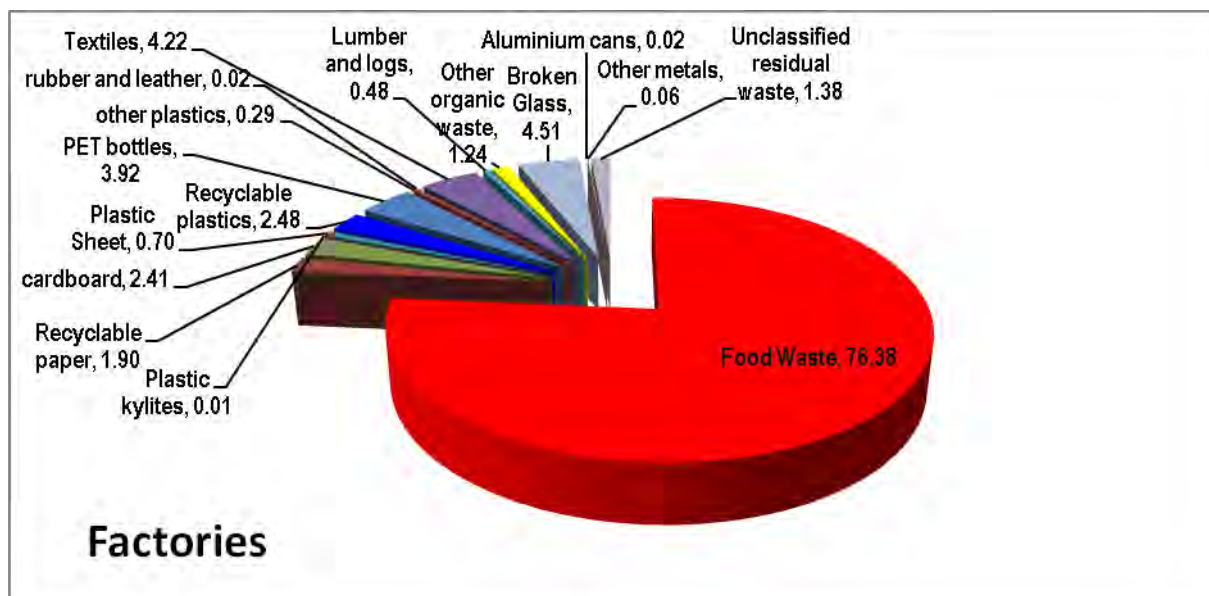
relationships with them. Therefore in most instances, only food waste was available for collection. The factories involved in the survey were all food factories i.e. beer brewing, dairy juice production and bread making and this could explain the high food waste component (76.38%) on the waste generated. The markets had very diverse waste components although food waste (38.78%) remained the main waste component generated.

Fig. A5.4.8 Waste Composition for Schools

Fig. A5.4.9 Waste Composition for Kiosks

Fig. A5.4.10 Waste Composition for Supermarkets

Fig. A5.4.11 Waste Composition for Factories

Fig. A5.4.12 Waste Composition for Markets

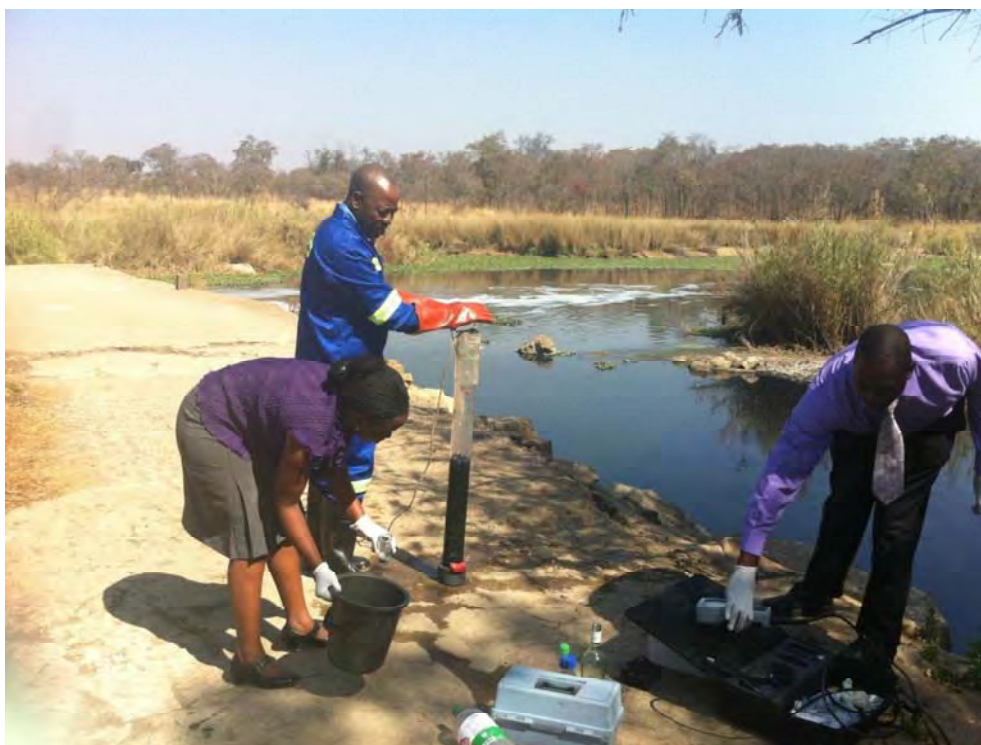
Photographs Showing Sampling Equipment- Location Marimba Stagnant
