APPENDIX 23-1 PILOT PROJECTS

23-1.1 Traffic Flow Improvement

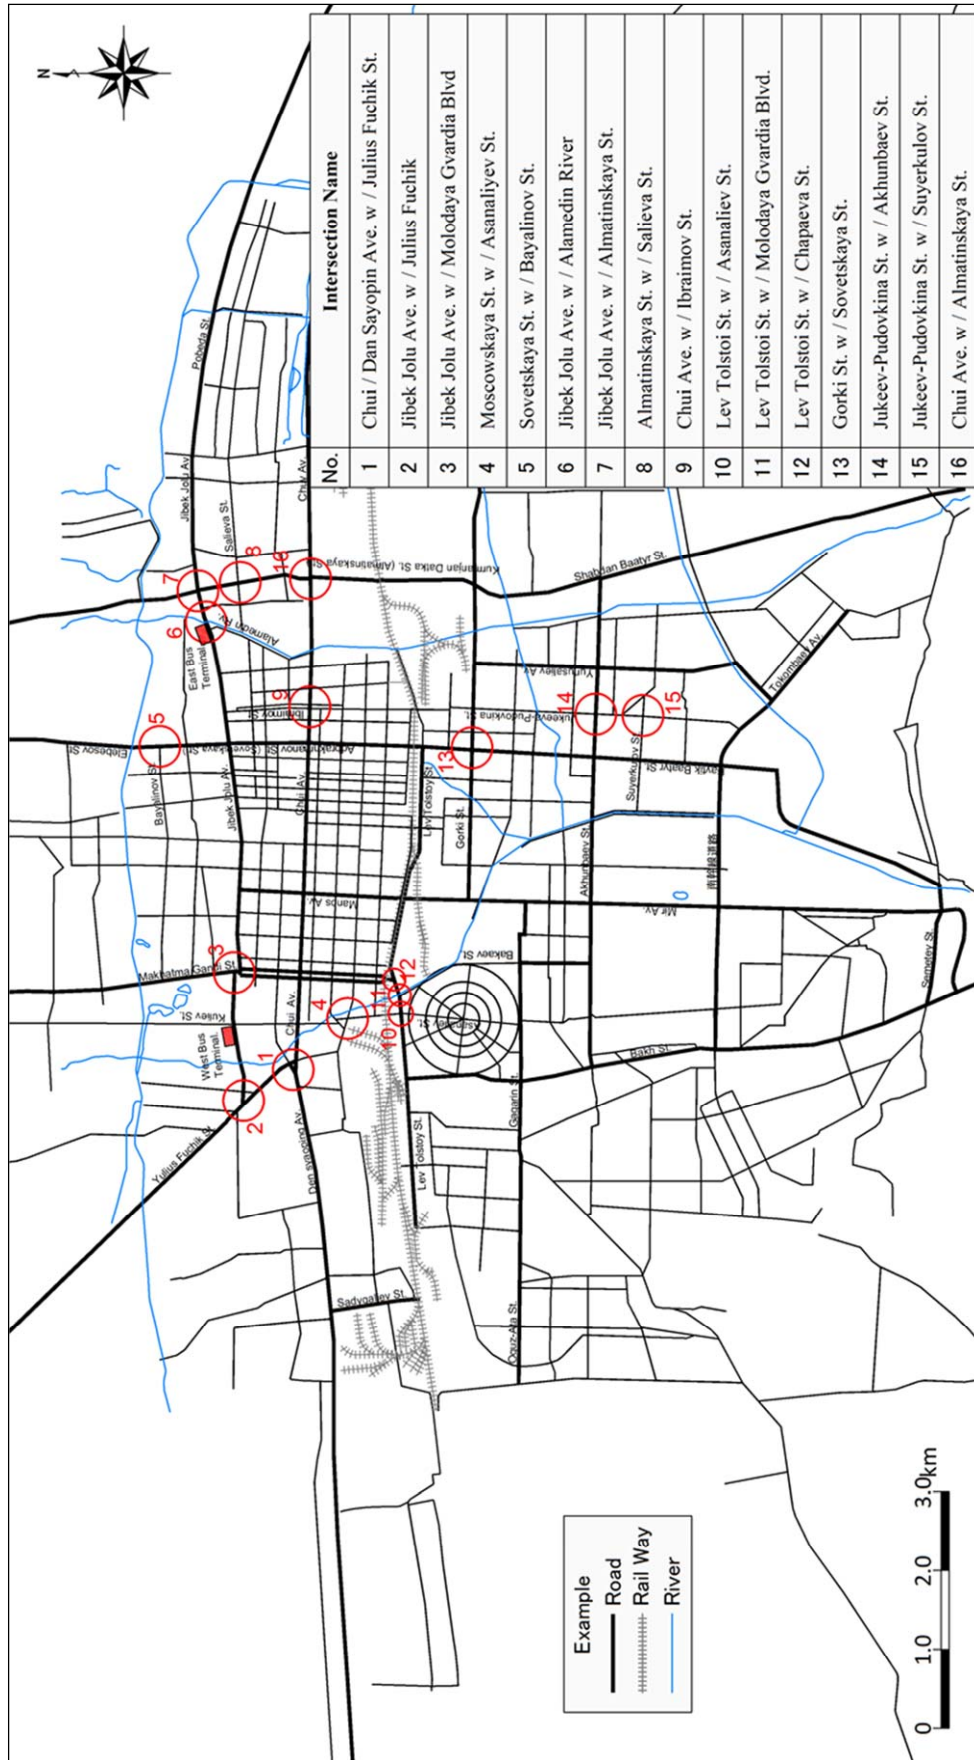
Figure A 23-1.1-1 Location of Candidate Intersections

Therefore, a total of 16 intersections was evaluated. **Figure A 23-1.1-1** shows the location of candidate intersections for Pilot Project.

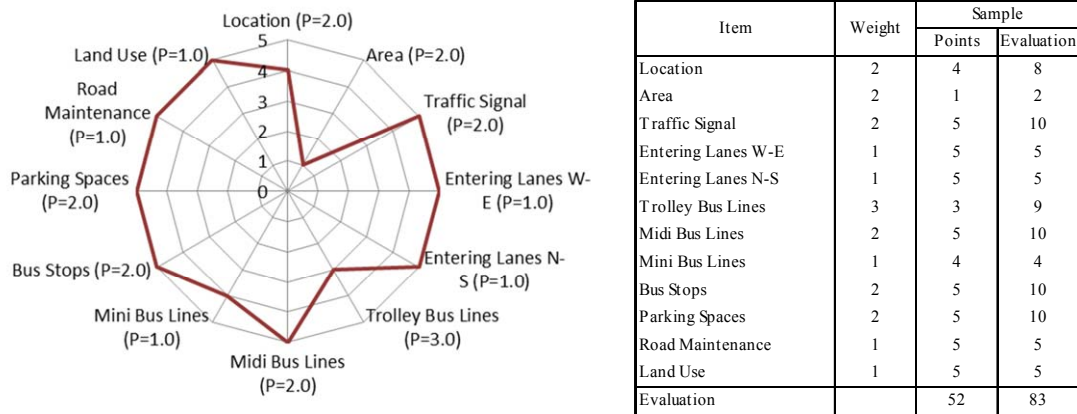
Figure A 23-1.1-3 Sample Evaluation of Score for Selected Intersections

The JICA Study Team proposed to give priority to the intersections with public transportation routes, in particular, public bus routes operated by Bishkek City, because the City has planned to procure more trolleybuses and renovate power supply systems with assistance from EBRD. Therefore, the JICA Study Team set a weighing factor for the important items in the criteria. Especially, trolleybus route weighs for 3 points while midibus and minibus routes weigh 2 and 1 point, respectively. Other criteria, such as location, area, traffic signal, bus stop and parking space weigh for 2 points each.

The total score becomes 100 points if all criteria scored 5 points because weighing factor is set fixed. The JICA Study Team categorized the evaluation score into 5 levels of priority as shown below.

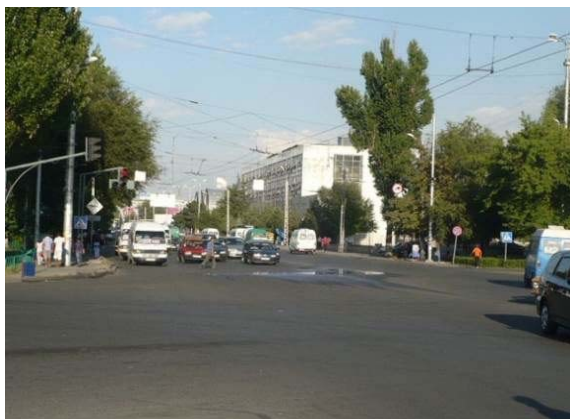
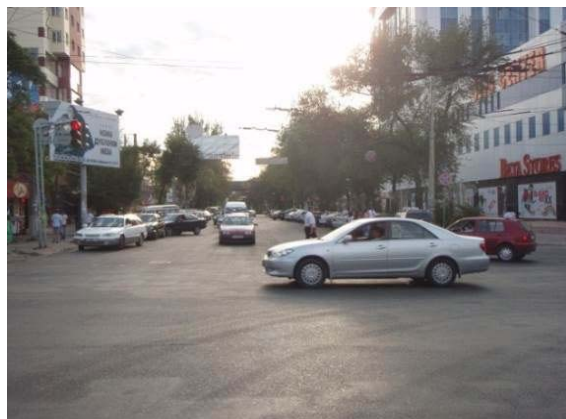
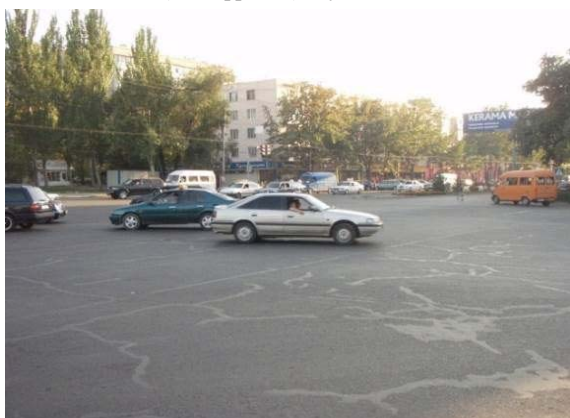
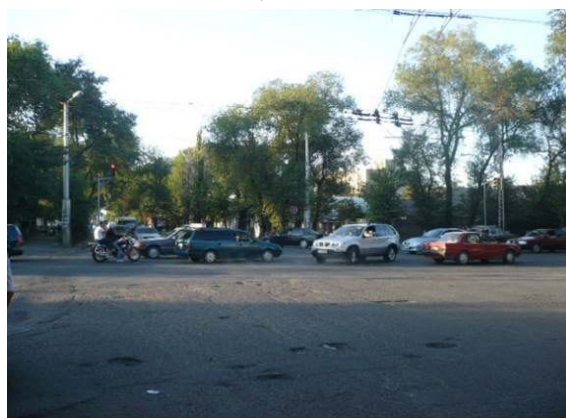
Picture A 23-1.1-1 The High - Priority Intersections

Chui / Dan Sayopin Ave. w / Julius Fuchik St.
(East Approach) July 26, 2011

Gorki St. w / Sovetskaya St. (West Approach)
July 28, 2011

Chui Ave. / Almatinskaya St. (West Approach)
July 28, 2011

Lev Tolstoy St / Asanaliev
July 26, 2011

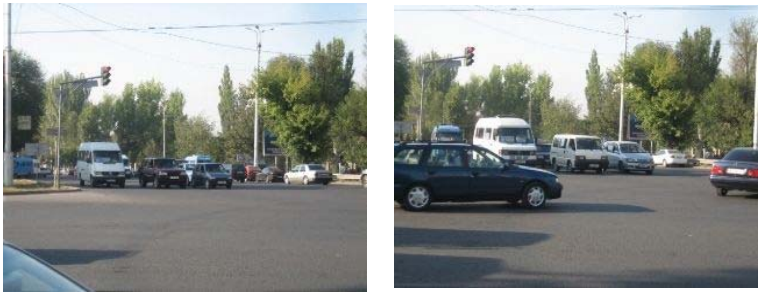
Direction	Usage Condition of Existing Road	Number of Lane
North

Straight lane: 2 lanes Left turn lane: 1 lane Right turn lane: 0 lane Total 3 lanes
South

The number of lanes in the original plan was intended to determine by the result of baseline survey. However, due to delay in opening of the Ryskulova St., it became impossible. Therefore, the number of lanes was determined based on the usage survey of the existing road condition. The result of the usage survey is shown in **Table A 23-1.1-3**.

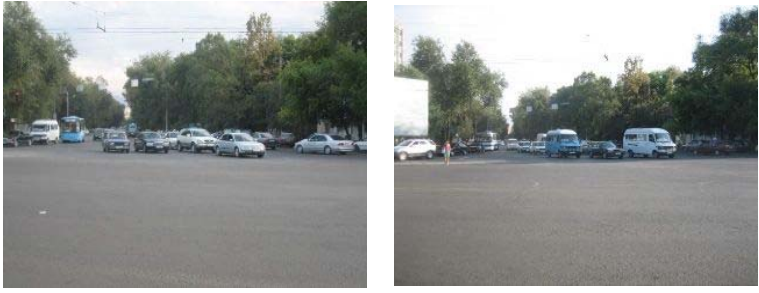
Straight lane: 2 lanes + 1 lane Left turn lane: 1 lane Right turn lane: 1 lane Total 5 lanes
West

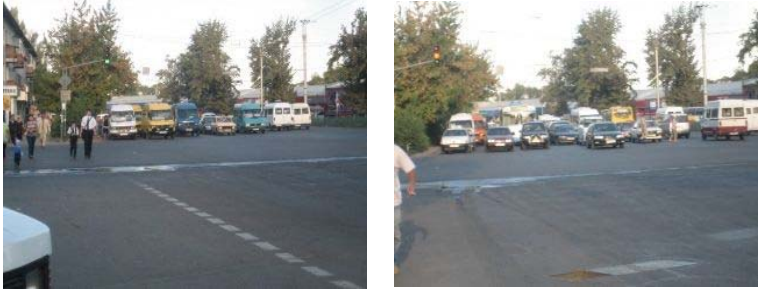
Straight lane: 2 lanes Left turn lane: 2 lanes Right turn lane: 1 lane Total 5lanes
East

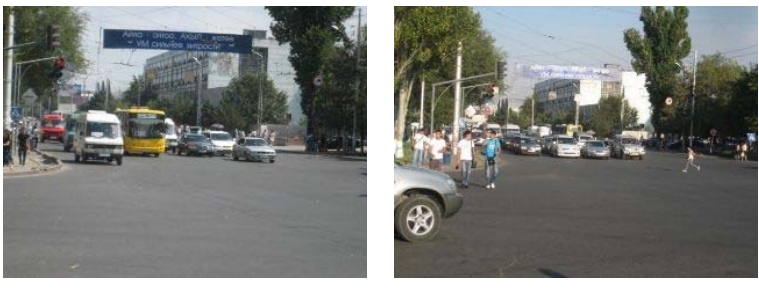
Straight lane: 2 lanes Left turn lane: 1 lane Right turn lane: 1 lane Total 4 lanes

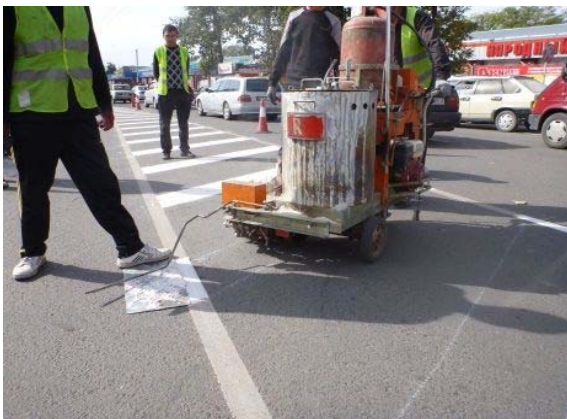
Road markings

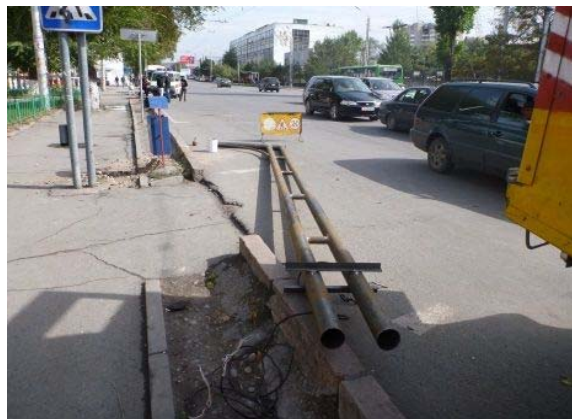
Traffic signal and the stop line relocated

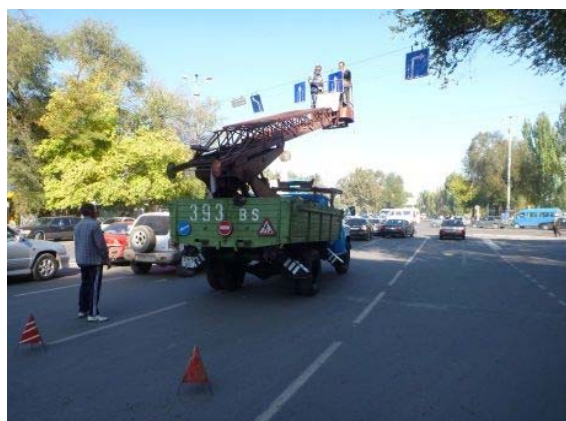
Road sign installed

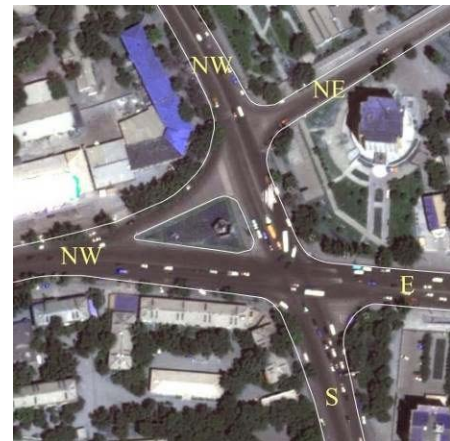
Figure A 23-1.1-11 Intersection with Directions

In **Figure A 23-1.1-12 to 14**, “NW” shows from / to Julius Fuchik St. and “NE” shows that of Ryskulova St.

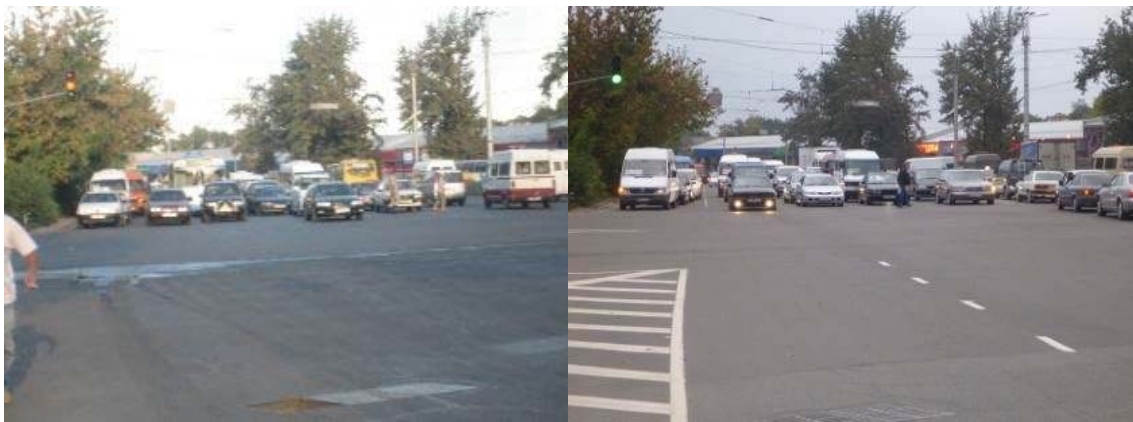
Before the making of road marking
along the West Approach

After the making of road marking
along the West Approach

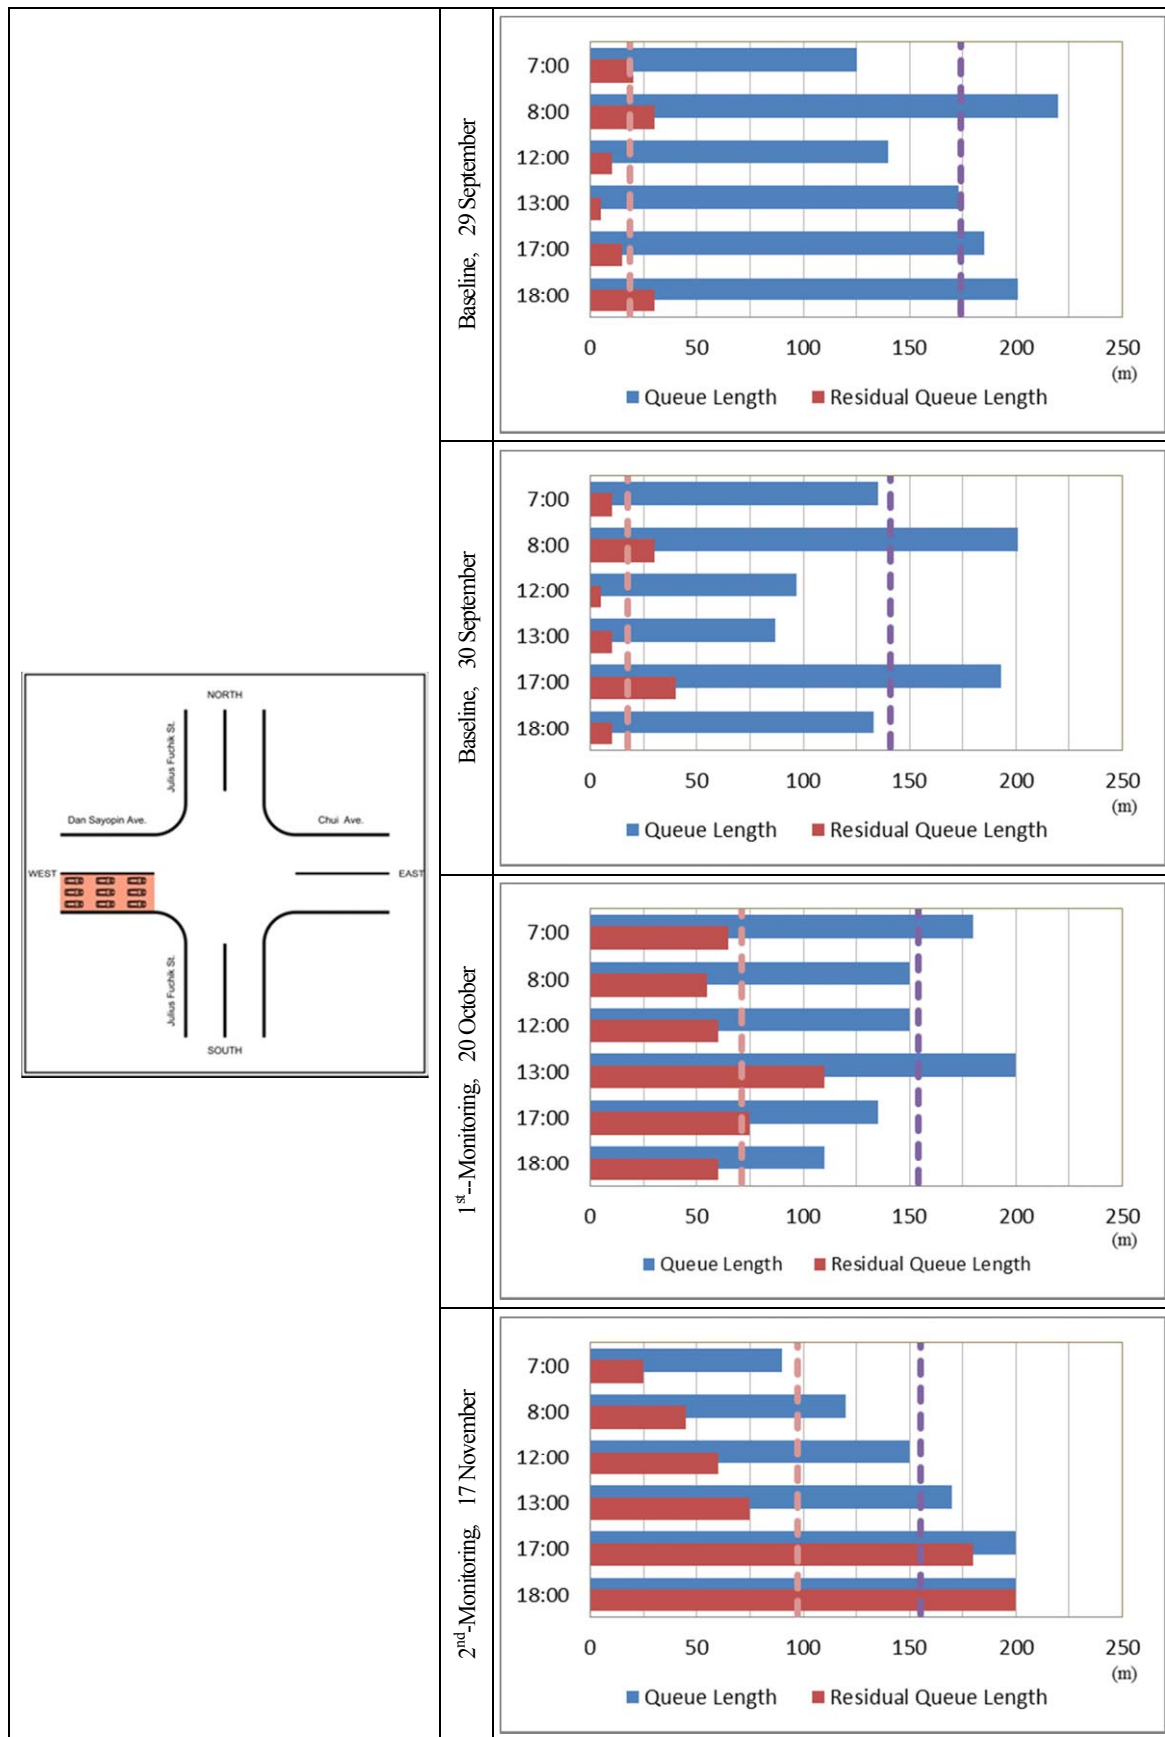
Figure A 23-1.1-18 Traffic Queue Length along the West Approach

About along the west approach, there is difference in the data of the average residual length between Baseline and Monitoring Surveys. The average of max residual length is increased after the implementation of Pilot Project. It is supposed that before the implementation of Pilot Project, the road users were stopped their vehicles freely during the red signal period by cramming their vehicles into the intersection.

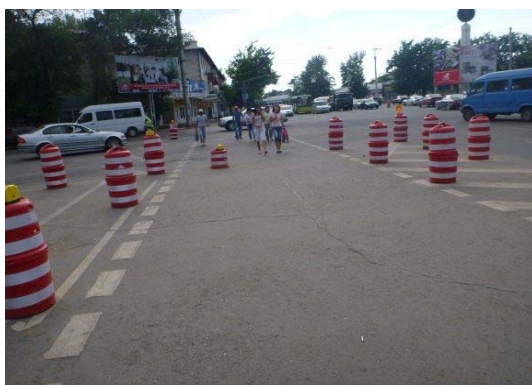
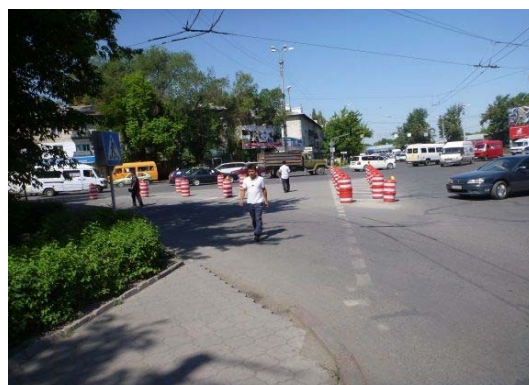
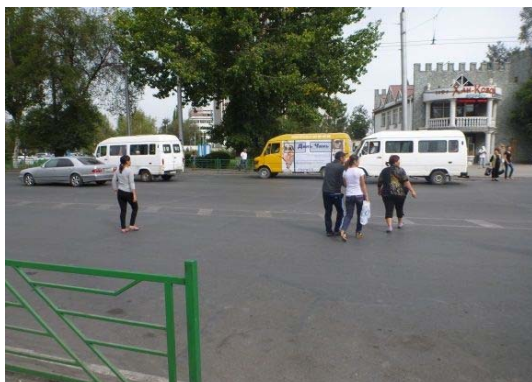
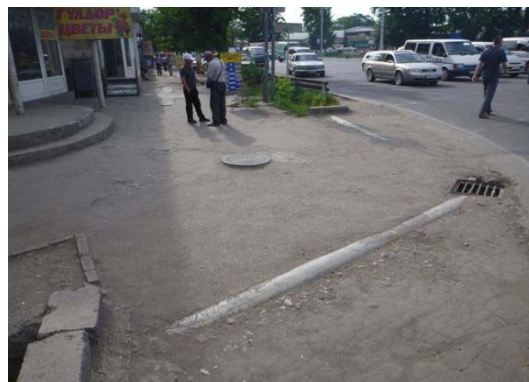
- ✓ The length of pedestrian crossing in the east-west direction is 49.9 m, and in the north-south direction is 30.2 m.
- ✓ The pedestrians are confused without the pedestrian signal.
- ✓ The pedestrians cross the intersection other than pedestrian crossing.
- ✓ The side walk is not good condition due to the broken drainage and gradient of pavement

Picture A 23-1.1-8 shows the above condition.

Pedestrian Crossing

Without the Pedestrian Signal

Pedestrians

Side Walk

Following table shows basic pedestrian crossing data at Chui-Fuchik Intersection. The pedestrians frequently disturb the traffic flow caused by missing of timing to cross and taking time to cross. Therefore, the pedestrian flow also is an important factor for Traffic Flow Improvement.

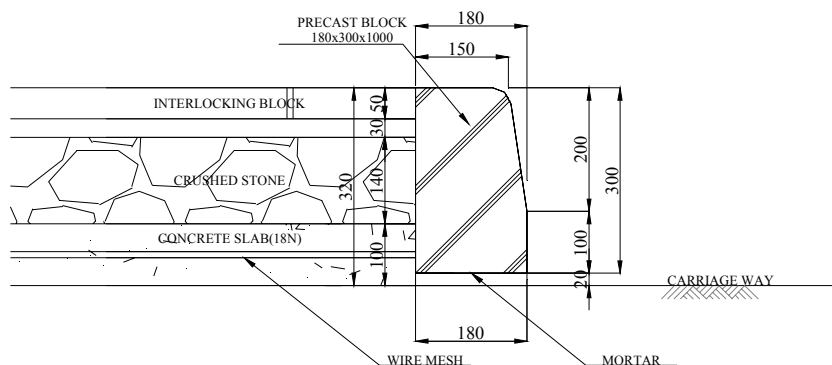
Figure A 23-1.1-32 Structure of Traffic Island

The traffic island was temporally constructed due to considered to remove. The reason that this project is social experiment and if it is ineffective for the traffic flow and pedestrian flow, can be efficient to remove. According to this policy, the traffic island was constructed without cutting existing asphalt. **Figure A 23-1.1-32** shows the structure of traffic island.

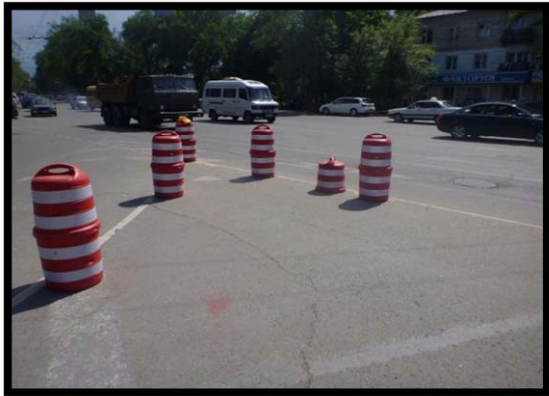
Before

In 1st year, only cushion drums were installed. After the installation, they were damaged by road users.

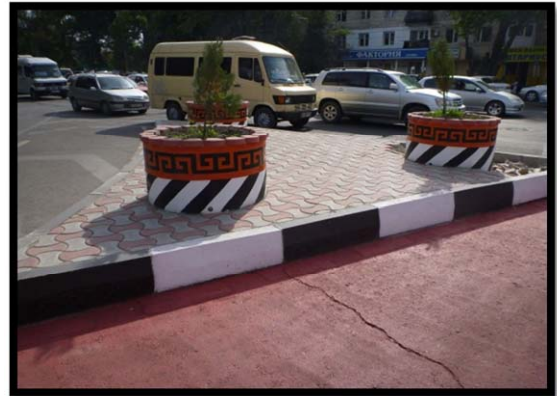
After

The corner of traffic island will be finished after the installation of traffic signal pole.

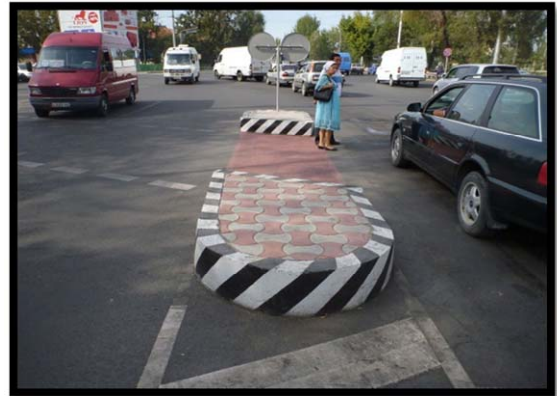
After

The traafic island has been installed and the marking also has been done.

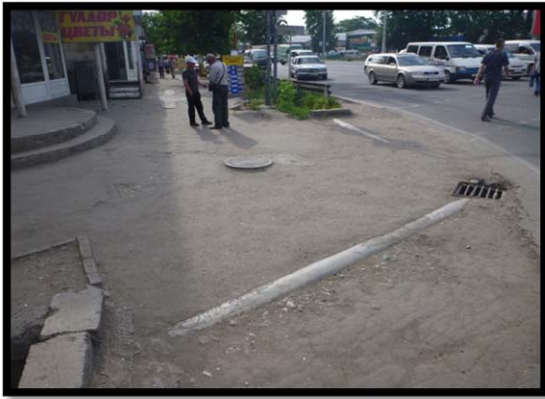
Before

There is puddle in the side walk in the winter season and it is not easy to walk. This is the part southwest of the intersection.

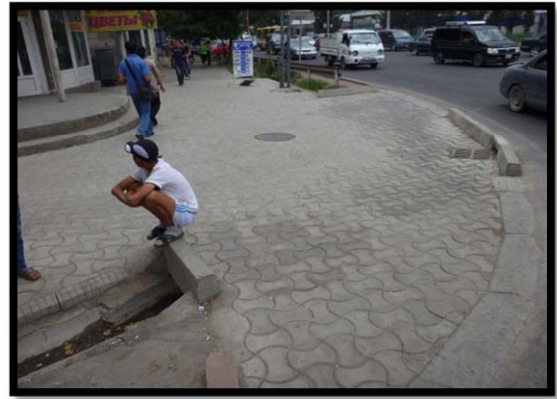
After

The interlocking blocks have been installed. The difference height was eliminated between side walk and road level.

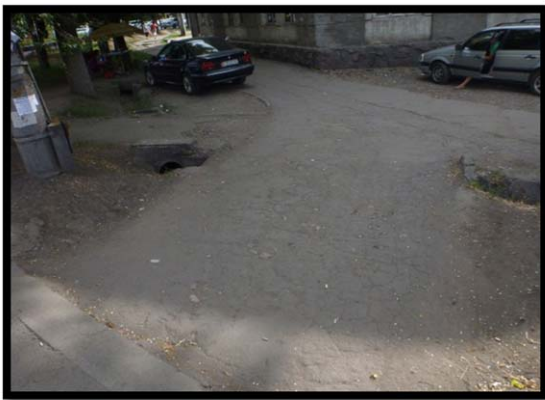
Before

There is flatness and it is not easy to walk. This is the part southwest of the intersection.

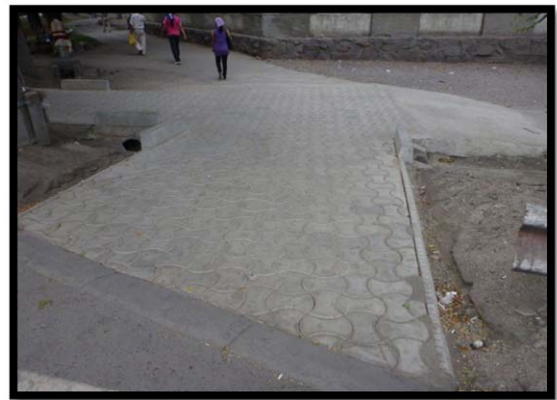
After

The interlocking block has been installed. The difference height was eliminated between side walk and road level.

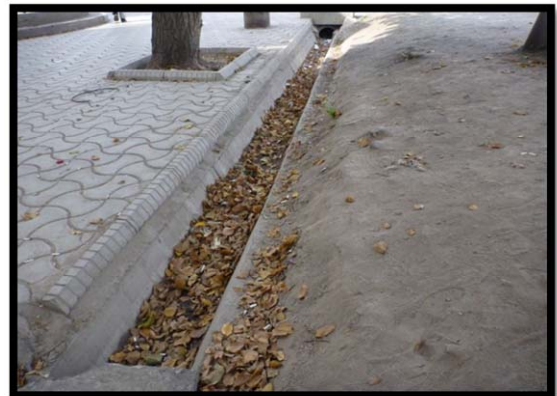
After

The precast concrete drainage has been installed. The drainage pipe also has been replaced.

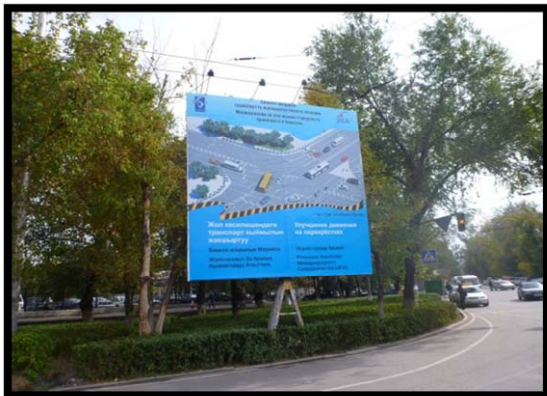
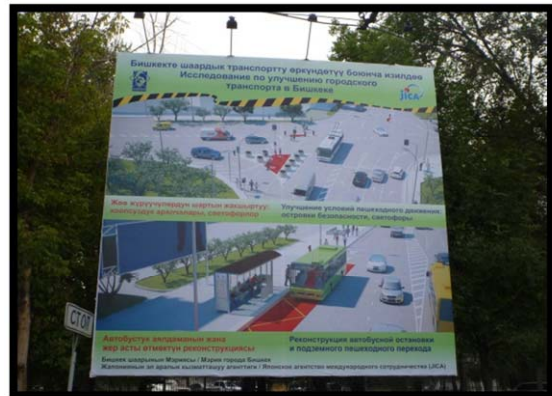
After

The road markings have been done at a minimal length, 30m from the center of the intersection in September, 2012.

Before

The advertisement was installed in September, 2011. This is for the road marking announcement only.

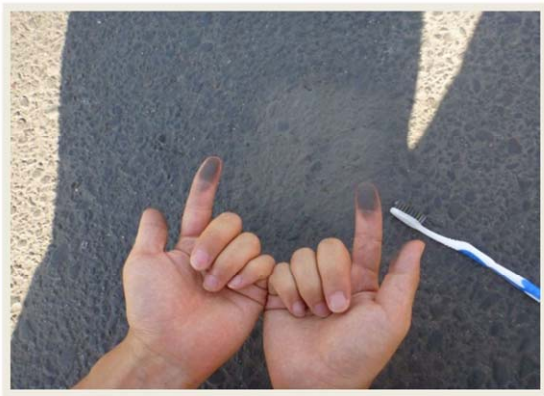
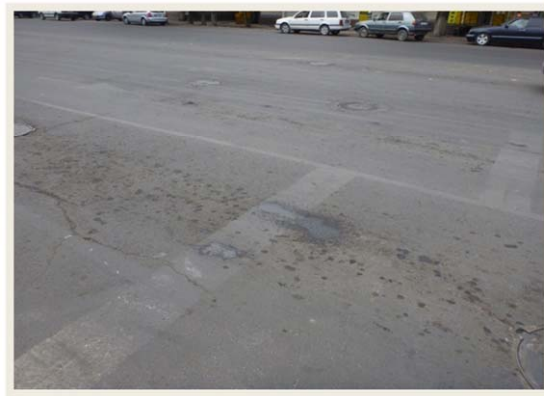
Picture A 23-1.1-11 Soiled Pavement Surface with Oil and / or Car Exhaust

The road markings which has been lined out in October, 2011 were almost disappeared. The causes of road

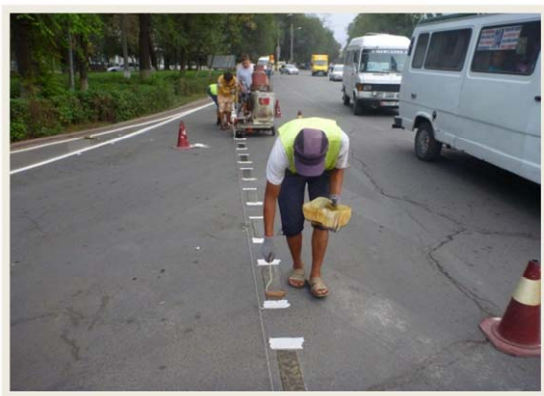
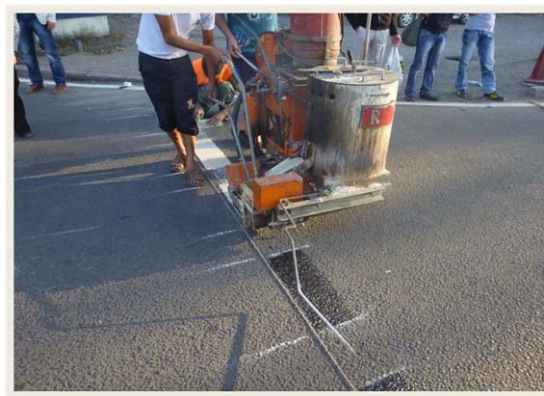
Picture A 23-1.1-12 Road Marking for Vehicle Flow

The road markings have been lined out due to the above described at IS-01 in 2nd year. The objective of road marking construction in 2nd year is to reflect the effect of Traffic Signal System Improvement. The road markings have been lined out 30m on each approach from center of intersection, and total road marking area including lane marking, allows and pedestrian crossing line are 310.4 sq.m.

Picture A 23-1.1-12 shows road markings at IS-01.
