### 23-1.1.13.3 Travel Speed Survey

### 23-1.1.13.4 Traffic Signal Cycle Survey

## **23-1.2 Public Transportation Facilities Improvement**

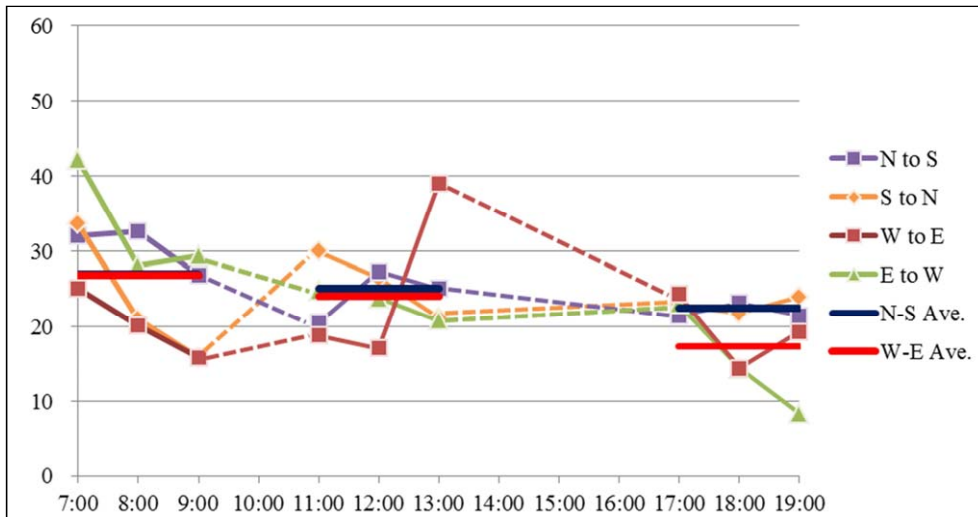
Figure A 23-1.1-47 Travel Speed Survey Baseline Survey

In 3<sup>rd</sup> and 4<sup>th</sup>-Monitoring Survey, Travel Speed Survey was carried out for 2 directions as the same method of previous survey, north-south and east-west directions. The result is the following.

The average travel speed was improved at North-South Direction after the implementation of the Pilot Project in each time zone; morning, daytime and evening. Even if the traffic signal cycle is longer than previous cycle. The road users have aligned in a line by following the new road markings so the left-turning vehicles might not likely retard subsequent vehicles by the making separated lane.

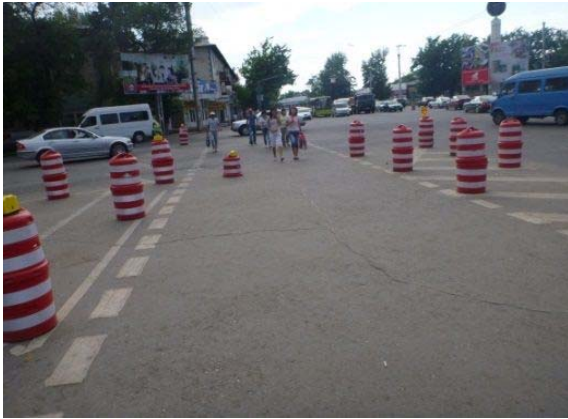
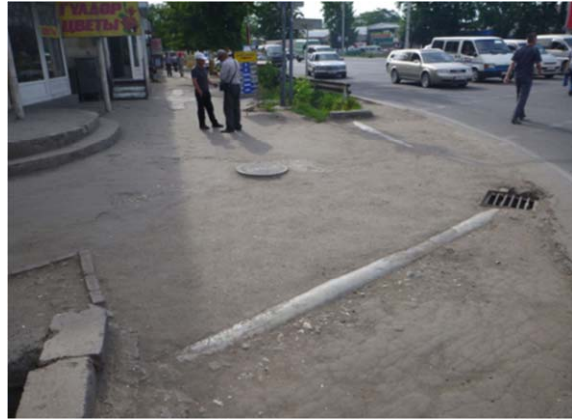
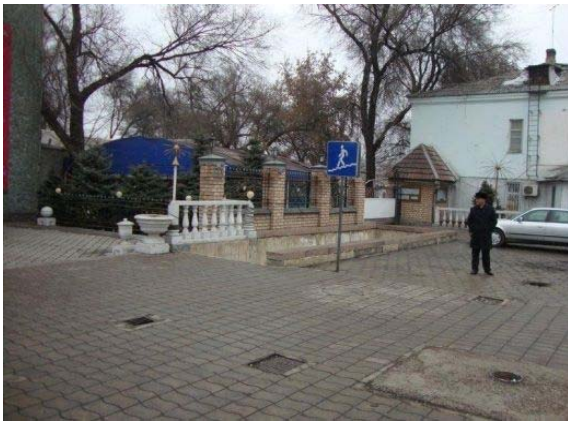
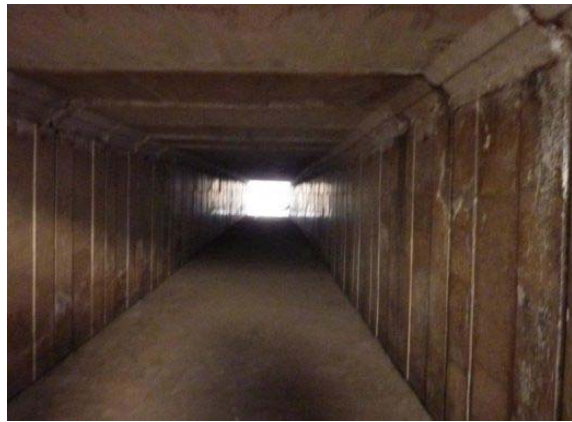
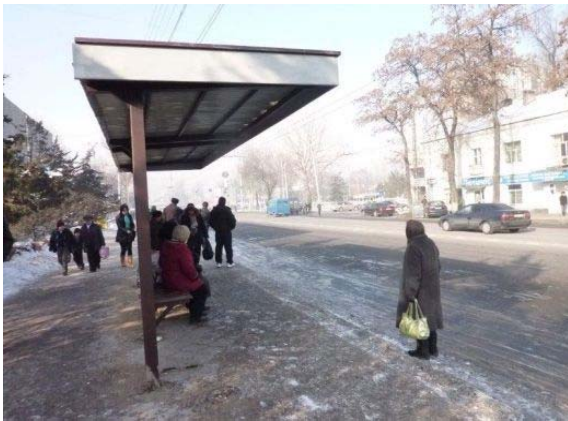
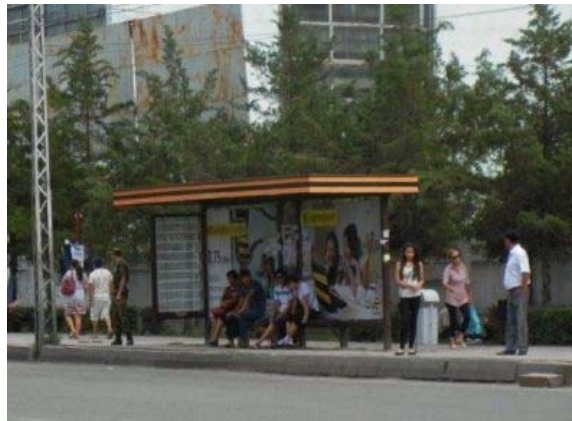
**Picture A 23-1.2-1 Pilot Project Site for Public Transport Facility**

- ✓ Pedestrian Crossing and Sidewalk on Chui / Fuchik Intersection
- ✓ Pedestrian Underpass on Chui Avenue

✓ Bus stop and waiting area on Chui Avenue

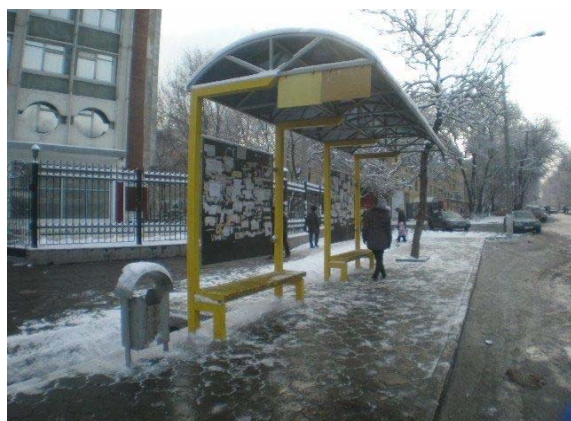
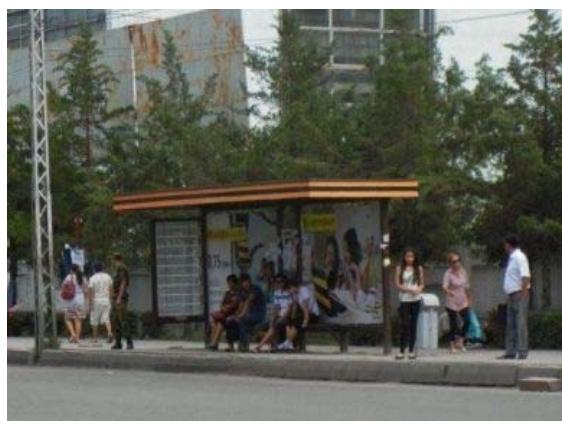
**Picture A 23-1.2-2 Old and New Bus Shelter**

In general, most of bus stop has accompanied with Bus shelter with bench and litter bin. There are several design observed for public transport furniture but most of them are deteriorating due to the poor material and fabrication. Currently Bishkek City has been undergoing to replace old bus shelter into the new uniformed design, which contract out to the private companies as advertisement space. The new design have bench, litter bin and advertisement side panel integrated lighting.

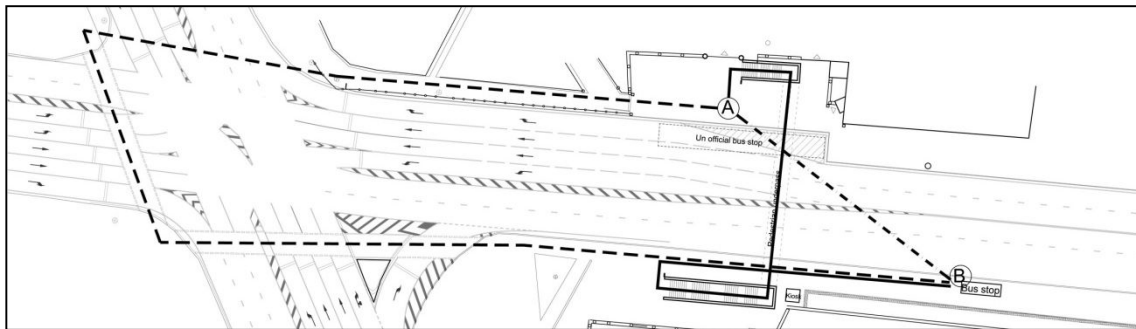
**Figure A 23-1.2-3 Pedestrian route**

For pedestrian there are 3 alternative route to get from A to B Bus stop as shown on below. Route 1 shows ground level route using pedestrian crossing, Route 2 shows using Pedestrian Underpass, and Route 3 is to cross road straightly. Following shows distance pedestrian have to take at each options.

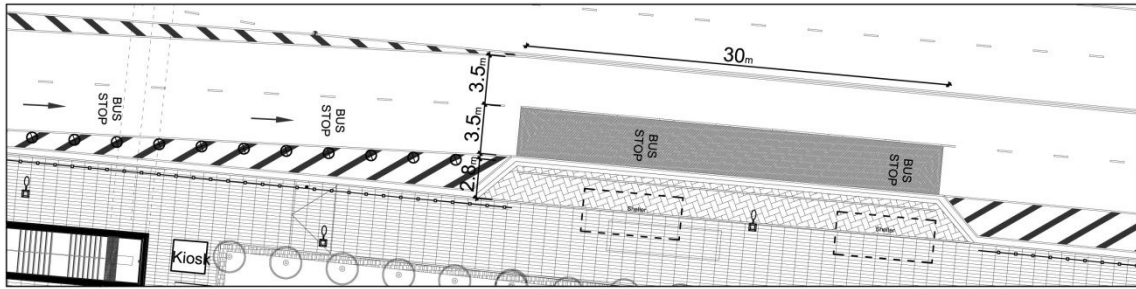
**Figure A 23-1.2-5 Full - width Boarder (Option 1)**

The Option 1 proposed to extend 2.8 m of bus boarder. One lane will be secured for running lane and second lane in front of bus boarder will be secured as Bus Priority zone.

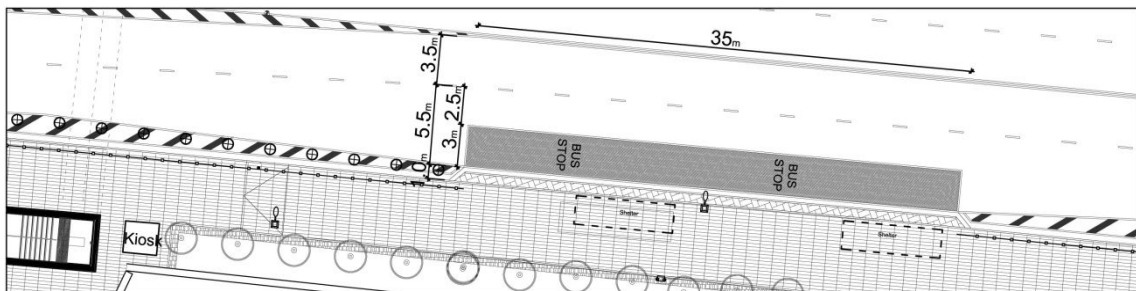
**Figure A 23-1.2-6 1 m Half - width Boarder (Option 2)**

The Option 2 shows Half-width boarder (1 m). One lane will be secure for running lane and the second lane will be half secured as 3 m wide Bus Priority Lane which allows other buses and cars to take over parked buses, without disturbing running lane.

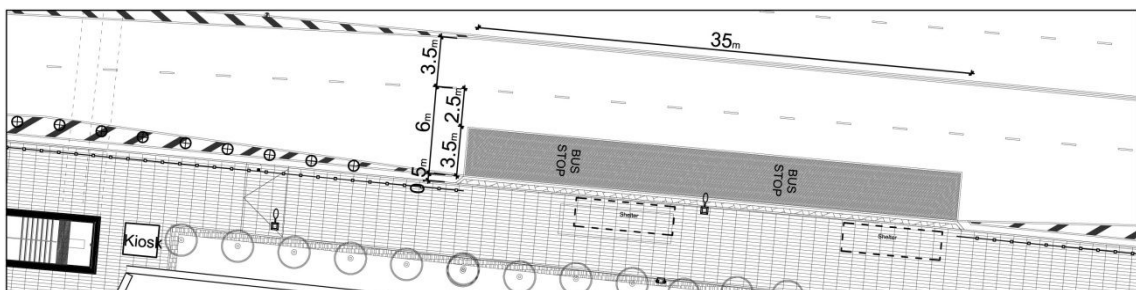
**Figure A 23-1.2-7 0.5 m Half - width Boarder (Option 3)**

The Option 3 shows Half-width boarder (0.5 m). One lane will be secure for running lane and the second lane will be half secured as 3.5 m wide Bus Priority Lane which allows other buses and cars to take over parked buses. Length of Bus boarder will require longer than Full-width boarder.

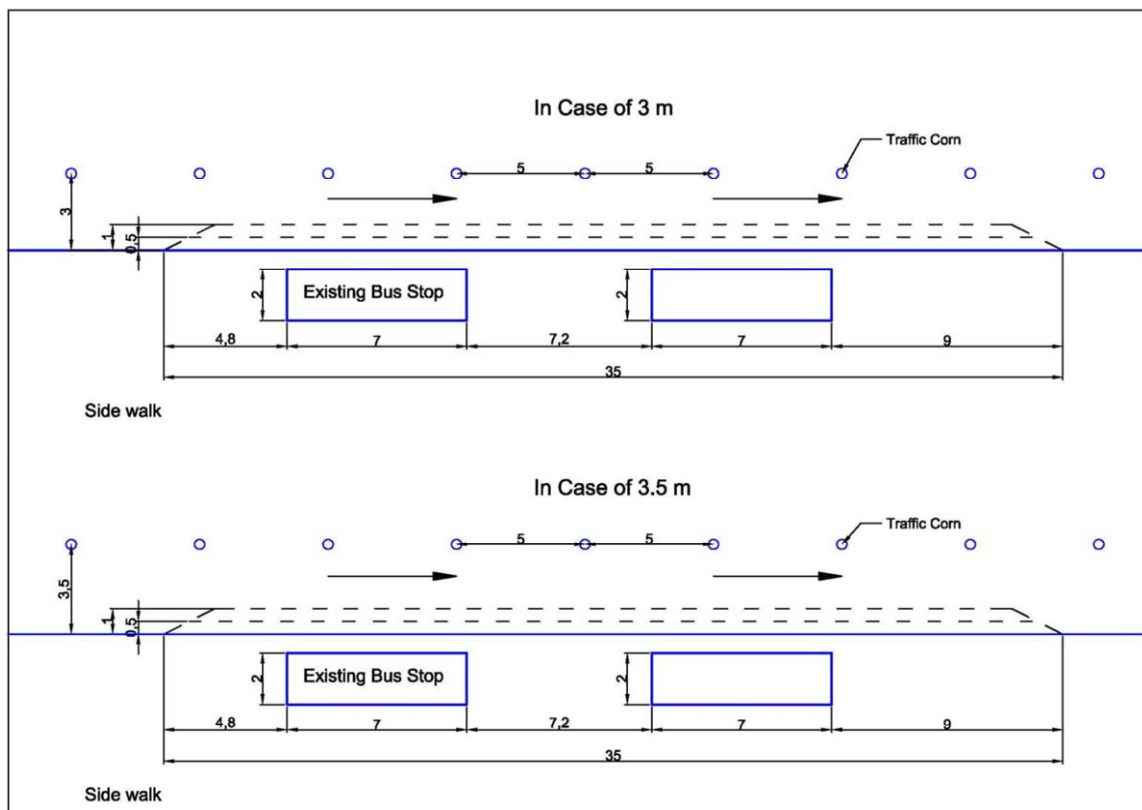
**Figure A 23-1.2-8 Proposed on Site Trial**

For the determination of appropriate bus lane width of 3 m or 3.5 m, on site trial was conducted on 7<sup>th</sup> and 8<sup>th</sup> June 2012 at the bus stop using traffic cones. The survey conducted to investigate how close each type of bus ( Mini Bus, Midi Bus and Trolley Bus) stopped to the curb line according to the width of bus lane of 3 m and 3.5 m. In total 528 no of buses were counted on the first day survey of 3 m width, and 466 buses were counted on the Second day survey of 3.5 m width.

Results showed that in 3 m width bus lane 35% stopped less than 1 m closer bus curb, whereas in 3.5 m width was 29% . For all type of buses 3 m width lane allowed buses to stop closer to bus curb. This result is also in line with the fact found narrower bus stop cage encourage bus drives to stop closer to the curb (Accessible bus stop design guidance, 2006, TfL).
