**Data Collection Survey on
Bridge Sector**

FINAL REPORT

APRIL 2014

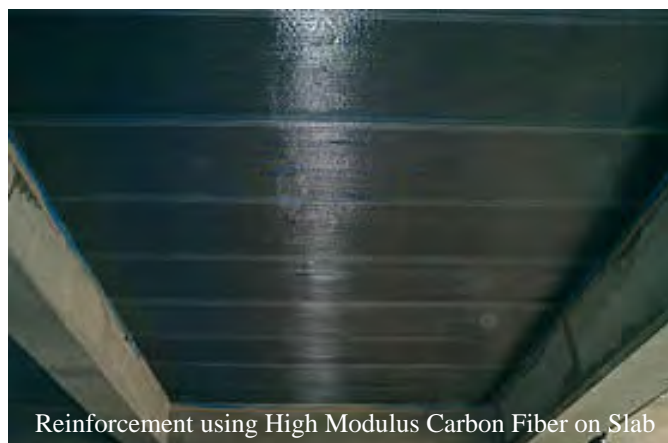
Reinforcement using High-Modulus Carbon Fiber

Bridges damaged by salt can be reinforced using high-modulus carbon fiber.

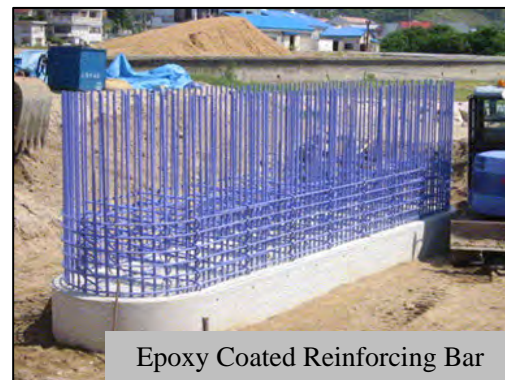
Epoxy Coated Reinforcing Bar

This method uses the epoxy coated reinforcement bar. This reinforcement has high anti corrosion property and is adopted to replace the reinforcement in areas affected by salt.

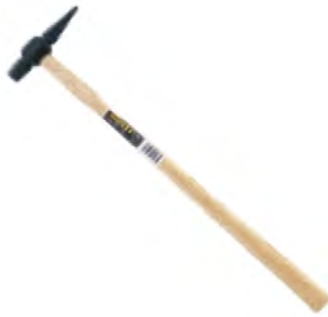
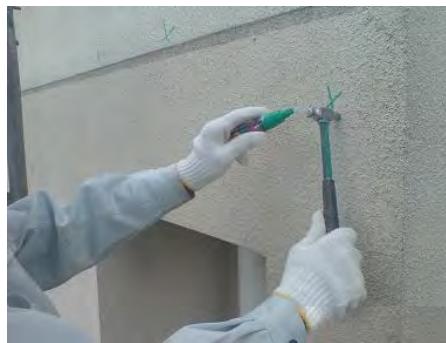
Figure 4.1.1 Testing Hammer (Left), Hammering Test (Right)

The hammering test involves striking the surface of concrete members with a test hammer, and measuring the location and amount of spalling by comparing the sound difference in shock using the human ear. As it is a simple test, it can be used as a test for deterioration on the structure's outer surface, and the soundness of an extensive range of concrete surfaces can be rapidly measured.

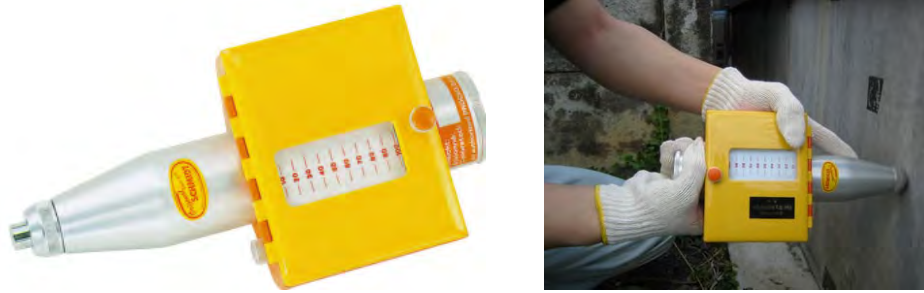
Figure 4.1.2 Rebound Hammer (Left), Schmidt Hammer Test (Right)

The Schmidt Hammer test uses the shock energy produced by the hammer and spring within the test apparatus, treats the rebound energy when the concrete surface is hit as the “degree of rebound”, and then estimates the concrete compressive strength from an empirical relationship between compressive strength and degree of rebound. It is also called the rebound hammer method.

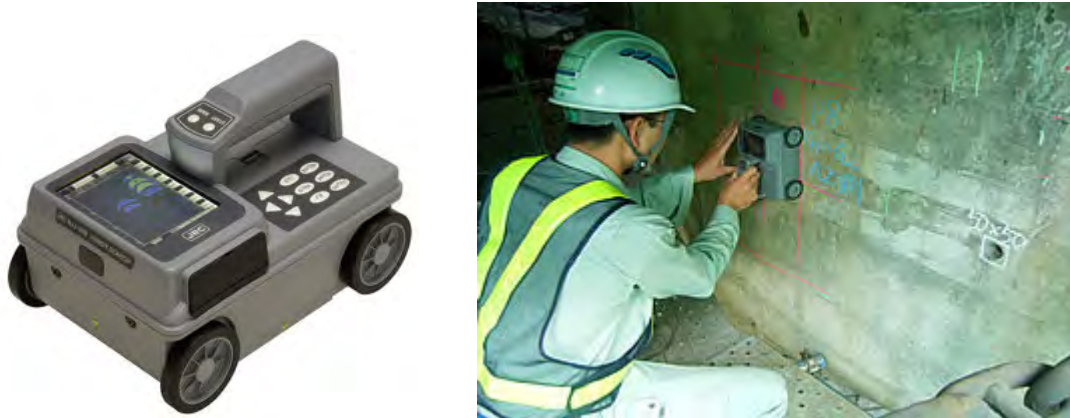
Figure 4.1.7 RC Radar Equipment (Left), RC Rader Inspection (Right)

The RC Rader inspection can be used to acquire information about the location of rebar, the concrete cover, internal porosity, the presence and location of foreign substances, and cavities in the rear of the concrete. In this method, a measuring apparatus equipped with transmitting devices (transmitter, transmitting antenna) and receiving devices (receiving antenna, receiver) is utilized to manually scan the surfaces of concrete structures. To comply with the degree of wave propagation within concrete, the device measuring device used for concrete was equipped with radar capable of sending/receiving RC Rader in the range of 200Mz to 2GHz.

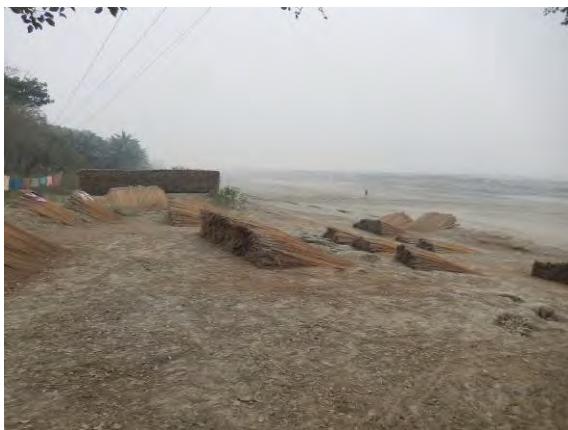
Dhuburi-Phulbari Bridge Candidate site (Assam side)

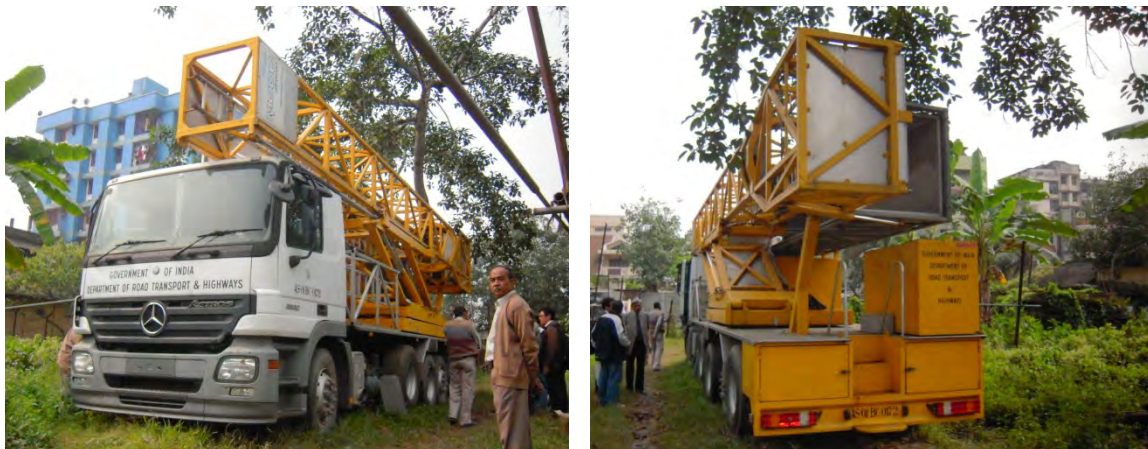
Figure 5.3.1 Photos of Mobile Inspection Unit of Assam PWD

In addition, Kerala PWD has sometimes borrowed it from Tamil Nadu PWD to inspect some inaccessible bridges.

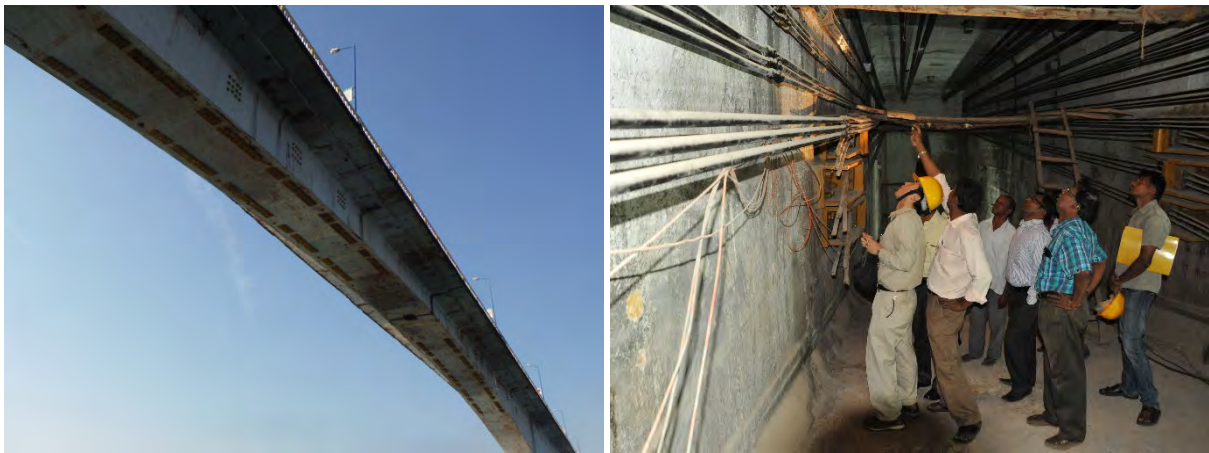
Figure 5.4.5 Photos of Rehabilitation of Zuari Bridge in Goa State

In Goa state, external cables for Zuari Bridge were installed in 1998 and in 2003 by Freyssinet Prestressed Concrete Co. (FPCC) to recover the displacement and fluctuation at the center hinges. A detailed investigation for installation of external cables for Zuari Bridge and design were carried out by the Central Road Research Institute (CRRI). However, de-stressed of installed external cables were founded in 2006; therefore additional rehabilitation (re-stressing) has been requested by Goa PWD to MORTH. The photos of Zuari Bridge are shown in Figure 5.4.5.
