**Bridge Survey Record by Non- Destructive
Inspection**

Outline of the Non- Destructive Inspection

Bridge No.	2	Location (State)	Assam
Bridge Name	Kaliabhomora Bridge	Road Name	NH37A
Station	-	Road Category	National Highway
GPS Data	N 26 ° 36 ' 43.0 "	Management Authority	State PWD
	E 092 ° 51 ' 12.5 "	Year of Construction	1987

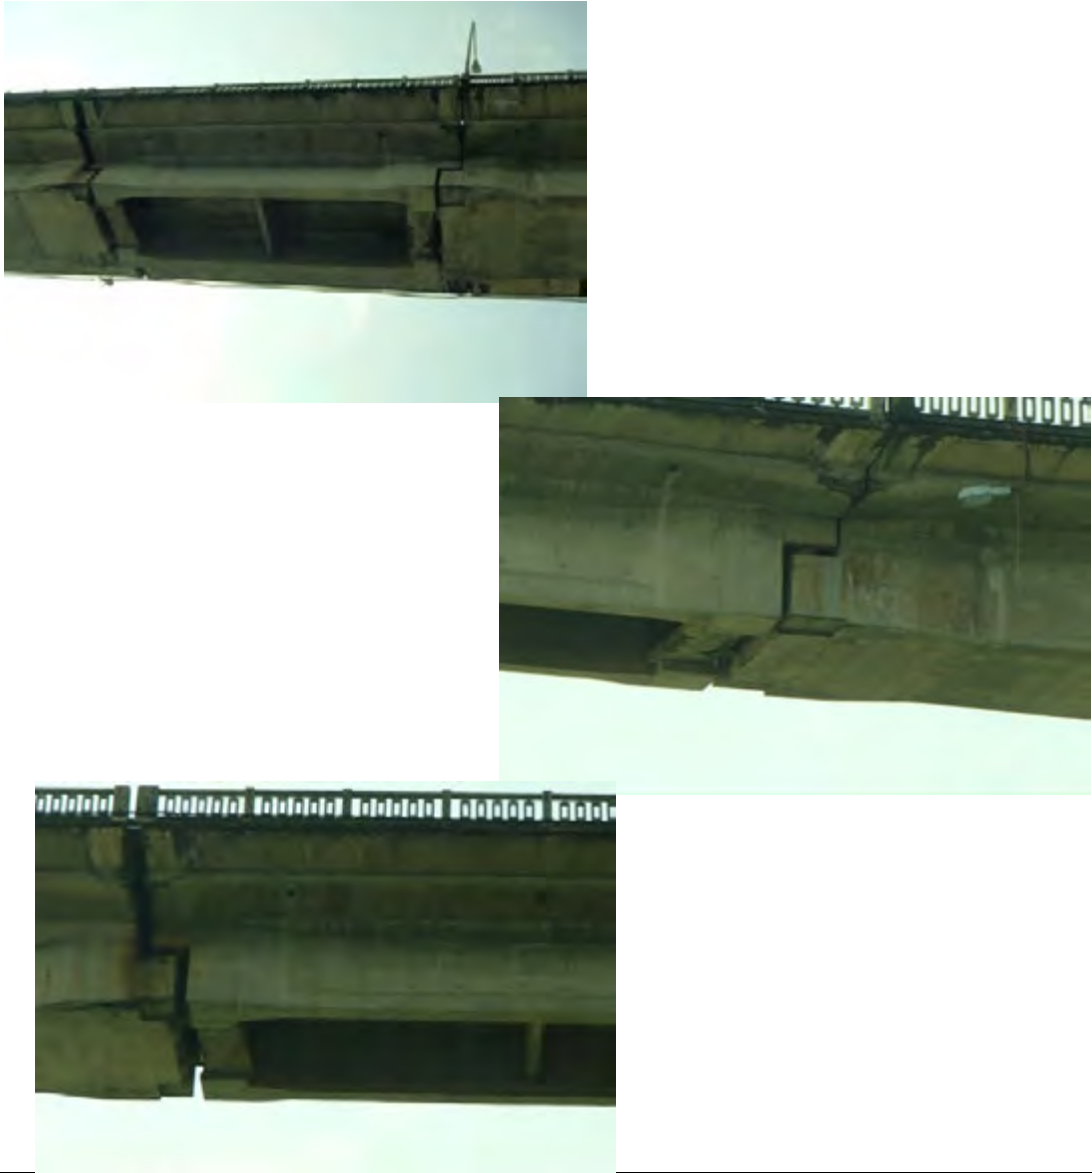
Damage Photoes (3/3)

Object Member	Gerber Girder (at some spans)
Kind of Damage	Level difference at Gerber Girder (P1-P2, P2-P3, P3-P4, P4-P5, P5-P6, P6-P7, P7-P8, P24-P25)
Sketch or Photo

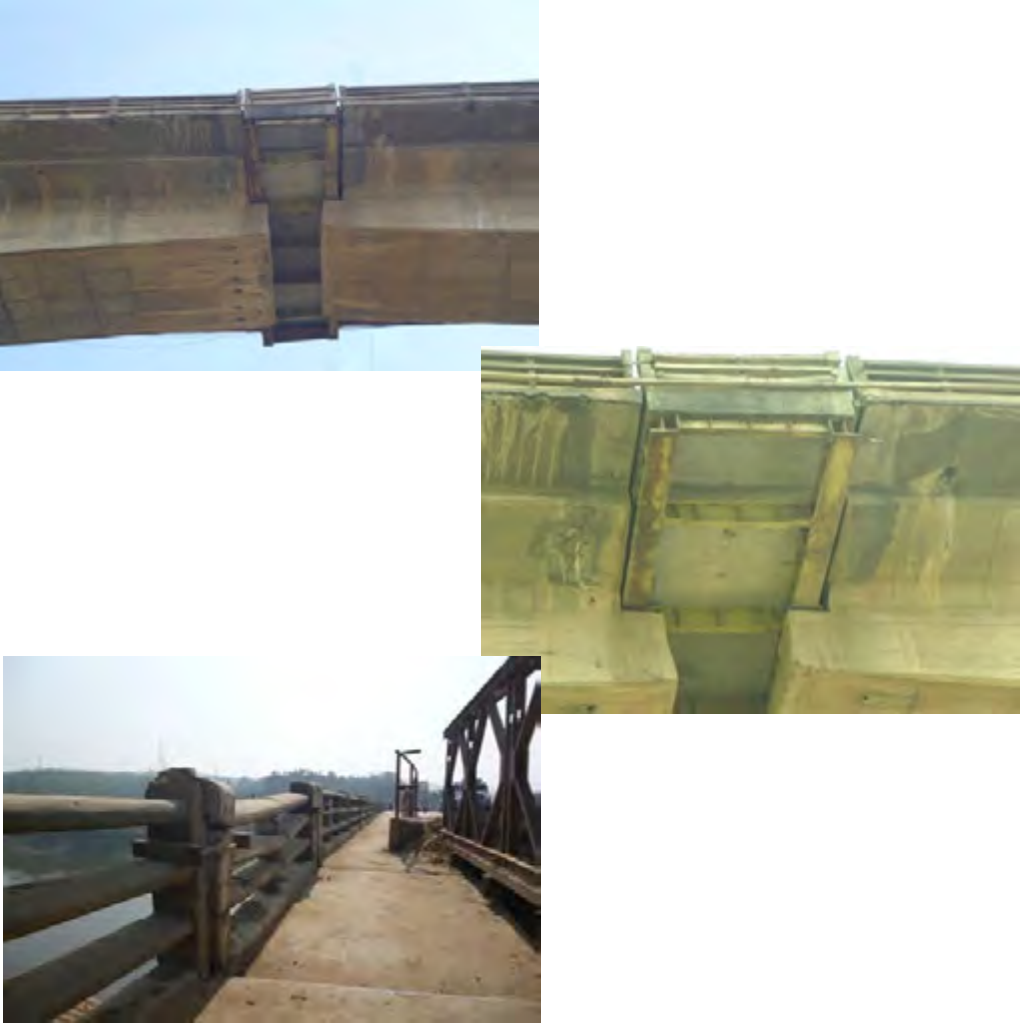
Damage Photos (3/4)

Object Member	Gap Slab (P1-P2)
Kind of Damage	End point of girders damaged. Abnormal deflection, and 10m span steel bridge are provided over the gap slab.
Sketch or Photo

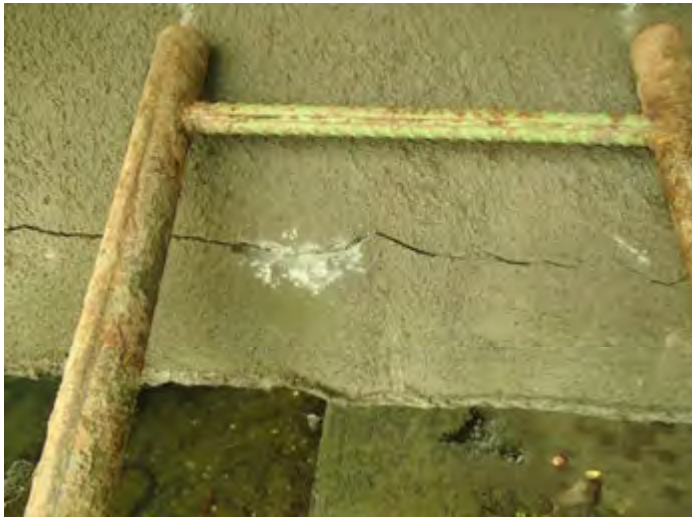
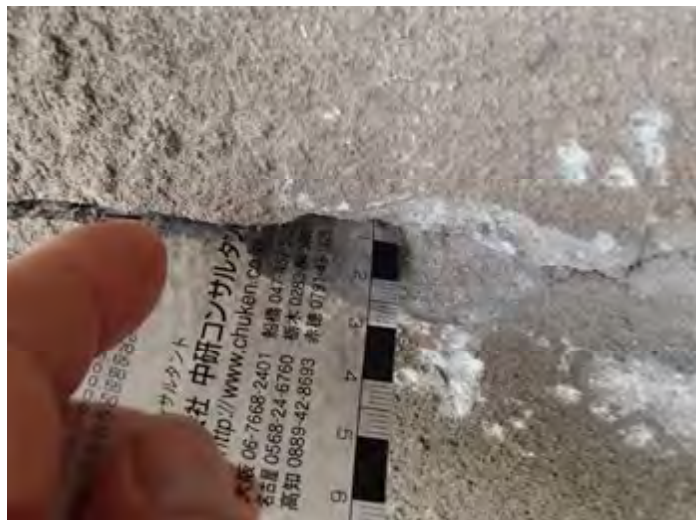
Damage Photos(2/4)

Object Member	Girder (A1-P1)
Kind of Damage	Cracks on web
Photo

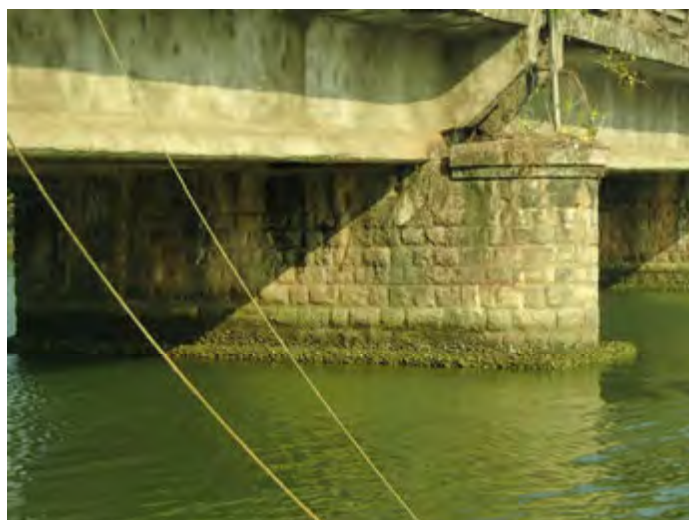
Damage Photoes (4/4)

Object Member	Girder (P1-P2)
Kind of Damage	EXP joints are plugged with asphalt or bituminous material
Photo

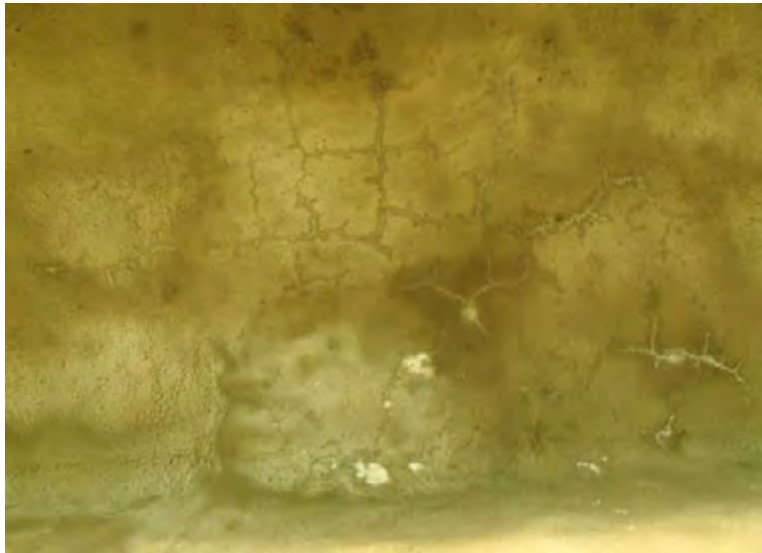
Object Member	Deck slab (P4-A2)
Kind of Damage	EXP joints are plugged with asphalt or bituminous material
Photo

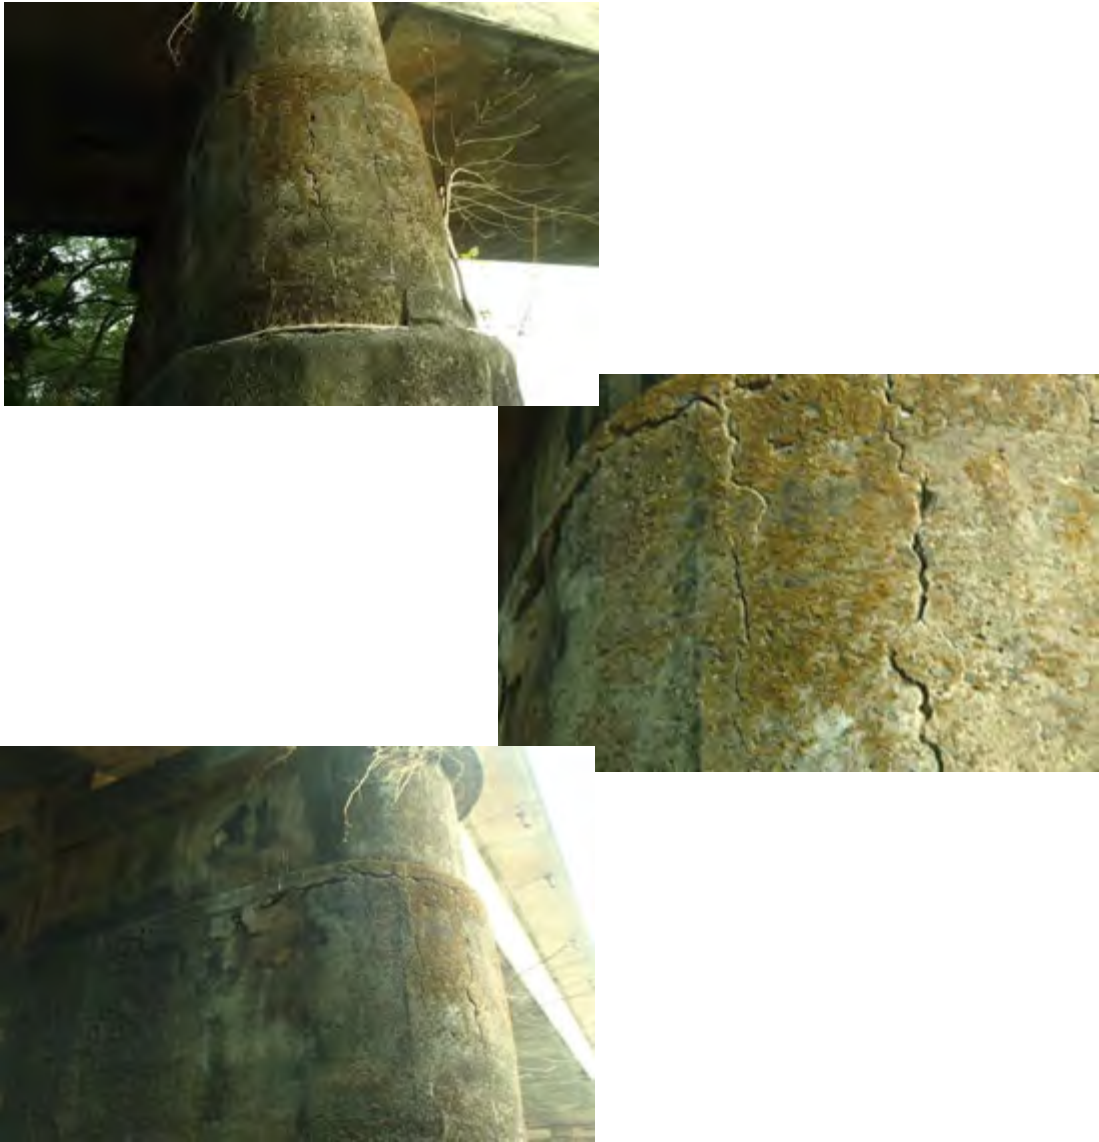
Object Member	P4
Kind of Damage	Crack
Photo

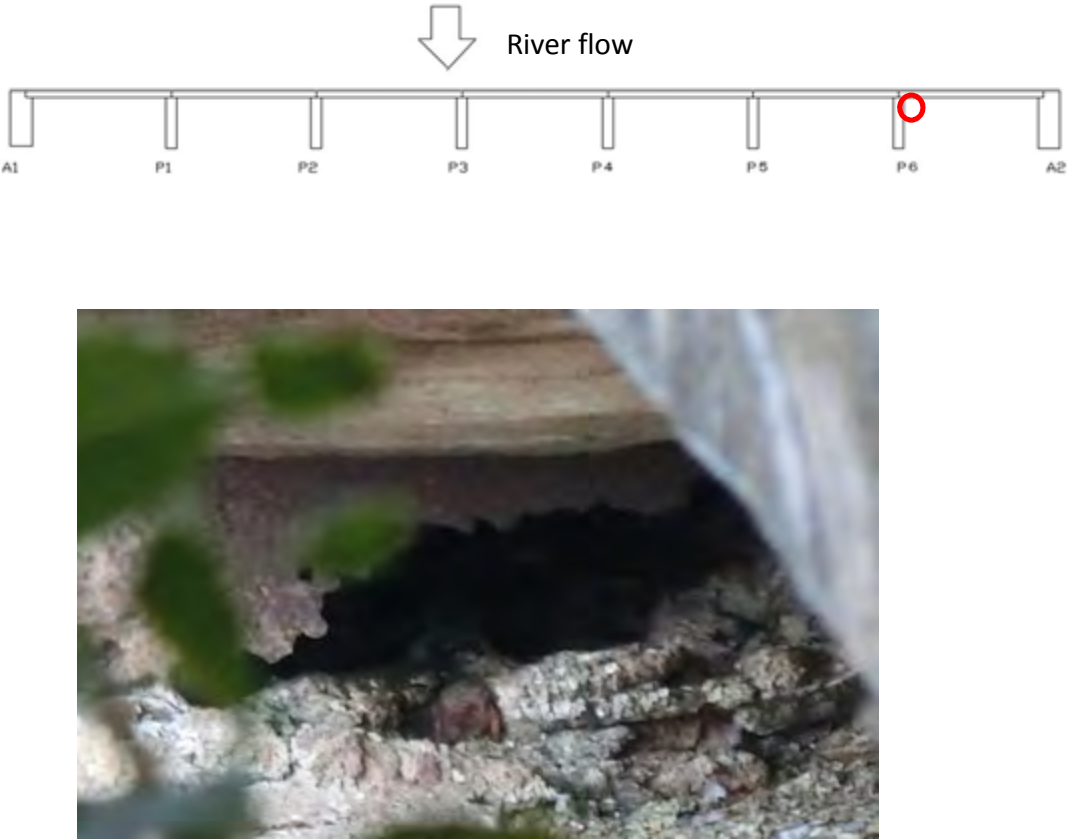
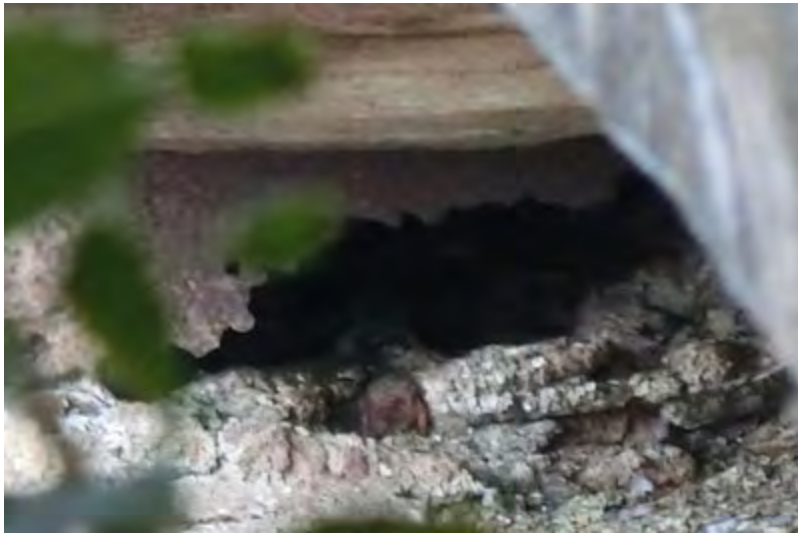
Object Member	Bearing Block (P6)
Kind of Damage	Void in bearing block
Photo

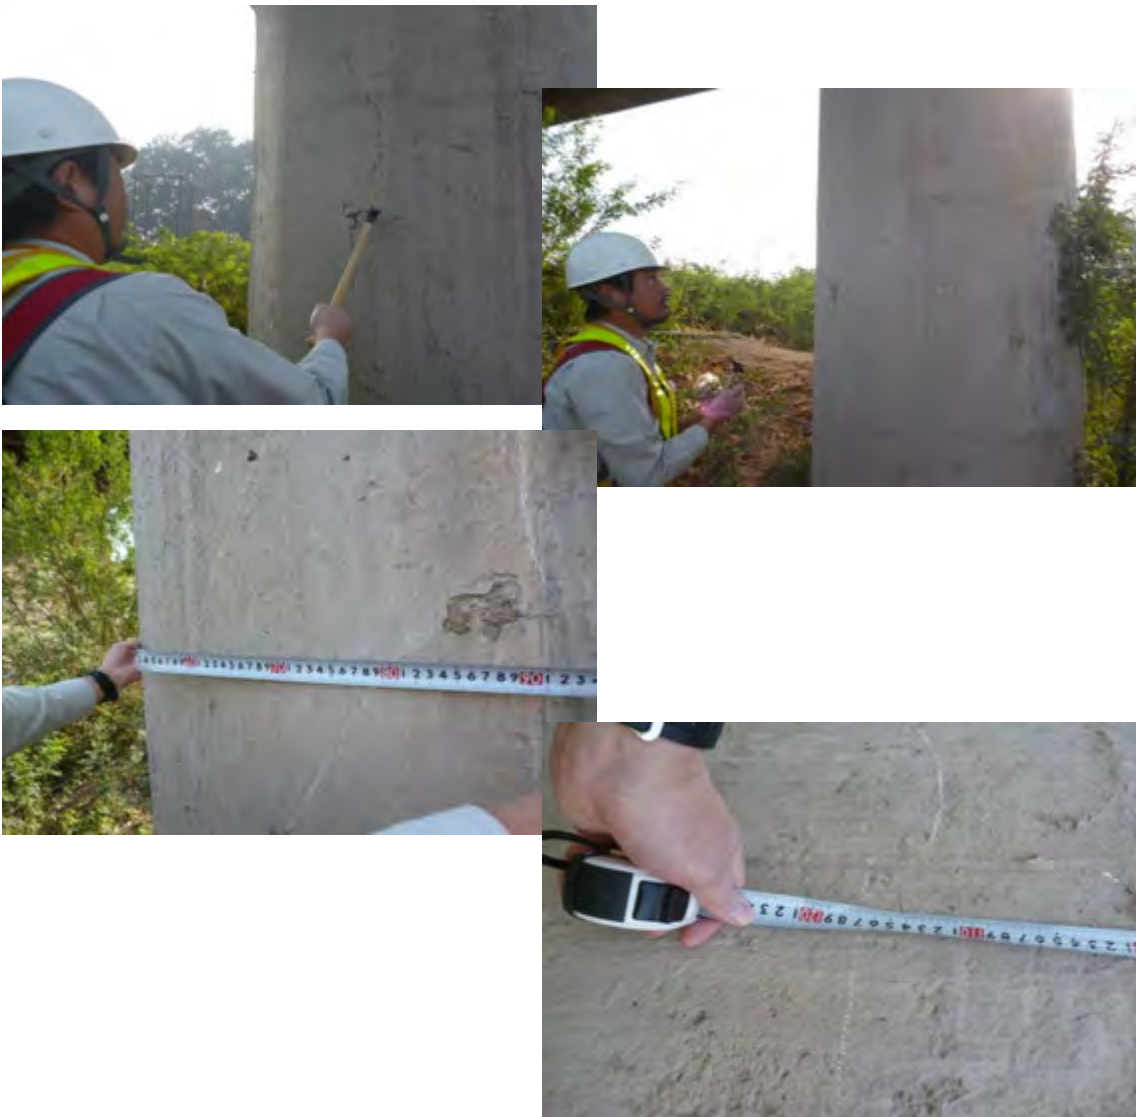
Object Member	P1
Kind of Damage	Swelling
Photo
