6-1 敷地測量図

COMMUNITY DAY SECONDARY SCHOOL

**REPORT ON GEOTECHNICAL INVESTIGATIONS ON
CHIMWALIRA CDSS IN ZOMBA, KABEKERE CDSS IN
NTCHEU DISTRICT, MUHASUWA CDSS IN
CHIRADZULU, UMBWI SS IN DEDZA AND ZOMBA
URBAN CDSS IN ZOMBA CITY**

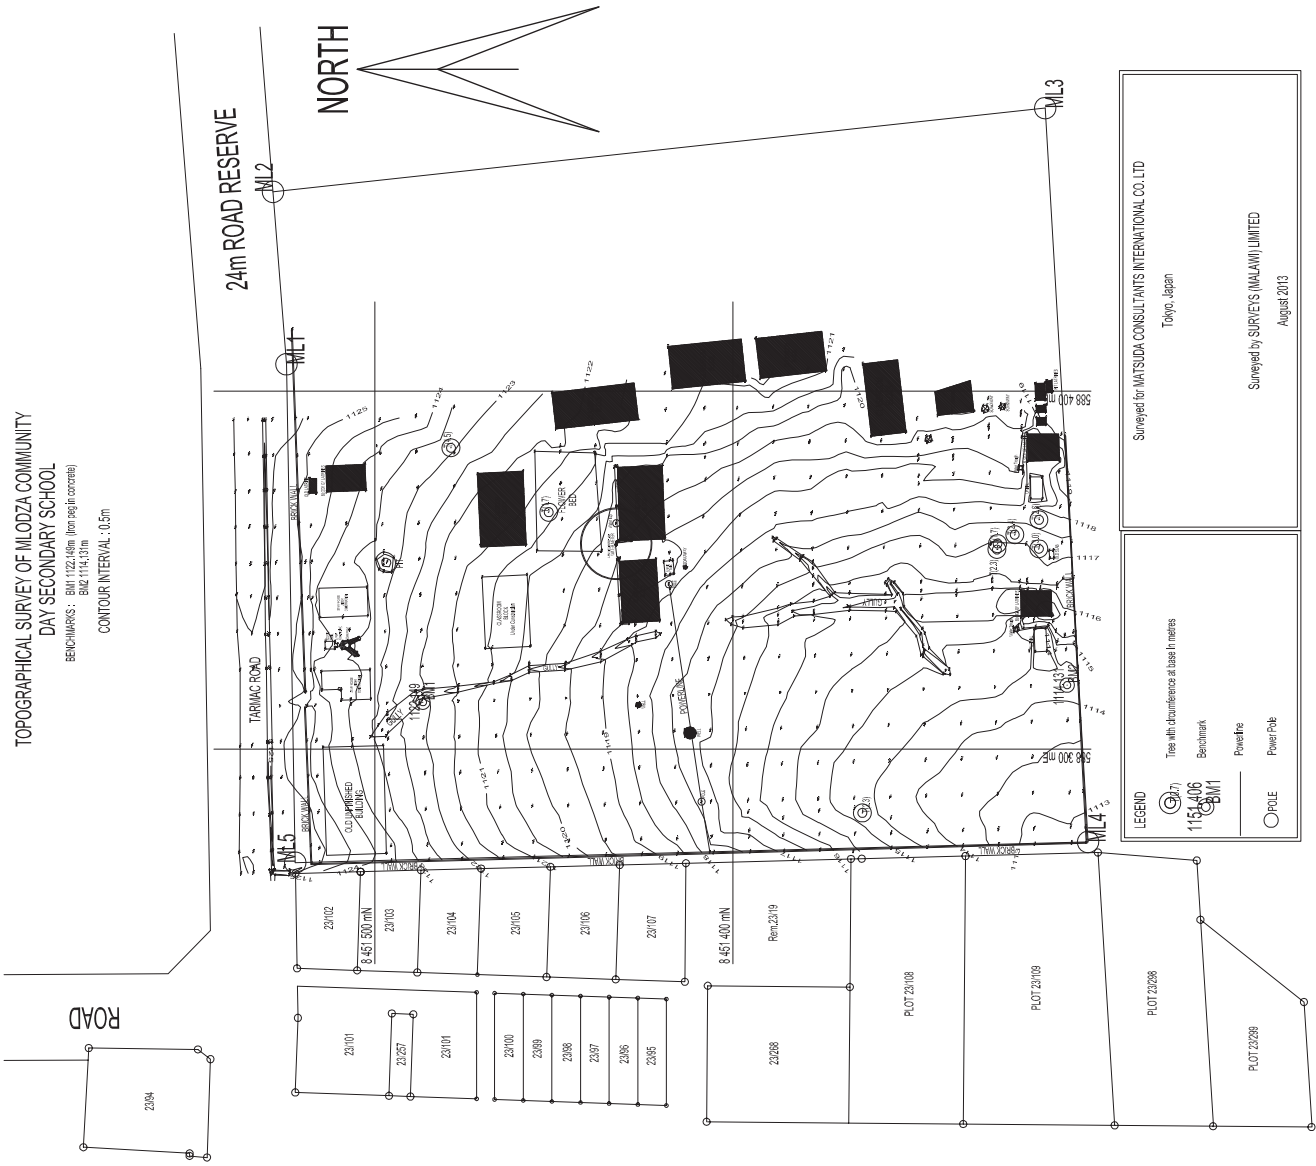
TOPOGRAPHICAL SURVEY OF MILODZA COMMUNITY
DAY SECONDARY SCHOOL

BENCHMARKS : BM 1122.48m (Iron n/g in concrete)
BM 1114.31m

CONTOUR INTERVAL : 0.5m

2.6 Mlodza CDSS

Six trial pits for sample collection and testing were dug at and around Mlodza CDSS. In addition three more pits were dug for Water penetration test. Furthermore 73 points were selected for DCP testing.

Observations on trial pits at 2m depth and classification tests indicated that the soils were basically reddish stiff gravelly clays of Intermediate plasticity with traces of sand size particles.

From the triaxial test, the worst case scenario was observed on Pit no. 3 which gave an angle of friction of 8. degrees and cohesion intercept of 68kN/m^2 . Using Terzaghis Ultimate bearing capacity equation and assuming a 1m deep foundation and 690mm wide strip footing, the ultimate bearing capacity of the soil is 544kN/m^2 . Applying a Factor of safety of two the safe bearing capacity is 272kN/m^2 which is adequate to support foundation loads from the buildings.

From the DCP test it was observed that most areas had a Penetration index of less than 14mm/blow (approx CBR of 14.4). This indicates that basically the surface at Mlodza CDSS is stable and sound. Foundations can safely be placed at depth of not less than 1m from the surface.

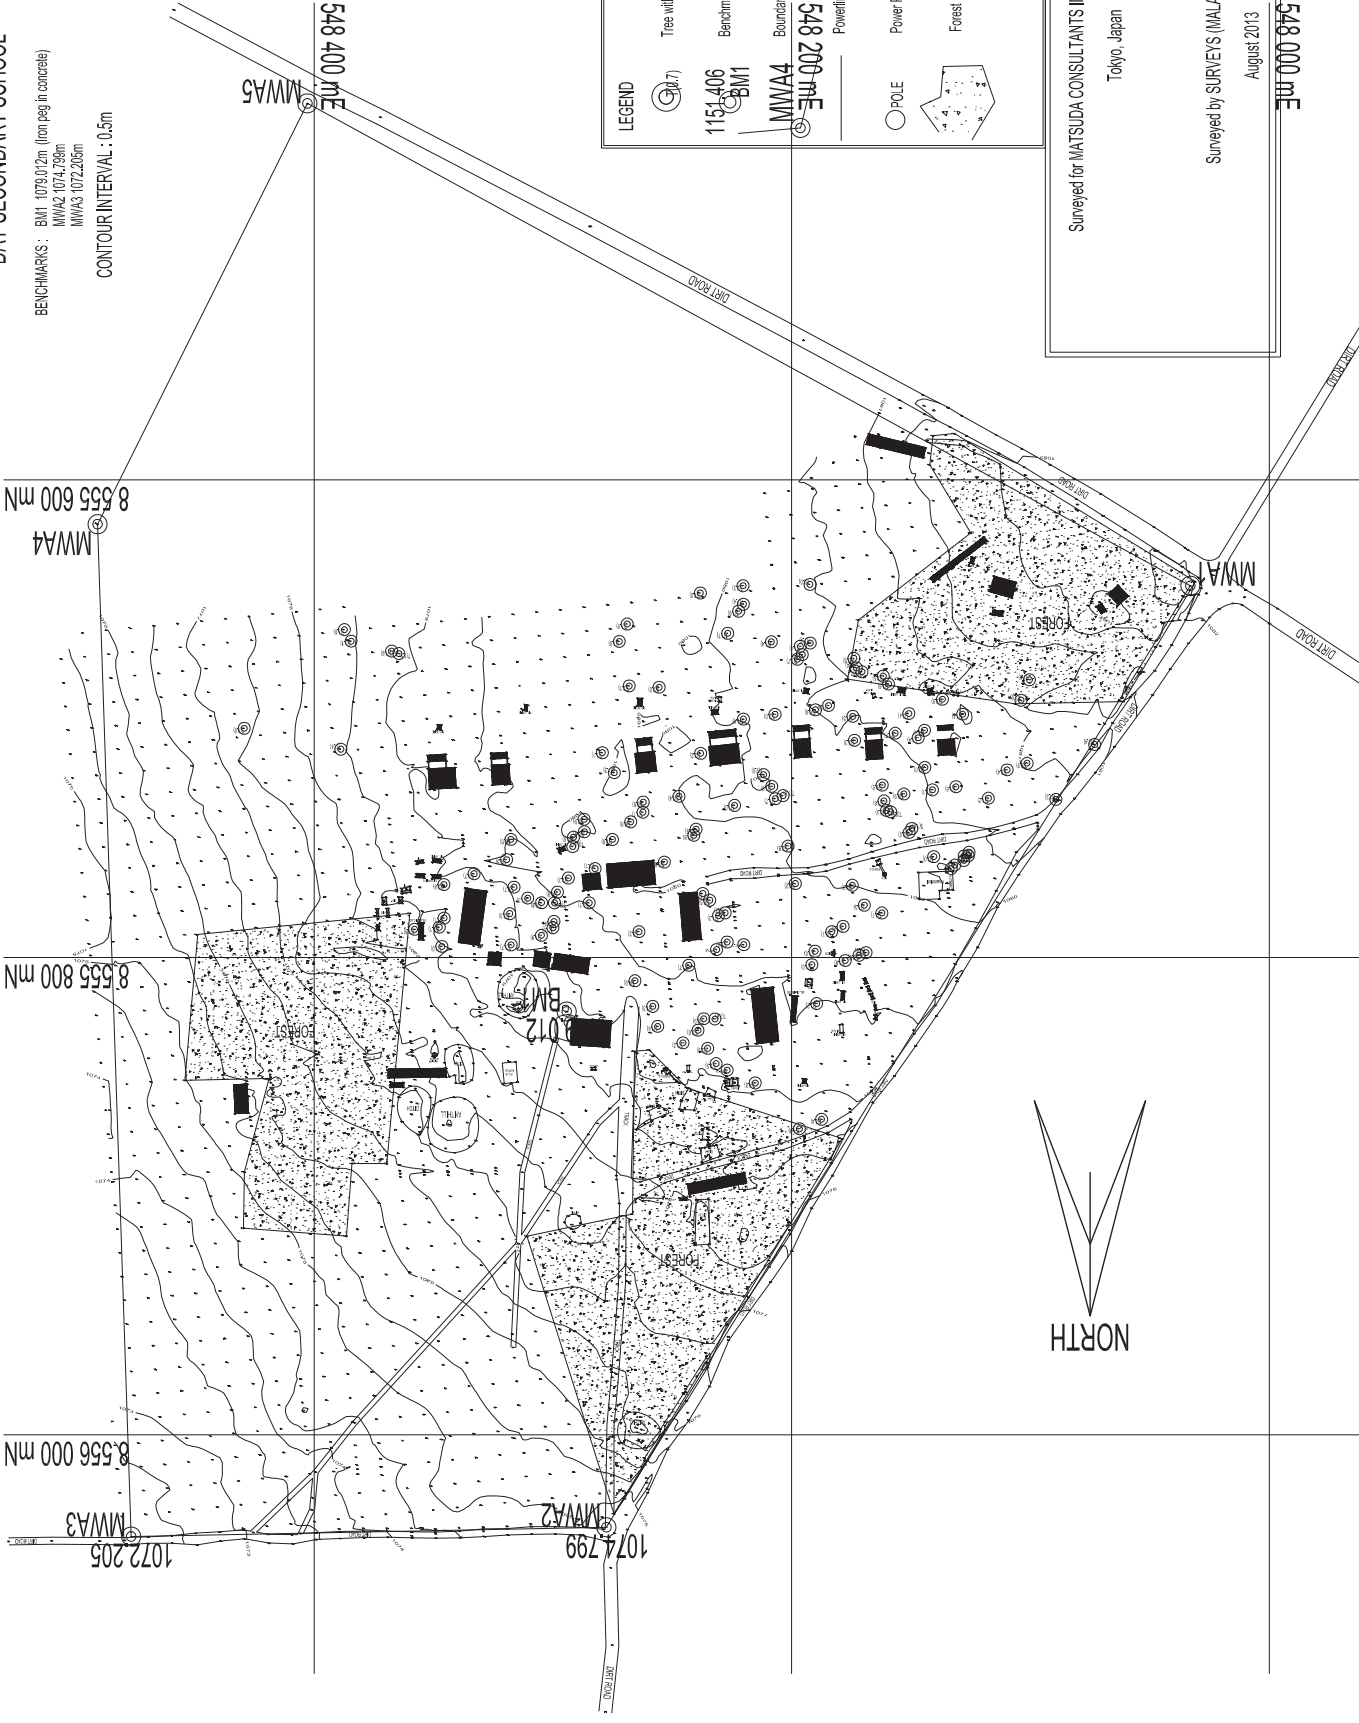
TOPOGRAPHICAL SURVEY OF MWALAWANYENJE COMMUNITY
DAY SECONDARY SCHOOL

BENCHMARKS : BM1 1078.012m (Iron peg in concrete)
MW42 1074.799m
MW43 1072.205m

CONTOUR INTERVAL : 0.5m

Six trial pits for sample collection and testing were dug at and around Mwalawanyenje CDSS. In addition three more pits were dug for Water penetration test. Results of penetration test were not realised because the water seeped away. Furthermore 46 points were selected for DCP testing.

Observations on trial pits at less than 2m depth and classification tests indicated that the soils were predominantly reddish silty sands of Intermediate plasticity with traces of gravel size particles. Beyond 2m a decomposed rock was noted.

From the triaxial test, the worst case scenario was observed on Pit no. 6 which gave an angle of friction of 8.5 degrees and cohesion intercept of 57kN/m^2 . Using Terzaghis Ultimate bearing capacity equation and assuming a 1m deep foundation and 690mm wide strip footing, the ultimate bearing capacity of the soil is 438kN/m^2 . Applying a Factor of safety of two the safe bearing capacity is 219kN/m^2 which is adequate to support foundation loads from the buildings.

From the DCP test it was observed that some of the areas had a Penetration index of less than 30mm/blow (approx CBR of 5.5). This indicates that basically most of the surface at Mwalawanyenje CDSS is weak. Before the foundation can be placed the foundation area need to be treated by placing at least a 200mm layer of compacted gravel to 98% MDD. This will assist to bridge up weak areas.

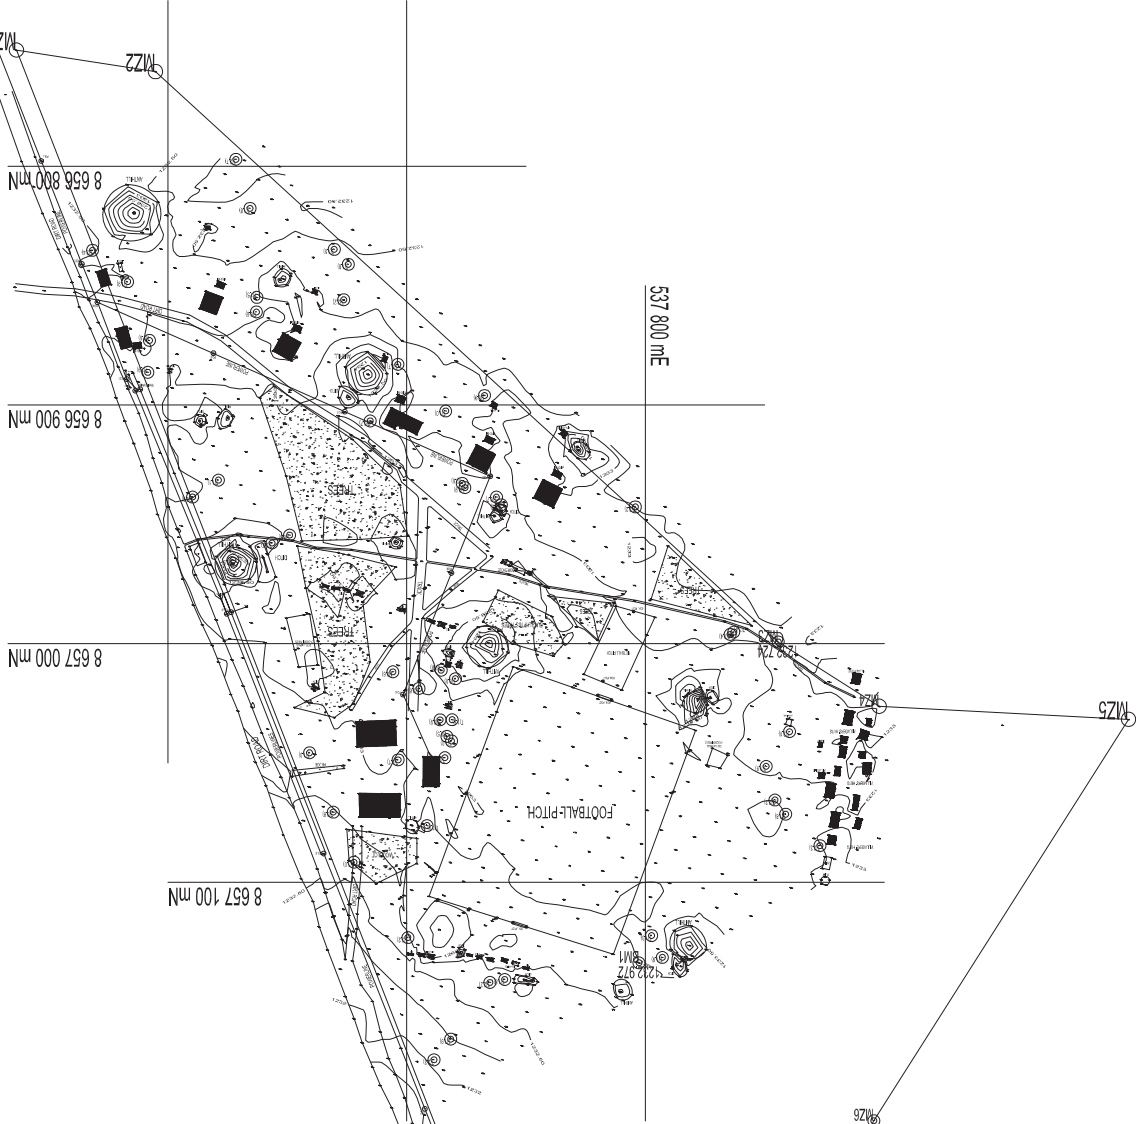
**TOPOGRAPHICAL SURVEY OF IZOMA COMMUNITY
DAY SECONDARY SCHOOL**

BENCHMARKS : BM1 : 1232.872m (Iron peg in concrete)
MZ3 : 1232.724m
MZ6 : 1232.808m

CONTOUR INTERVAL : 0.25m

Six trial pits for sample collection and testing were dug at and around Mzoma CDSS. In addition three more pits were dug for Water penetration test. Results of penetration test were not realised because the water seeped away. Furthermore 46 points were selected for DCP testing.

From the triaxial test, the worst case scenario was observed on Pit no. 2 which gave an angle of friction of 8.6 degrees and cohesion intercept of 60kN/m^2 . Using Terzaghis Ultimate bearing capacity equation and assuming a 1m deep foundation and 690mm wide strip footing, the ultimate bearing capacity of the soil is 478kN/m^2 . Applying a Factor of safety of two the safe bearing capacity is 239kN/m^2 which is adequate to support foundation loads from the buildings.

From the DCP test it was observed that most areas had a Penetration index of less than 13mm/blow (approx CBR of 15.8). This indicates that basically the surface at Mzoma CDSS is stable and sound. Foundations can safely be placed at depth of not less than 1m from the surface.
